# Development of Inspection and Repair Technology for Heat Exchanger Tubes in Fast Breeder Reactors

A prototype probe system with a hybrid optical fiber scope was designed for inspecting and repairing heat exchanger tubes in fast breeder reactors (FBRs). It comprises a laser processing head combined with an eddy current testing unit. Ultrashort laser pulse ablation is used to remove work-hardened layers. And spot laser welding is used to repair cracks. This system is both a safe and economical option for the maintenance of FBRs because it extends the lifetime of the heat exchangers.

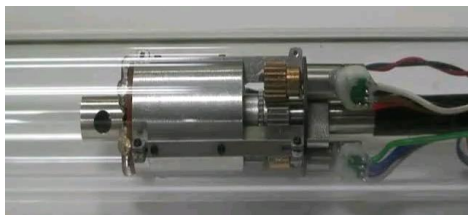
Fig. 4 Laser processing head

The laser processing head was specifically designed to access the inner walls of heat exchanger tubes. It comprises a movable sleeve that is driven by two pulse motors. Both rotational and longitudinal motion are possible on the sleeve, which has a 45° tilted mirror at the inside end and an oval hole where a high-energy laser beam and images are transmitted. Figure 4 is a photograph of the laser processing head inserted in a 1-inch acrylic pipe. The outer diameter was designed to be less than 20 mm. The movable sleeve is supported by ball bearings in a housing, which make it possible to move the processing head 5 mm in the longitudinal direction and rotate it by  $\pm 185^\circ$ .

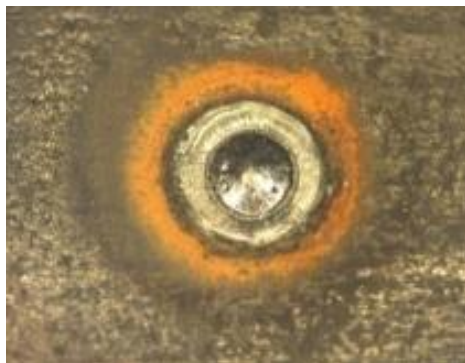
**Fig. 9** Molten pool on a heat exchanger tube

Figure 9 shows a laser welding demonstration by a high power fiber laser. An ytterbium fiber laser and the composite-type optical fiberscope were connected in the

coupling device. The laser output was increased to 1 kW. The target was a STBA24 tube containing 2.25% Cr. The working distance from the fiberscope to the target was 19 mm. A shielding glass plate was set to protect the fiberscope lens. An input power of 300 W with 1 second irradiation had sufficient heat-load for spot welding. The target surface had a shallow dimple of 0.52 mm in diameter and a surrounding molten zone with a diameter of 0.87 mm. Oxide particles were deposited up to a diameter of 1.5 mm. As the input power was increased over 400 W, surface evaporation and fume generation at the molten pool became strong. Contamination on the shielding glass plate prevented a laser power of over 400 W from reaching the target surface. Therefore, it is determined that a high brilliant fiber laser of 300 W is satisfactory for spot laser welding.
