# NAVAL POSTGRADUATE SCHOOL

## THESIS

### FEASIBILITY OF UNDERWATER FRICTION STIR WELDING OF HY-80 STEEL

March 2011

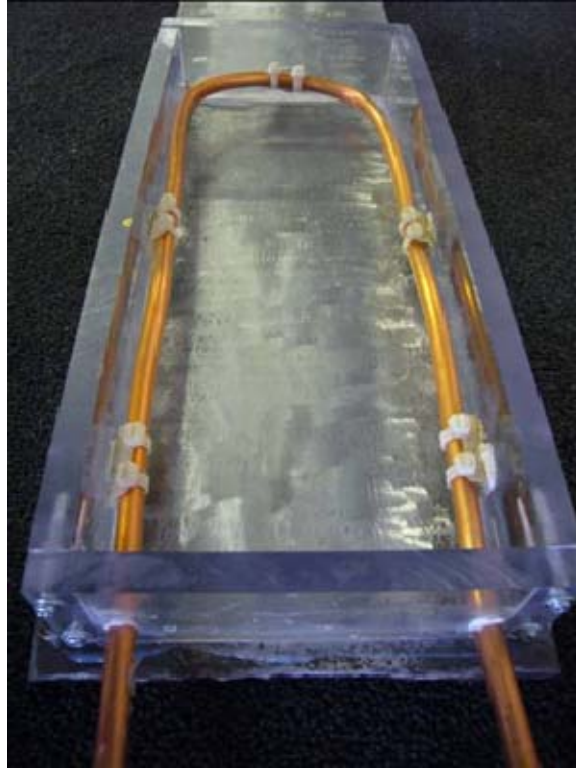
Figure 2. Underwater chamber with cooling coil for FSW/P. From [13]

A steel plate was obtained from the Naval Surface Warfare Center – Carderock Division, Bethesda, MD, that was 0.25 inches (6.4mm) thick and 26.5 inches (mm) wide by 43.5 inches (mm) long. Pre-welding chemical analysis was conducted by Anamet, Inc., Hayward, CA and confirmed the material conformed to the HY-80 steel specification. The plate was cut into three sections for base metal analysis and dry and wet (underwater) friction stir processing and for future research. Each plate measured approximately 26.5 inches (mm) long by 14.5 inches (mm) wide. One plate was sectioned to produce 25 Charpy V-notch samples and 5 tensile test samples each in both the rolled and transverse directions. The second plate was cut into two sections each measuring approximately 26.5 inches (mm) by 7.25 inches (mm). One section each was used for dry and wet (underwater) FSP. Initially, the plate was sand blasted to remove mill-scale. However, following the dry friction stir weld, the second plate was hand-ground to be sure all mill-scale was removed. All FSW was performed parallel to the long dimension [13]. The FSP was conducted by Advanced Metal Products and MegaStir Technologies in Provo, Utah. Figure 2 is the underwater friction stir welding chamber. It is made from clear plexiglass to enable clear observation of the FSW/P process. A copper cooling coil is attached to a chiller to provide heat removal of the water and prevent the salt water from boiling off. The chamber is sealed to plate using silicone adhesive. The water in the chamber is saltwater (3.5% salt content).

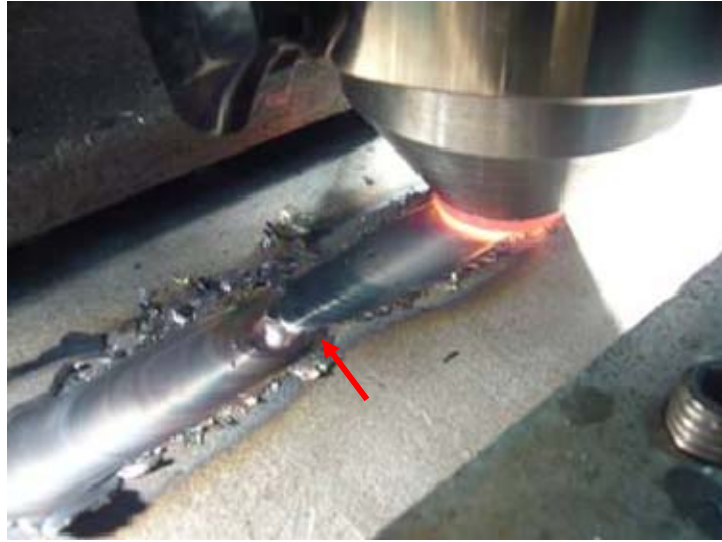
Figure 3. Dry FSW second plunge and traverse. From [13]

A dry FSP run of approximately 25 inches was completed at 400 RPM and 2 IPM. A plunge load of greater than 15,000 pounds was applied and decreased to 10,000 pounds. A software error caused the tool to extract after a few inches of weld, requiring a second plunge and traverse (Figure 3) [13]. Following the second plunge, the first 12 inches of weld surface looked good. There were, however, occasional surface flaws on the advancing side that may have been caused by surface oxides or mill-scale but further study is required to determine the exact cause (Figure 4). As the weld progressed, the surface flaws became more pronounced and severe. In the final 10 inches of the weld run, severe lack of bonding on the advancing side is visible (Figure 5) [13]. As a result, the tool was moved to a parallel location and an attempt was made using different approaches to produce a defect free weld including improved surface preparation and different FSW parameters (Figure 6). The severe defects remained but weld flash was reduced with improved surface finishing.

Surface defects are readily apparent in the dry FSW. As shown previously in Figures 3–7, there is significant weld flash and lack of bonding on the advancing side of the weld. The wet FSW runs appear to be defect free and fully penetrated welds with the exception of minor weld flash.

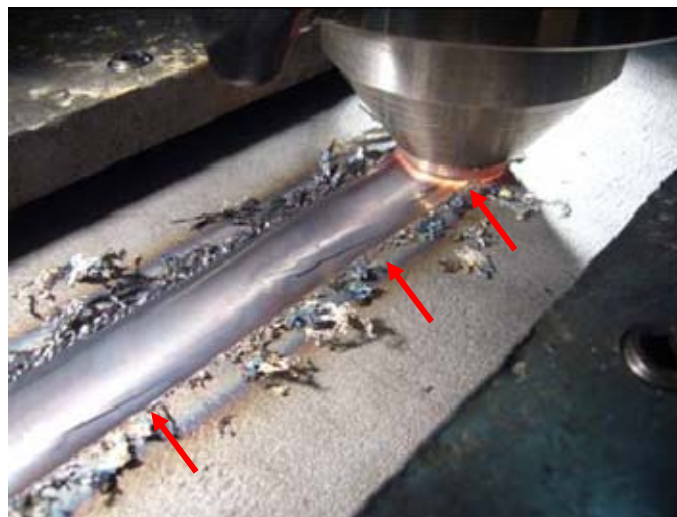
Figure 4. Shallow surface defects on the tool advancing side of dry FSW. From [13]

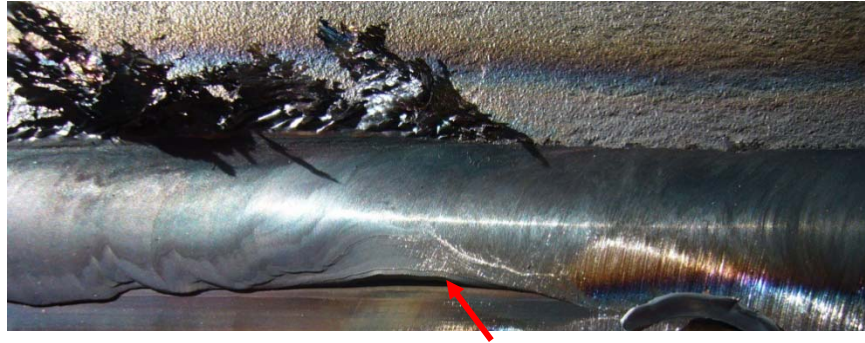
Figure 5. Lack of bonding on advancing of last 10 inches of weld length. From [13]

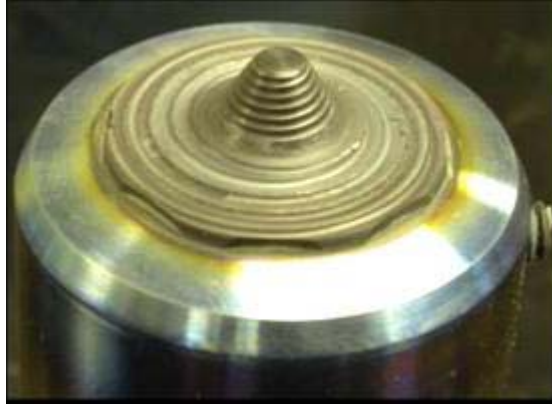
Figure 7. Polycrystalline cubic boron nitride (PCBN) CS4 tool used for FSW. From [13]

The tool material was polycrystalline cubic boron nitride (pcbn) consolidated with a metallic binder identified as MS80. The tool design was a convex scroll shoulder with a step spiral pin (CS4) (Figure 7) [13].

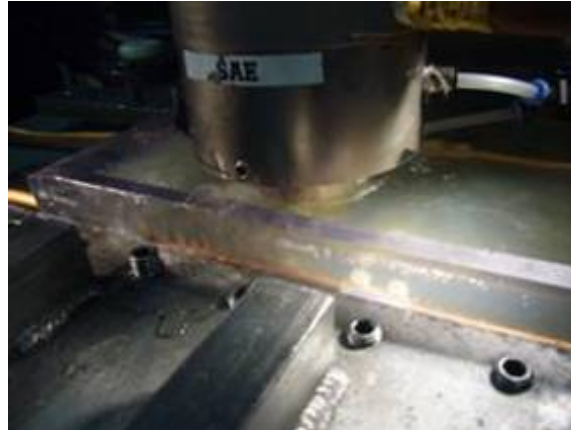
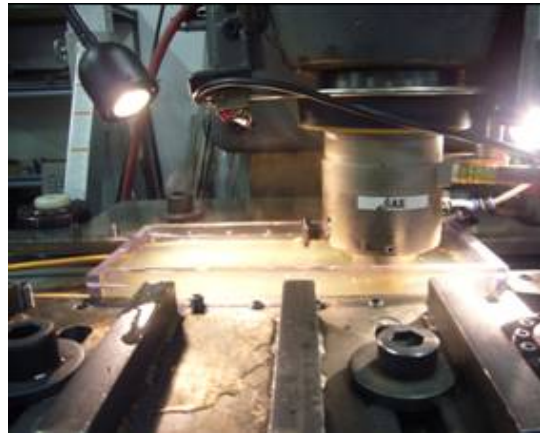
Figure 8. Underwater FSW in progress. From [13]

Due to the size limitations of the underwater chamber, two approximately 10 inch underwater weld runs were completed for a total length of approximately 20 inches. Figure 8 shows the underwater weld setup in progress. Figure 9 shows a relatively good surface appearance for the first weld. A small amount of weld flash and surface oxidation is visible but the weld appears to be free of defects and full penetration. Figure 10 shows the weld root surface and the tool extraction site [13]. Underwater welding was carried out in water containing 3.5wt% NaCl in order to simulate the welding in seawater.

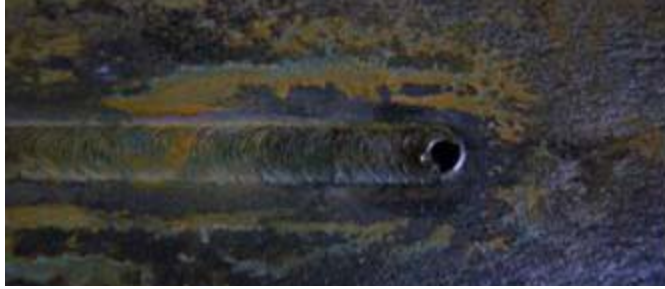
Figure 10. Root surface of underwater friction stir weld. From [13]

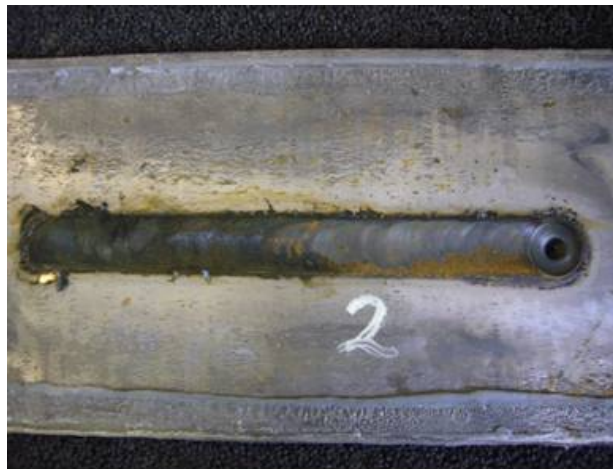
Figure 11. Second underwater FSW. From [13]

For the second underwater FSW run, the chamber was moved to the other half of the plate and resealed. During the second FSW, a leaked occurred and all of the water drained from the chamber. The chamber was refilled with fresh tap water and the weld was finished [13]. Figure 11 shows the weld surface of the second wet FSW [13].

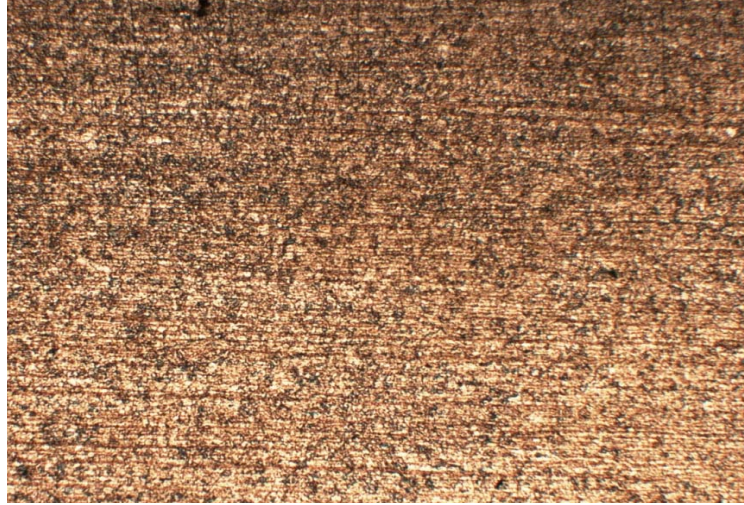
Figure 16. Base material at 2.5x. A band-like distribution is visible.

In the base material, lighter and darker bands parallel to the plane of the rolled sheet were visible (Figure 16). This indicates that the thermomechanical processing did not completely homogenized the material by removing all remnants of segregation and coring effects. The microstructure is suggestive of a ferritic–pearlitic structure in lower strength steels and the final heat treatment to produce a tempered martensitic structure evidently did not remove these effects.

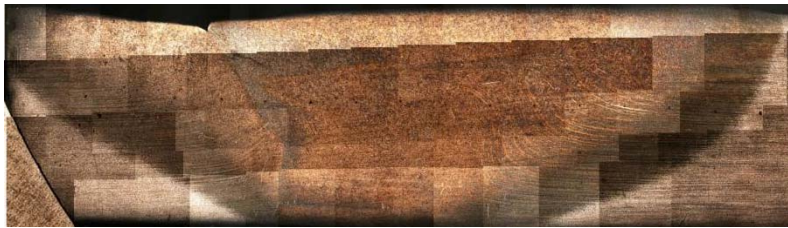
Figure 17. Montage of micrographs of dry FSW at 2.5x

The dry stir zone appears to be narrower than the wet stir zone. The wet TMAZ appears to be narrower than the dry TMAZ. This likely caused by the higher quenching rate of the wet FSW. The wet stir zone appears to be more homogenized as well.

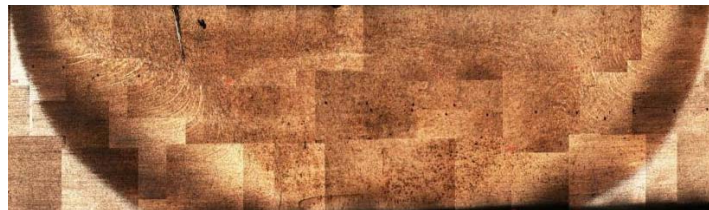
Figure 18. Montage of micrographs of wet FSW at 2.5x
