**US Army Corps  
of Engineers®**  
Engineer Research and  
Development Center

## Deformable Bullnose Energy Absorbing System (BEAS)

### Report 2: Head-On Impact with a Deformable BEAS and Introducing a Collapsible Arch

July 2011

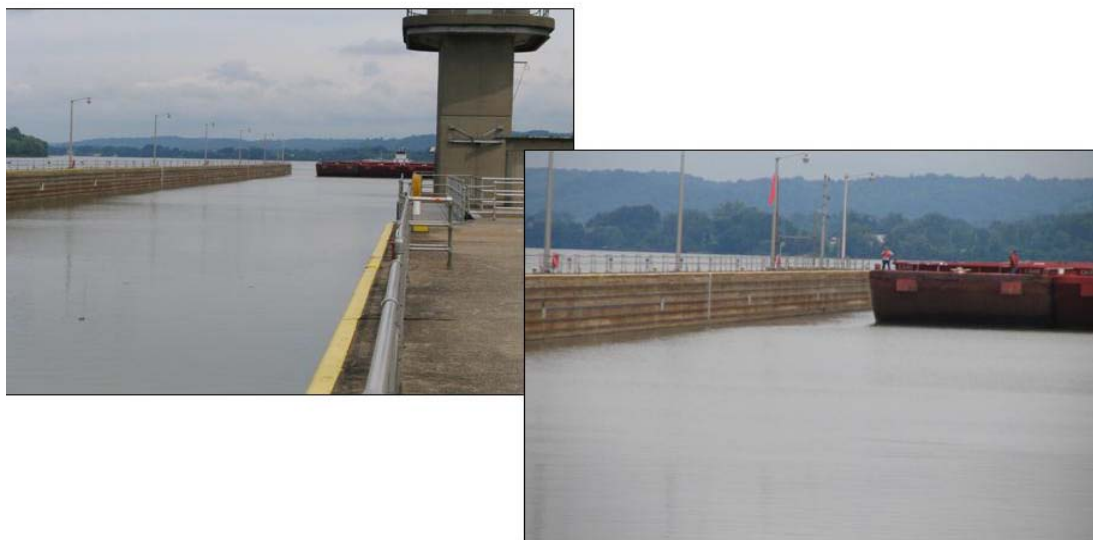
Figure 2.2. Low flow downbound tow approaching guard wall at Markland main lock.

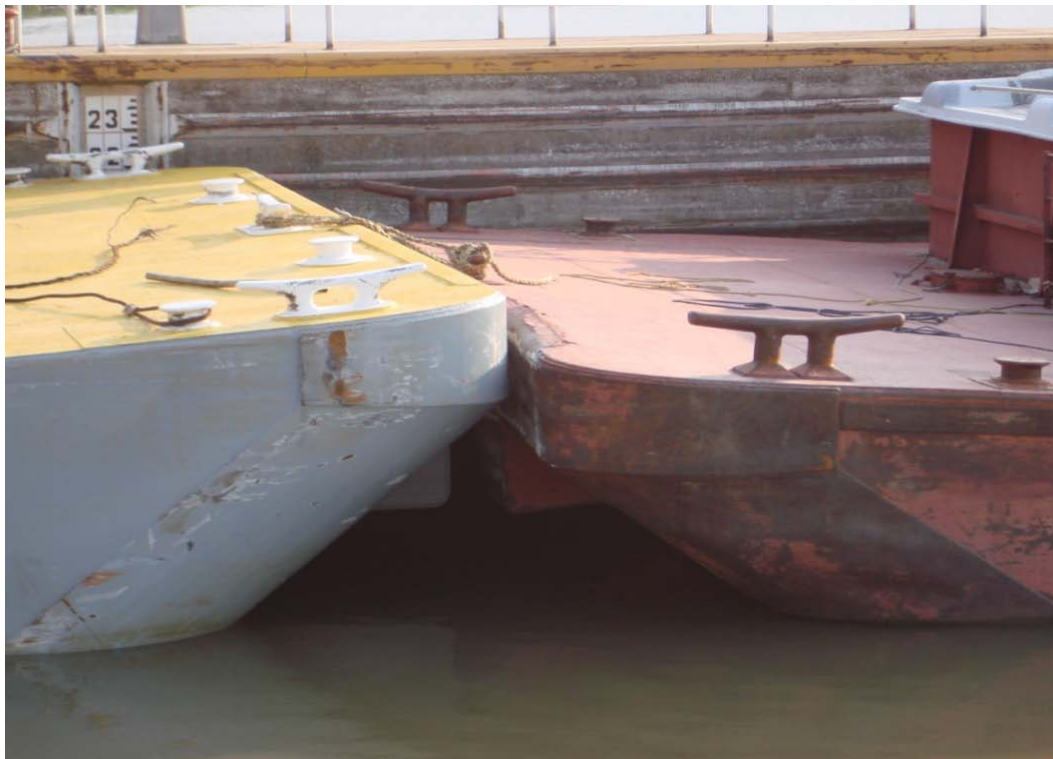
Figure 2.20. View of damage to barges that hit the guide wall at Newt Graham Lock and Dam 18.

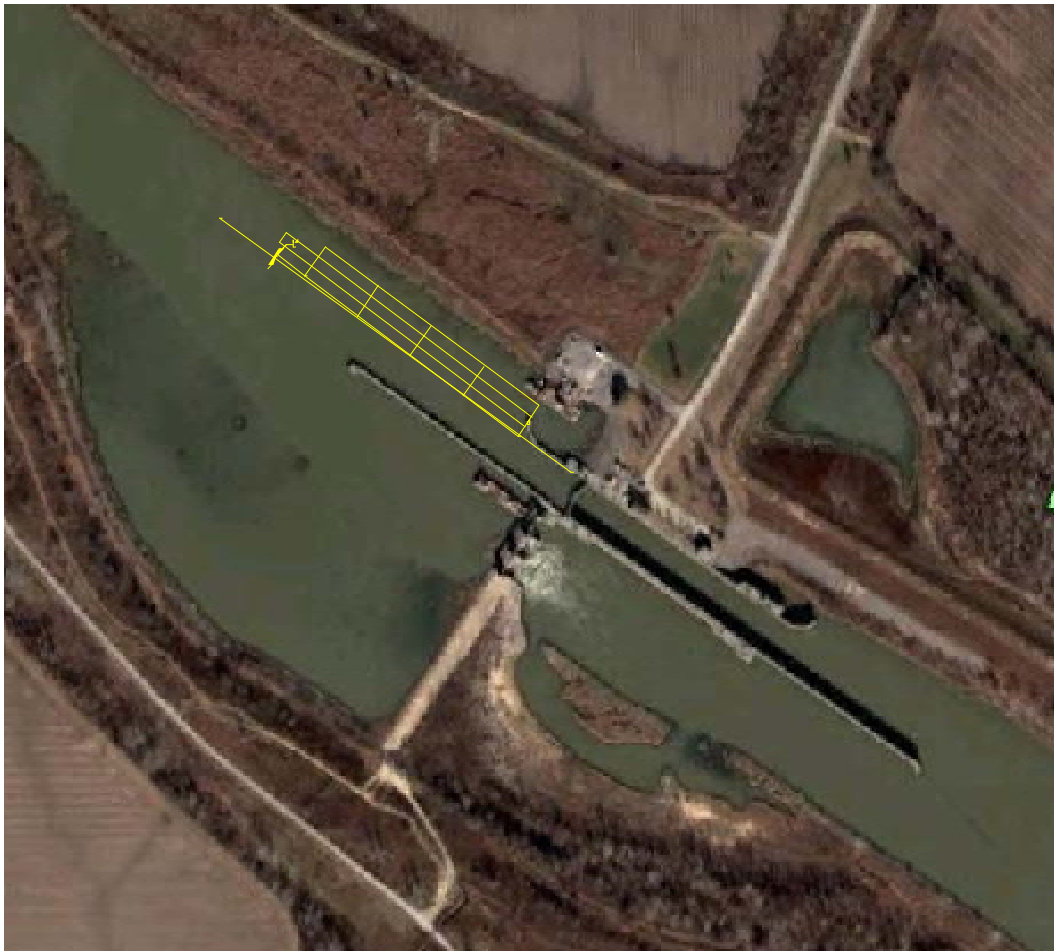
Figure 2.21. Depiction of geometry limited approach angle for 3 x 4 barge tow impacting the guide wall.

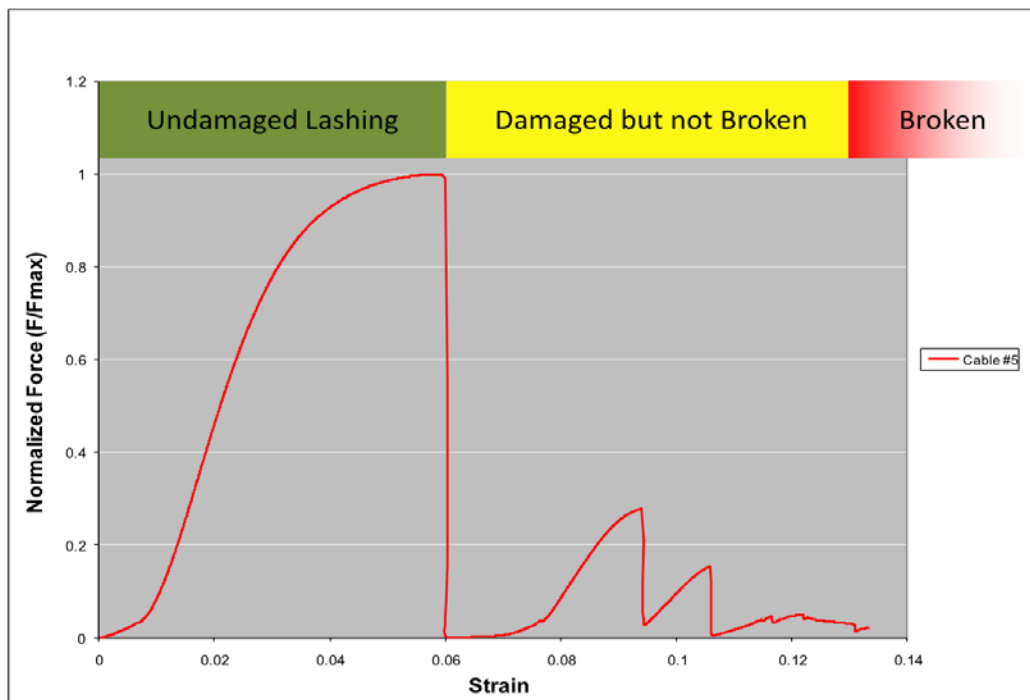
Figure 3.15 Three Lashing States Based on Strain with Normalized Force.

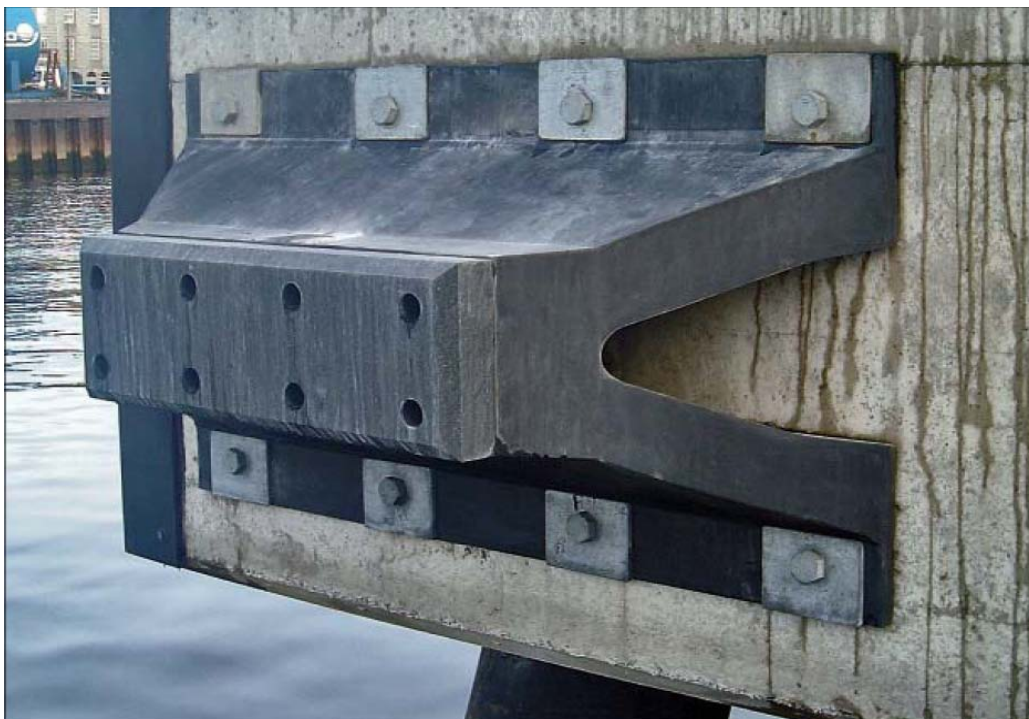
Figure 5.7 A Super Arch Delta energy absorbing system (after Trelleborg, 2007).

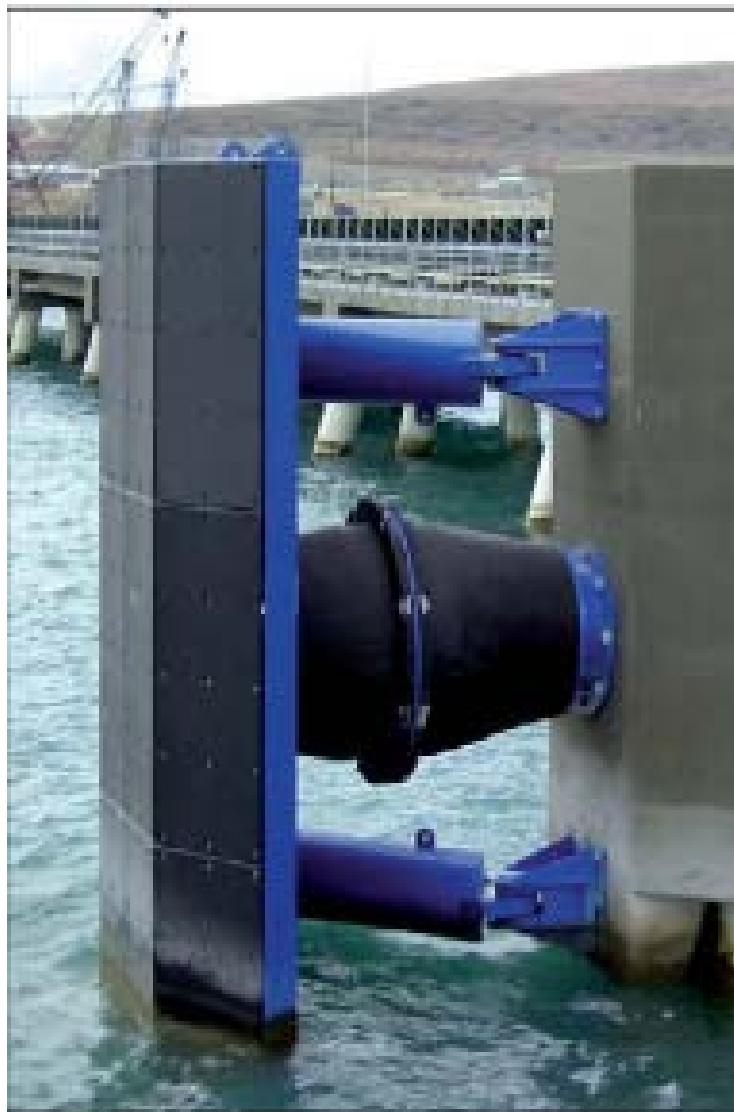
Figure 5.10 Double Super Cone Fenders (after Trelleborg, 2007).

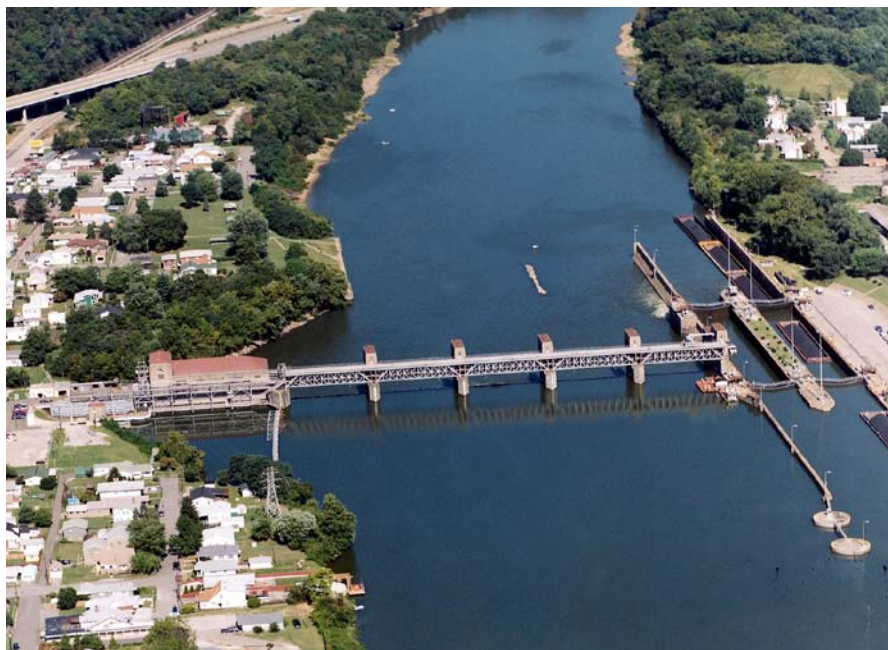
Figure 5.17 Marmet Lock and Dam with Cellular Bullnose

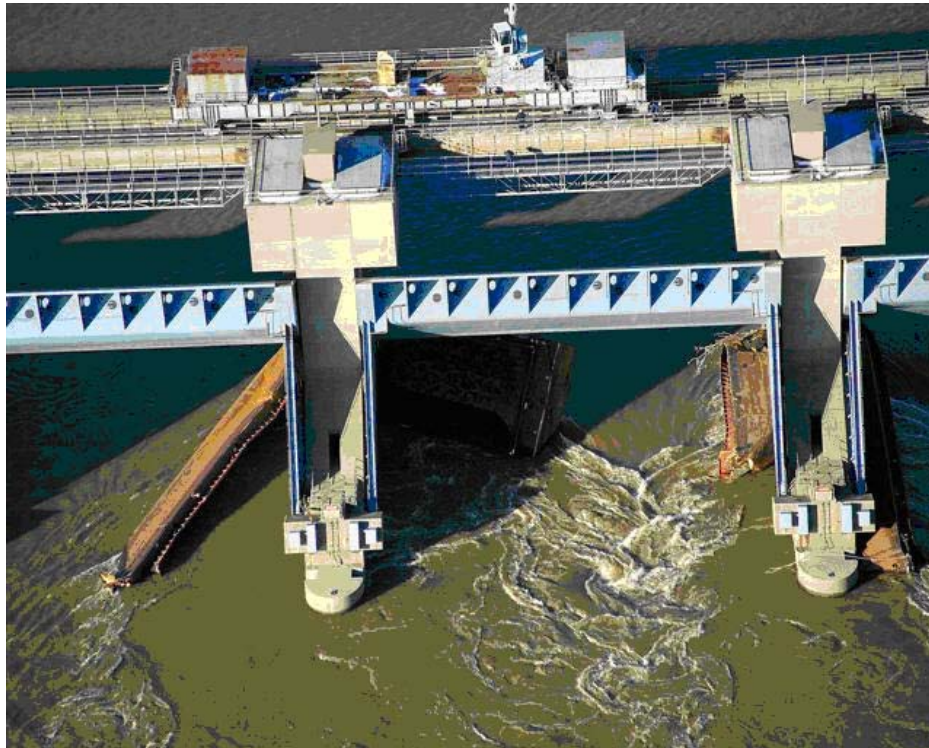
Figure 5.19. Barges blocking dam gate operations at Belleville Locks and Dam.

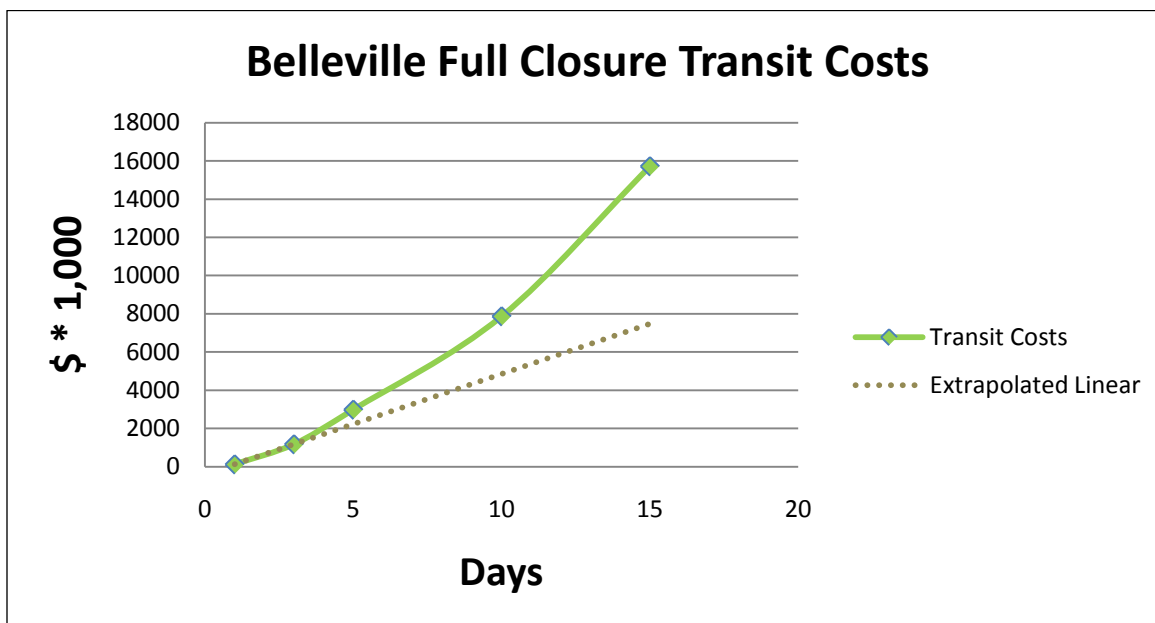
Figure 5.20 The non-linear costs for full closure of the locks and dam at Belleville
