# **NAVAL POSTGRADUATE SCHOOL**

**LASER PEENING FOR MITIGATION OF STRESS  
CORROSION CRACKING AT WELDS IN MARINE  
ALUMINUM**

June 2011

**Approved for public release; distribution is unlimited**

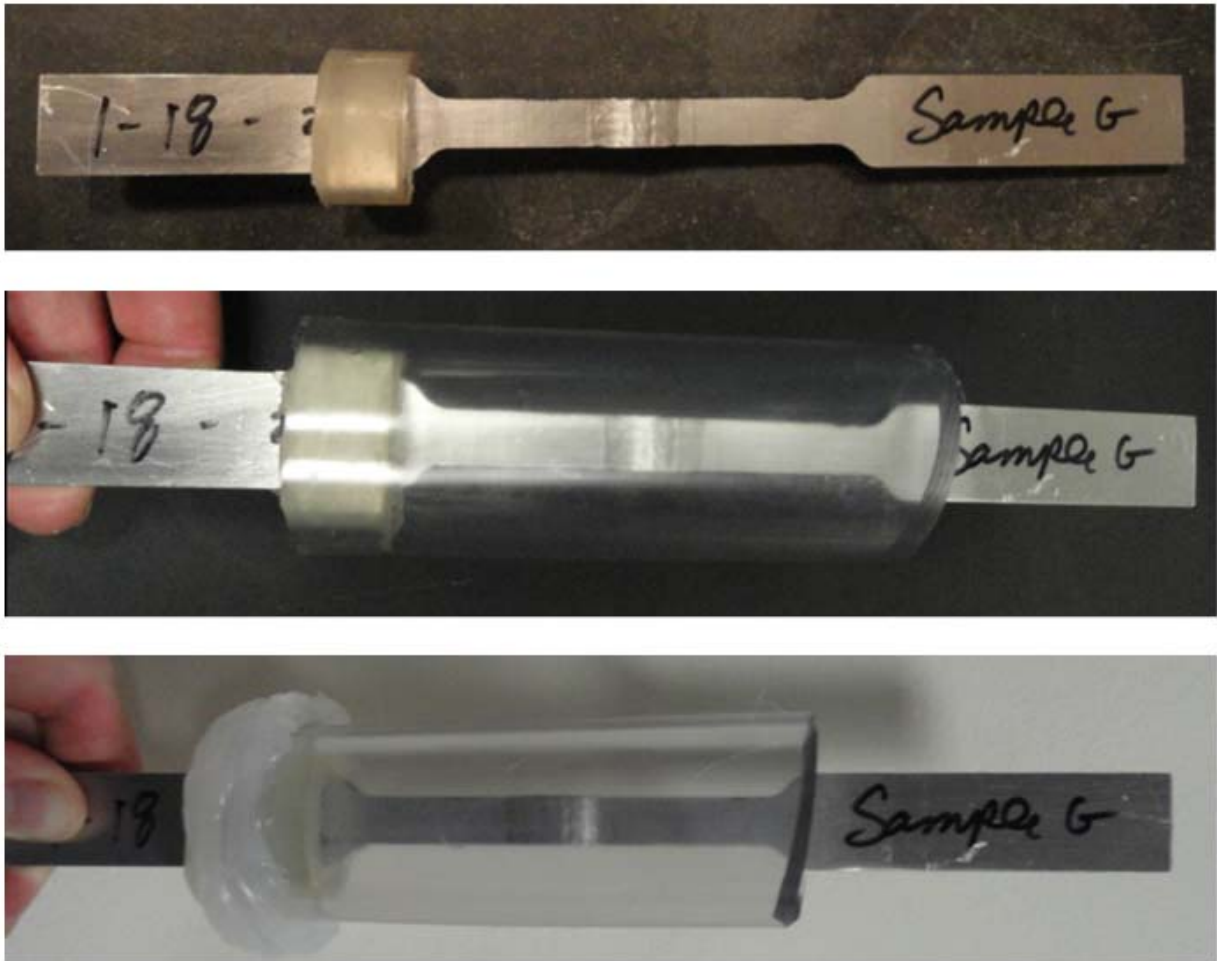
Figure 16. SSRT sample from top: initial securing puck, with Tygon tubing, and with silicone.

A special sample holder was designed for this work to allow intimate contact of the SSRT specimen with the corrosive solution during testing while allowing unconstrained displacement of the load frame (Figure 16).

The specimens can strain as much as twenty percent during these tests, so the unconstrained displacement requirement is essential. The sample holder geometry consisted of pushing the grip section of an SSRT specimen through a mold and then filling the 1 ¼" mold with Buehler Sampl-Kwick two-part epoxy. Once the epoxy had set, the sample was removed from the mold. A Tygon tube, with a 1 ¼" inner diameter, was then fitted over the epoxy cylinder. This tube served as the container for the corrosive solution and was 11 mm in length, which is long enough to allow for the entire gage section of the SSRT specimen to be immersed during testing. To prevent leaking of the corrosive solution, silicone caulk was placed around the outside bottom of the specimen. The silicone was allowed to cure for 24 hours prior to testing.

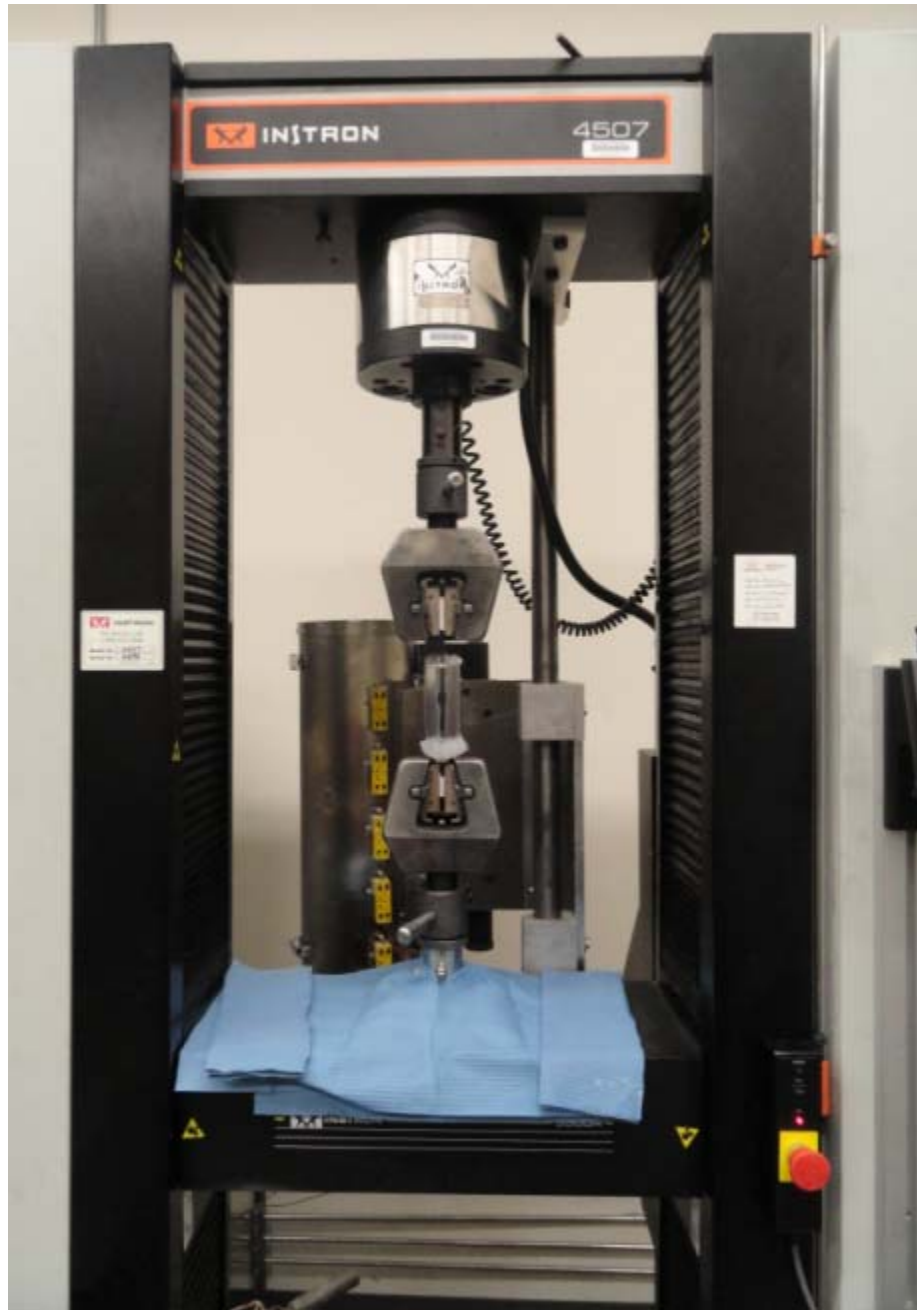
Figure 17. Instron 4507 test frame used in the SSRT testing of laser peened samples.

The SSRT was carried out on an Instron 4507 test frame (Figures 17 and 18). This instrument used an Instron load cell with a load rating of 200 kN static and 100 kN dynamic in both compression and tension, for force measurement and screw-driven, cross-head displacement for strain measurement. The 4507 frame has a testing speed range of 0.001 to 500 mm/min. All stresses and strains were computed as engineering stresses and strains using the original and final dimensions of the specimen. As these tests were concerned primarily with strain to failure, these measurements of stress and strain were deemed sufficient. All tests were performed with a constant extension rate of 50 nm/second. This displacement rate was chosen based upon a desired uniaxial strain rate of  $10^{-6}$  for the geometry of specimen shown in Figure 15. This strain rate is consistent with the work done by Zucchi and Hatamleh [5, 13]. It is also within the parameters set forth in ASTM G 129-00, Standard Practice for Slow Strain Rate Testing to Evaluate the Susceptibility of Metallic Materials to Environmentally Assisted Cracking [19]. It should be noted that this displacement rate only gives a strain rate of  $10^{-6}$  at the start of the test. The strain rate decreases as the specimen becomes longer.

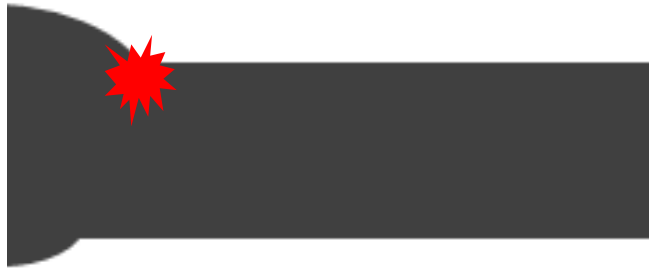
Figure 28. Vickers hardness as a function of position across the weld for the control weld and LP 3-27-2. The red indicator on the below diagram (the base of the HAZ) aligns with the 0 point on the distance axis.

The microhardness data was then gathered across the weld through the HAZ into the base metal using the Vickers Hardness test. Figure 28 compares the microhardness data and the most intense laser peened condition, LP 3-27-2. The control weld displayed a typical hardness profile with a softer area in the weld and into the HAZ. There is only slight increase in hardness in the base metal but a qualitatively large difference in hardness in the welded region and the HAZ. LP appears to even out the hardness profile of the HAZ into the weld, making a more uniform hardness profile throughout the sample.
