**AFRL-RX-WP-TP-2011-4236**

**DEVELOPING THE CAPABILITY TO MONITOR SMALL  
FATIGUE CRACK GROWTH UNDER ELEVATED  
TEMPERATURE, ULTRA-HIGH VACUUM CONDITIONS  
(Preprint)**

**JULY 2011**

**AIR FORCE RESEARCH LABORATORY  
MATERIALS AND MANUFACTURING DIRECTORATE  
WRIGHT-PATTERSON AIR FORCE BASE, OH 45433-7750  
AIR FORCE MATERIEL COMMAND  
UNITED STATES AIR FORCE**

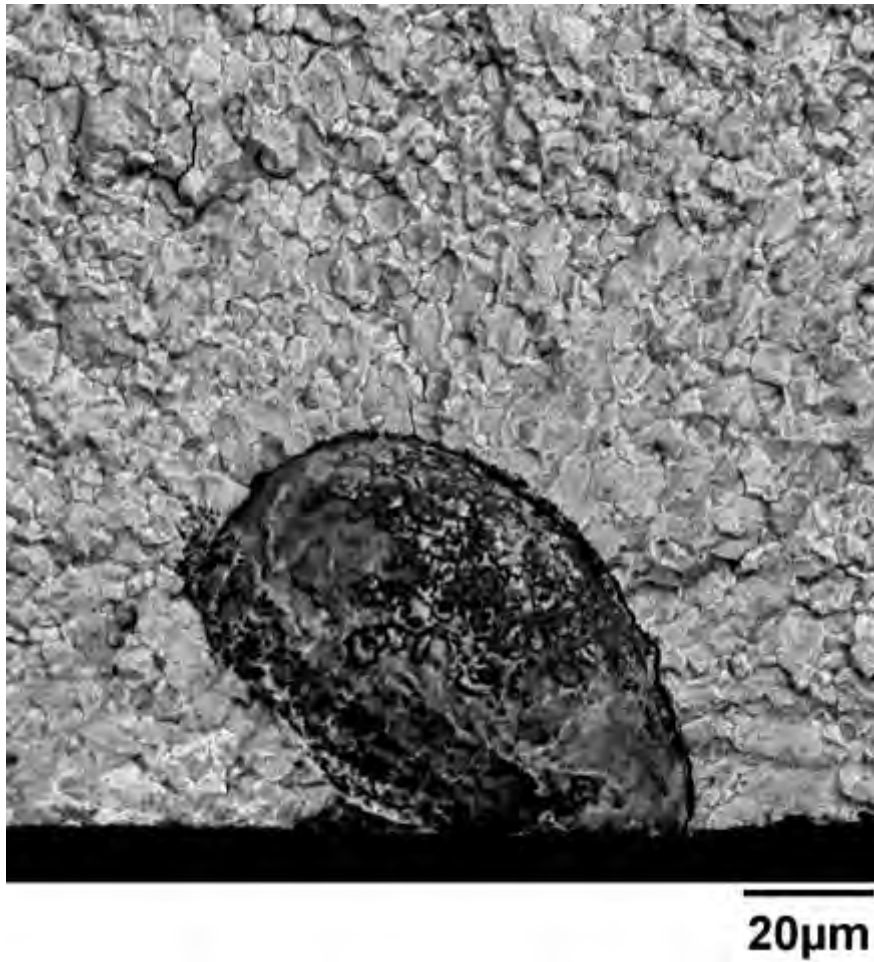
Figure 10. Surface non-metallic particle from laboratory air test

While the fatal cracks did not grow from the notches, both specimens demonstrated longer fatigue lifetimes than those specimens that have been tested under identical conditions in a laboratory air environment. The specimen that failed from the NMP had a lifetime that was approximately 5.5x longer than what would be conventionally predicted by a conservative life prediction code. Also, the lowest life shown in Figure 8 failed from a crack that initiated from the NMP shown in Figure 10. This NMP is much smaller yet had a shorter total life. The specimen that was declared a runout showed approximately an order of magnitude increase in life compared to other similar tests. This effect appears to be due to the lack of environmental interaction, displaying the importance of developing the capability to quantify the effect on small crack growth.
