## **Architectural Survey of Pence Elementary School, Fort Leonard Wood, Missouri**

Sunny Adams, Chris J. Cochran, and Adam Smith

September 2011

Final Report

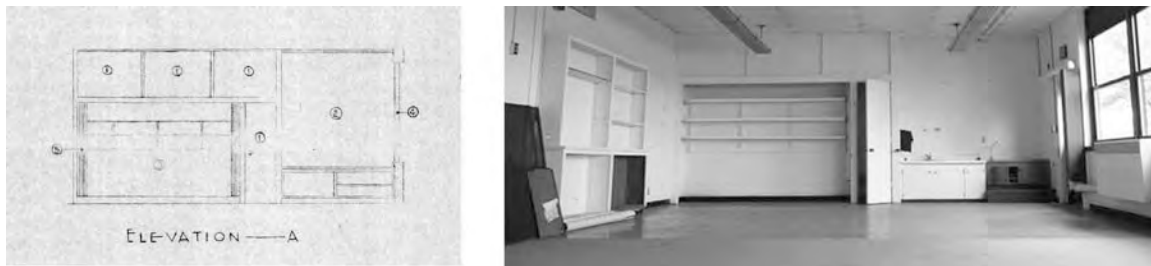
Figure 27. Classroom detail of coat “cubby” area, teacher’s storage closet, and workstation with sink: original drawing on the left from 1954, compared to the current condition of a typical classroom detail in photo on the right.

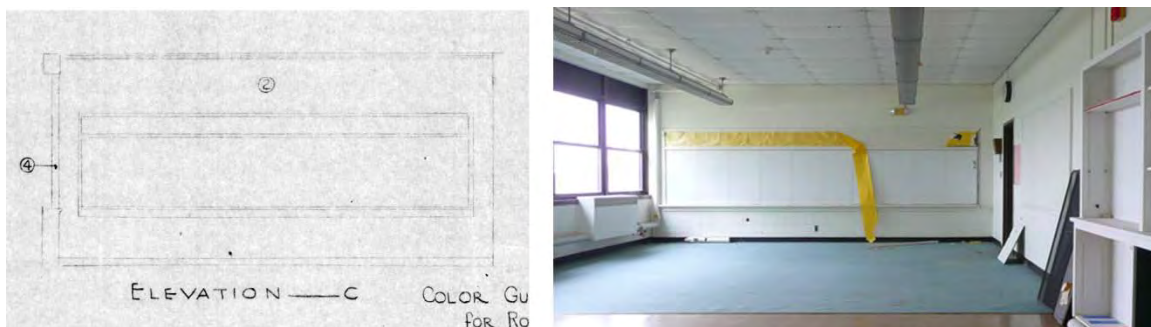
Figure 29. Classroom detail of chalkboard: original drawing on the left from 1954, compared to the current condition of a typical classroom detail where the original chalkboard has been replaced by a whiteboard in photo on the right.

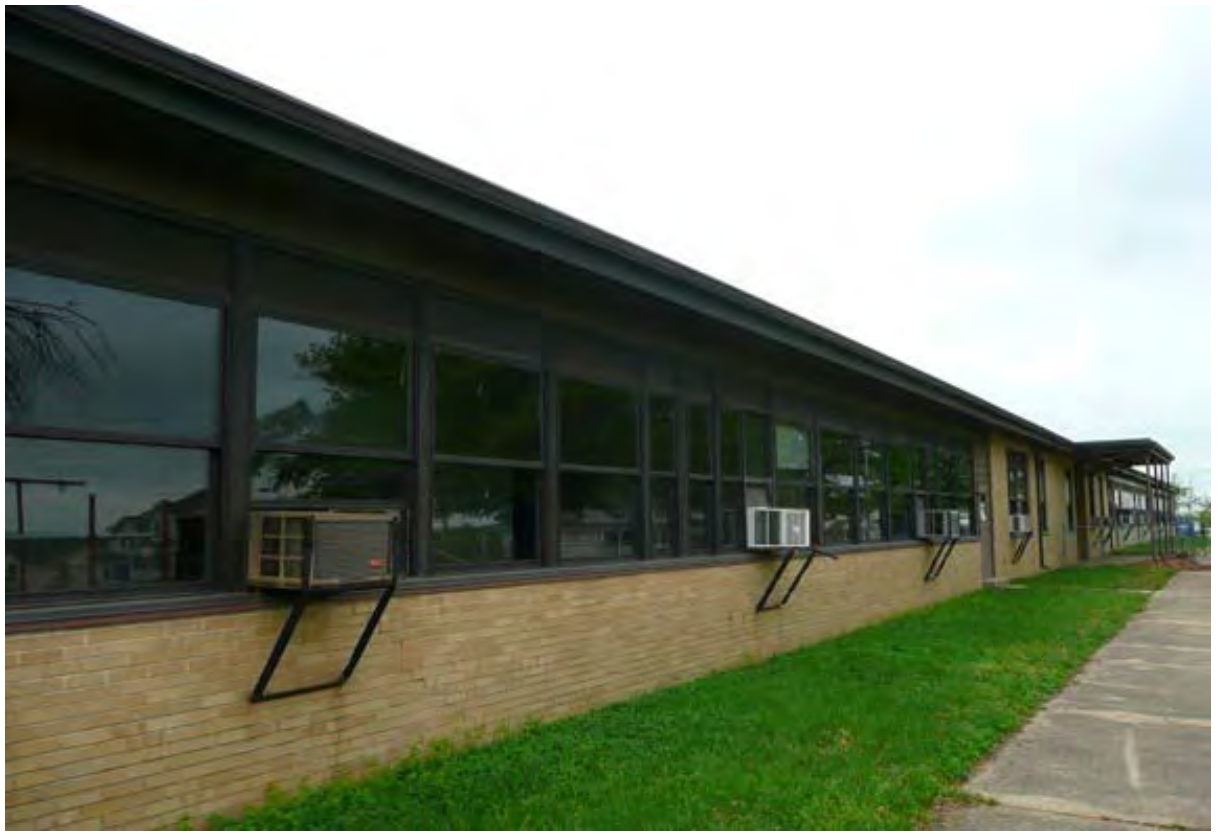
**Photo 3. Replacement windows and modified window pattern.**

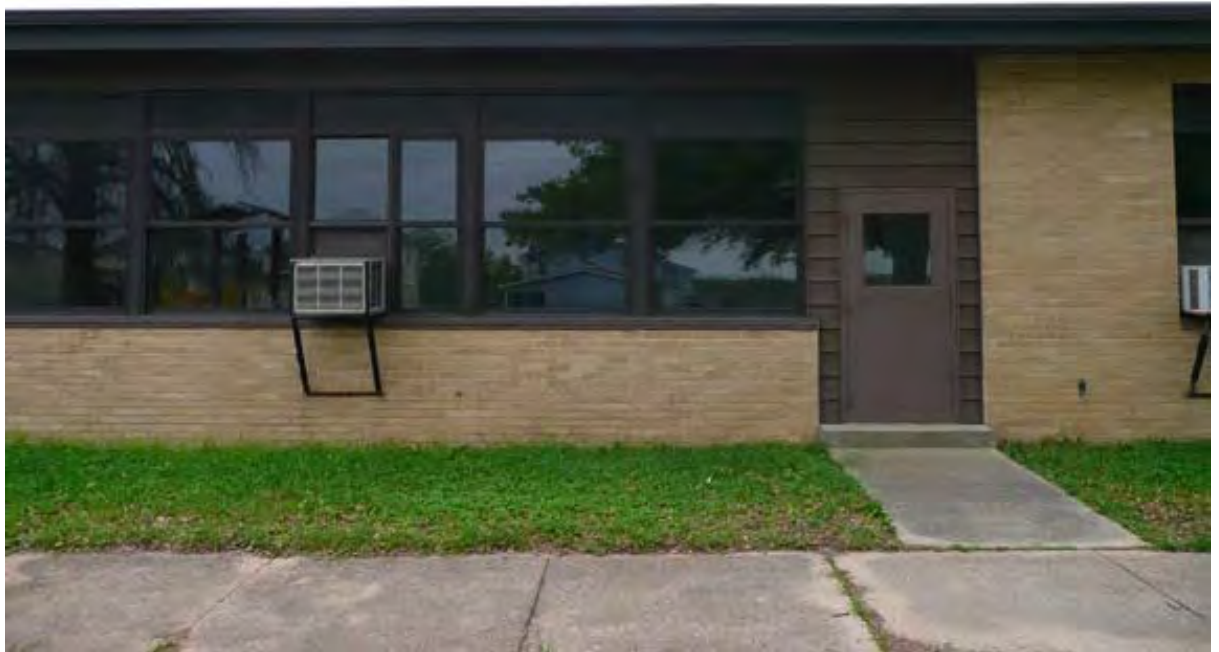
**Photo 4. North elevation with newer door opening.**

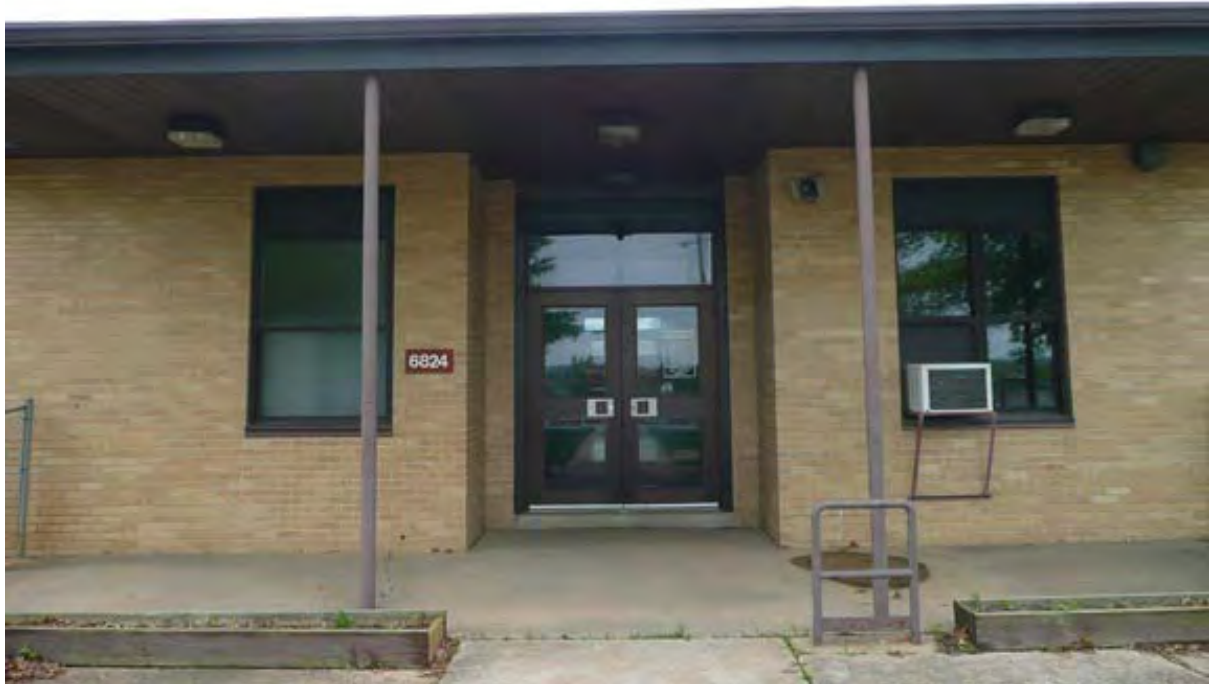
**Photo 5. Replacement anodized bronze aluminum and plate glass doors, transom, and windows on the north elevation at the main entry.**

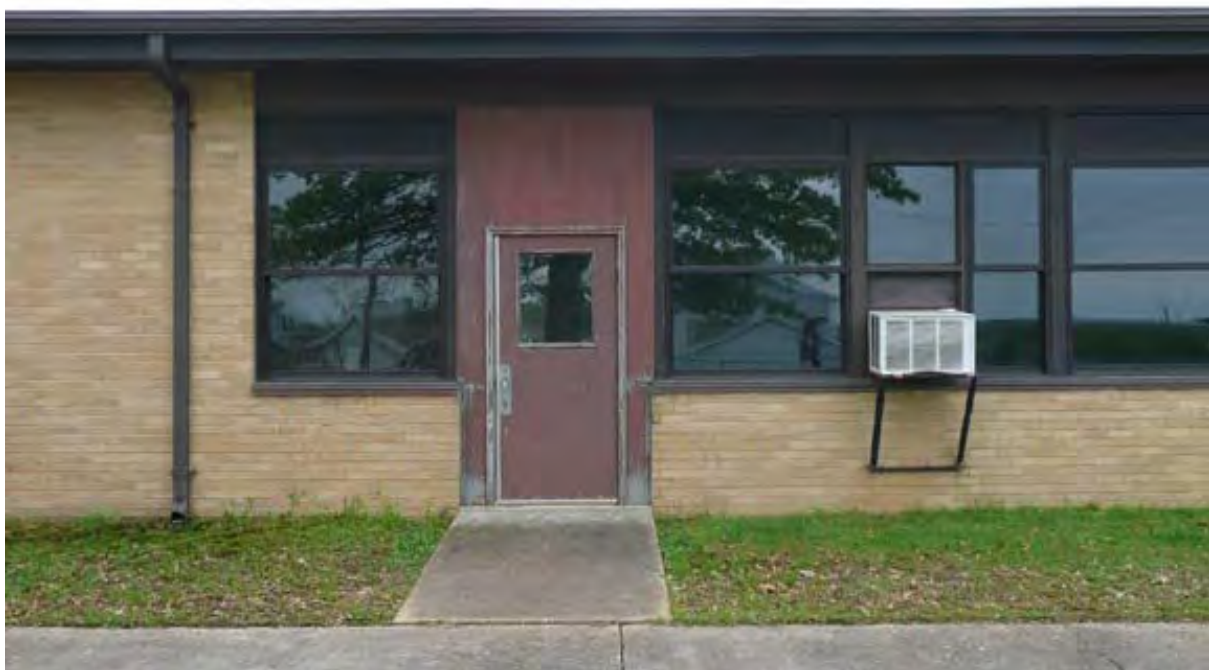
**Photo 6. Newer door opening on the right side of the north elevation.**

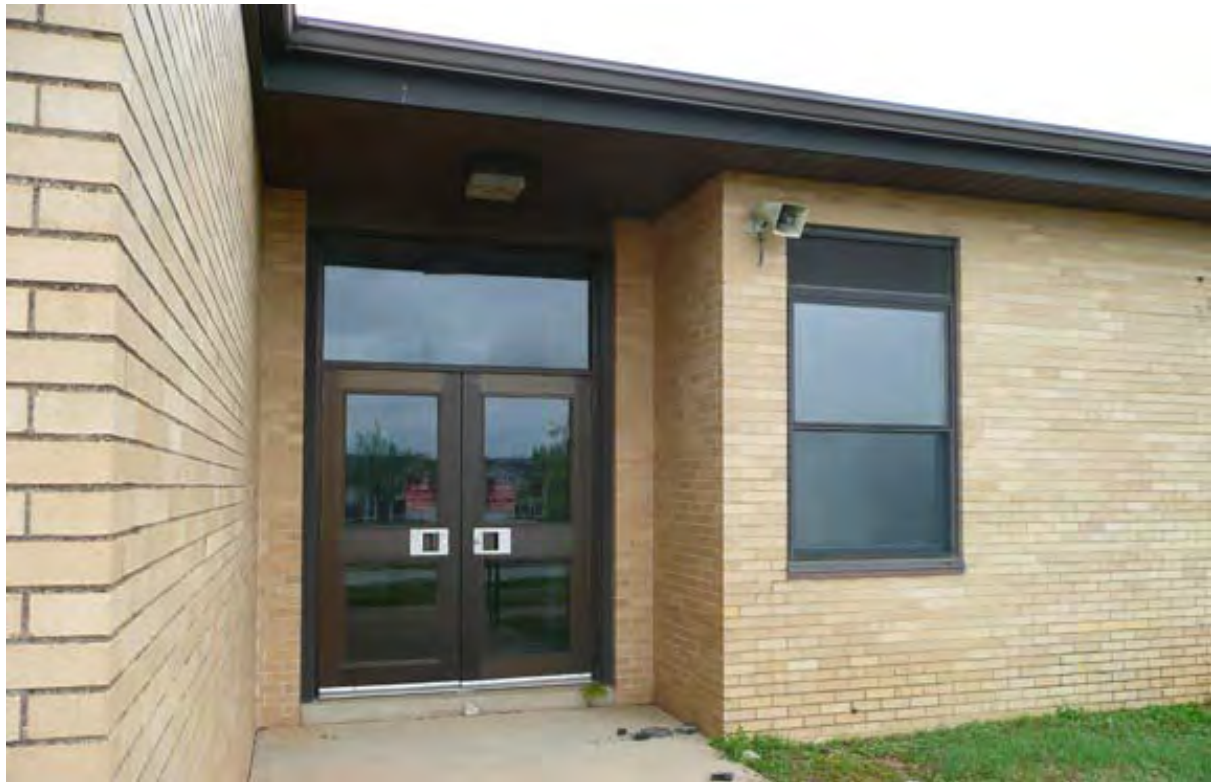
**Photo 9. Replacement doors located on the west elevation.**

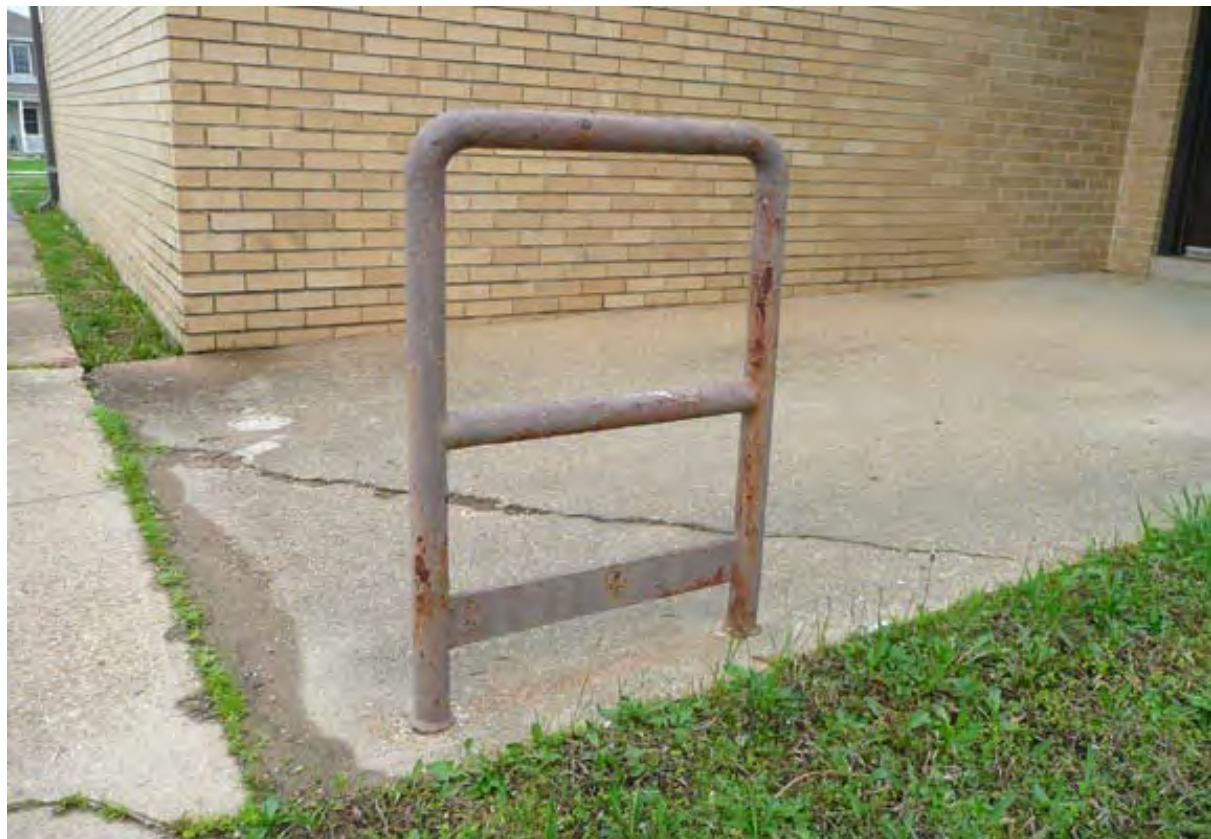
**Photo 10. Original “footscraper” for shoes located near the entry on the west elevation.**

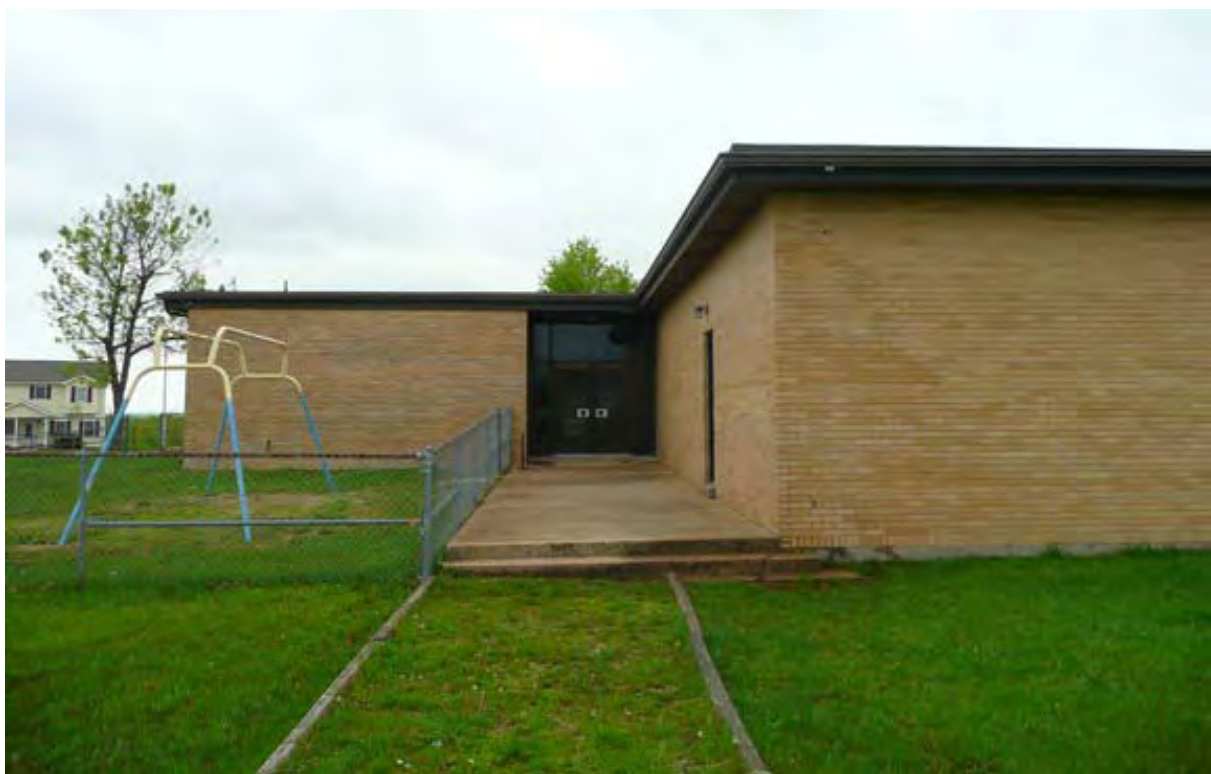
**Photo 14. Left side of the south elevation with replacement entry doors.**

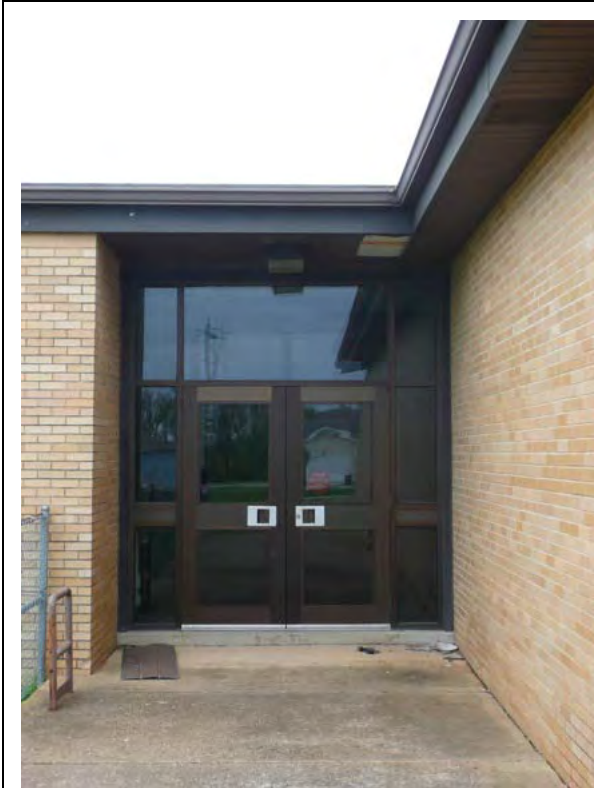
Photo 15. Close-up of replacement doors, transom, and sidelights on the left side of the south elevation.

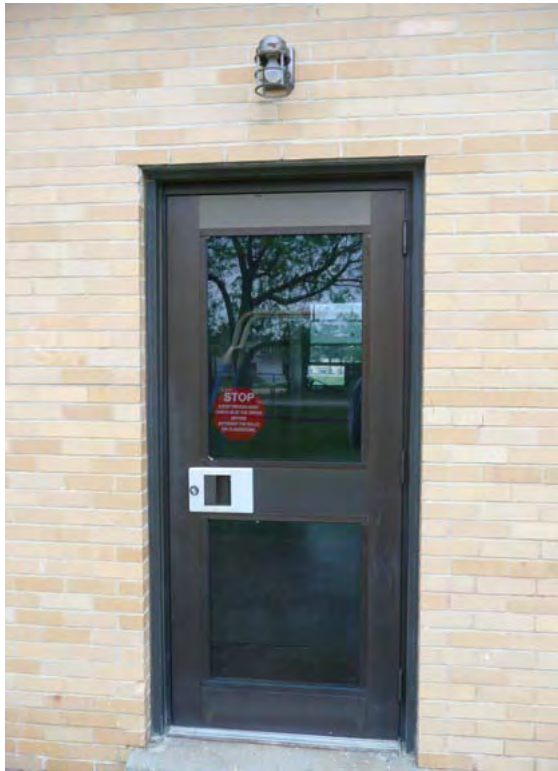
**Photo 17. Typical replacement entry door.**

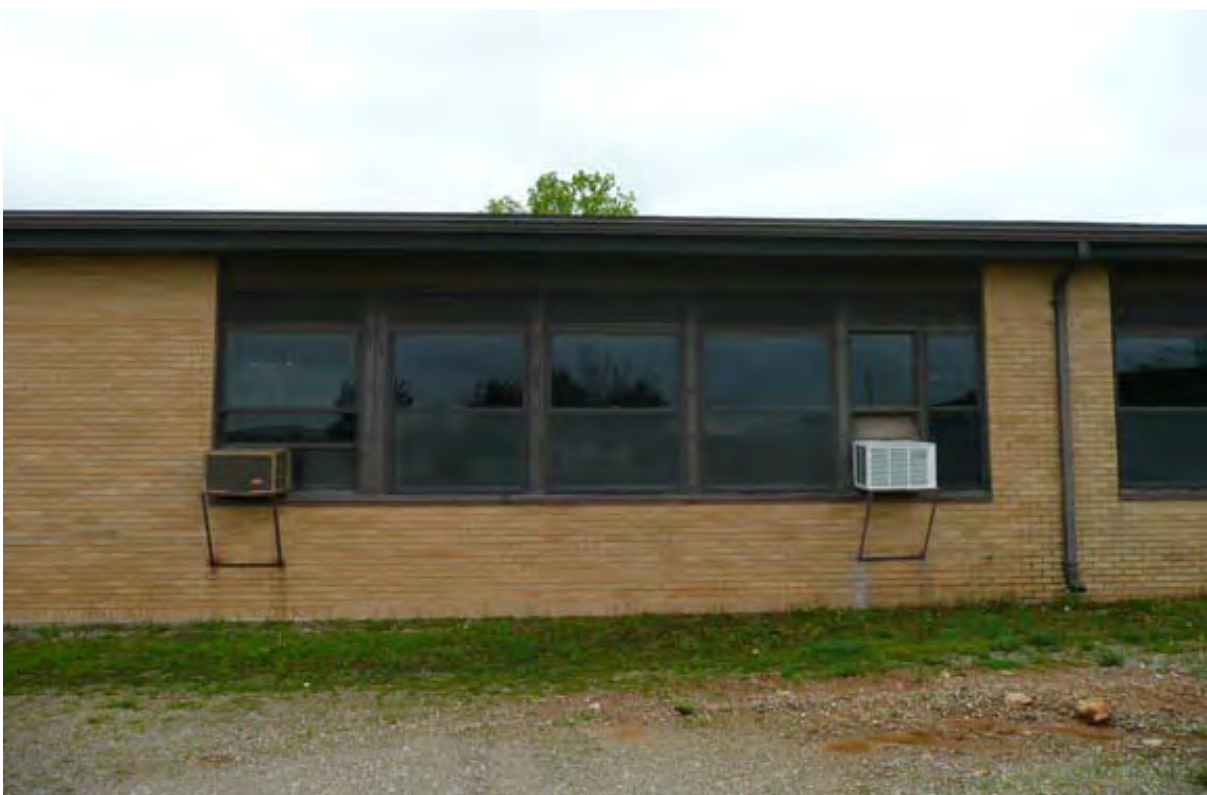
**Photo 18. Typical replacement one-over-one double-hung windows on the addition portion of the cafeteria.**

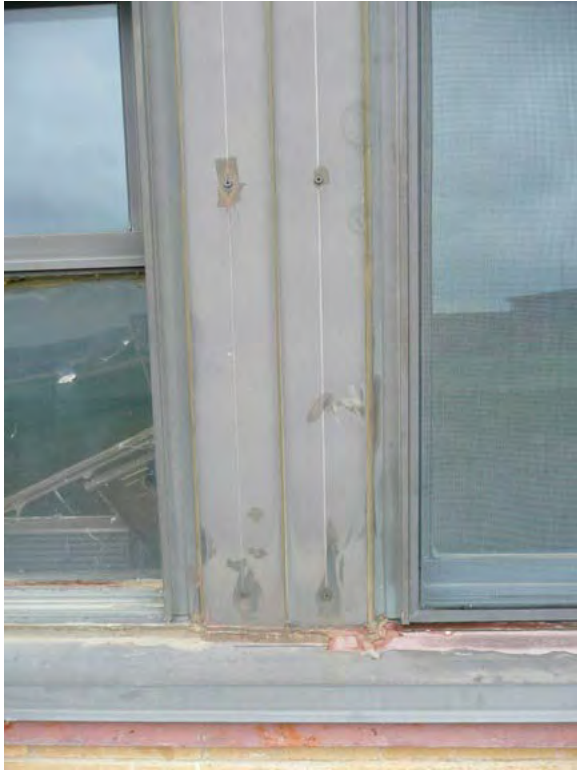
**Photo 19. Close-up of replacement window and windowsill.**

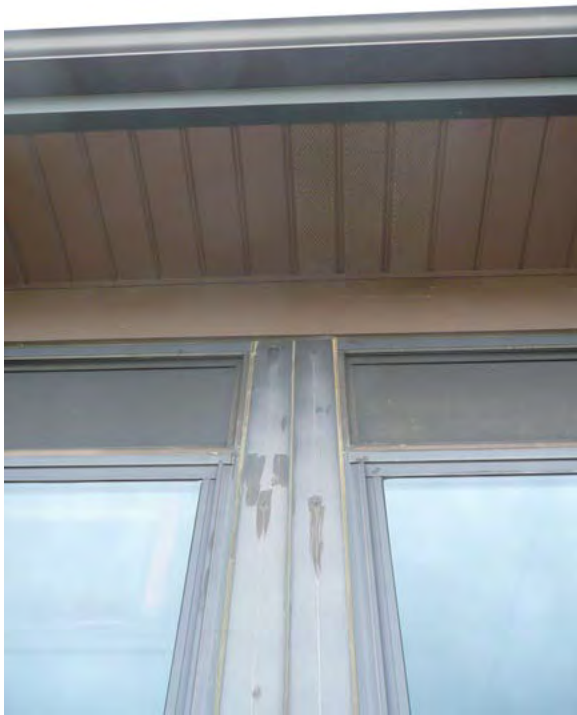
**Photo 20. Replacement aluminum soffit and gutters.**

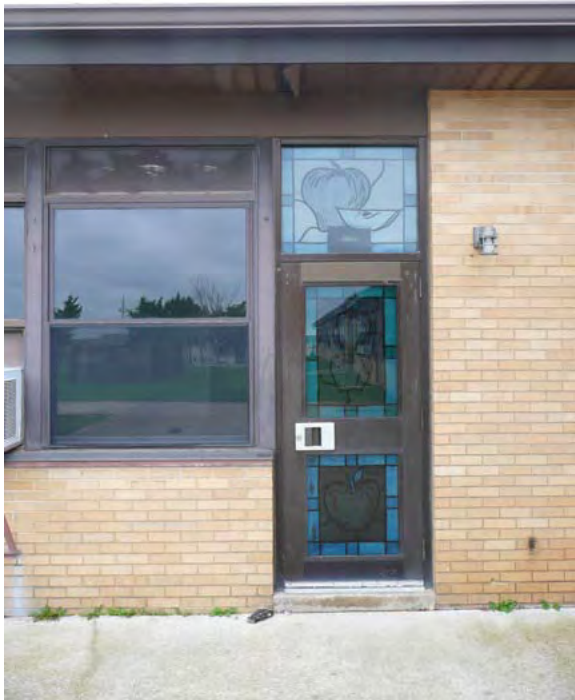
Photo 21. Replacement door into the cafeteria.

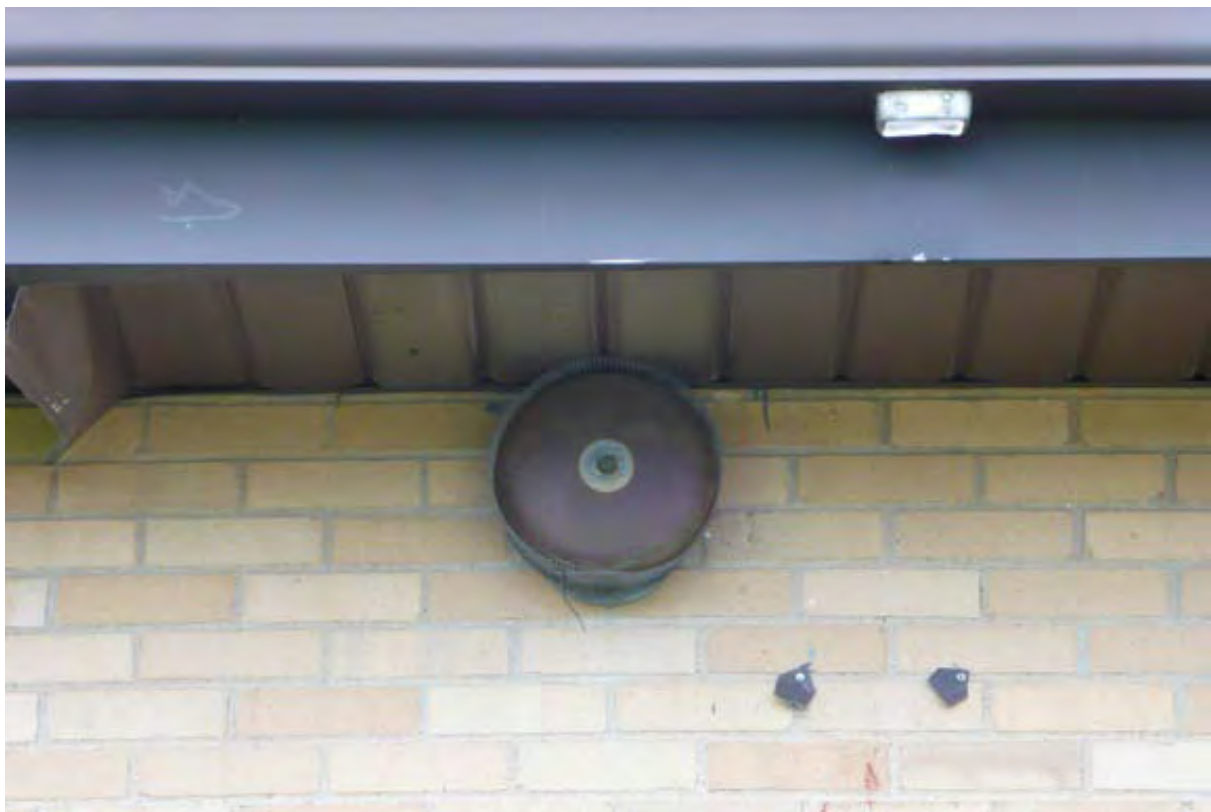
**Photo 26. Bell and replacement metal soffit and fascia.**

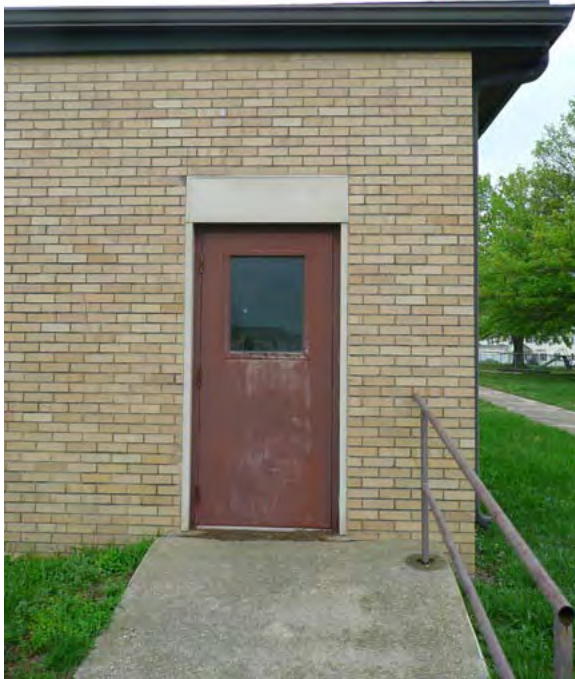
Photo 31. Older style replacement door on the right side of the east elevation.

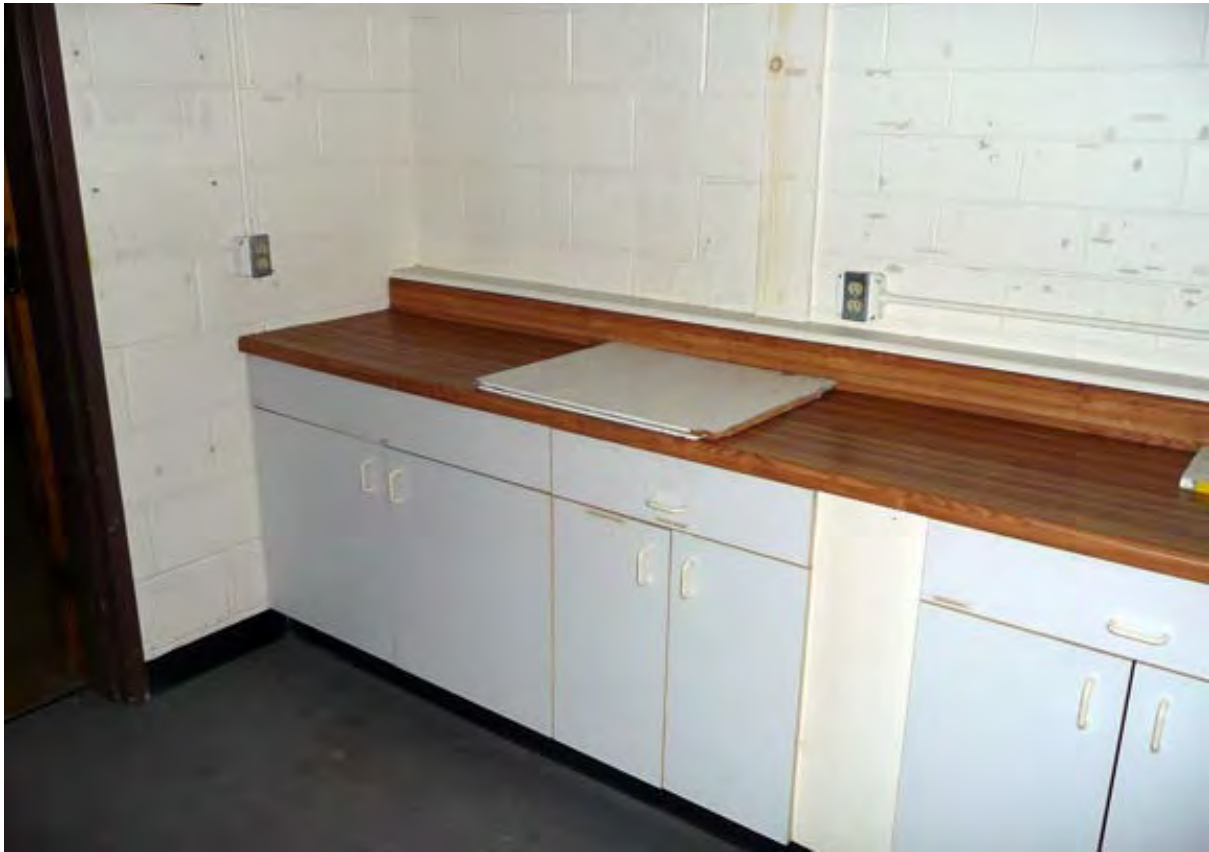
Photo 59. Replacement cabinets in Health Room No. 5.

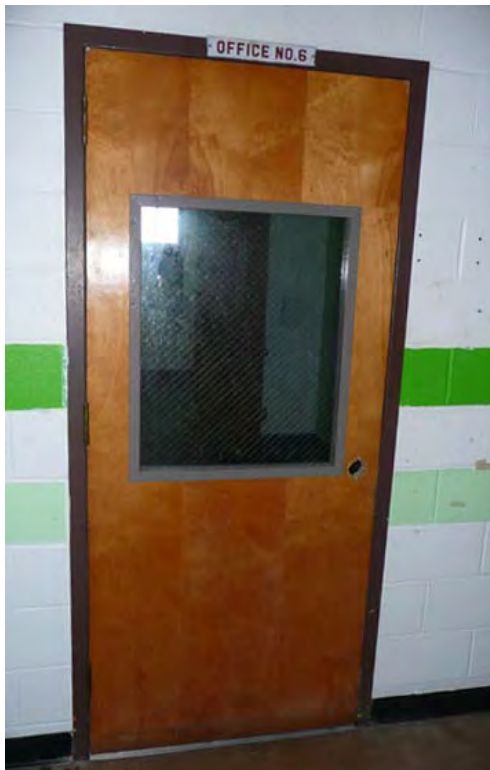
Photo 60. Office No. 6 replacement door.

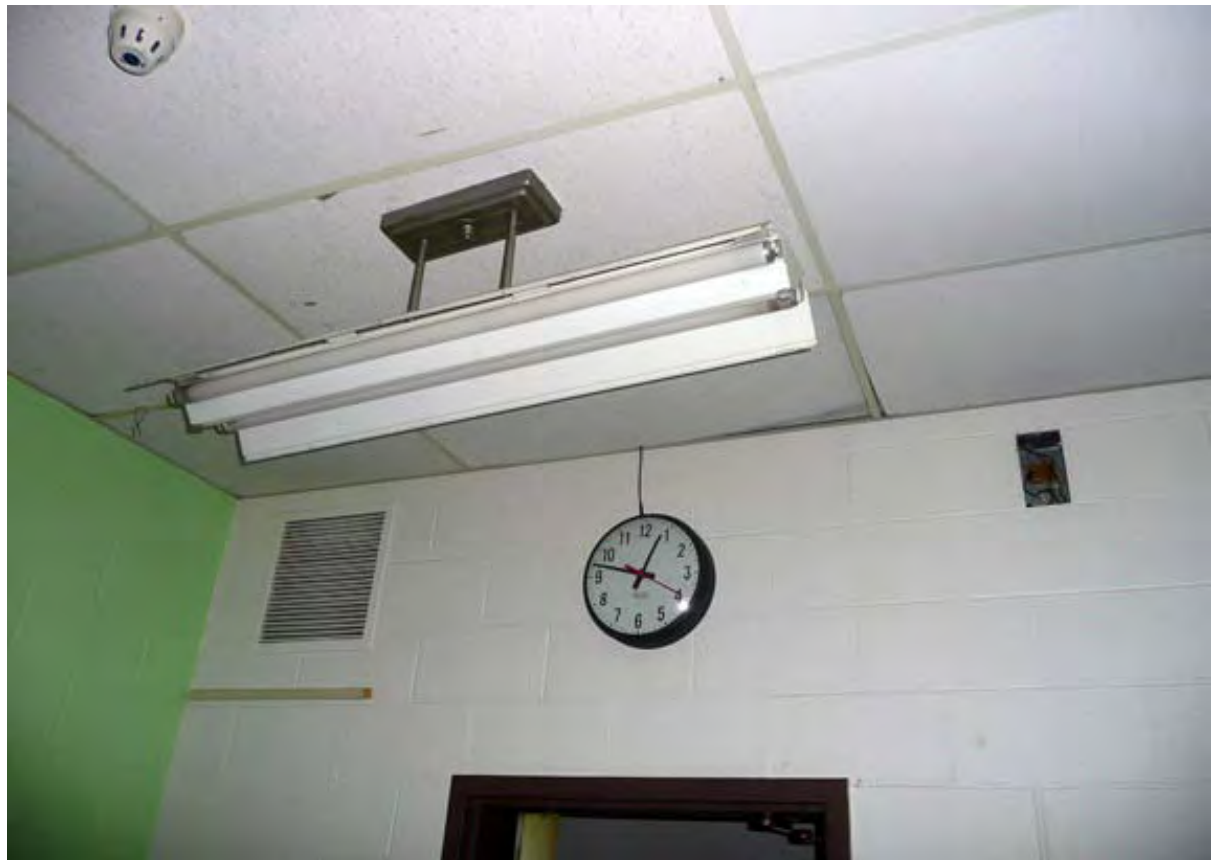
Photo 61. Replacement light fixture in Office No. 6.

**Office No. 6:** The room is located near the main entry and vestibule on the north elevation. The office has concrete block walls, carpeted floors, acoustical tile drop-ceiling, and replacement pendent light fixtures (photo 61). A newer window opening has been cut into the east wall of the office in order to provide visual access to the main entry on the north corridor/vestibule area (photo 42). According to the original plans, there was a dividing wall between Health Room No. 5 and Office No. 6; however, this wall has since been removed, making this one large room.

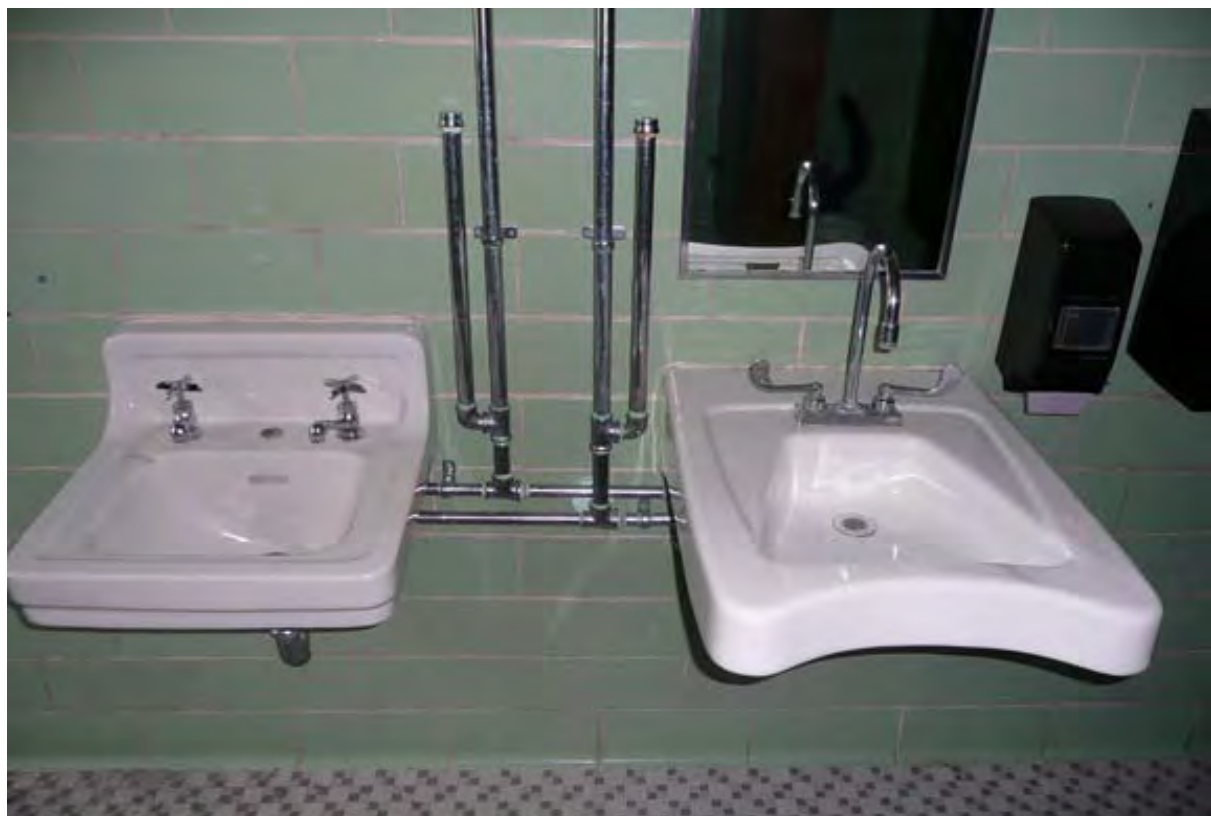
**Photo 68. Original sink (left) replacement sink (right), original glazed tile wall, and original tile floor in Girls' Toilet No. 8.**

**Girls' Toilet No. 8:** The room is located between Janitor Room No. 9 and Teacher Work Room No. 10 on the north side of the building. The toilet room consists of the original mosaic tile floor, original glazed tile walls, and an original light fixture. There is a single replacement window located on the north wall (photo 67-69).

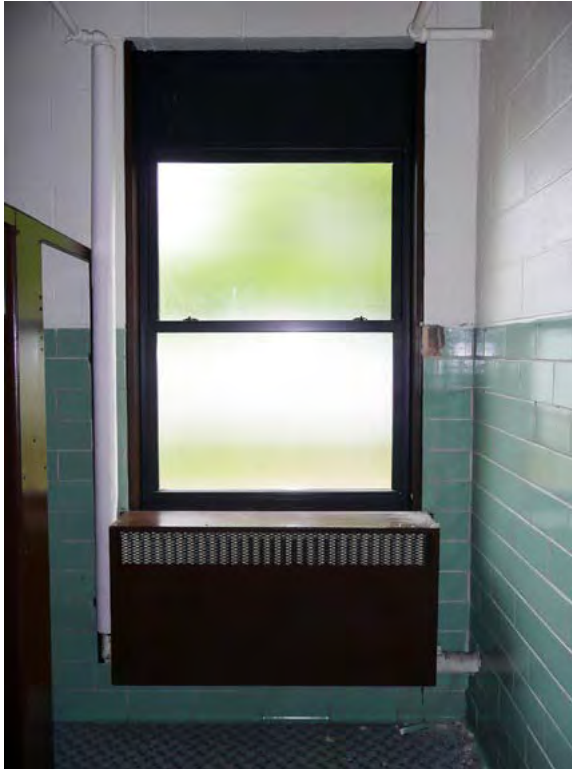
Photo 69. Replacement window in Girls' Toilet No. 8.

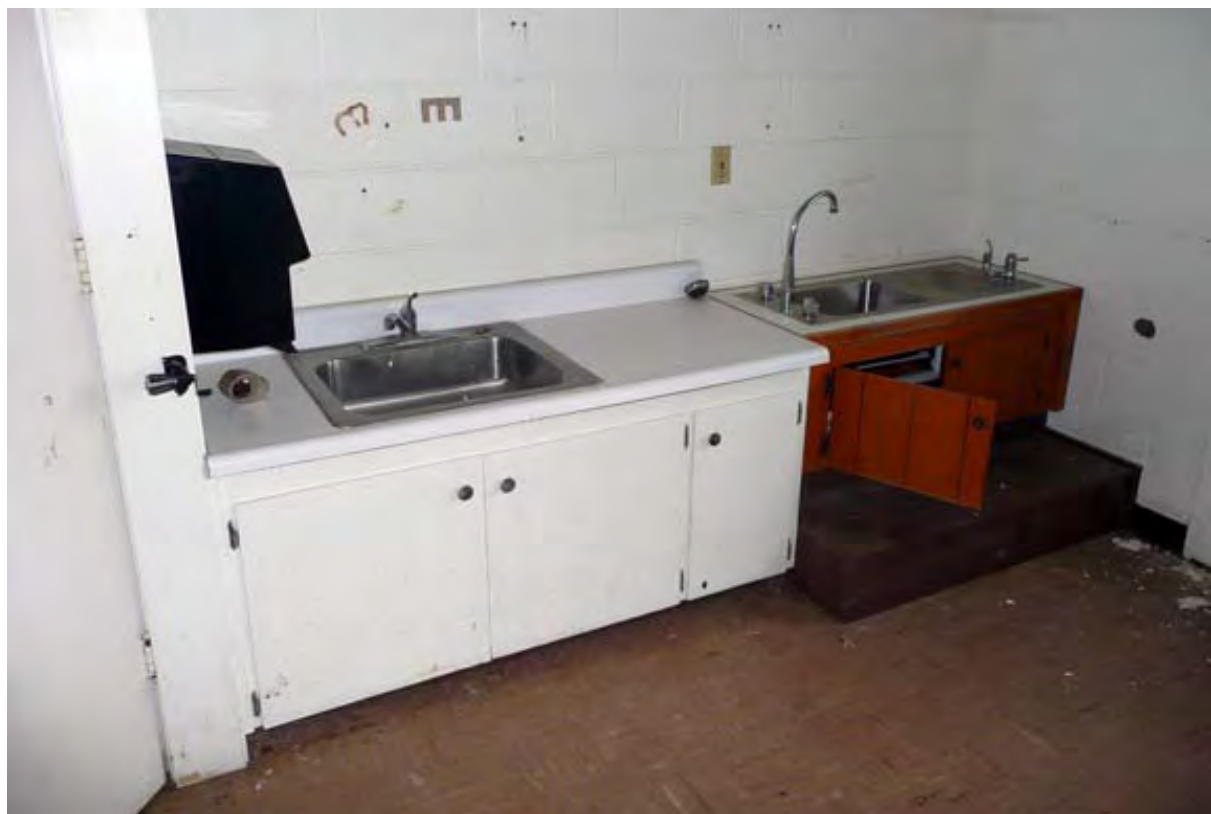
**Photo 72. Workstation in Classroom No. 11 with replacement countertops.**

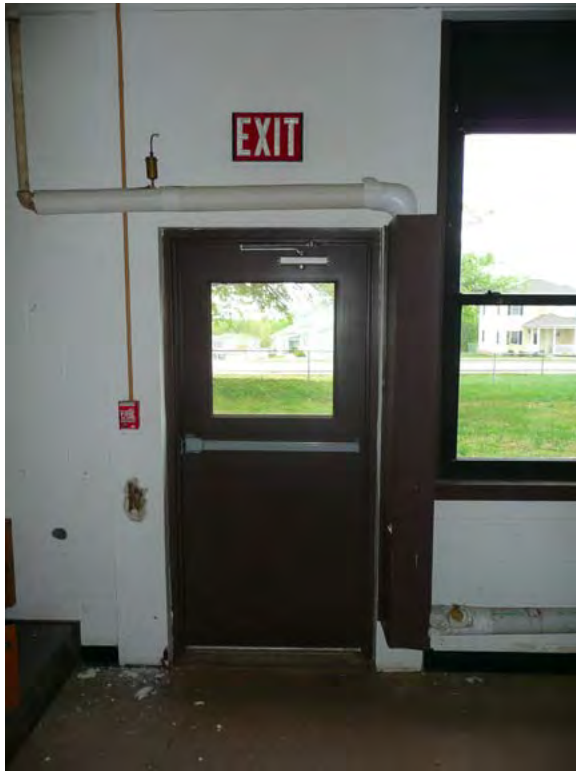
**Photo 73. New door leading to the outside from Classroom No. 11.**

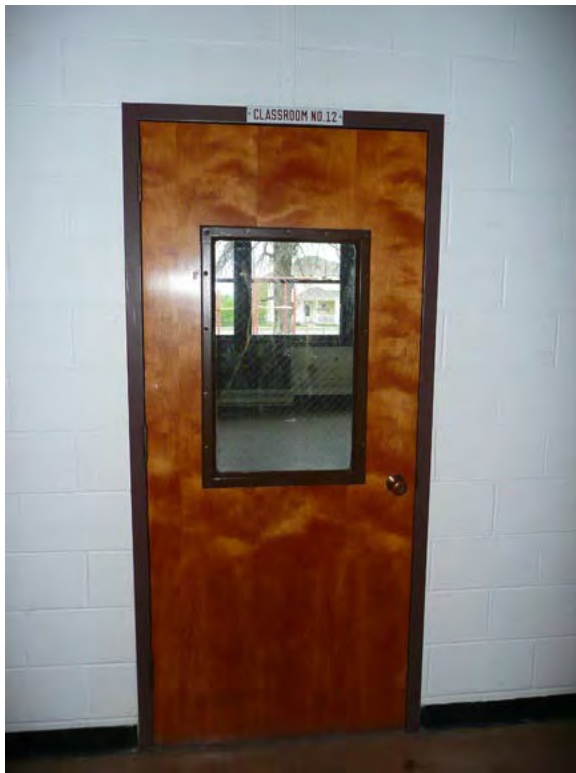
Photo 75. Classroom No. 12 replacement door.

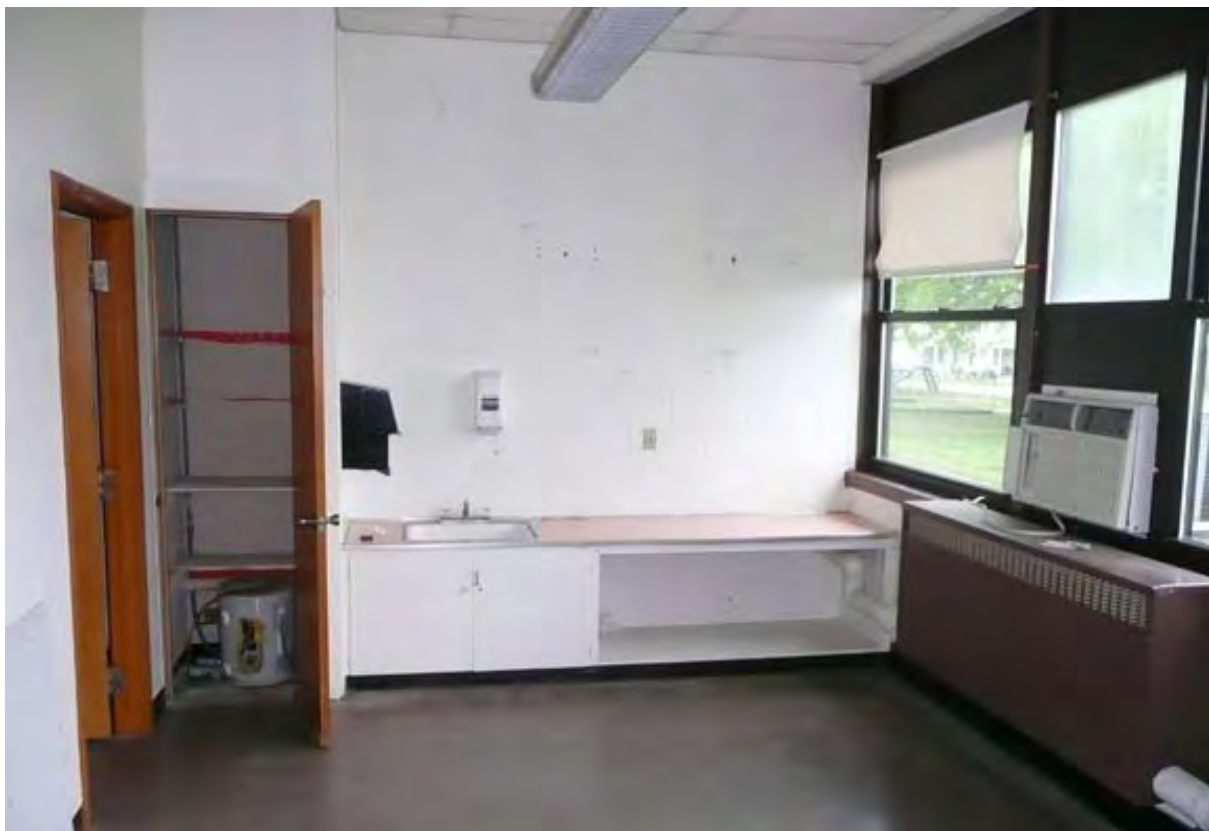
Photo 76. Workstation and storage closet in Classroom No. 12 and a newer enclosed addition on the left side of the image.

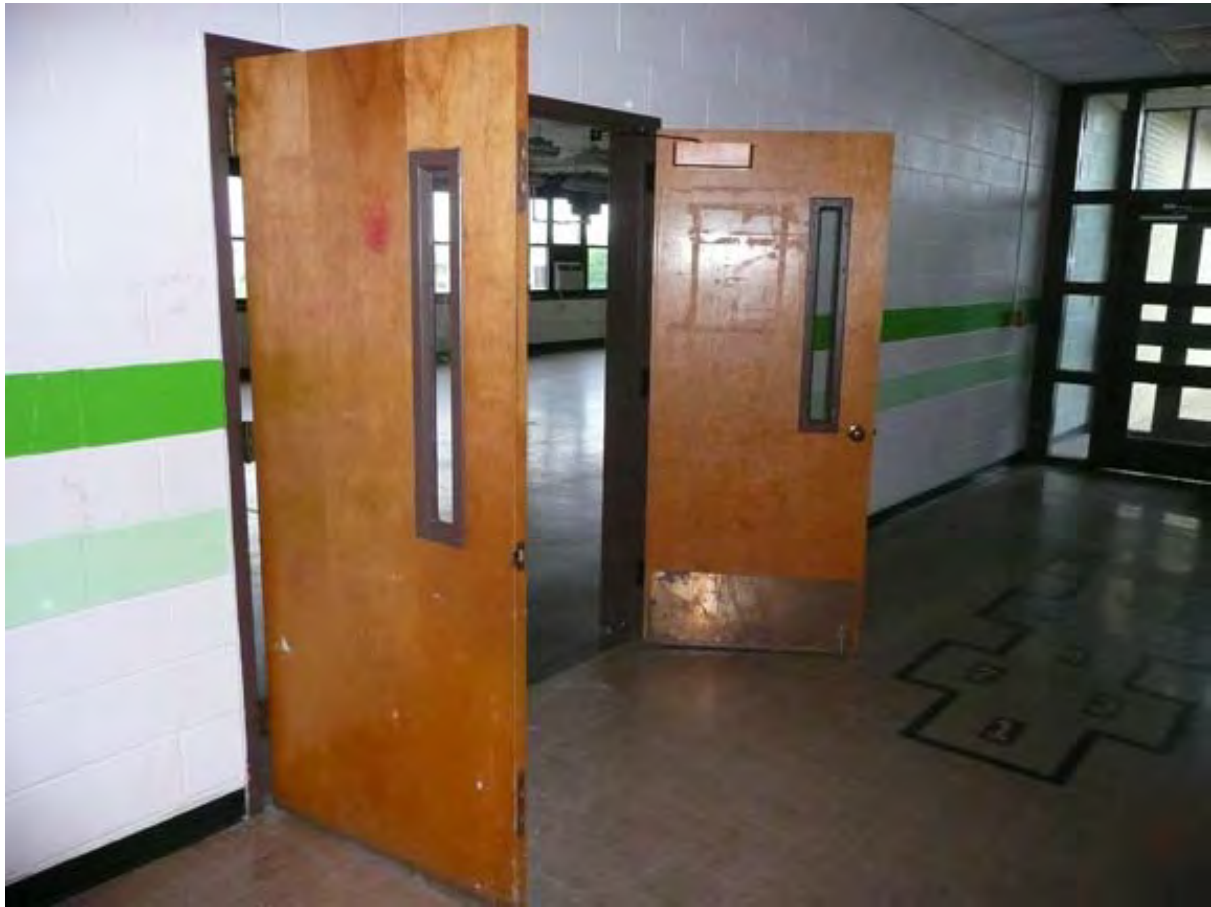
**Photo 109. Replacement wood doors leading into the cafeteria.**

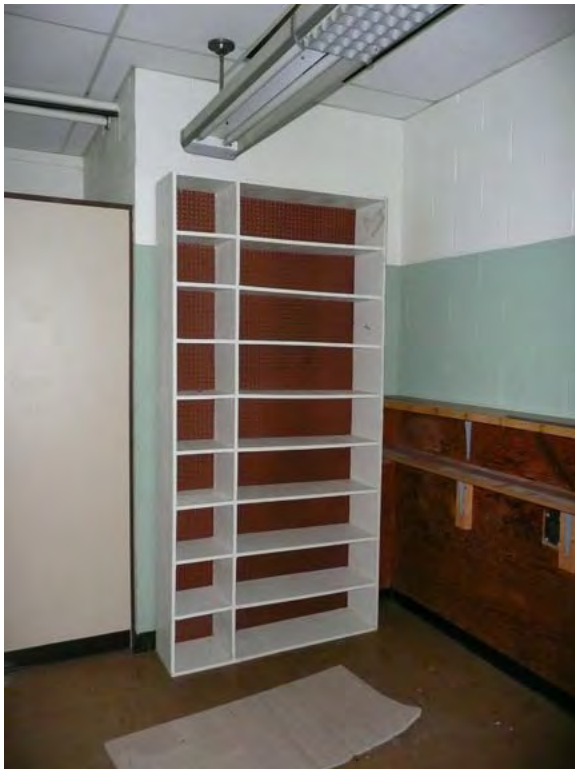
**Photo 125. Replacement bookshelf in Primary Room No. 23.**

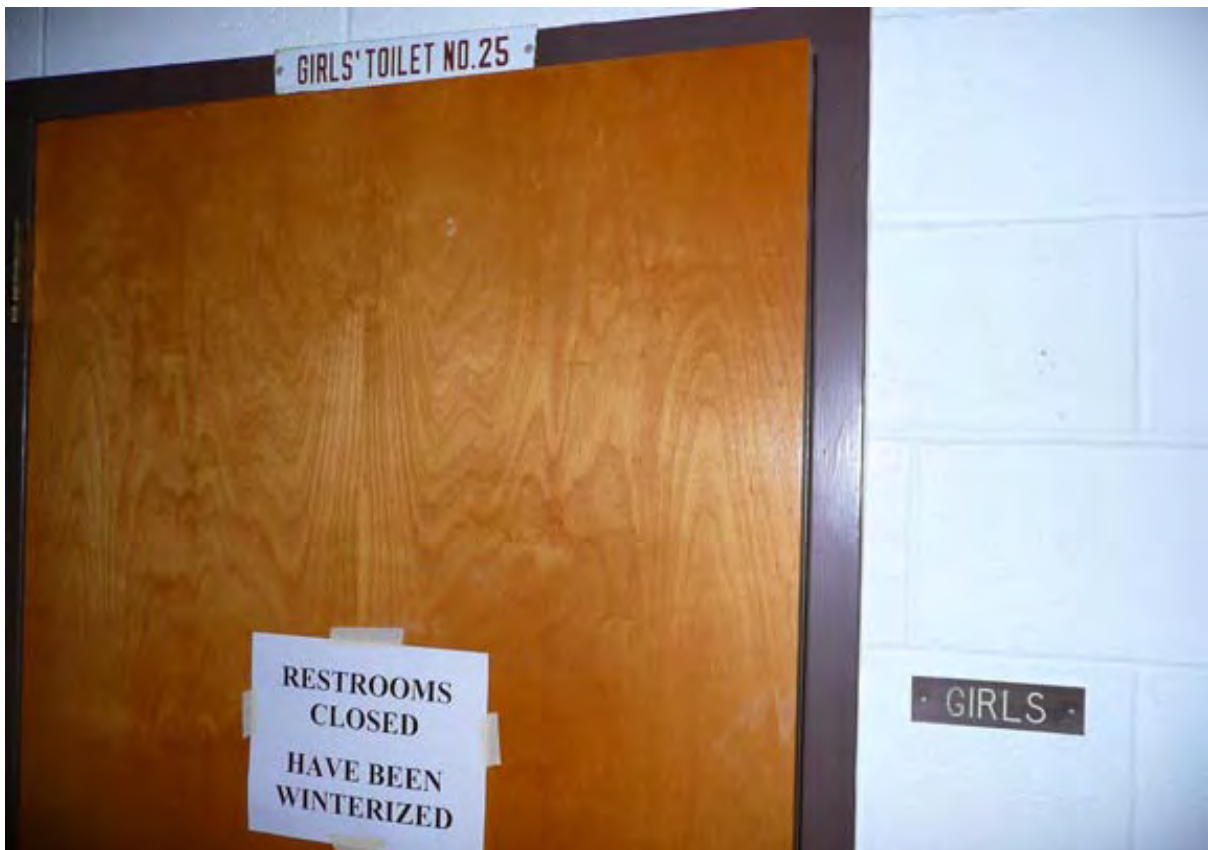
Photo 131. Original Girls' Toilet No. 25 sign and replacement door.

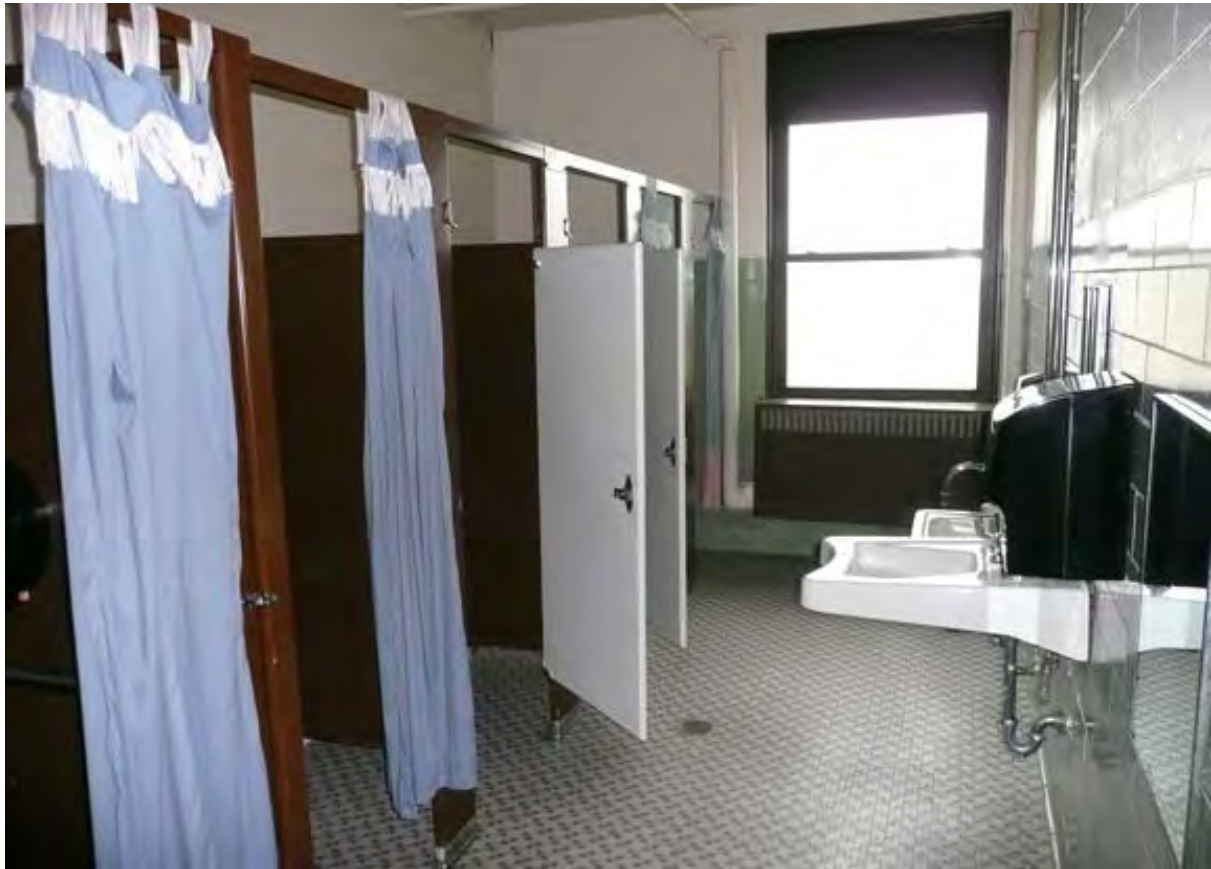
Photo 132. Original mosaic tile floor and glazed tile walls in Girls' Toilet No. 25.

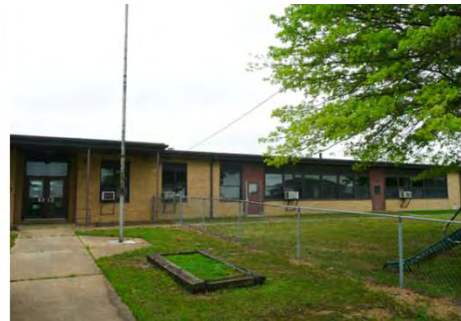
Photo 136. North elevation with main entrance and wall of windows: Original drawing on the left from 1954 with original five-pane awning windows compared to the current replacement doors, sidelights, transom, and metal double-hung windows.
