## **Architectural Survey of Pence Elementary School, Fort Leonard Wood, Missouri**

Sunny Adams, Chris J. Cochran, and Adam Smith

September 2011

Final Report

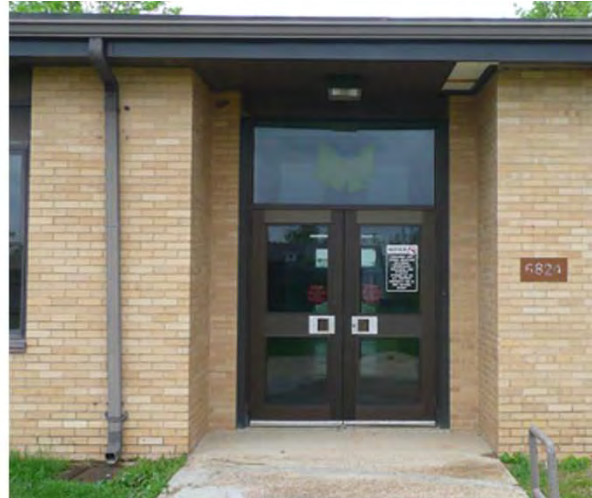
**Photo 139. Entrance on south elevation: Original drawing on the left from 1954 compared to the current replacement doors and transom.**

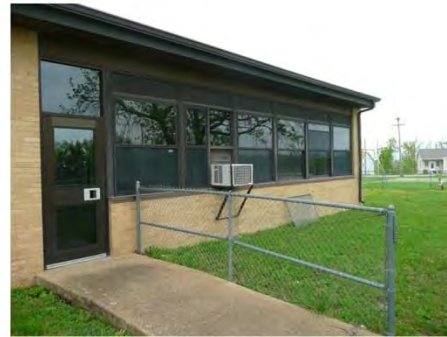
Photo 141. Right side of the west elevation: Original drawing on the left from 1954 compared to the current replacement door, transom, and windows on the right.

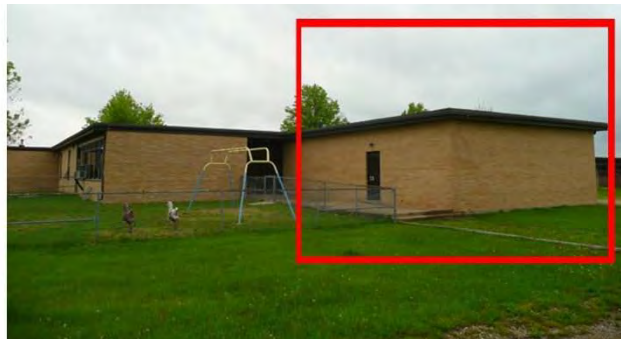
Photo 142. Cafeteria addition: Original drawing on the left from 1954 with no expanded cafeteria space compared to the current size of the cafeteria with the construction of an addition, highlighted in red.

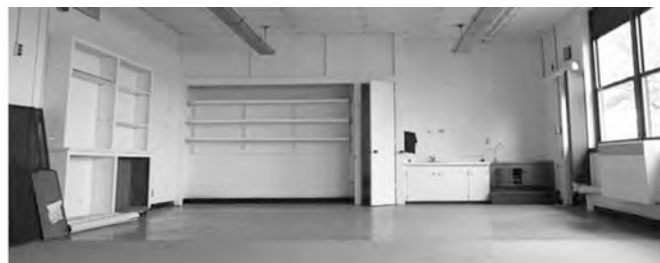
Photo 143. Classroom detail of coat "cubby" area, teacher's storage closet, and workstation with sink: Original drawing on the left from 1954 compared to the current condition of a typical classroom detail on the right.

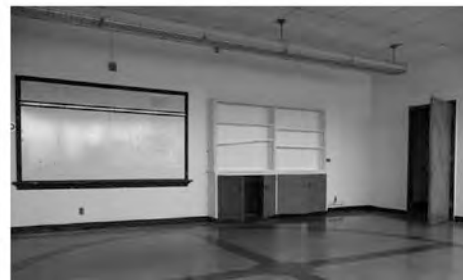
**Photo 144. Classroom detail of storage shelf and tack board: Original drawing on the left from 1954 compared to the current condition of a typical classroom detail with a replacement whiteboard where the tack board use to be located on the right.**

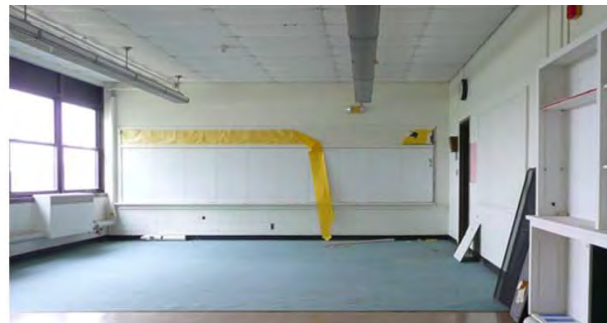
**Photo 145. Classroom detail of chalkboard: original drawing on the left from 1954 compared to the current condition in the photo on the right of a typical classroom detail where the original chalkboard has been removed.**

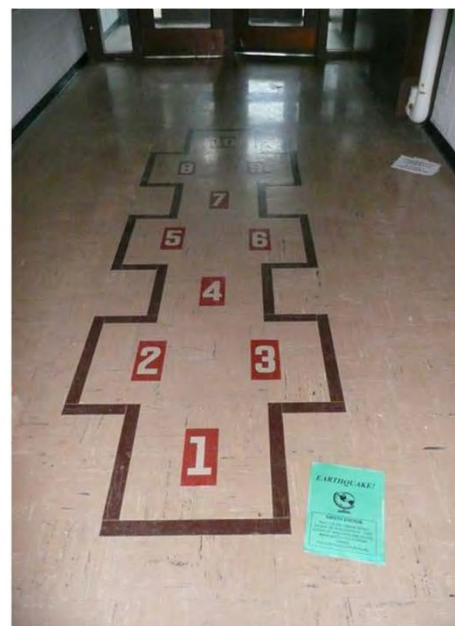
**Photo 146. Hopscotch detail: original drawing on the left from 1954 compared to the current condition of a hopscotch detail (location on drawing and actual location are different- see Drawing 3 below).**
