## System Chemistry To Control Potential Environmental and Safety Hazards of Recycled Concrete Aggregate with Lead-Based Paint

Stephen D. Cosper

January 2010

Final Report

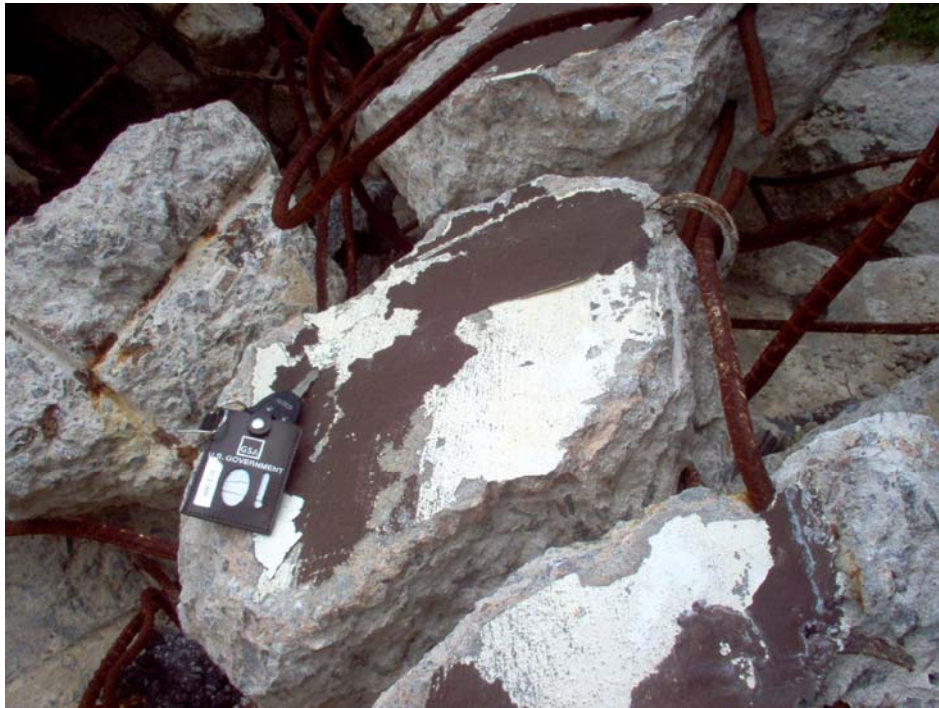
Figure 6. Closeup of concrete debris with adhered paint.

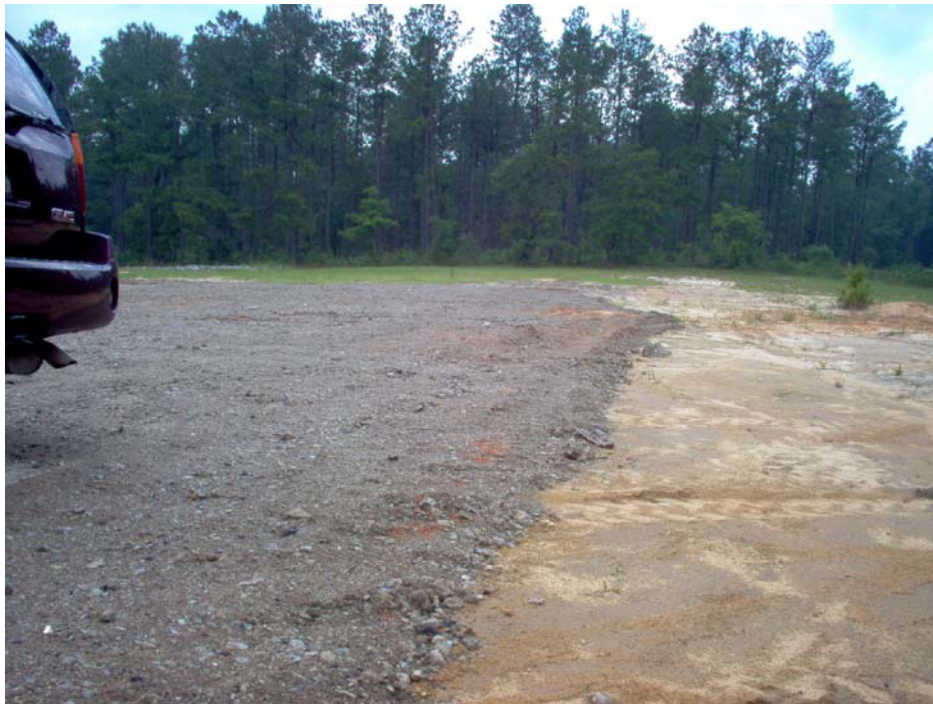
Figure 9. Crushed concrete as paving material at Fort Jackson.

Figures 1 through 10 show the events described, above. Figure 1 shows the title block from one of the original contraction drawings for the CSB. Until the vast acceleration of activity leading up to World War II, the Army Quartermaster was in charge of military design and construction. That responsibility then shifted to U.S. Army Corps of Engineers (USACE). Figures 2 and 3 show the CSB before demolition. Figure 4 shows an image from a short movie of the building demolition, taken by AEC staff. Figures 5 and 6 show large pieces of concrete and reinforcing steel that result from demolition. Figure 6 shows a closeup of a typical painted surface. As the concrete goes through the crusher, some paint is knocked off the surface and ends up in the fines. Figure 7 shows the portable concrete crushing plant that Fort Jackson DLE contracted to crush the material from the CSB, and other debris. Figure 8 shows Mr. Ed McDowell of the Fort Jackson DLE next to the stockpile of RCA from the CSB. Figure 9 and 10 show the RCA deployed as paving material for a parking lot. The depth of RCA is roughly 6 in. Note that the clay soil surface would tend to limit contaminant migration. Excess rainwater would tend to flow horizontally, rather than percolate into the soil. This study will show if any Pb from the RCA will migrate with the runoff.

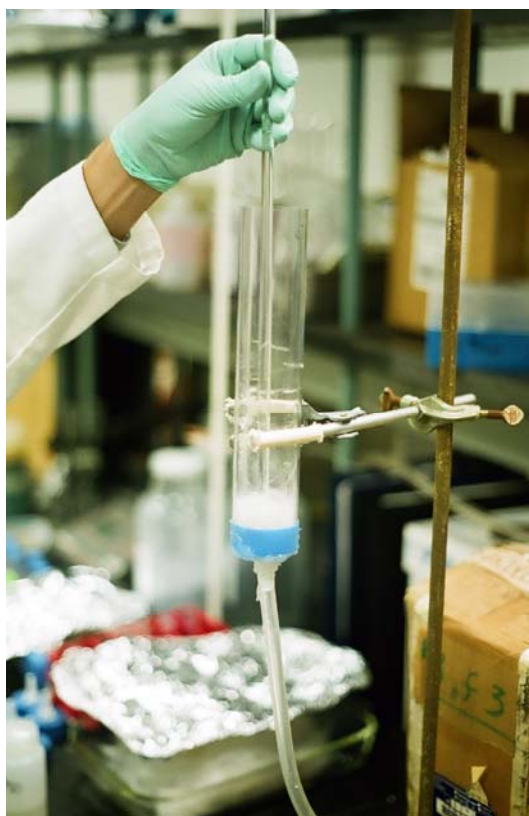
Figure 14. Packing leaching column with a base of glass wool to retain solids.

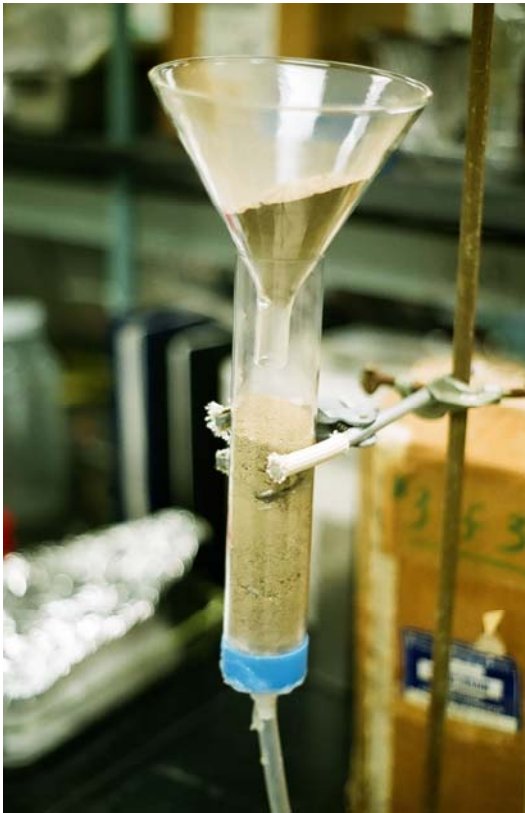
Figure 15. Loading leaching column with crushed concrete.

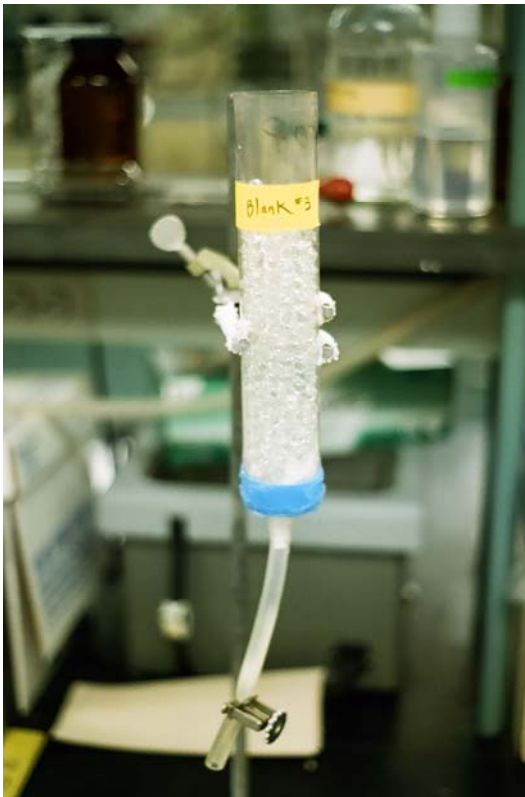
Figure 16. Glass beads in column, used as control for leaching experiment.

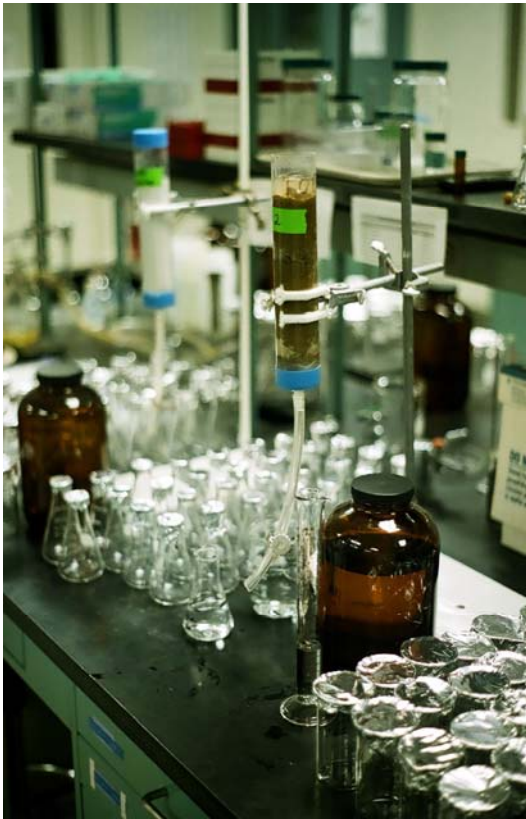
Figure 18. Bench with mounted columns and beakers for aliquot collection.

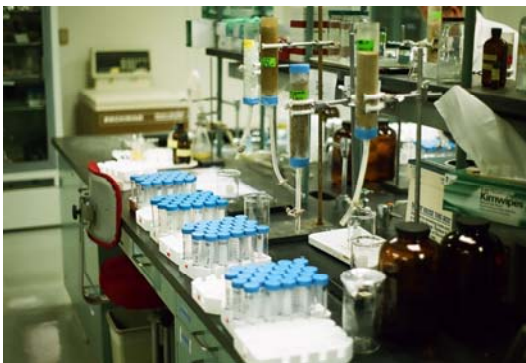
Figure 19. Bench with Falcon tubes for aliquot collection.

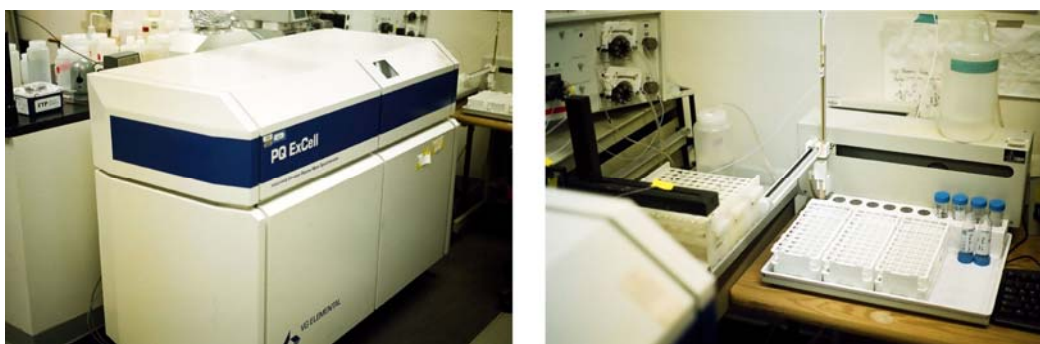
Figure 20. Inductively coupled plasma mass spectrometer with autosampler, used for total Pb analysis of column leachate.

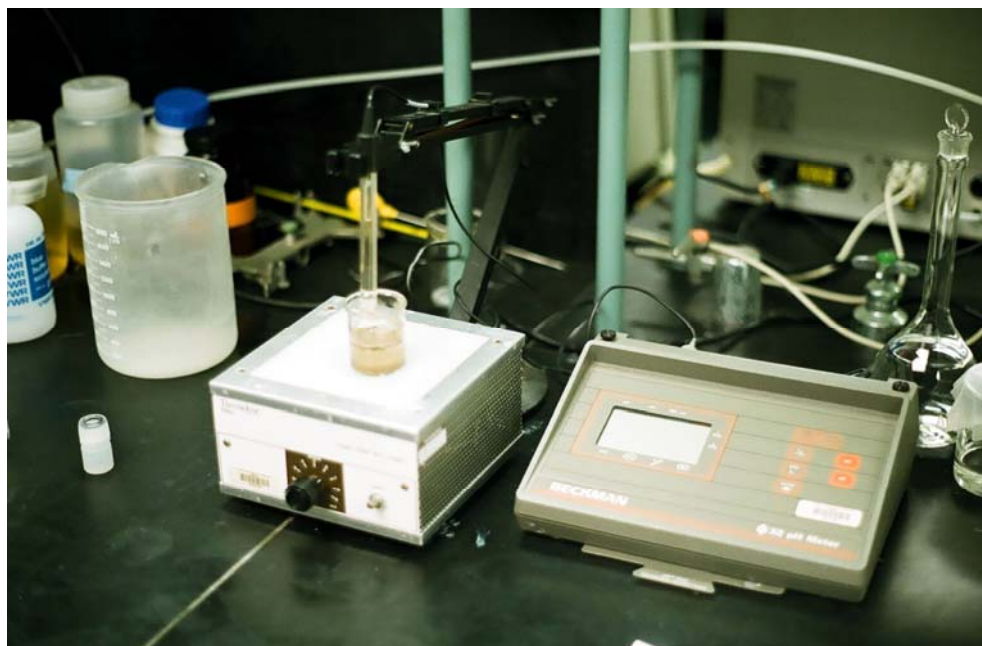
Figure 21. Measuring pH.

Soil samples must be mixed with some amount of distilled water (or other solution) so that the pH can be measured with a standard electronic pH meter. A soil-to-water ratio (mass) of 1:1 or 1:2 are most commonly used because this most closely reflects natural soil conditions (Tan 1996).
