## **Evaluating Alternative Methodologies for Capturing As-Built Building Information Models (BIM) for Existing Facilities**

Eddy Rojas, Carrie Dossick, and John Schaufelberger

August 2010

Final report

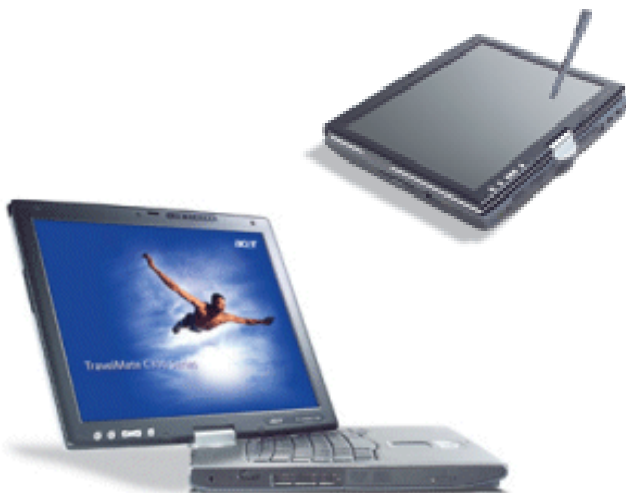
Week Two of the field trials ran from 21 July 2008 to 25 July 2008 following the standard schedule in Figure 1. The technology and methodology utilized that week was a Microsoft Access database used on an Acer TravelMate C300 laptop. The Acer laptop featured the following:

- Microsoft Windows XP Tablet PC Edition
- Office 2007 Professional Suite
- Intel Centrino Pentium-M 1.5GHz
- Weight 6.23 lbs
- Battery Run Time 4 hours
- 4-in-1 card reader

- Display Type 14.1" TFT active matrix
- Max Resolution 1024 x 768 (XGA)
- 4-way scroll button, digital pen
- RAM Installed 512 MB / 2 GB (max)
- Hard Drive 40 GB

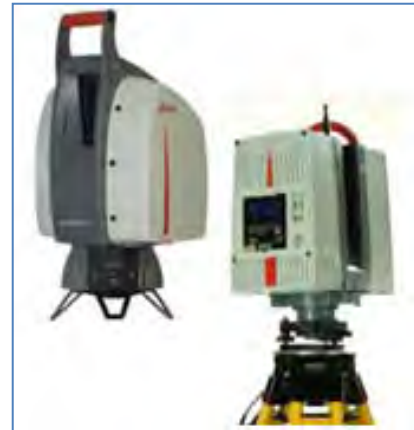
Leica ScanStation 2 and HDS6000  
Laser Scanners

- Leica high-speed laser scanners emit a pulsed laser that measures tens of thousands of points per second.
  - o Leica ScanStation 2
  - o Leica HDS6000 Scanner
  - o Total Stations, such as the Leica TP S800, establishes a control network for the exterior scanning and references the scan to global position coordinates.
- Camera mounts, such as the 0-360 Panoramic Optic™ is a specially designed lens attachment, with an exclusive optical reflector, which captures an entire 360 degree panorama with a single shot.
- Digital cameras, such as the Canon Powershot G9 and A650 IS, can produce 12.1 megapixel photos that are overlain on point clouds.

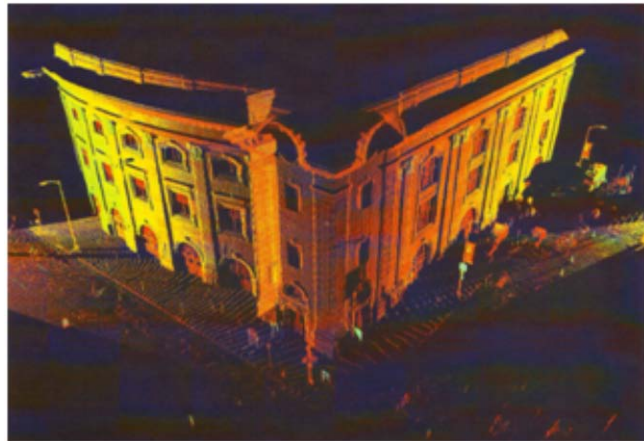
Through survey contractors, such as David Evans and Associates (DEA), highly accurate 3D renderings of a facility can be achieved. DEA has owned and operated High-Definition Surveying systems (laser scanning) since 2001. Their Leica HDS technology allows the collection, visualization, and modeling of complex structures and sites with remarkable speed. The Leica 3D laser scanner employs pulsed laser technology to scan target areas and return "point clouds", which looks like a detailed color rendering of a scene, in a matter of minutes. Experienced DEA technicians ensure the accuracy and completeness of several scans that are "interstitched" into a three dimensional system of point clouds, which can be viewed from any perspective.

Leica HDS Scan - Point Clouds

High-resolution photographs are overlain on the point clouds and viewable through a Leica freeware, known as TruView. Coordinates may be acquired from the photograph, since every point has an accurate horizontal and vertical position.

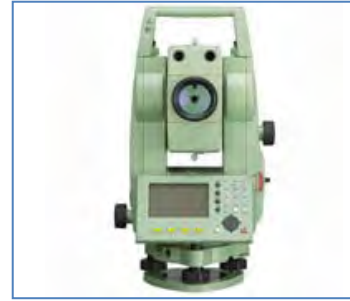
Leica TP S800

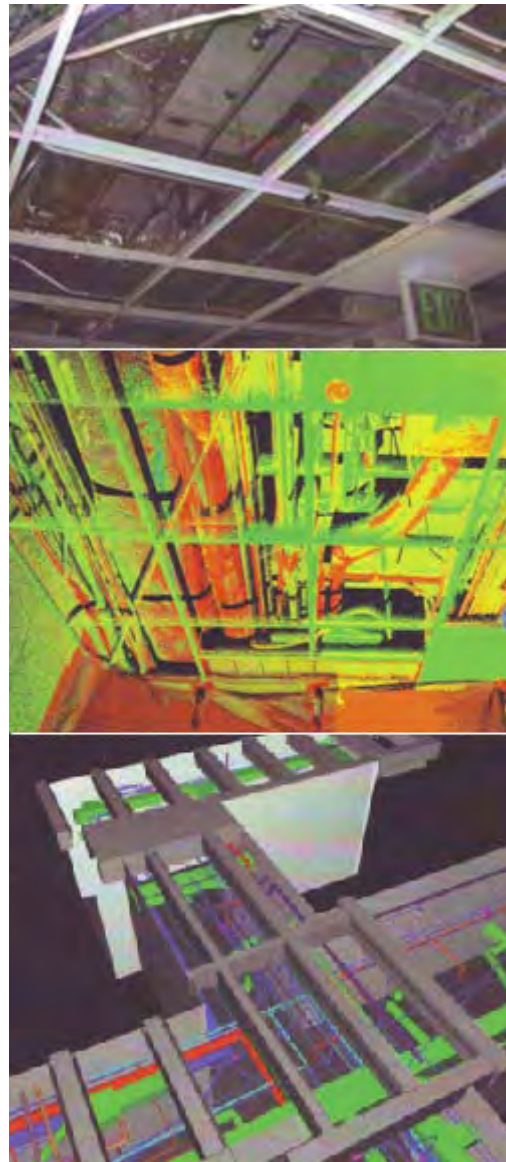
Photo, Point Clouds, and 3D Model  
of Ceiling Space
