# Development of the Larzac Engine Rig for Compressor Stall Testing

*A M Abdel-Fattah and A S Vivian*

DSTO-RR-0377

## ABSTRACT

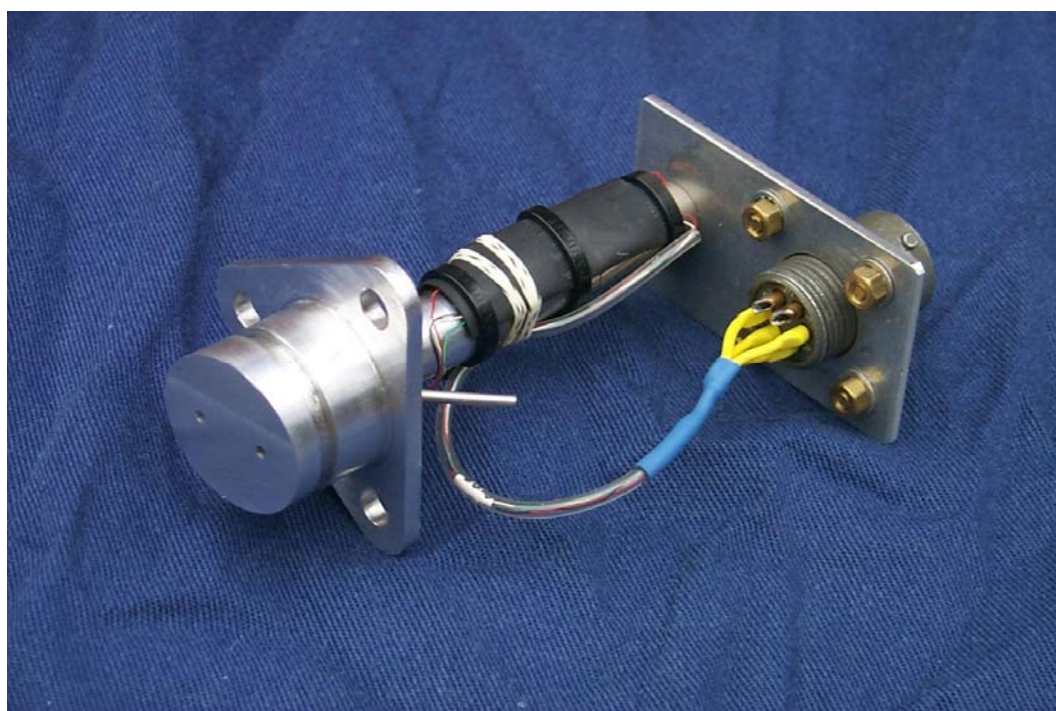
Figure 6: Miniature Kulite transducer static pressure probe at the exit of the fan upstream of the HPC inlet

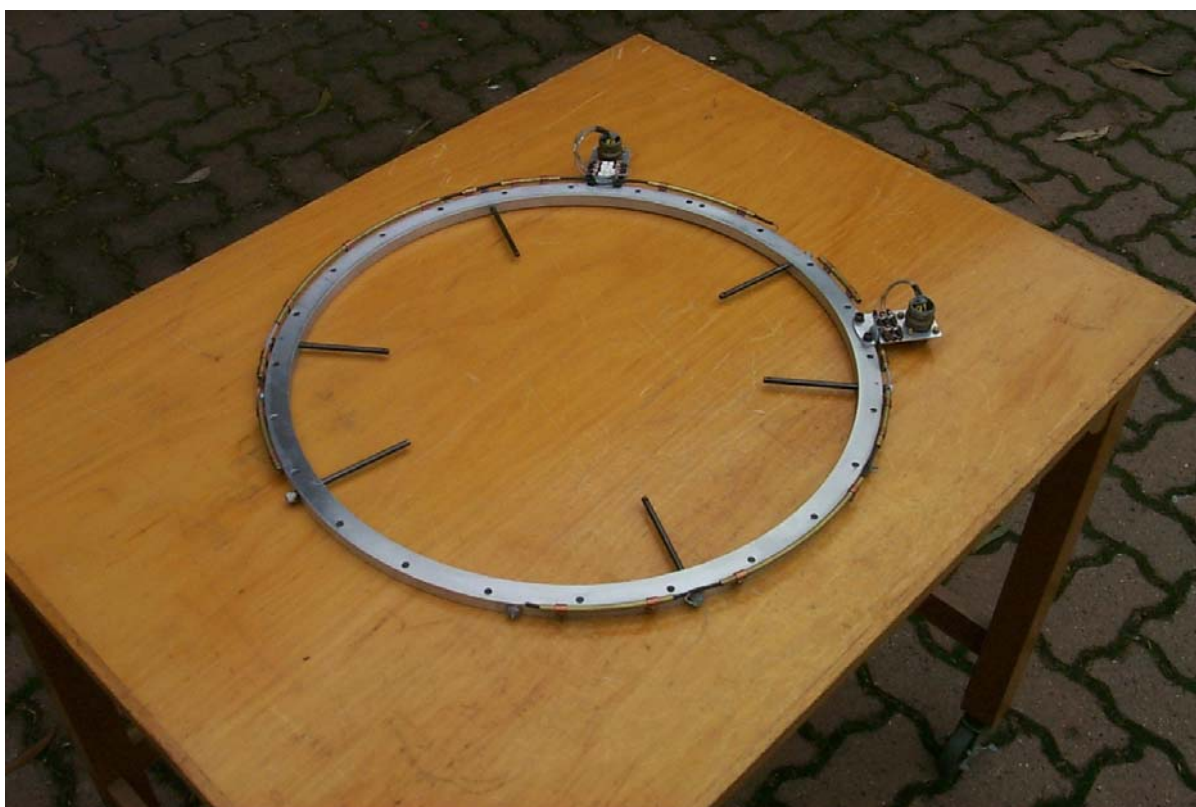
*Figure 7: The Larzac fan ring probe holder for the miniature Kulite transducers at the fan inlet, and angular probe location as viewed from the front and numbering starts at TDC and runs clockwise*
