| REPORT DOCUMENTATION PAGE | | | Form Approved<br>OMB No. 074-0188 | |
|---|---|---|---|---|
| 1. AGENCY USE ONLY (Leave blank) | | 2. REPORT DATE<br>21 August 2009 | | 3. REPORT TYPE AND DATES COVERED<br>Final, 1 August 2007 – 31 January 2009 |
| 4. TITLE AND SUBTITLE<br>An X-Ray Micro Computed-Tomography System for 3-Dimensional Microstructure Characterization of Multifunctional Composites | | | 5. FUNDING NUMBERS<br>FA9550-07-1-0557 | |

## An X-Ray Micro Computed-Tomography System for 3-Dimensional Microstructure Characterization of Multifunctional Composites

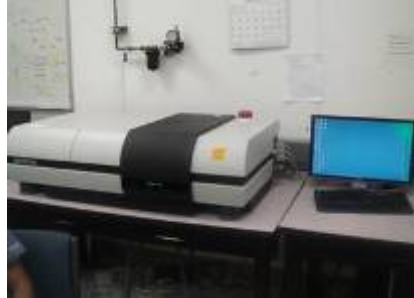
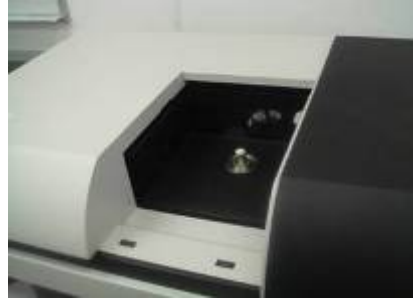
Fig. 1. The installed Skyscan 1172 scanning X-ray micro computed-tomography system: (a) overall system; (b) specimen holder inside the chamber

A Skyscan 1172 scanning X-ray micro computed-tomography system (Skyscan 1172) including a mechanical loading stage, a cooling stage and an X/Y stage was purchased and installed at UCLA to carry out non-destructive characterization of multifunctional composites, Fig. 1. The specifications of the machine are provided in Table 1.
