**AFRL-RH-WP-TR-2012-0103**

**ASSESSMENT OF CARGO SPACE SEATING  
PERFORMANCE APPLICABLE TO PAVE HAWK AND  
BLACK HAWK AIRCRAFT DURING HELICOPTER  
MISHAPS**

**June 2012  
Interim Report**

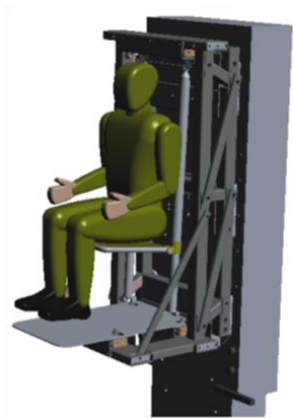
**Figure 4.** Pure Vertical

(3) Pure Vertical (PV) – The seats has no offset relative to the positive z-axis acceleration pulse. The orientation is shown in Figure 4.

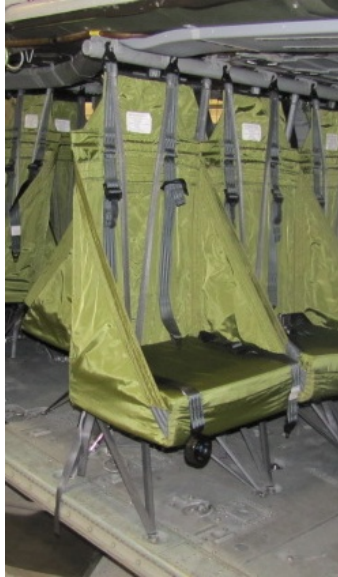
**Figure 7.** Glatz Aeronautical Prototype Seat

The Glatz Aeronautical Prototype seat was partially developed under an Air Force Research Laboratory (AFRL) Phase I Small Business Innovative Research (SBIR) program. The seat delivered to AFRL for testing is called the “Next Generation Troop Seat (NGTS) Mrk5Mod1A”. The seat was modified during testing with stronger seat floor mounts and additional structure for higher energy tests. The modified seat is called the NGTS Mrk5Mod1B. Both variants will be called the “Glatz seat” in this paper and any modifications to the seat are noted in the individual test notes. The seat is unconventional in that it has limited hard structure and consists of a large foam seat pan with fabric side supports (Figure 7). The seat hangs from H-60A/L seat supports and has 1-inch webbing to secure the seat structure to the floor. All seats were purchased new. The seat is in development and does not represent a finalized design.

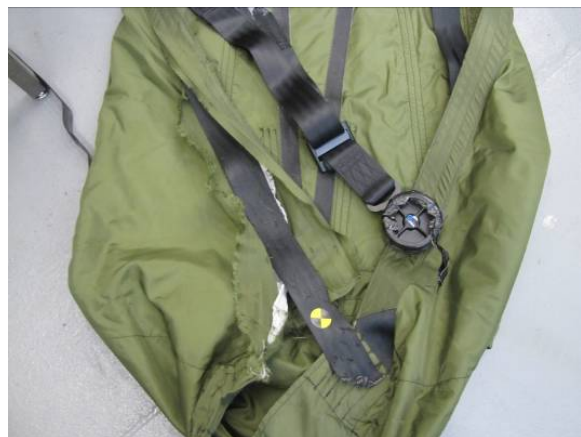
**VDT6223 – Cell B, CV, Glatz, LOIS, 35.26G, 48.37ft/s, 25.4ms rise time**

VDT6223 was a structural failure of the seat. The front right webbing that held the seat cushion ripped and allowed the seat cushion and manikin to submarine. The right lap restraint belt ripped free from the seat structure. The manikin was ultimately hung by the torso restraints still

attached to the buckle. The cause of the seat structure ripping was due to a manufacturing error according to Glatz Aeronautical. Fixes to the seat were applied to tests VDT6256 and HIA8510 by lengthening the structural webbing further around the front of the seat pan. Also, the lap restraint belts were lengthened behind the seat pan in later tests to prevent the complete separation of the lap belt from the seat. Seat attachment points were again deformed but did not break. A peak lumbar Z force of 1153 lb was recorded, though comparison to other testing is not valid due to structural failure of the seat.

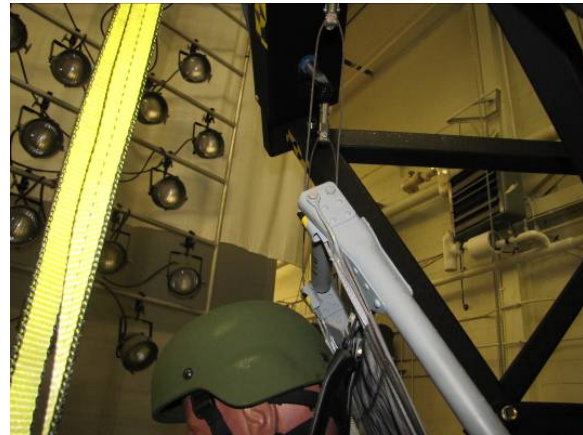
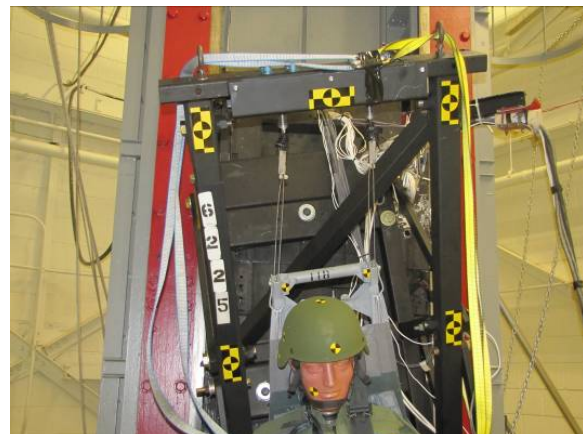
**VDT6225 – Cell D, CV, H-60A/L forward-facing, LARD, 36.67G, 48.96ft/s, 24.7ms rise time**

VDT6225 was the first test at the high energy level with LARD. The feet of the manikin remained on the floor during the impact. The seat pan fabric ripped from side to side during the impact. The seat stroked 10” on the left and 10.25” on the right. All mounting points remained secured to the fixture. The seat pan strut extended during the impact 2.125”. A peak lumbar Z force of 778 lb was recorded during the test. This force is relatively low most likely due to the seat pan ripping. The seat pan X and Z accelerometers were broken during the test. All the remaining data channels were successfully collected. The restraint buckle disengaged with 36 lb force.

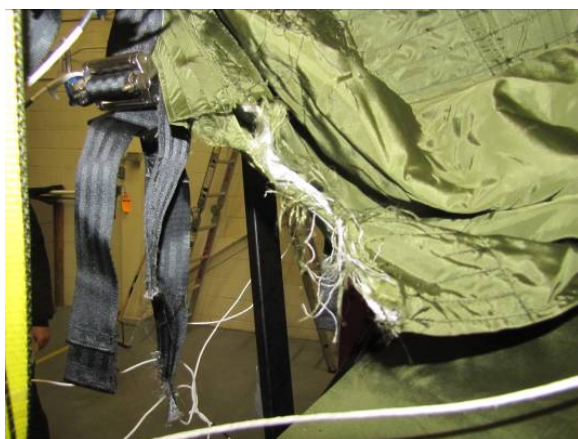
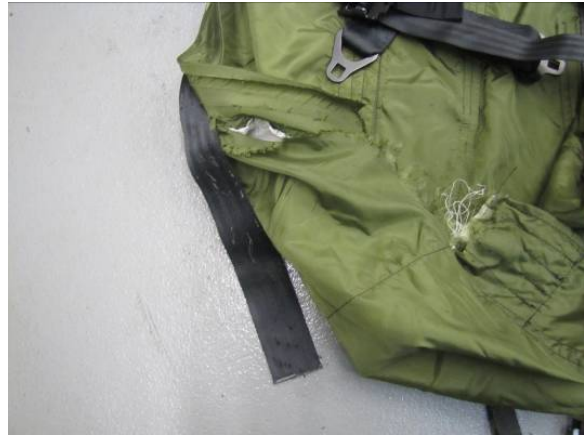
**VDT6226 – Cell C, CV, Glatz, LARD, 25.82G, 40.48ft/s, 28.9ms rise time**

VDT6226 was the first test with LARD in the Glatz seat. The seat structurally failed in multiple places, causing the manikin to be completely unrestrained in the seat. During impact the manikin submarined and was momentarily hung by the torso belts still attached to the rotary buckle. The right rear side webbing pulled out of the seat structure. The front right seat pan structure ripped. This was again due to manufacturer error, according to Glatz Aeronautical. The original aluminum mounting feet used during the first two Glatz tests with LOIS were replaced with stainless steel feet. The new feet did not show any signs of deformation. Both lap belts ripped from the seat. There was an Nij tension-flexion value of 0.6815, or equivalent to a 22% probability of an AIS  $\geq 2$  neck injury. Since the seat structurally failed, lumbar load and seat pan acceleration are meaningless and are not comparable to other seat tests. The left torso restraint belt force channel went bad well after the impact. All other data were successfully recorded. The restraint buckle disengaged with 9 lb force.

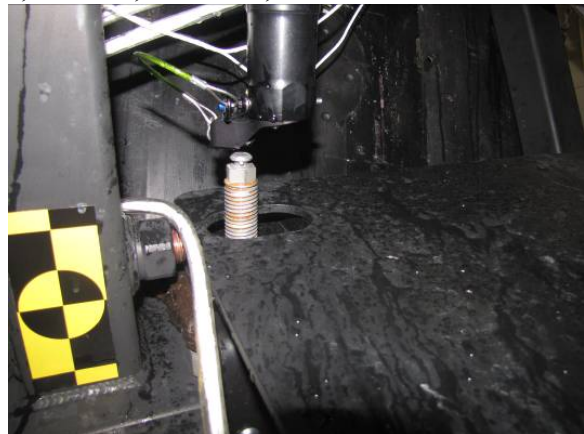
**VDT6227 – Cell C, CV, UH-60M, LARD, 25.56G, 40.53ft/s, 29.1ms rise time**

VDT6227 was the first LARD test with the UH-60M seat. The right foot of the seat disengaged during the impact. After further inspection it was found there was some interference with the AFRL mounting points and that the foot may have not been fully engaged. A modification to the mounting bracket was made after VDT6228, and in subsequent tests, the feet stayed attached. Even with the foot becoming disengaged, the seat stroked 4.625". The only structural damage observed was slight deformation in the seat pan. A peak lumbar Z force of 1346 lb was recorded. All data were successfully collected. The restraint buckle disengaged with 8 lb force.

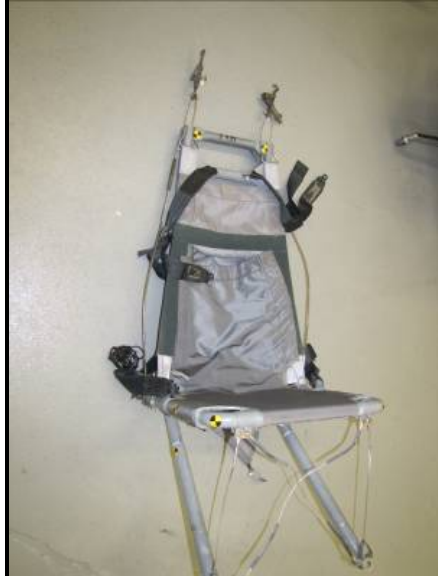
**VDT6233 – Cell A, CV, H-60A/L aft-facing, LOIS, 23.23G, 38.56ft/s, 30.2ms rise time**

VDT6233 was the first test of the H-60A/L aft-facing seat. The top mounting hooks were wrapped with tape and secured with zip-ties, preventing inadvertent release during rebound after the primary impact. All mounting points successfully stayed attached during impact. The seat stroked 3.5”. The manikin did sink into the backpack pouch. No other structural damage was noted on the seat. A peak lumbar Z force of 602 lb was recorded. All data were successfully collected. The restraint buckle disengaged with 29 lb of force.

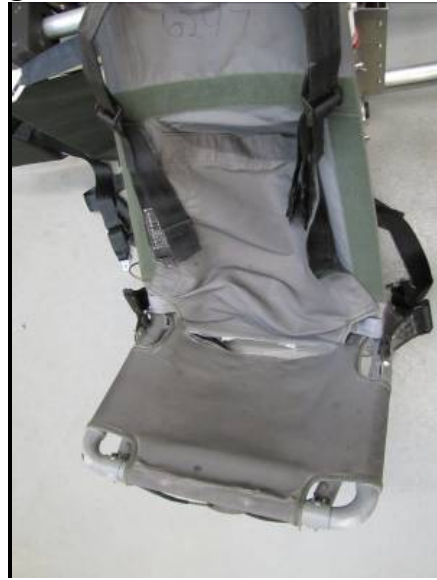
**VDT6247 – Cell H, PV, H-60A/L forward-facing, LOIS, 33.91G, 46.25ft/s, 26.5ms rise time**

VDT6247 was the last PV with LOIS using the H-60A/L seat. The seat stroked 3.25" during impact. The rear of the seat pan ripped, though the manikin was successfully held in the seat. Lap belt tension was not recorded during the test due to available belt length. A very short Z acceleration of 54.75G was recorded. A peak lumbar Z force of 1104 lb during the impact as well as a 31.03G peak chest resultant acceleration were observed. An Nij tension-extension of 0.5763 was calculated, resulting in a 20% probability of an AIS  $\geq 2$  neck injury. The restraint buckle released with 9 lb of force.

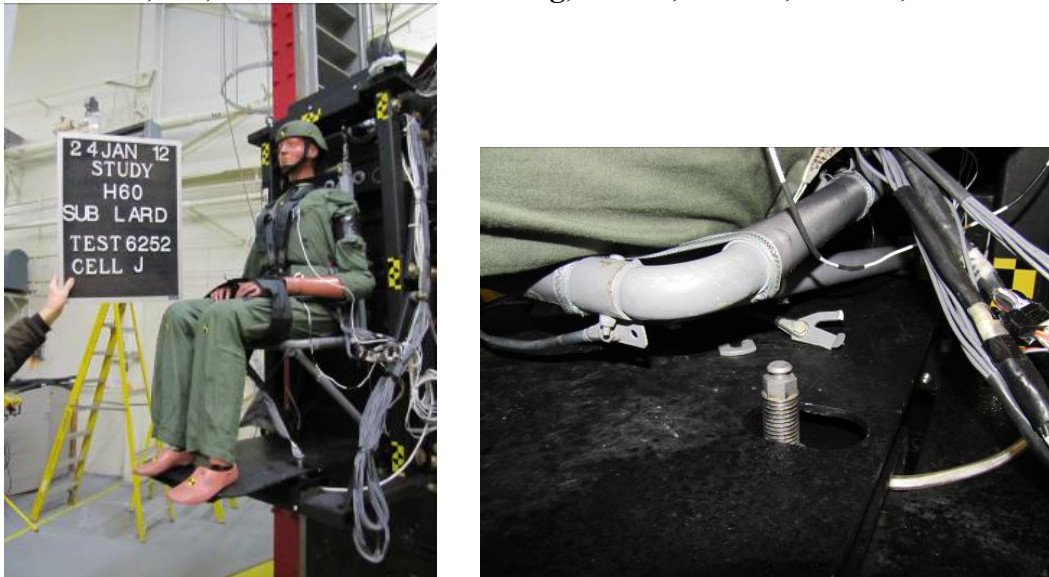
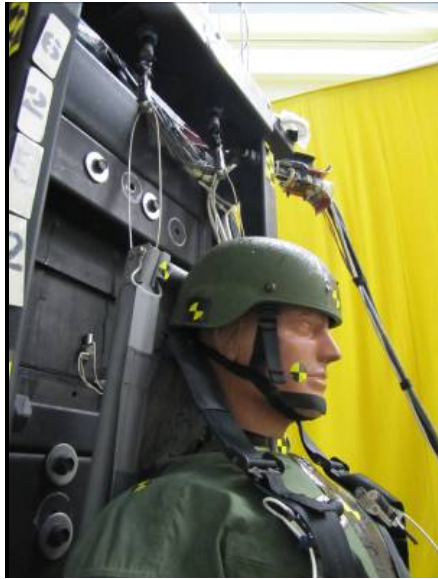
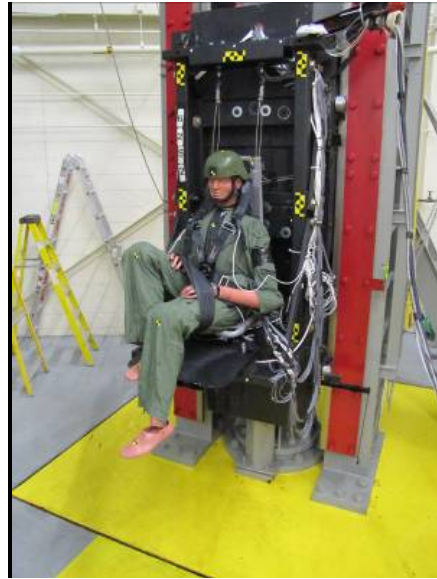
**VDT6252 – Cell J, PV, H-60A/L Forward-facing, LARD, 34.92G, 46.9ft/s, 26.4ms rise time**

VDT6252 was the last PV test with the H-60A/L seat. The seat stroked 11.75in. There was significant tearing of the right side of the seat pan along the seat pan structure. The front left mounting point failed and tore away. The bottom left front mounting Y force channel was bad during the test. The lumbar moment about the Y axis peaked at the set range of the channel. A peak chest acceleration resultant of 45.19G was recorded along with a peak lumbar Z force of 1752 lb. A seat pan acceleration of 37.41G was recorded during the pulse, and a higher 72.81G was recorded soon after. This was most likely due to the ripping and subsequent bottoming out of the seat on the fixture, and was consistent with the peak lumbar forces recorded. No neck injury criteria were exceeded. The restraint buckle released with 15 lb of force.

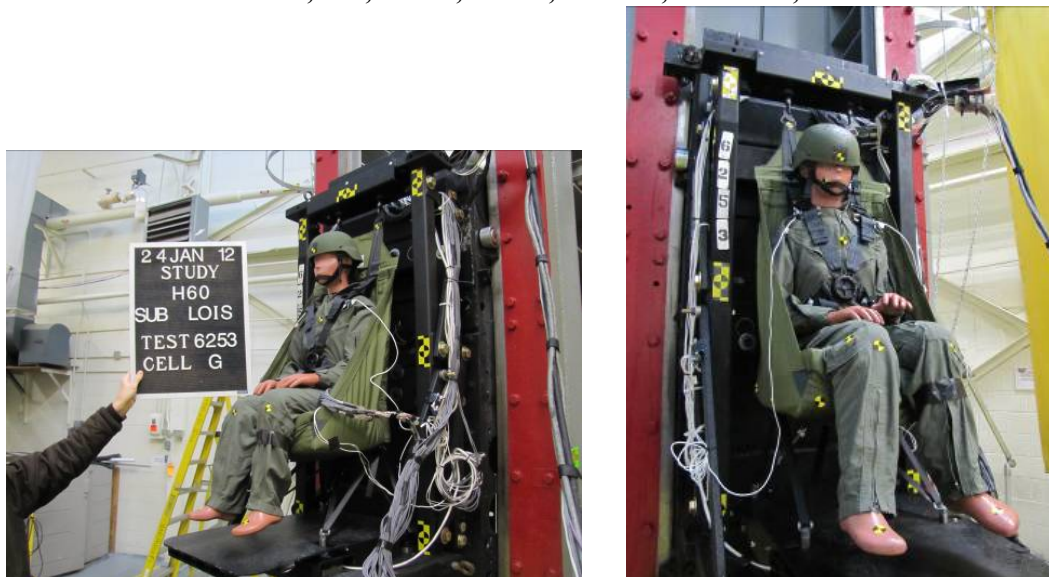
**VDT6253 – Cell G, PV, Glatz, LOIS, 16.92G, 31.85ft/s, 35ms rise time**

VDT6253 was the first PV test with the Glatz seat. Lap belt tension was not recorded due to the length of the belts. Seat pan acceleration Y went bad after the primary pulse. There was no structural damage to the seat during the test. The seat pan accelerometer package was placed on top of the cushion for the PV testing, unlike during the CV testing. Because of this configuration, seat pan data can be directly compared to other PV seat tests. There was a peak seat pan Z acceleration of 45.88G. A peak chest acceleration resultant of 26.22G was recorded along with a peak lumbar Z force of 939 lb. No neck injury criteria were exceeded. The restraint buckle released with 5 lb of force.

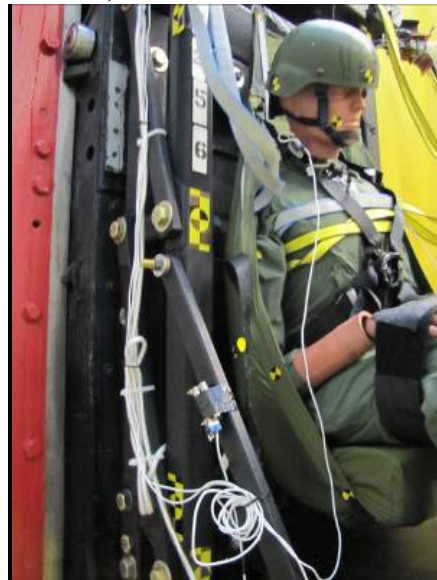
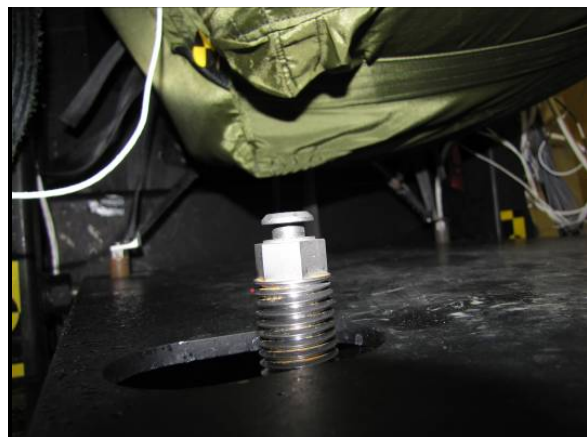
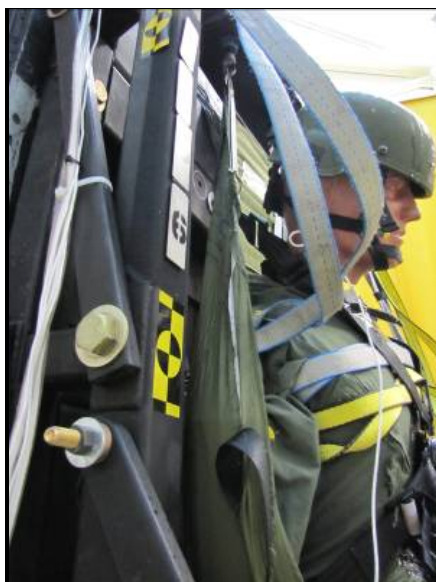
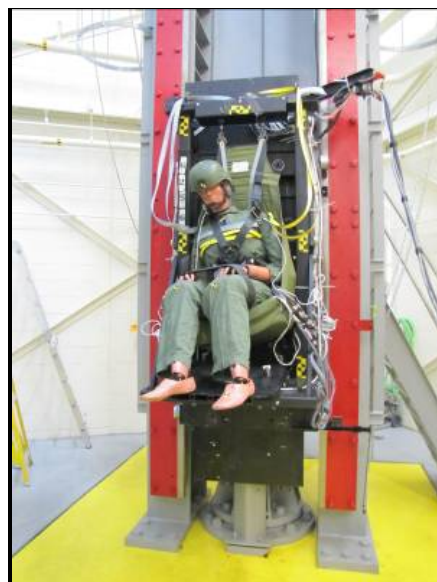
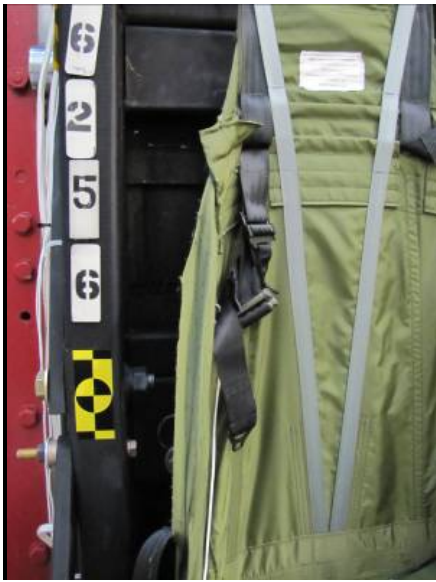
**VDT6256 – Cell J, PV, Glatz, LARD, 34.99G, 46.85ft/s, 26.4ms rise time**

VDT6256 used a modified Glatz seat. Additional webbing was placed on the back of the seat, the structural webbing down the side panel of the seat was extended around the front of the seat pan, and the lap belt webbing was extended behind the seat pan. The lap belt forces were not collected due to space and length of available belts. All other data channels were successfully collected. During impact the webbing to the front feet came loose as the seat pan descended and put tension on the webbing. The seat cushion started to come of the seat bucket, and the structural webbing on the right side panel ripped out. The back of the seat pan ripped, and the lap belts ripped out of the seat back. One of the tension rods at the top of the seat broke. A peak chest acceleration resultant of 44.34G was recorded along with a peak lumbar Z force of 1251 lb. The seat pan acceleration Z was noisy – most likely due to stitching in the seat coming out. A peak seat cushion Z acceleration of 21.86G was recorded. No neck injury criteria were exceeded. The restraint buckle released with 4.5 lbs.
