| <b>1. REPORT DATE (DD-MM-YYYY)</b><br>01-6-2012 | | <b>2. REPORT TYPE</b><br>Master's Thesis | | <b>3. DATES COVERED (From - To)</b><br>JAN 2012 - JUN 2012 | |
| <b>4. TITLE AND SUBTITLE</b><br>Remote Nondestructive Evaluation of Composite-Steel Interface by Acoustic Laser Vibrometry | | | | <b>5a. CONTRACT NUMBER</b><br>N00244-09-G-0014 | |

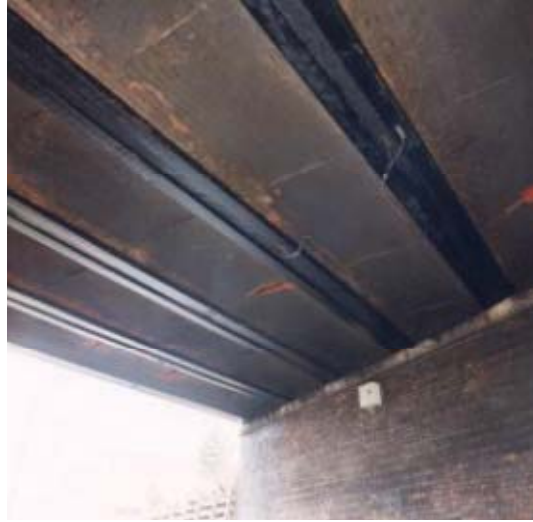
**Figure 1: King Street Railway bridge with CFRP plates installed on cast iron girders with strain gauges for structural health monitoring (Farmer and Smith 2001)**

The King Street Railway Bridge in Mold, North Wales, United Kingdom was constructed in 1870 from cast iron. The free span of the bridge is 8.93 m (29.30 ft) but due to age, and decreased load carrying capacity, the structure had to be propped up at midspan until a strengthening plan could be devised. Even with the propped span, a weight restriction of 17 metric tons (18.7 short tons) was applied to the bridge, well below the desired capacity of 40 metric tons (44 short tons). The strengthening plan required the use of CFRP plates to stiffen the longitudinal cast iron girders running the length of the span as shown in Figure 1. The composite plates were also outfitted with strain gauges to monitor the performance of the structural system after strengthening. Structural monitoring under known loads has shown the strengthening with CFRP has achieved the desired results (Farmer and Smith 2001).

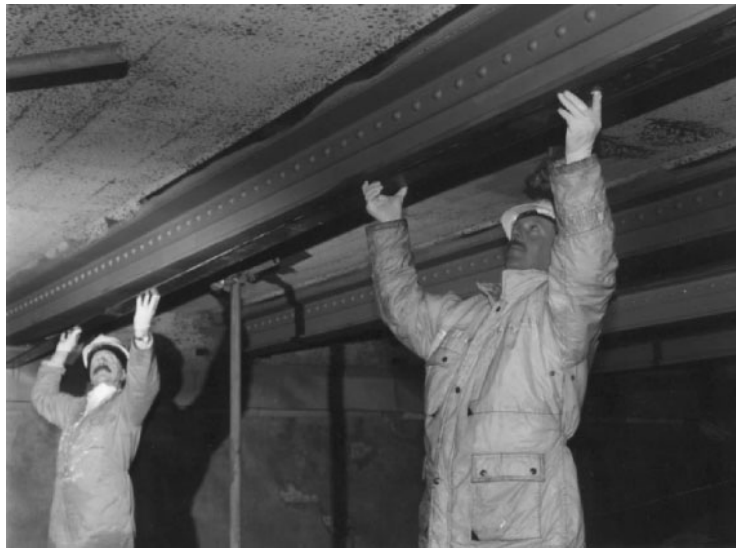
**Figure 4: Installation of CFRP plates on girders of Slattocks Canal Bridge in Rochdale, UK (Luke 2001)**

The Slattocks Canal Bridge in Rochdale, United Kingdom was built in 1936 with steel girders supporting a reinforced concrete deck. The girders have a free span of 7.62 m (25 ft) between abutments. Due to deterioration the bridge's load was limited to 17 metric tons (18.7 short tons), but its desired load was to be 40 metric tons (44 short tons). CFRP plates were chosen to retrofit the structure due to minimal impact to traffic carried by the bridge and minimal impact to the clearance below the bridge. The plates used were only 10 mm (0.39 in) thick which did not affect the clearance above the waterway below. As seen in Figure 4, the plates did not require a large amount of equipment for installation due to their light weight. After installation the bridge was able to have the load restriction removed and was able to carry loads up to 40 metric tons as designed. The limited impact to normal operation of the bridge made the use of CFRP strengthening less expensive than other retrofit options (Luke 2001).

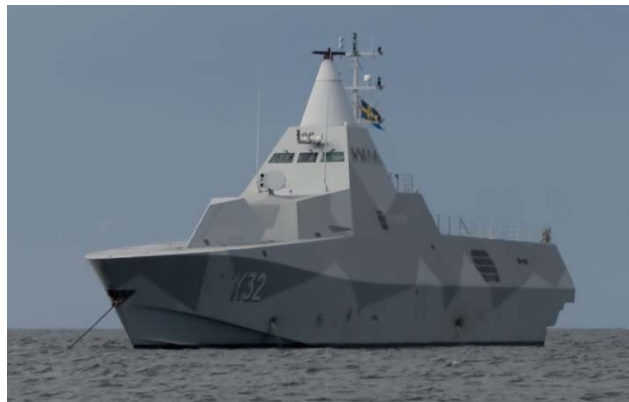
**Figure 7: Swedish Visby class corvette built entirely of composite materials (Visby Class Corvette 2008)**

The Swedish Navy has used composites for the entire construction of its Visby class corvette. The Visby, which is 73 m (239.5 ft) long and displaces 600 metric tons (590 long tons), is constructed out of CFRP sandwich material. Stealth was a primary design requirement as such a small ship cannot take many hits from either missiles or surface gunfire. Therefore reduction of all ship signatures was used in this design to include optical and infrared signature, above water acoustic and hydroacoustic signature, underwater electrical potential and magnetic signature, pressure signature, radar cross section, and actively emitted signals (Visby Class, Sweden 2011). Its design uses a reduction of angles by maintaining a very flat surface as can be seen in Figure 7. This drastically decreases the radar cross section of the ship thereby making it stealthier. The use of composites led to a dramatic decrease in the ship's displacement which is half of a conventional corvette. This allows for a very high speed vessel as evidenced by the Visby's top speed of 64.8+ km/hr (35+ kts) (Summers 2004).

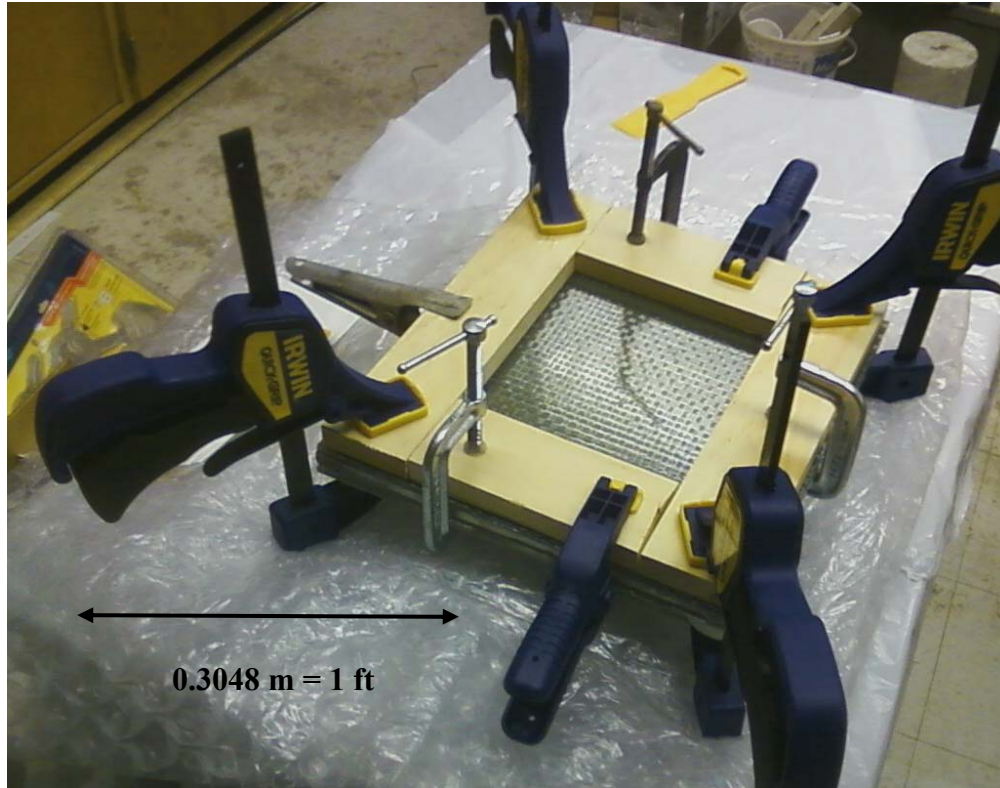
**Figure 16: Specimen construction showing clamping of edges to ensure only a central defect**

To prepare the bond surface the stainless steel plate was abraded with varying roughness sandpaper (100 - 220 grit) until the surface appeared to be smooth and uniform. Then the surface of both plates was wiped clean using acetone. With both surfaces clean the epoxy was applied using a mixing tip on a discharge gun which made for easy application. The epoxy beads were smoothed with a plastic putty knife to achieve as uniform a layer as possible. It is important to note that when applying the epoxy, special care was taken to ensure a portion of both plates had no epoxy which created the defect in the bond. For the initial specimen a 0.1524 m (6 in) square area was left free of epoxy in the center of both the stainless steel and GFRP plates. Once the areas on both surfaces to be bonded were fully wetted the GFRP plate was placed on top of the steel one. Then the two pieces were clamped together to ensure a full bonding all around the defect as shown in Figure 16.
