*National Erosion Control Development and Demonstration Program*

## **Lake Michigan Bluff Dewatering and Stabilization Study – Allegan County, Michigan**

September 2012

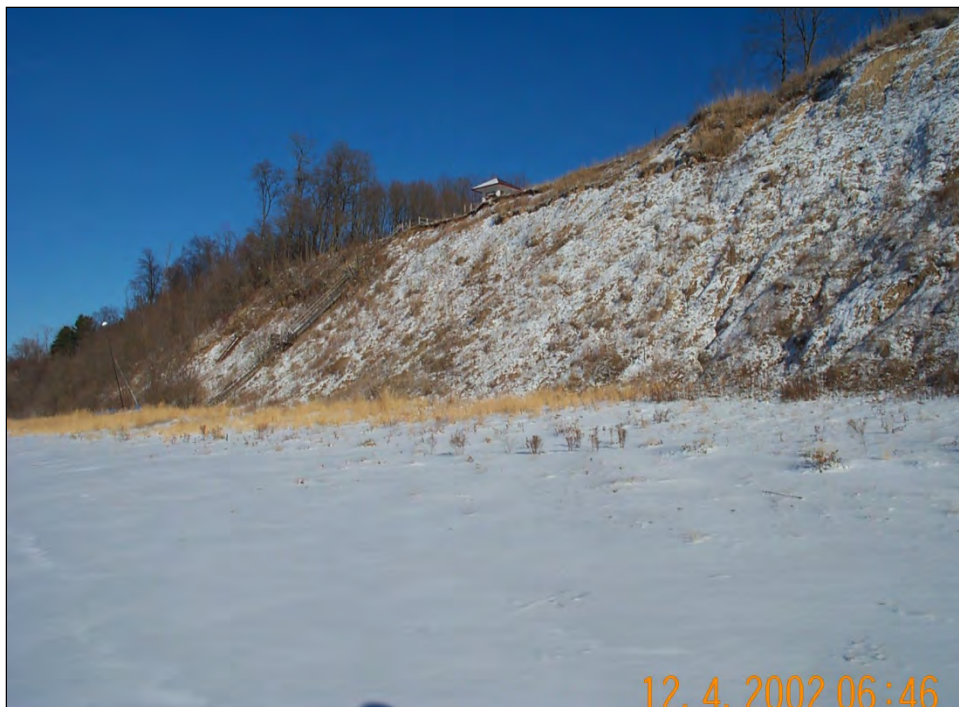
Figure 11. Cross section, top, for MPN to show height of bluff (by Ronald B. Chase); bottom photo, bluff at MPN in 2002.

The height of the bluff is approximately 65 ft (Figure 11). The elevation of the top of the bluff is approximately 645 ft at MPN (STS 2005). Like MPS, the site is approximately 500 ft long and 4.6 miles north of South Haven. The plan view of the site is given in Figure 12.

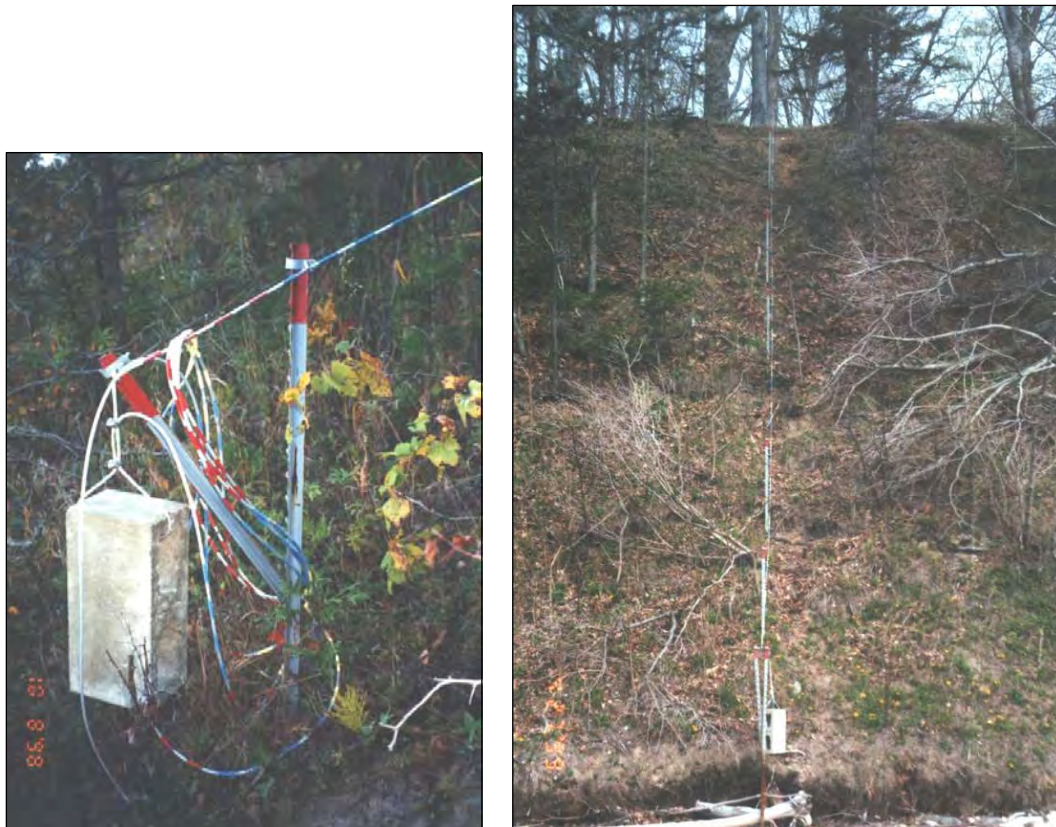
Figure 18. Last pole, left, of the calibrated pole-cable system and concrete anchor, and, right, calibrated cable system shortly after installation at 116<sup>th</sup> Avenue.

Each 8-ft fence pole was driven manually into the slope, and its end was positioned in an assumed clay rich layer. Figure 18 is a photograph of the last pole in a survey line with a weight (concrete block) attached to the cable for tension. Figure 19a illustrates the original position of the poles installed at MPS in 1996, while Figure 19b shows the dramatic displacement of the poles from 1996 to 2001. Pole 8 moved almost 50 ft downslope during the five-year period. Poles 9, 10, and 11 have moved completely off the slope and were removed by wave action.

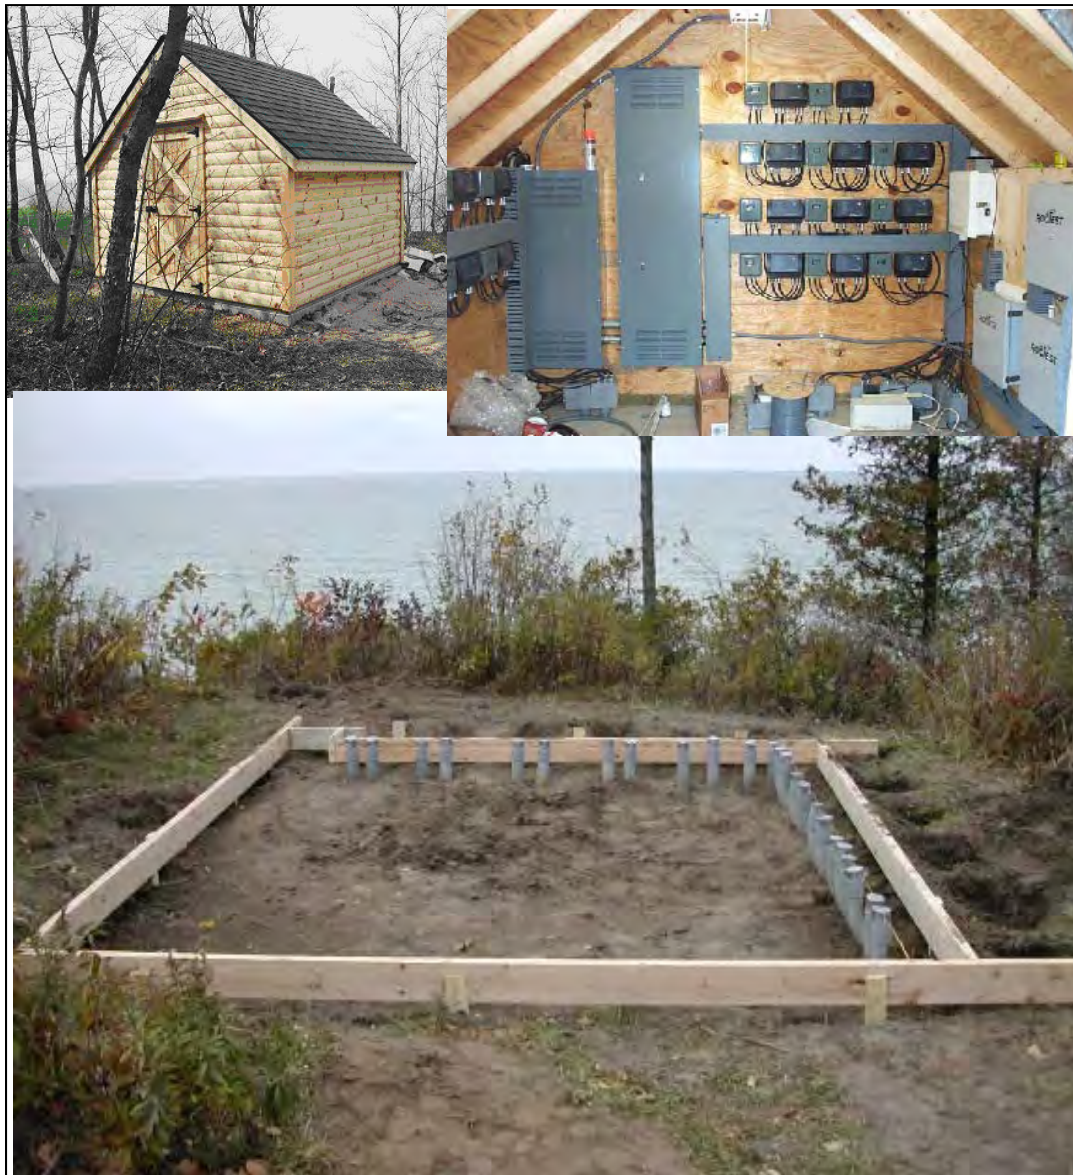
Figure 29. Data-control shed, clockwise from top left, atop each bluff site; pump and instrument control boxes and DAUs inside shed; and construction of shed foundation showing buried conduits for instrumentation wiring.

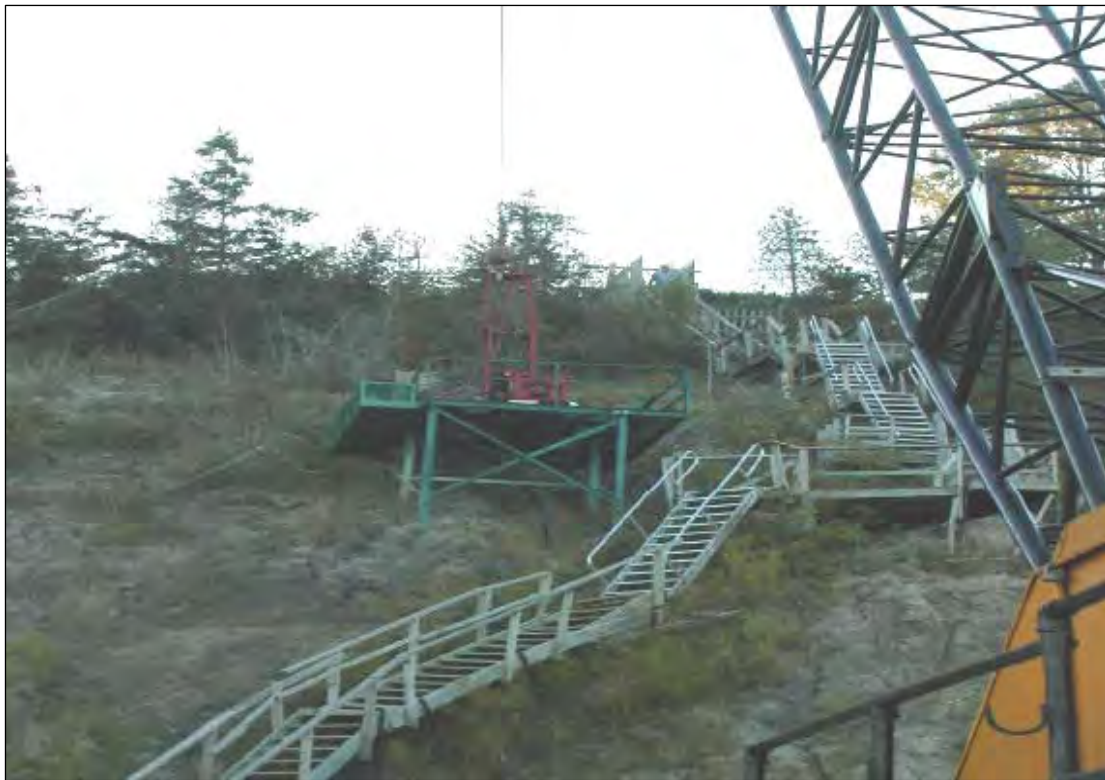
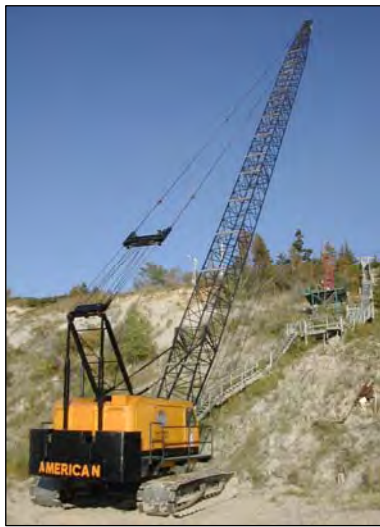
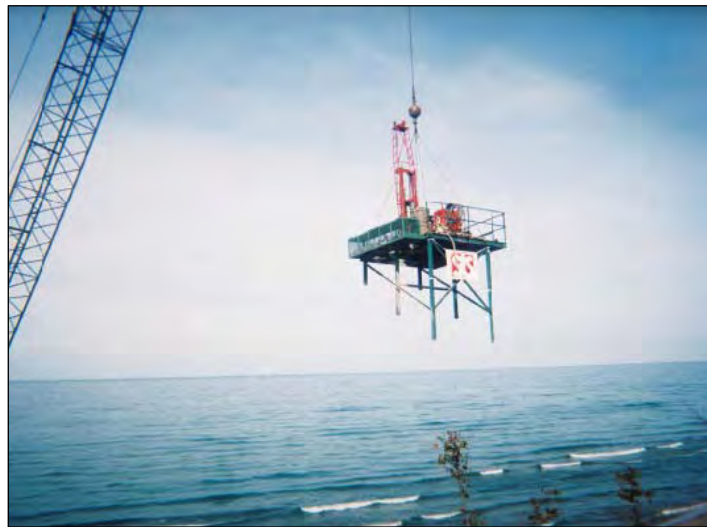
Figure 34. Green drilling platform and red drill at MPS suspended by 100-ft crane. Stairs have been rebuilt three times by property owners because of slope failures (photos after STS 2005).

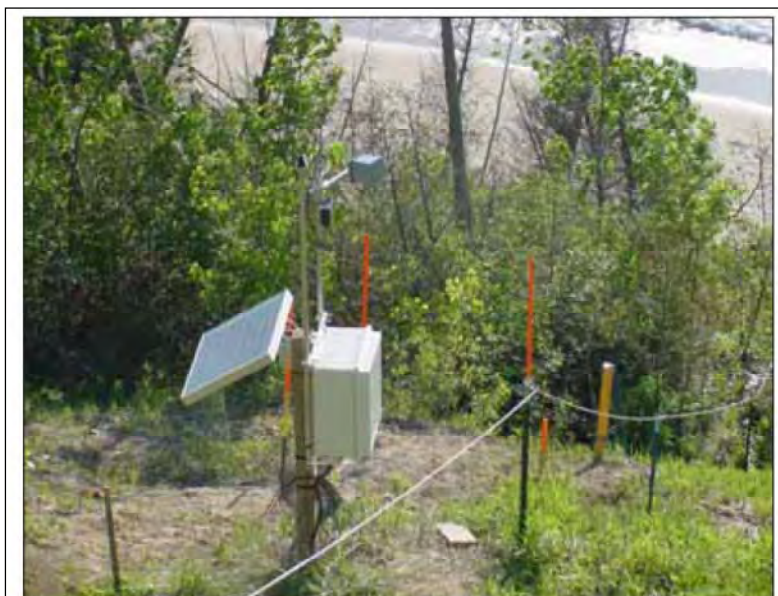
**Figure 5.** View from above of our site in a nearby control section of the bluff. Soil temperature, moisture, and resistivity instrument profiles in the bluff are marked by orange stakes, with solar panel, data logger, and web camera visible as a cluster in the foreground.

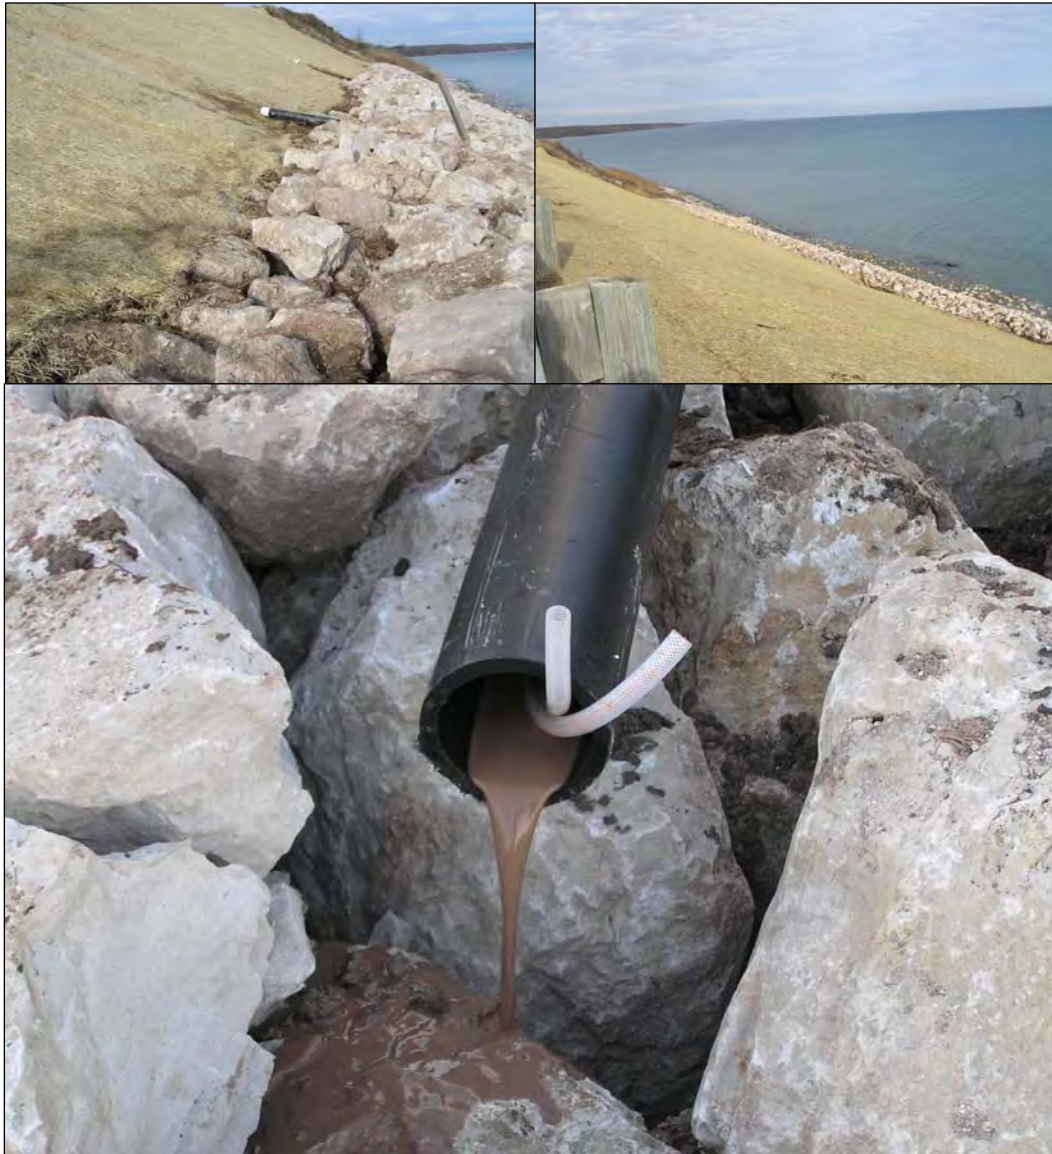
Figure 52. Slope, clockwise from top left, after cut and fill of the surface material; installation of gravity drains and toe revetment; and view of drain outlet at the revetment just after construction (photos courtesy of Ross, USACE, Detroit District).

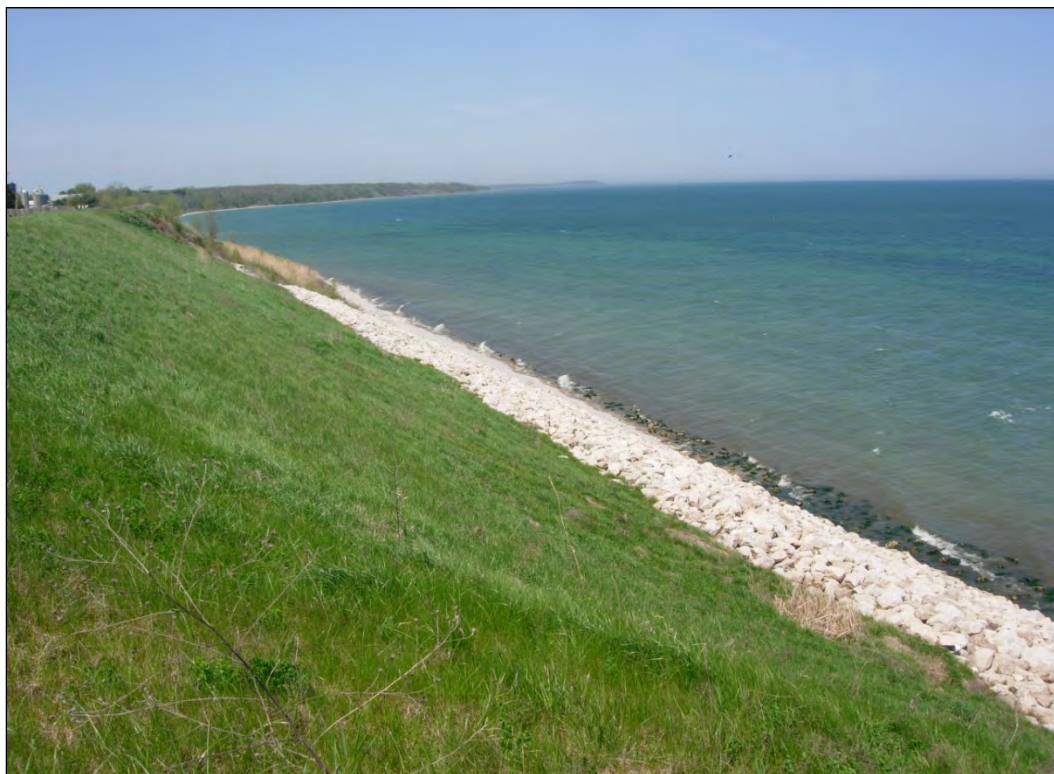
Figure 53. View after construction of gravity drained Mosel Bluff, Sheboygan County, Wisconsin. Note heavily constructed revetment at toe to prevent foreshore erosion (photos courtesy of Ross, USACE, Detroit District).
