# **Mechanical Testing of 3D Fabric Composites and Their Matrix Material SC-15**

**ARL-TR-6245**

**November 2012**

# **Army Research Laboratory**

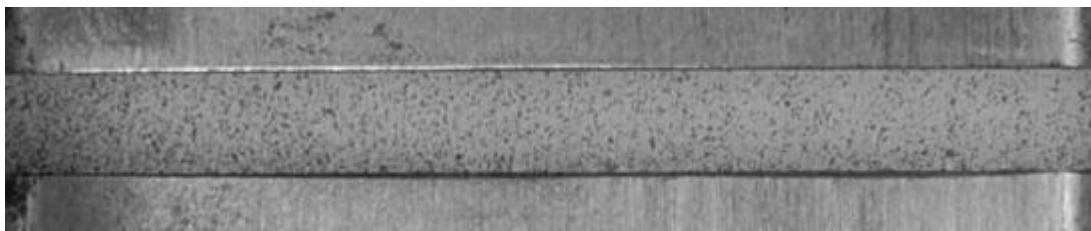
Figure 3. Side image showing the applied speckle and cropped raw image for compressive tests of the SC-15.

Compression tests for the matrix were performed according to the ASTM D695 specification (17). The samples were loaded at a rate of 0.05 in/minute. Strain gauges were not used for this testing because strains beyond the failure strain of the gauges were expected. Instead, a speckle pattern was applied to the side of the sample using Krylon fusion paint. Images were then taken every two seconds using a Nikon D80 digital SLR camera. The images were then cropped using a MatLab script and were analyzed using the ARAMIS DIC software (18). A sample of the raw image is seen in figure 3.
