First Year Sedimentological Characteristics and Morphological Evolution of an  
Artificial Berm at Fort Myers Beach, Florida

A thesis submitted in partial fulfillment  
of the requirements for the degree of  
Master of Science  
Department of Geology  
College of Arts and Sciences  
University of South Florida

Keywords: berm nourishment, nearshore sediment transport, coastal  
morphodynamics, nearshore bar, beach erosion

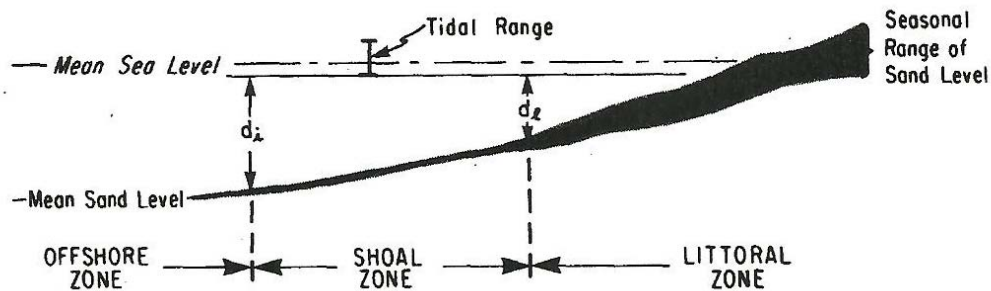
Figure 1. Shore Perpendicular Profile Zonations. (Hallermeier, 1981).

Hallermeier (1981) proposed a model to divide a seasonal sand beach into three shore-normal zones based on mobilization of sand by waves. The zones from the nearshore are the littoral zone, the shoal zone, and the offshore zone. The shoal zone, according to Hallermeier, is bound by two water depths (Figure 1):  $d_l$ , which is maximum water depth for significant alongshore transport and intense on/offshore transport by waves during extreme conditions, and  $d_i$  which is the maximum water depth for initiation of motion of sediment by median wave conditions. Hallermeier suggests that when considering subaqueous beach nourishment, the dredged material should be placed within the littoral zone, or landward of  $d_l$ .

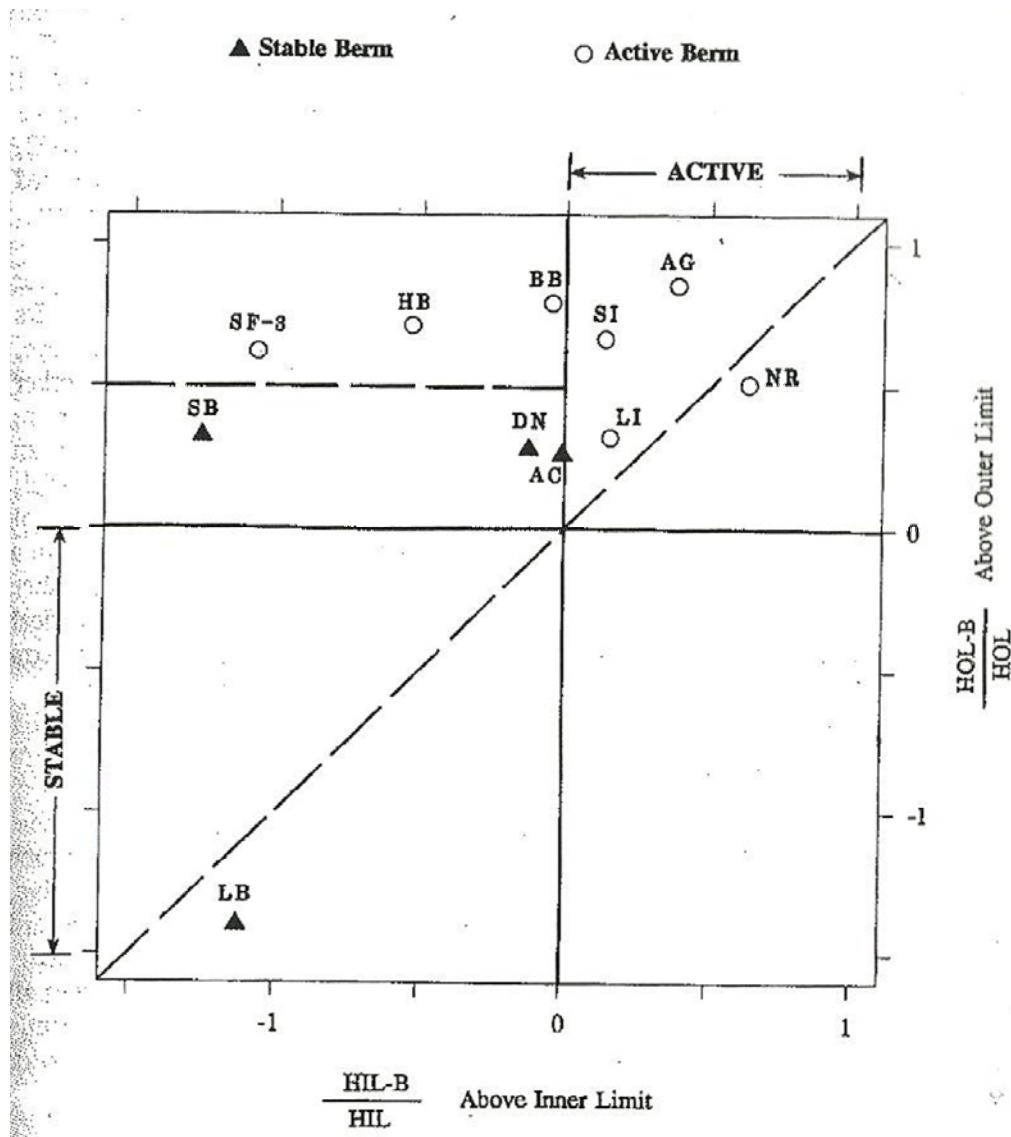
Figure 2. Hands and Allison (1991) Active vs. Stable Berms.

Active berms are those that show significant movement within the first few months. Stable berms retain most of their original volume and remain at the placement site for years. For the purposes of their study, the authors defined  $d_i$  and  $d_o$  as Hallermeier's inner limit (HIL) and Hallermeier's outer limit (HOL), respectively. The results showed that in the 11 cases, berms constructed in depths above HIL included only active berms, and depths below HOL included only stable berms. Within the 'buffer zone' or 'shoal zone' (HOL-HIL), active berms were found at depths 50 percent above the HOL, but still below HIL, and stable berms were found at depths below the 50 percent cutoff (Figure 2). Through wave climate study results, the authors also stated that in locations where wave-induced bed disturbances were low, the dredged material failed to move landward, and remained stable. The results showed that the distribution of long-term, wave-induced, near-bed velocities categorized each of the 11 cases into active or stable berms accurately.

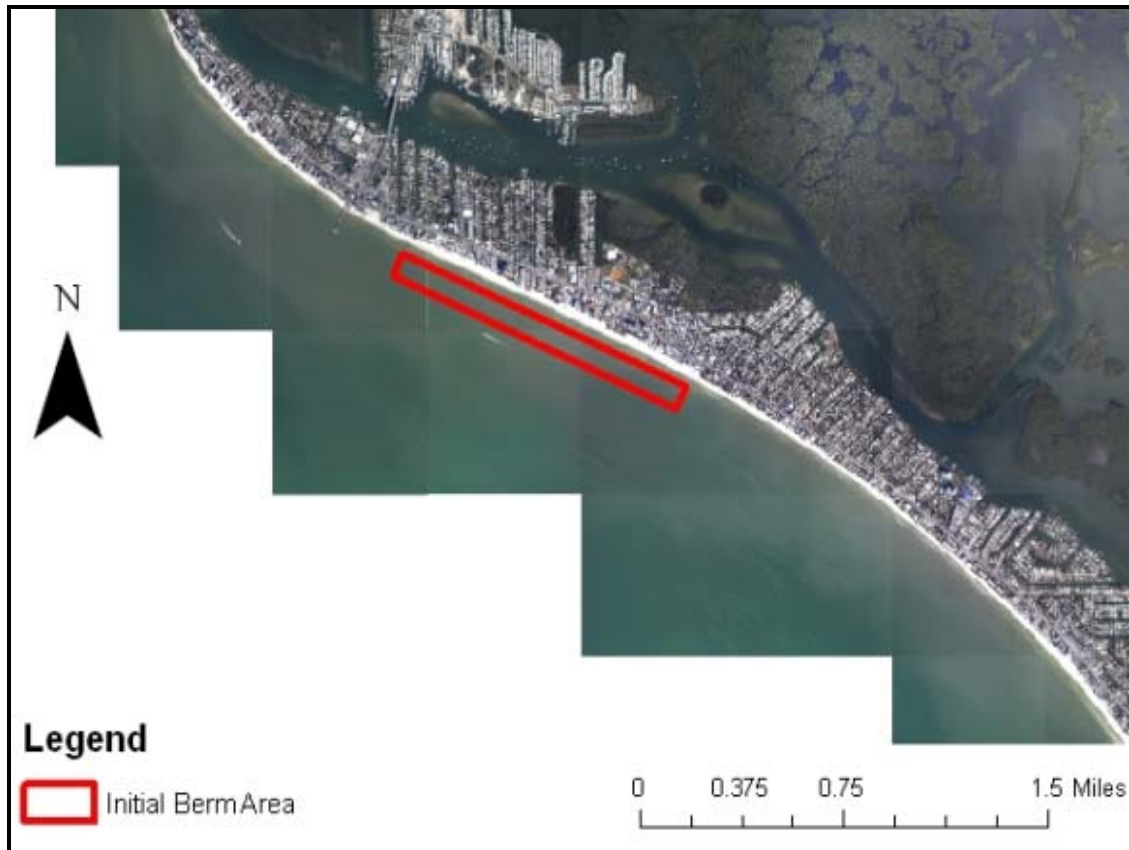
Figure 4. Designed Berm Placement Location.

The Fort Myers Beach berm was constructed using material dredged from Matanzas Pass and Bowditch Point. The dredging project took place between April and October 2009. A hydraulic dredge was used and the material was placed in the form of a nearshore berm, 1.5 miles southeast of the dredging area. Figure 4 shows the initial design location of the berm. The berm was designed to be placed 600 ft offshore, in 6 ft water depth (NAVD88). Initially, the berm was designed to be 6,000 ft long, 400 ft wide and 3 ft high, with slopes of 1 to 20. A total of 229,313 cu. yd was placed in the nearshore. The nearshore berm was made up of both silt and sand fractions, with an average silt concentration of 7.71%, and a maximum concentration of 16.15% (Florida Department of Environmental Protection, 2009).

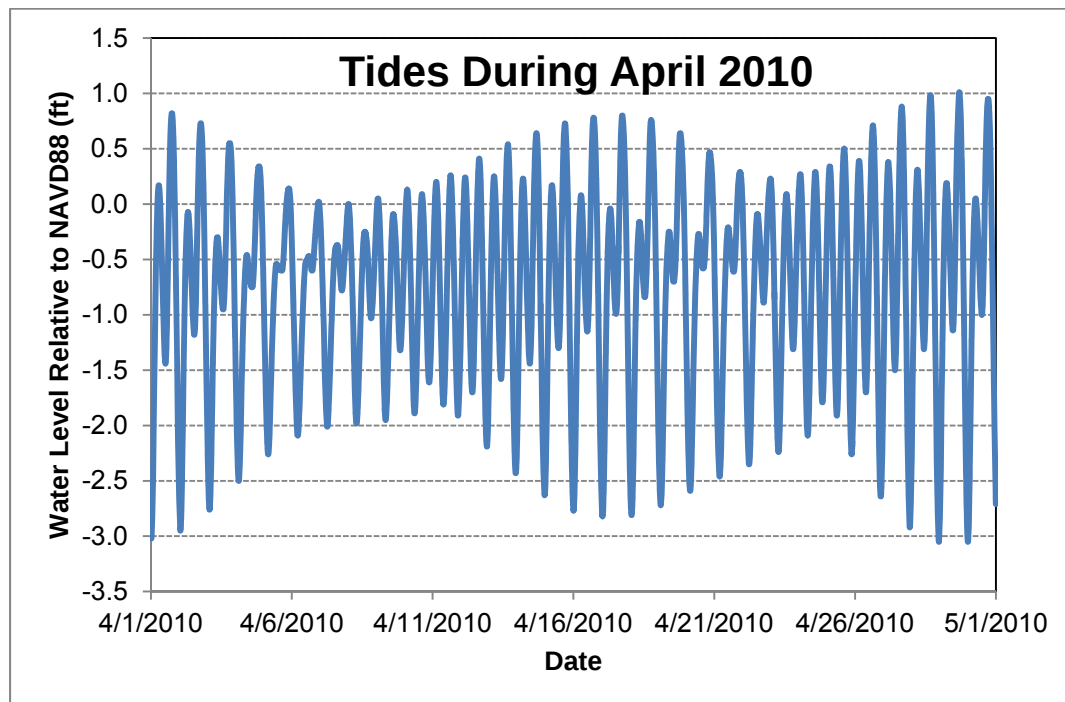
Figure 5. Measured Tides during April 2010. Data collected from the NOAA Naples Station (8725110), approximately 20 miles south of the study area.

Nearshore waves in the area are mostly generated by local winds, except during rare extreme events such as tropical storms. Table 1 summarizes the post construction wind conditions during the study period from October 2009 until October 2010, including only on-shore directed winds (NOAA station 8725110, approximately 25 miles south of Estero Island). Onshore wind, averaging slightly less than 13 ft/s (9 mph), occurs 32% of the time. The relatively stronger winds approach from the southeast (130-175 degrees) and from the northwest (266-310 degrees). These winds are highly oblique compared to the shoreline orientation (130-310 degree strike). The overall intensities and occurrences of the southeast and northwest winds, which drive longshore sediment transport in opposite directions, are statistically similar (Table 1). However, the study area may be sheltered by Sanibel to the northwest (refer to Figure 3), and therefore the winds recorded from the northwest may be stronger than the actual winds that occur at Fort Myers Beach, as the station is located 25 miles south of the study area in an region with no potential sheltering. No major tropical storm occurred during the first year after construction. The study area is influenced by a mixed tide regime. Spring tides tend to be diurnal with a range of nearly 4 ft, while neap tides are semi-diurnal ranging about 2.0 to 2.5 ft (Figure 5).

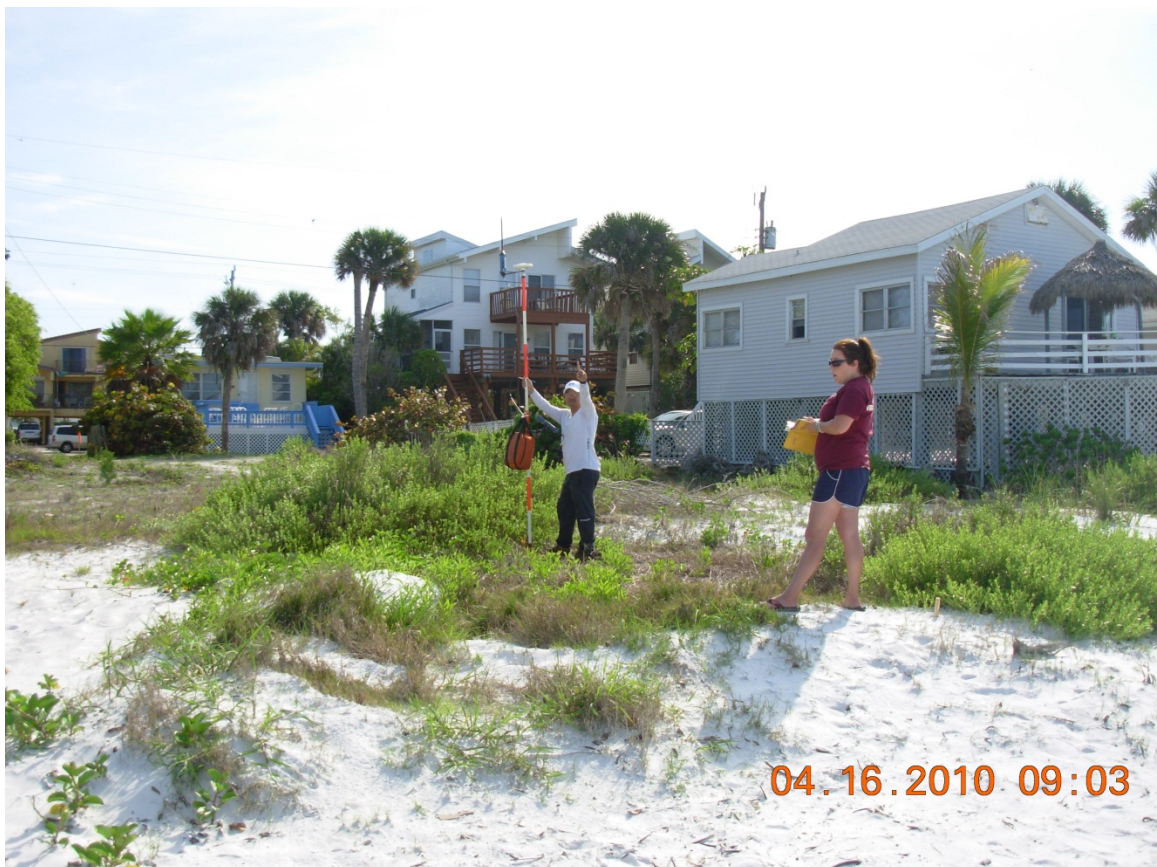
Figure 8. Temporary Benchmark Establishment. At each line, two stakes were placed so that the same line could be reoccupied and surveyed again.

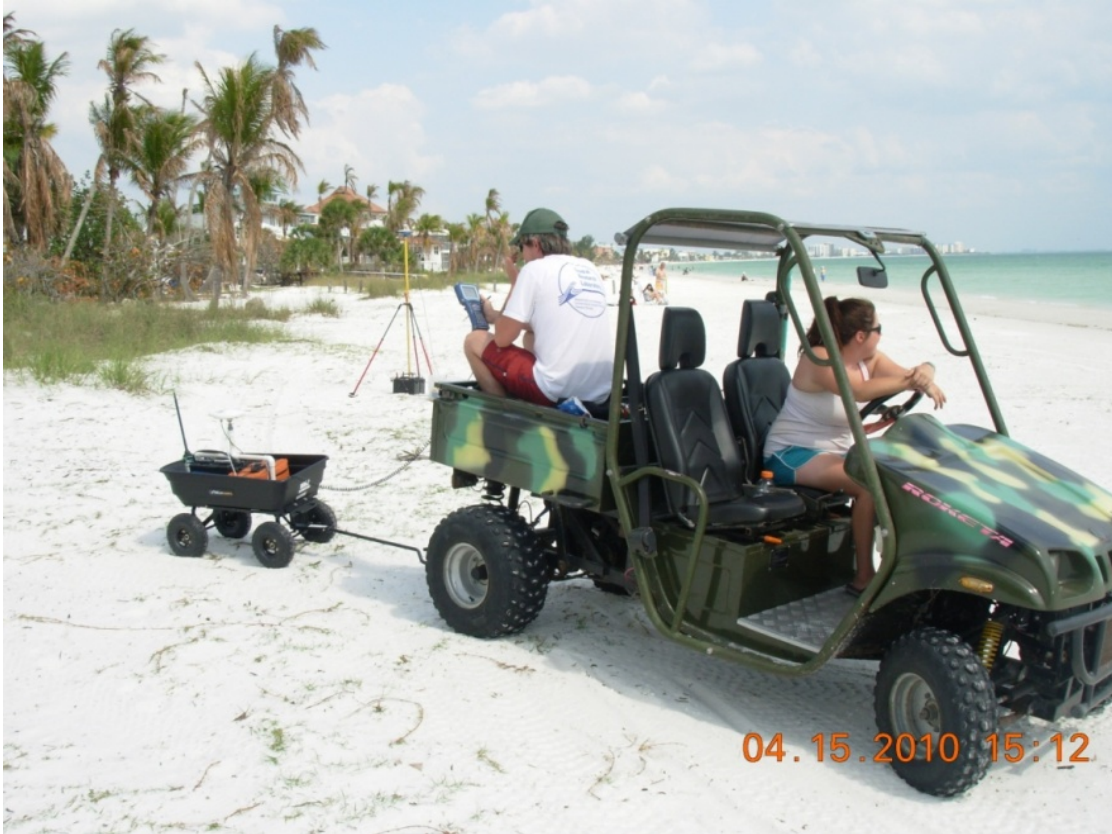
Figure 9. Shoreline Survey Using an ATV and a Cart. A small cart was towed by an ATV for shoreline surveys.

Shoreline survey data was collected using RTK GPS. A four wheel all-terrain vehicle was used to tow a small cart carrying the RTK GPS to reduce inaccurate elevation data due to suspension on the vehicle (Figure 9). Shore parallel lines at approximately the vegetation line, mid back beach, berm crest, mid-tide line, and foreshore were surveyed. Shoreline surveys extended approximately 1 mile northwest and southeast of the berm project area.

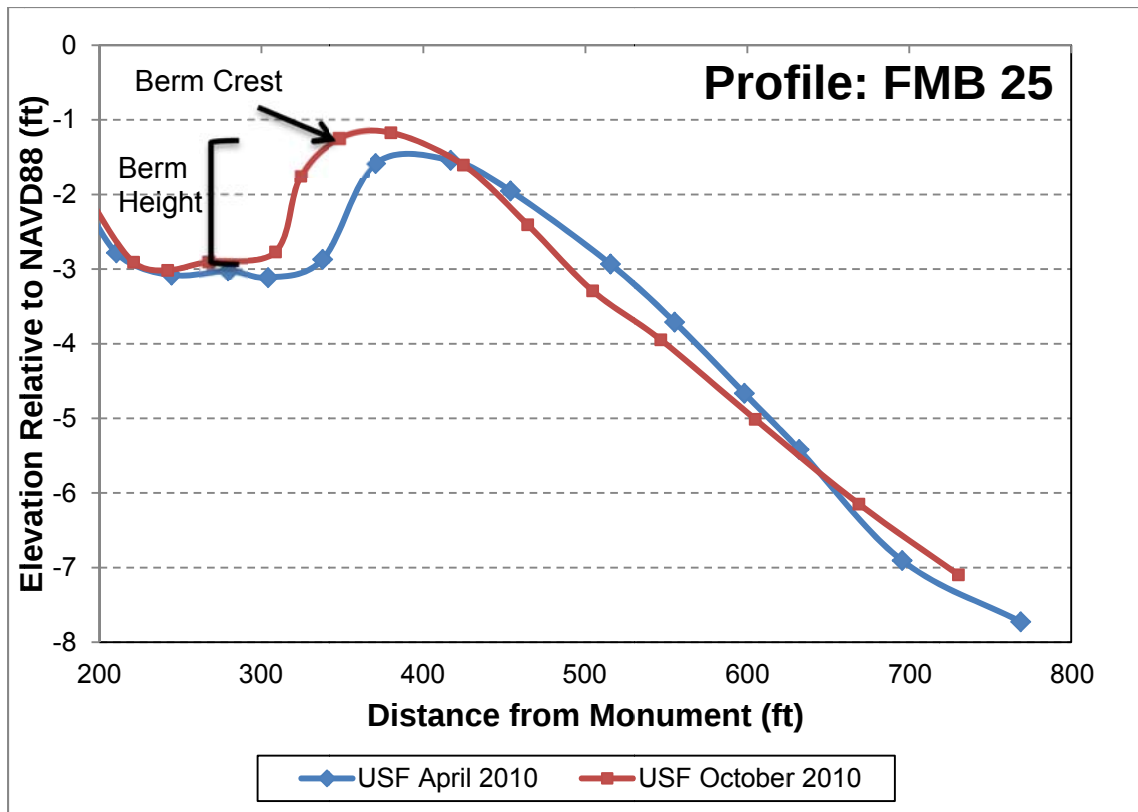
Figure 10. An Example of a Beach Profile. This graph is focused on the berm portion of profile FMB 25. The berm height is defined as the distance between the landward trough and the berm crest. The migration rate is defined as the difference between the distance to the berm crest between consecutive surveys.

Beach profile data were processed using the U.S. Army Corps of Engineers Coastal Hydraulics Laboratory developed program, Regional Morphology and Analysis Package (RMAP) and Microsoft Excel. Using the State Plane Florida West northing and easting coordinates that were collected during the surveys, distances were calculated from the monument of the survey line being processed. With the calculated distances and their associated recorded elevations, beach profiles were created. Profiles were analyzed to find location of berm crest, elevation of berm crest, berm height, rate and direction of bar migration. Berm crest is defined as the highest survey point on the berm portion of the survey, Berm height is the difference between the berm crest elevation and the landward trough elevation. For each survey within the berm project area, rate and direction of berm migration was calculated by finding the difference between the distances to the berm crest between consecutive surveys. Figure 10 is an example of a beach profile that was analyzed for this study.

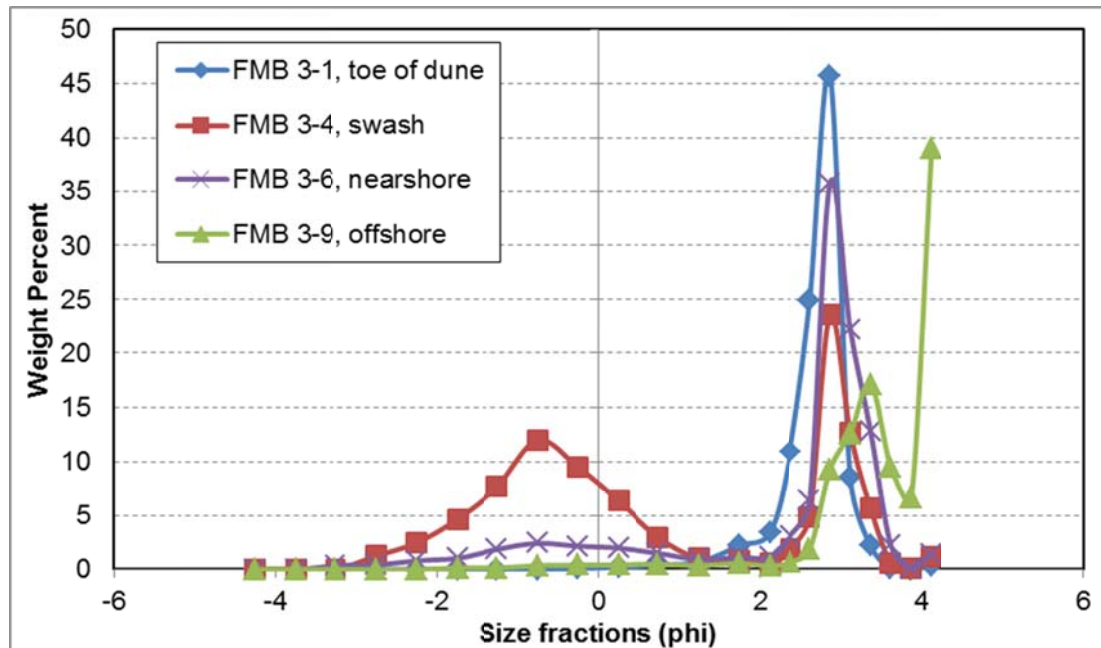
Figure 11. Grain Size Distribution of a Typical Sample Profile Southeast of the Artificial Berm Area. The samples shown are located at the toe of the dune (FMB 3-1), swash zone (FMB 3-4), nearshore (FMB 3-6) and offshore (FMB 3-9).

coarsest sediment and was composed of poorly sorted medium shelly sand, and the nearshore (breaker zone) area contained moderately sorted very fine sand, with an increase in mud content toward offshore. Figure 11 shows the grain size distribution across the sample profiles in the control area southeast of the berm.

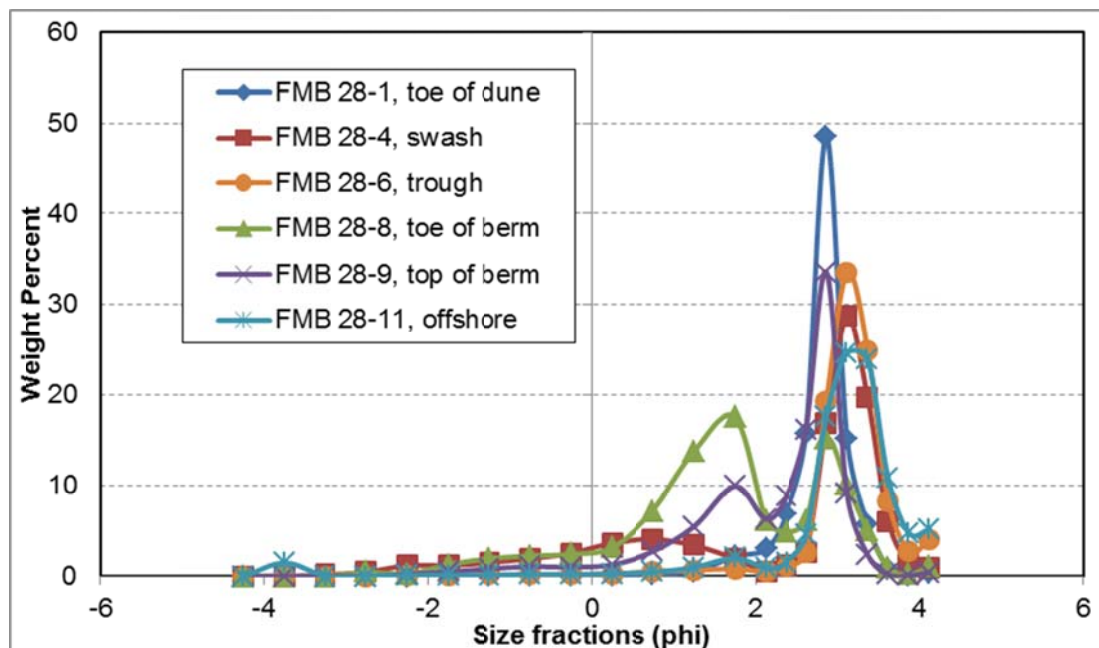
Figure 12. Grain Size Distribution of a Typical Sample Profile Within the Artificial Berm Area. The samples shown are located at the toe of the dune (FMB 28-1), swash zone (FMB 28-4), trough landward of the berm (FMB 28-6), toe of the berm (FMB 28-8), top of the berm (FMB 28-9), and offshore (FMB 28-11)

sediment at the landward toe of the berm was also coarse with high content of shell debris. The top of the berm was characterized by moderately sorted fine sand. The sediment along the seaward slope of the berm and offshore was moderately to well sorted fine sand. Figure 12 shows a typical grain size distribution of a sample profile within the berm project area.

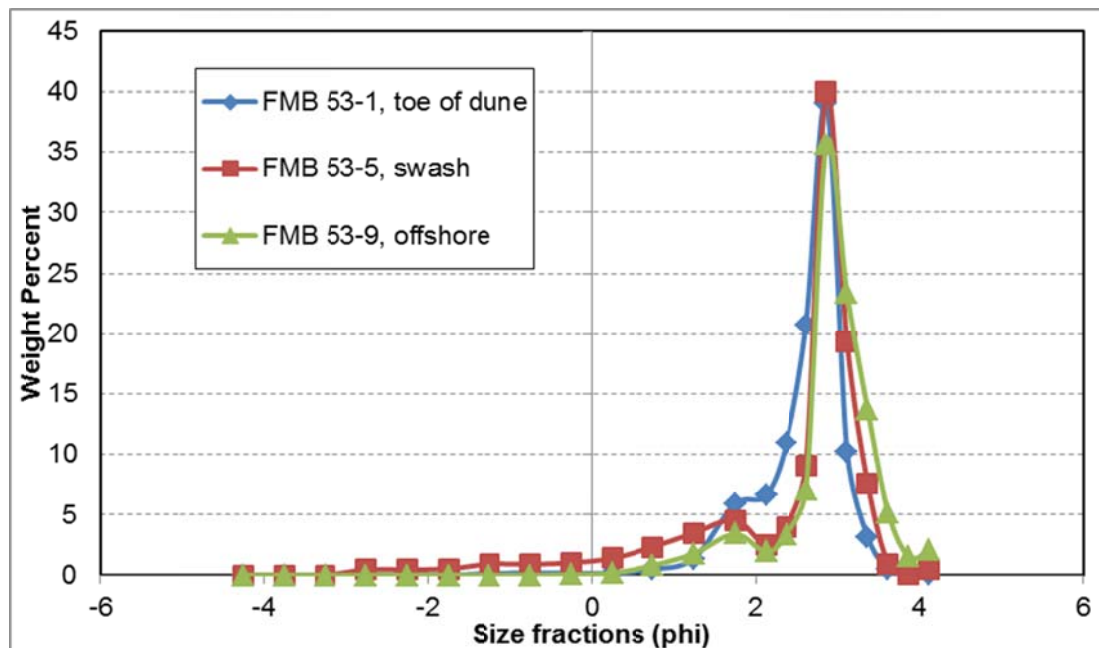
Figure 13. Grain Size Distribution of a Typical Sample Profile Northwest of the Artificial Berm Area. The samples shown are located at the toe of the dune (FMB 53-1), swash zone (FMB 53-5) and offshore (FMB 53-9).

13 is an example of a typical grain size distribution of a sample profile in this area. Overall, compared to the sediments to the south, the content of shell debris was less.

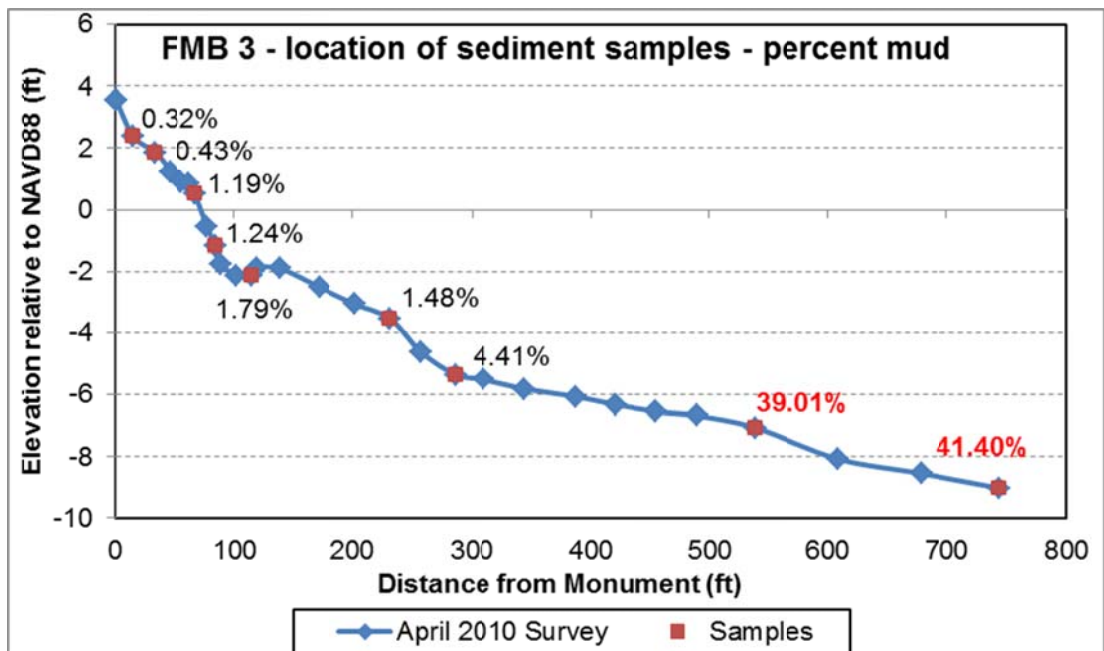
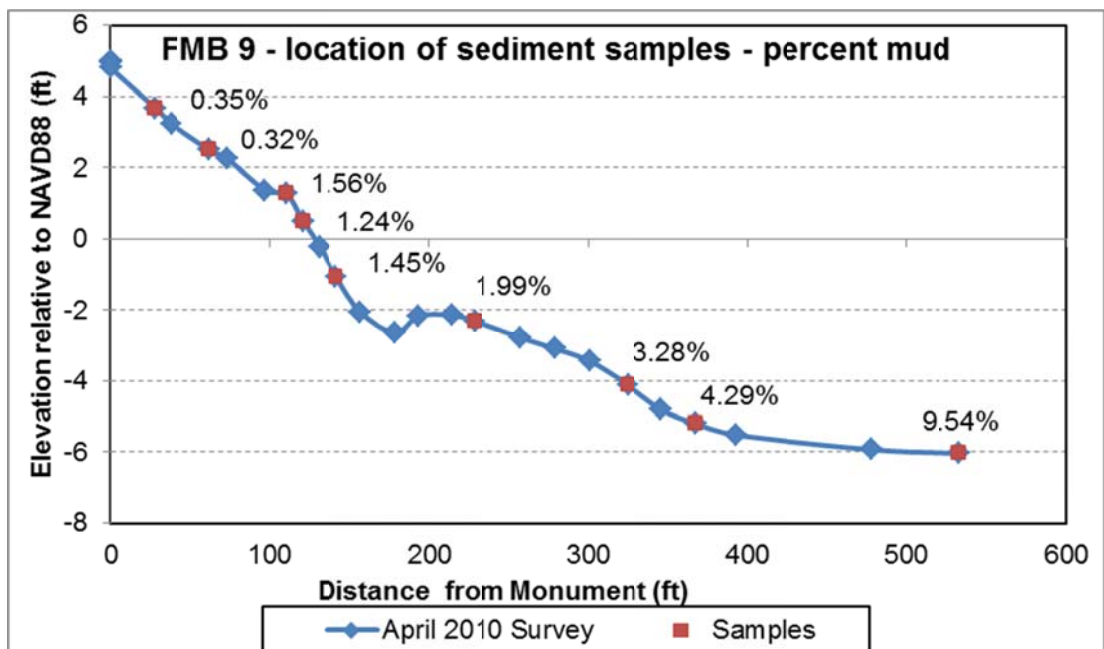
Figure 14. Beach Profile of FMB 3 with Sediment Sample Locations and Mud Percentages.

Figure 15. Beach Profile of FMB 9 with Sediment Sample Locations and Mud Percentages.

A seaward increasing trend of mud content was measured at most of the profiles. Figures 14 and 15 show representative sample lines located southeast of the berm, with percentage of mud indicated at each sample location. Little mud (mostly less than 1%) was found on the dry beach. Some mud (mostly less than 4%) was found between mean sea level and about 4 ft water depth. Significant mud contents of up to 40% were found in the surface sediment seaward of the 4 ft contour. Considerable variations of mud content are measured in the offshore area (Figures 14 and 15).

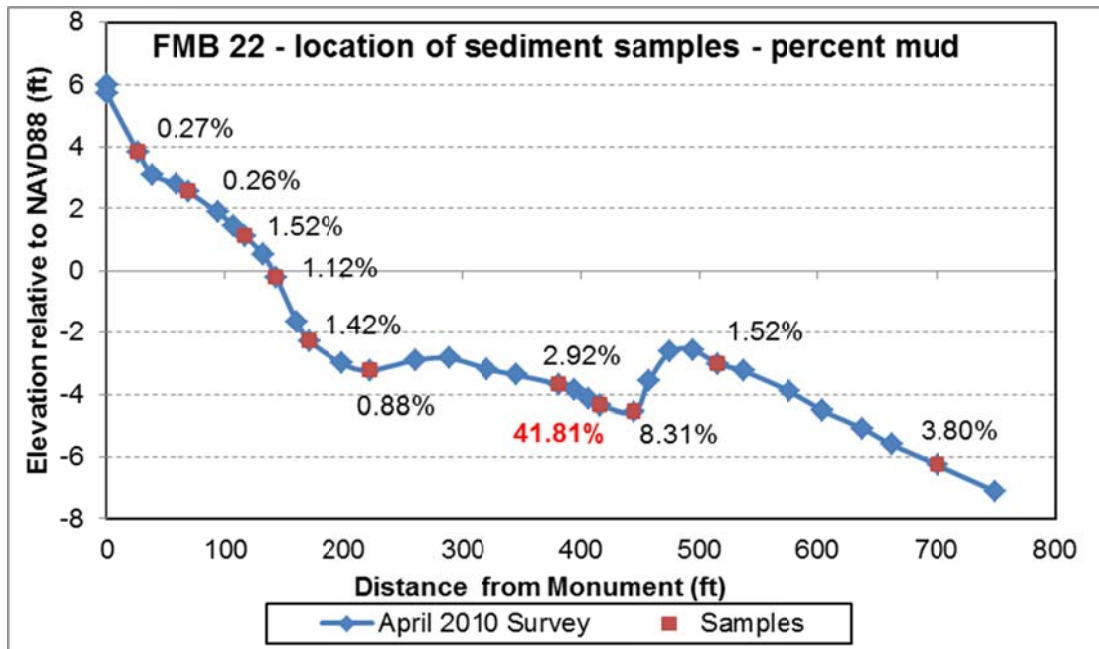
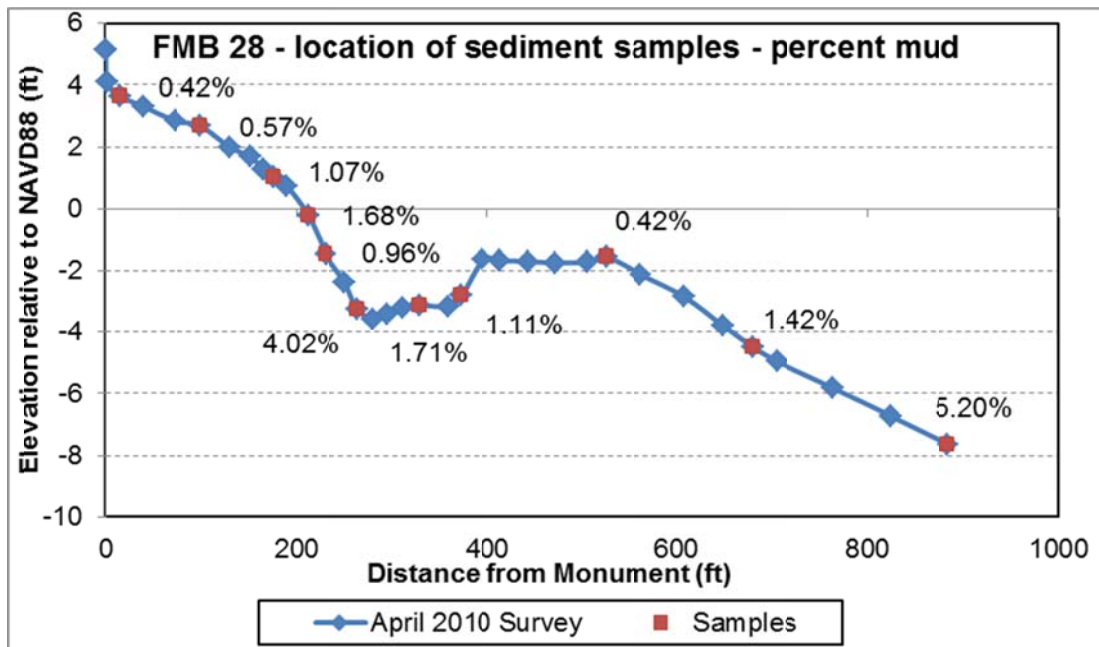
Figure 16. Beach Profile of FMB 22 with Sediment Sample Locations and Mud Percentages.

Figure 17. Beach Profile of FMB 28 with Sediment Sample Locations and Mud Percentages.

Figures 16 and 17 show the percentage of mud indicated at each sample of representative profiles within the artificial berm area. Generally, less than 2% mud was found on the beach above mean sea level. Less than 3% mud was found on the surface of the berm. The highest mud content was found in the trough landward of the berm, ranging 1 to 4%, with an extreme case at FMB 22, where a patch of mud deposits occurred, (Figure 16) with mud content of 41%.

Seaward of the berm the sediment samples contained up to 4% mud.

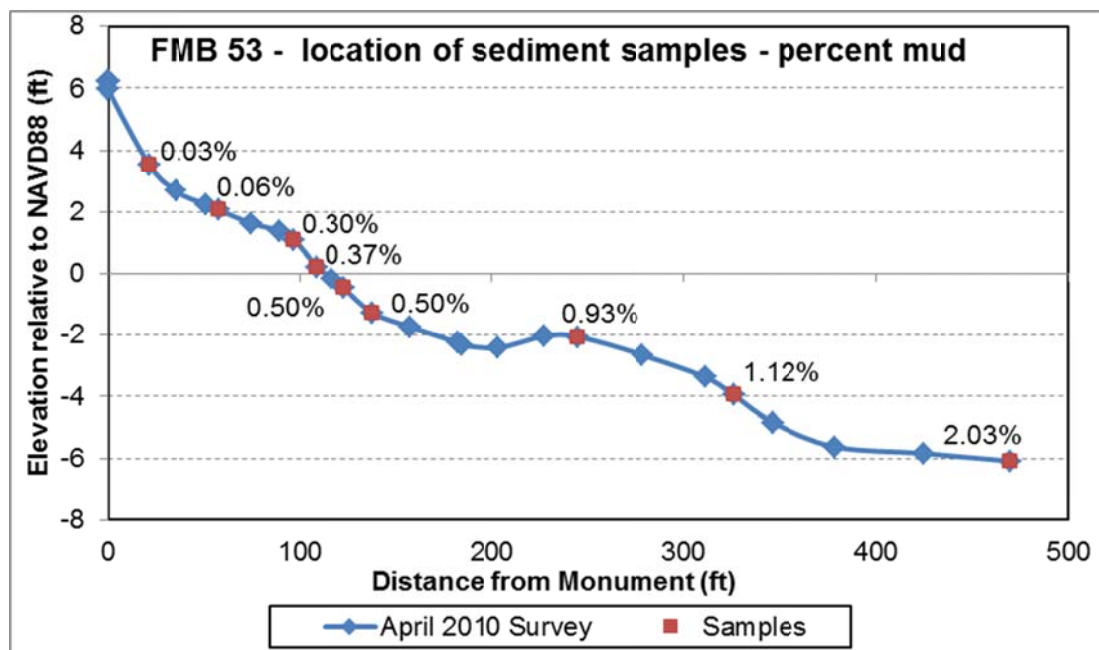
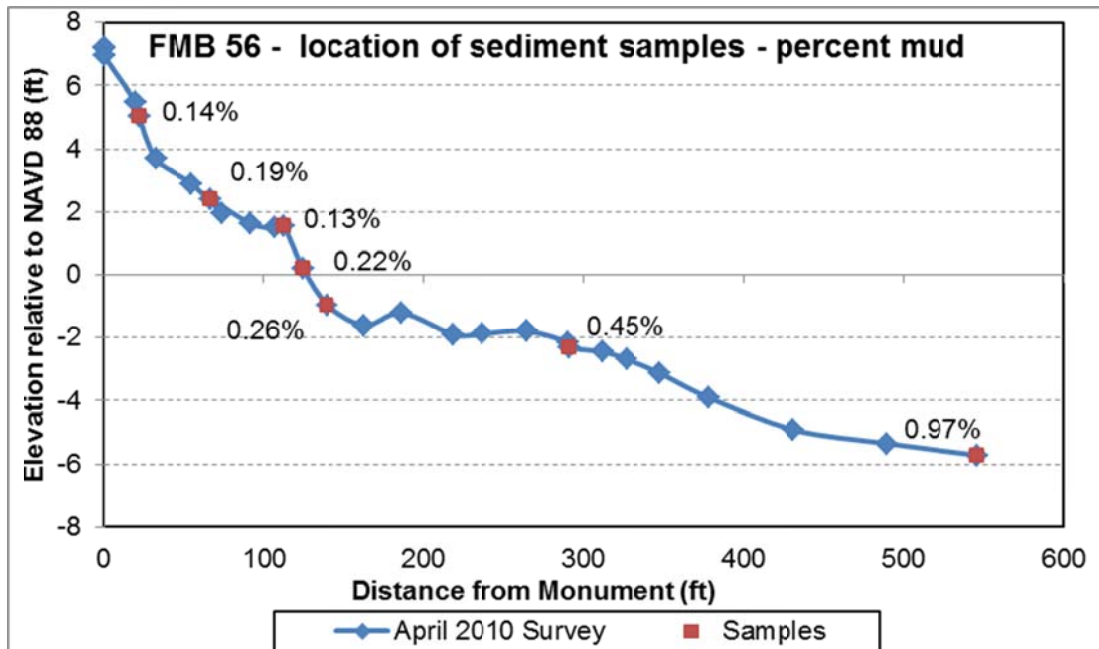
Figure 18. Beach Profile of FMB 53 with Sediment Sample Locations and Mud Percentages.

Figure 19. Beach Profile of FMB 56 with Sediment Sample Locations and Mud Percentages.

Overall, the sediment in the control area northwest of the berm was much less muddy as compared to the berm area and the control area southeast of the berm. Mud content less than 2% was found in the surface sediment across the entire profile for transects northwest of the berm. Figures 18 and 19 show mud content of representative samples taken in the control area northwest of the artificial berm.

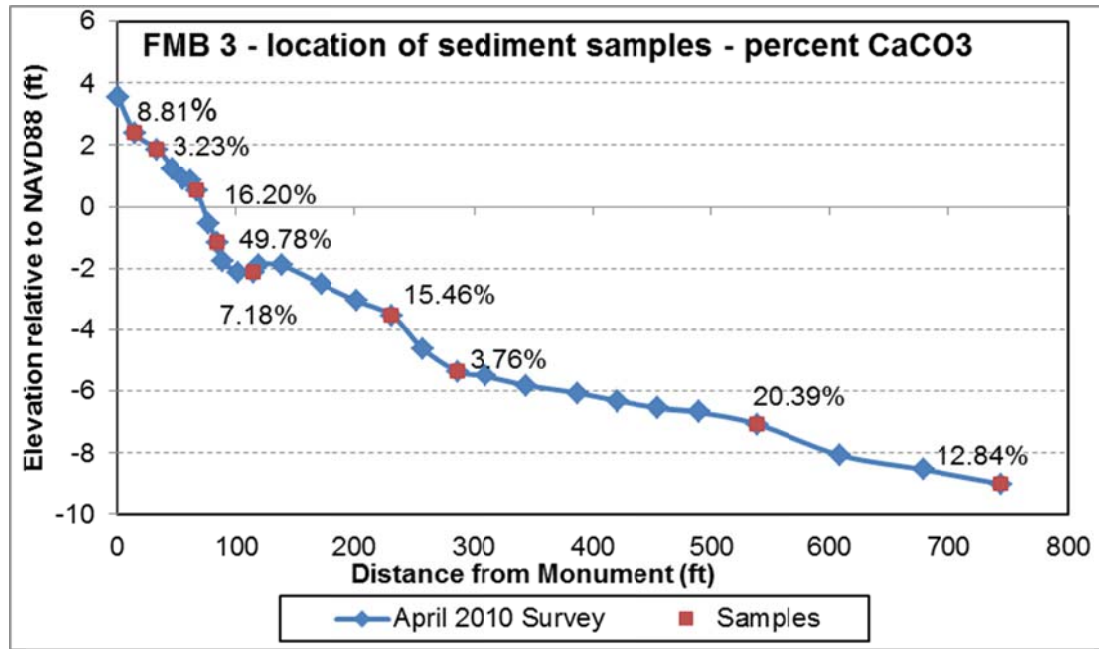
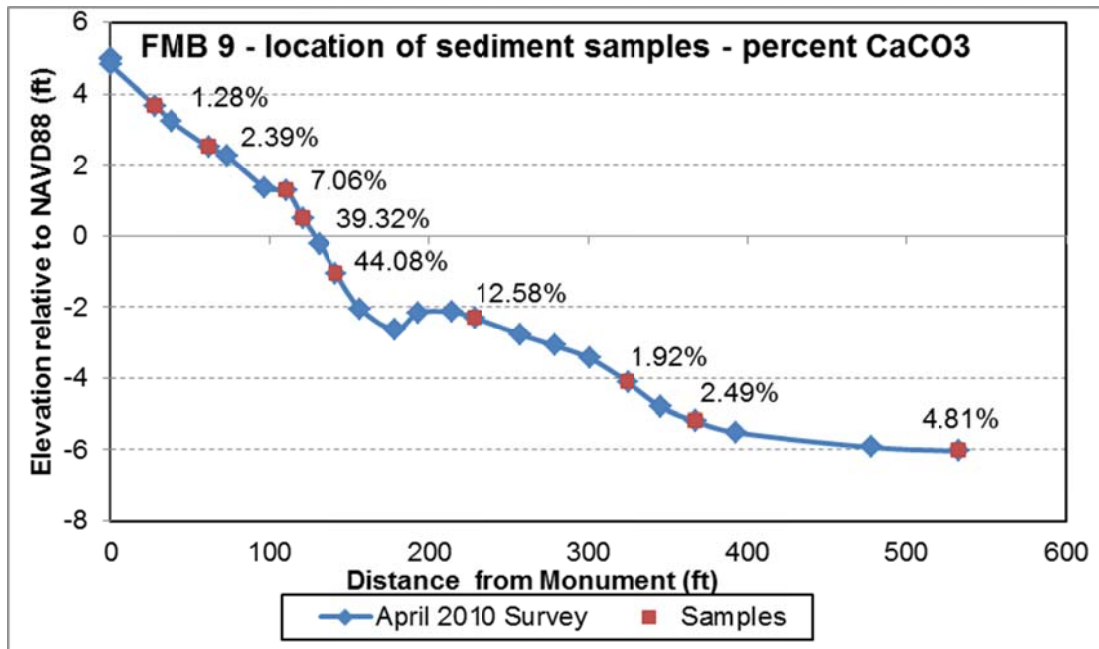
Figure 20. Percentage of Carbonate in Coarse Fraction of Samples along FMB

Figure 21. Percentage of Carbonate in Coarse Fraction of Samples along FMB 9.

The highest carbonate concentration along the profiles in the control area southeast of the berm was located within the swash zone (approximately sample 4). High carbonate concentrations were also found offshore in FMB 3 (Figure

20). Figures 20 and 21 show the percentage of carbonate in each sample across the profile for two example profiles.

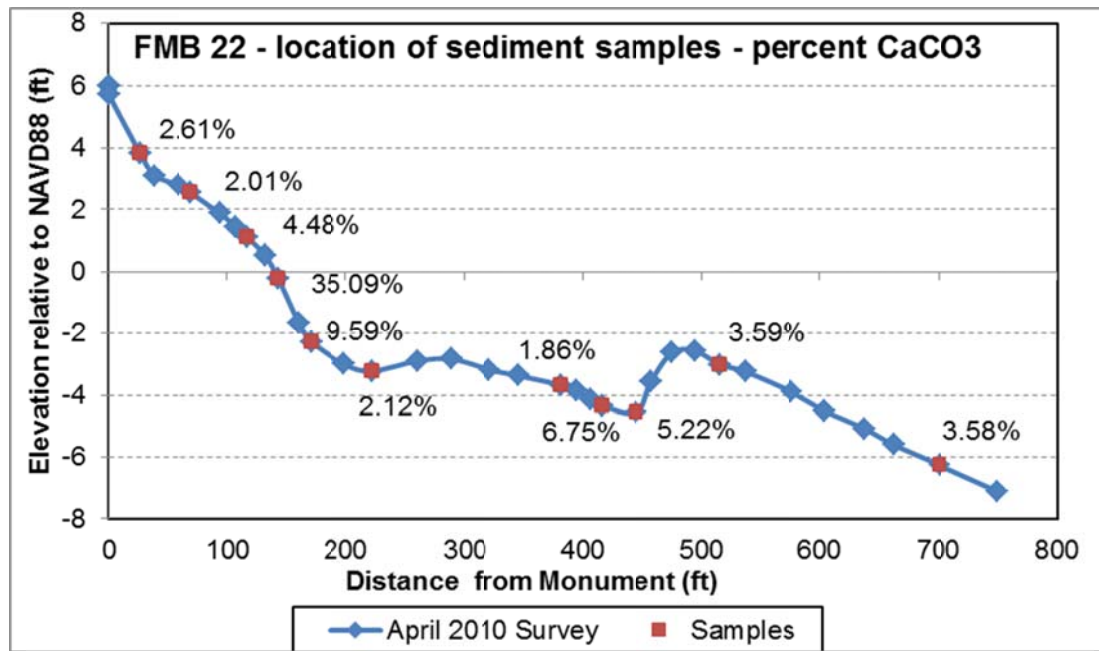
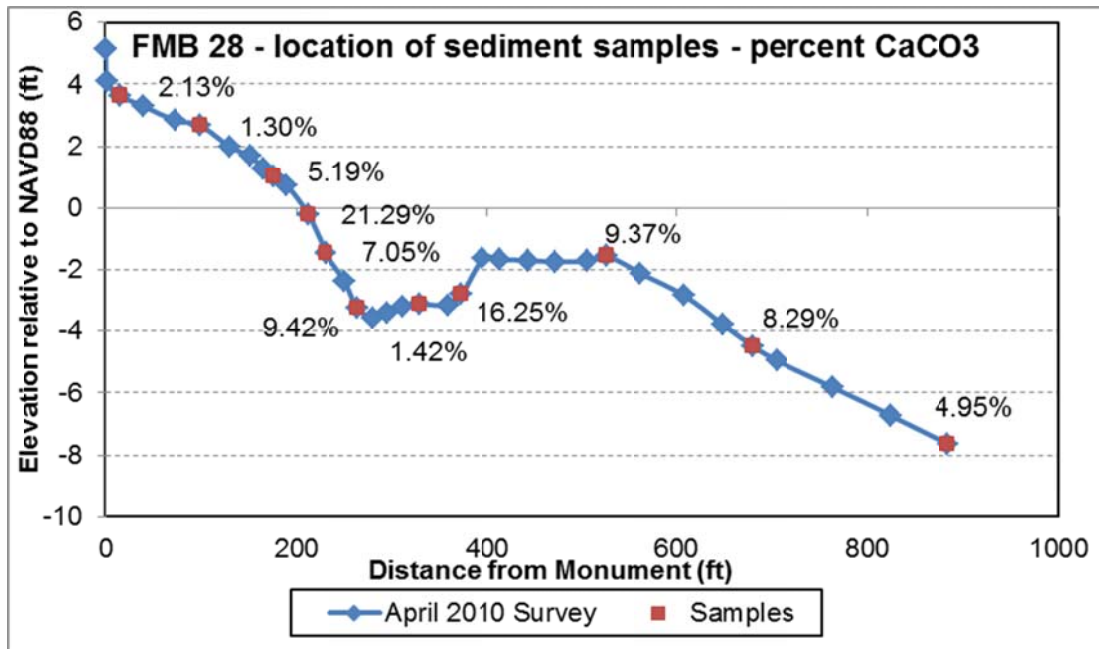
Figure 22. Percentage of Carbonate in Coarse Fraction of Samples along FMB 22.

Figure 23. Percentage of Carbonate in Coarse Fraction of Samples along FMB 28.

Within the berm project area, the highest carbonate content in the sample profiles was also within the swash zone, as expected. Greater percentages of shell debris were also found at the landward toe of the berm. Across the artificial berm, the coarsest sediment with the highest shell debris content was found at the landward toe of the berm. This provides some evidence that coarser sediments tend to move landward, as often desired for berm nourishment, provided that wave energy is such that the coarse sediment can be mobilized. However, it is important to note that further investigation into the native beach prior to berm placement is needed to confirm this conclusion. Figures 22 and 23

show the percentage of carbonate in each sample across the profile for two example profiles.

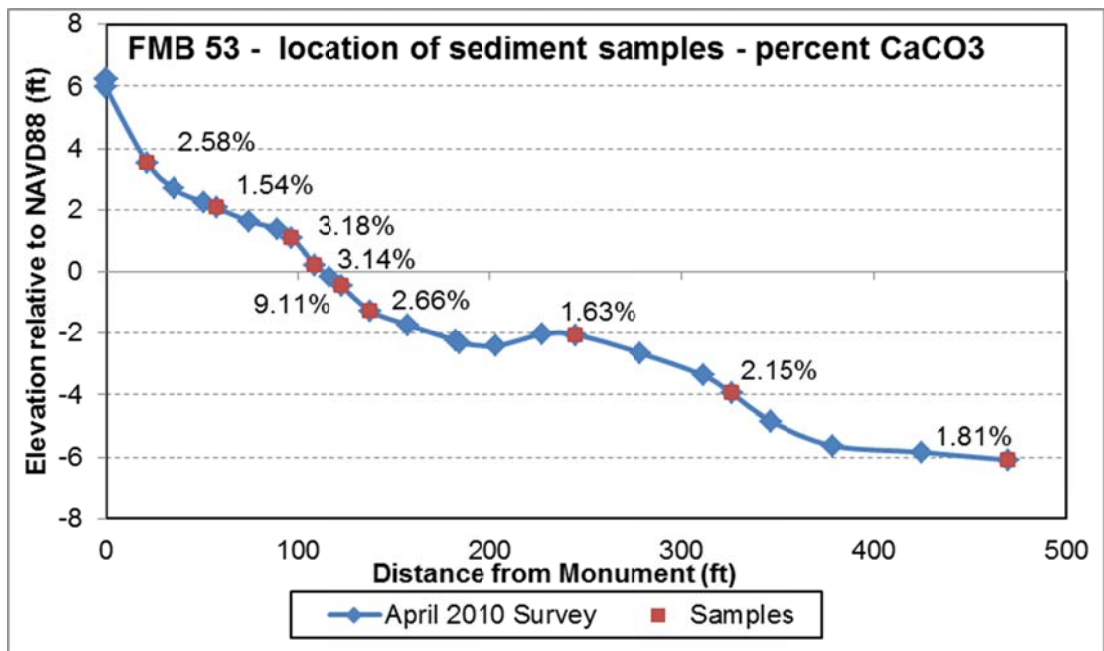
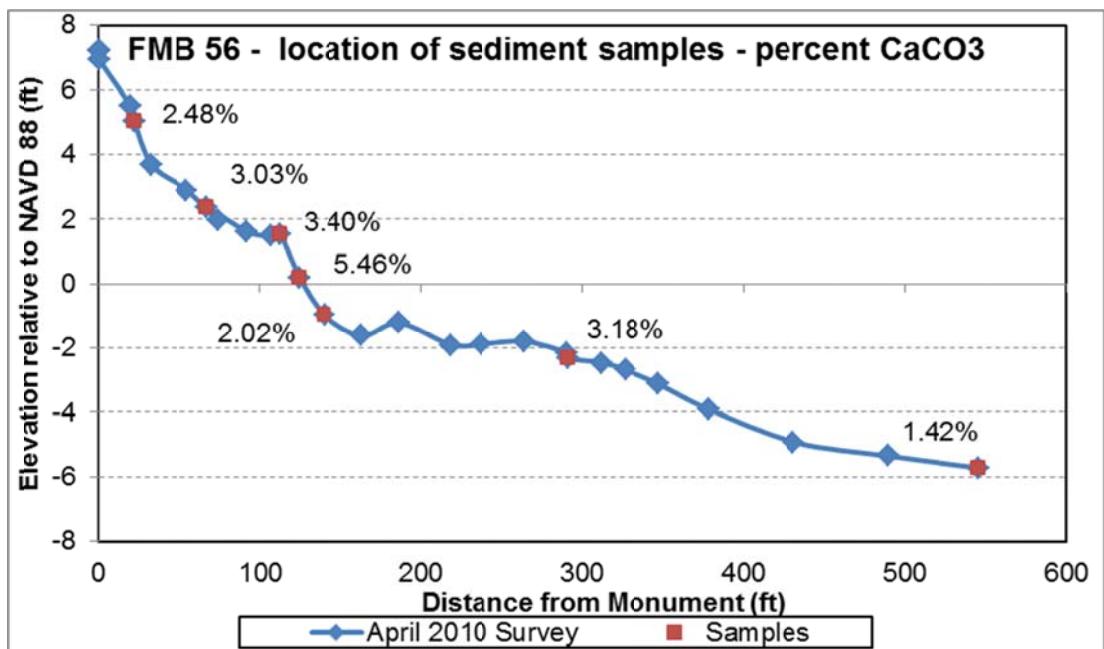
Figure 24. Percentage of Carbonate in Coarse Fraction of Samples along FMB 53.

Figure 25. Percentage of Carbonate in Coarse Fraction of Samples along FMB 56.

Within the control area northwest of the artificial berm, the lowest percentages of carbonate were measured (Figures 24 and 25). This is consistent with the relatively well sorted sand, as discussed above. Along the individual profiles, the highest carbonate concentration was located in the swash zone, as expected.

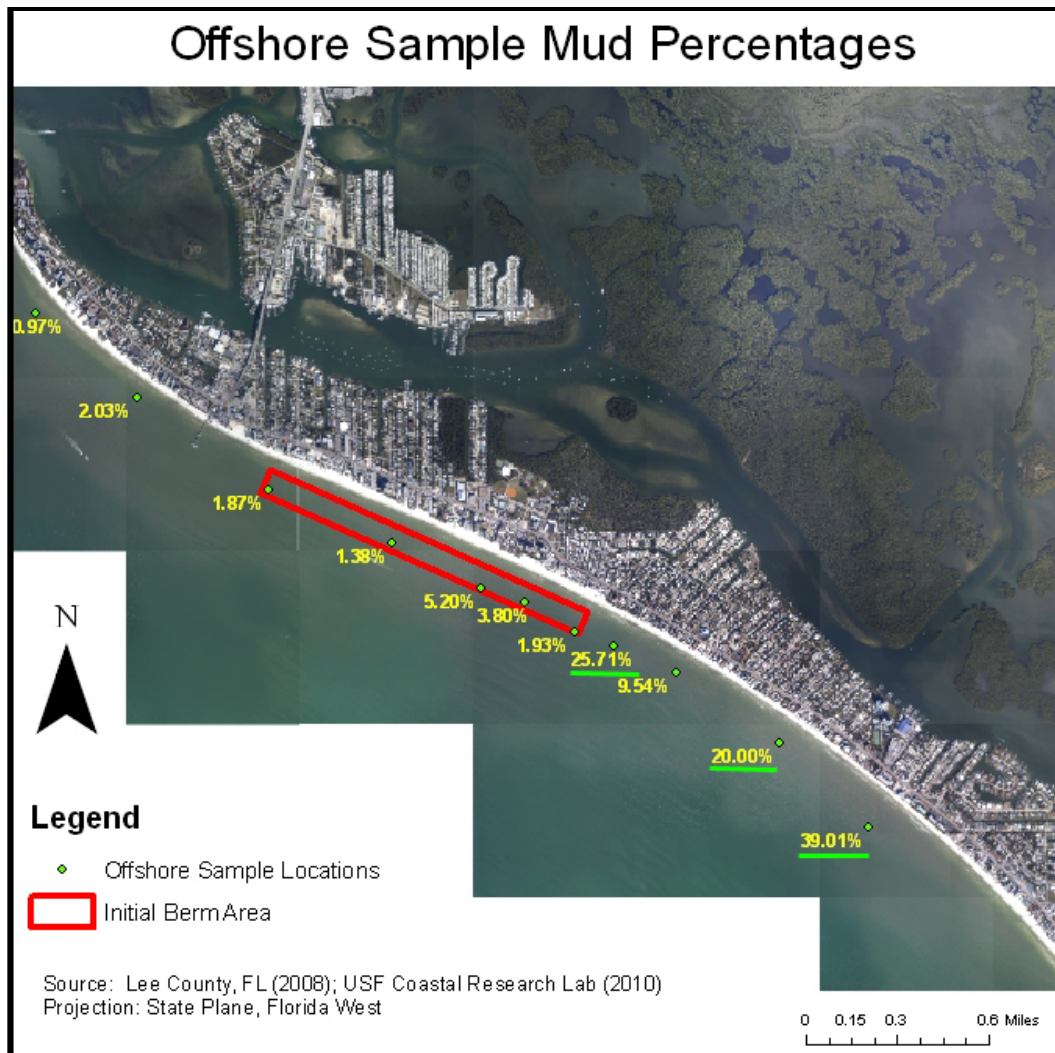
Figure 26. Percentage of Mud in the Surface Sediment Samples Collected at Approximately 8 ft Water Depth (NAVD88).

Most of the sediment in the surface samples above mean sea level had less than 4% mud. Highest mud contents were found in the offshore of the control area southeast of the berm, and in the localized mud patches in the trough landward of the berm. In the control area northwest of the berm, minimal mud content of less than 4% was found. Figure 26 is a map showing the offshore mud sample percentages. All of the sample profiles with sample locations and mud percentages are included in Appendix D.

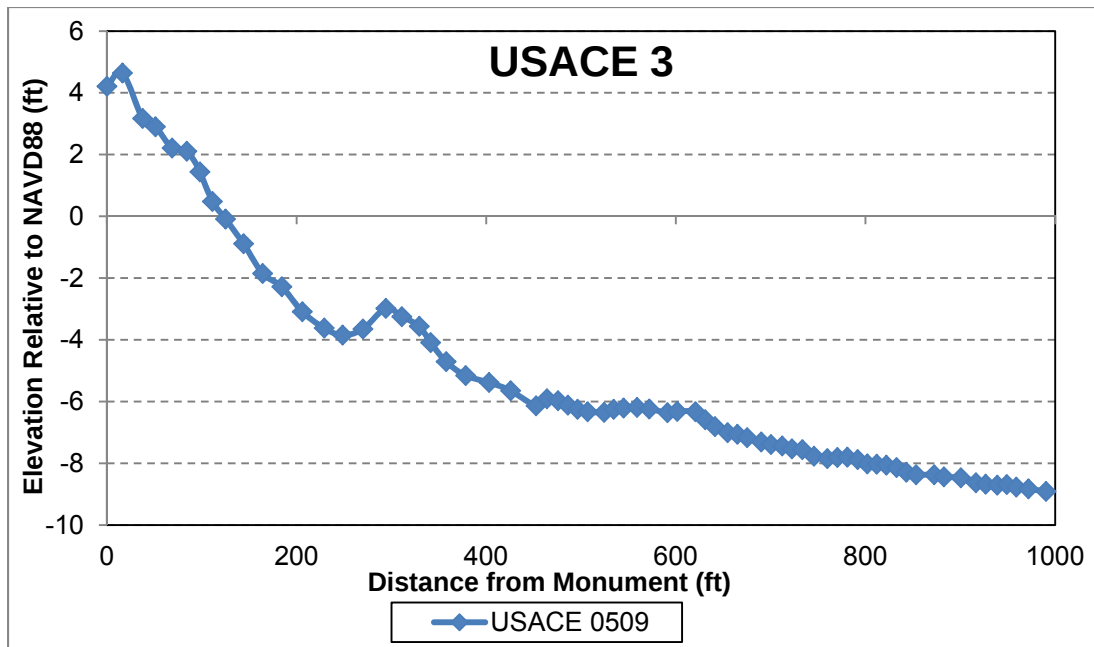
Figure 27. Beach Profile at USACE 3.

Pre-construction morphology of Fort Myers Beach contained a small natural bar that has a height of about 1 ft, and approximately 300 ft offshore. The beach width was approximately 100 to 200 ft with a gentle slope. Figure 27 provides a representative profile of the study area surveyed in May 2009, before the construction of the nearshore berm. This morphology was representative of the entire study area.
