First Year Sedimentological Characteristics and Morphological Evolution of an  
Artificial Berm at Fort Myers Beach, Florida

A thesis submitted in partial fulfillment  
of the requirements for the degree of  
Master of Science  
Department of Geology  
College of Arts and Sciences  
University of South Florida

Keywords: berm nourishment, nearshore sediment transport, coastal  
morphodynamics, nearshore bar, beach erosion

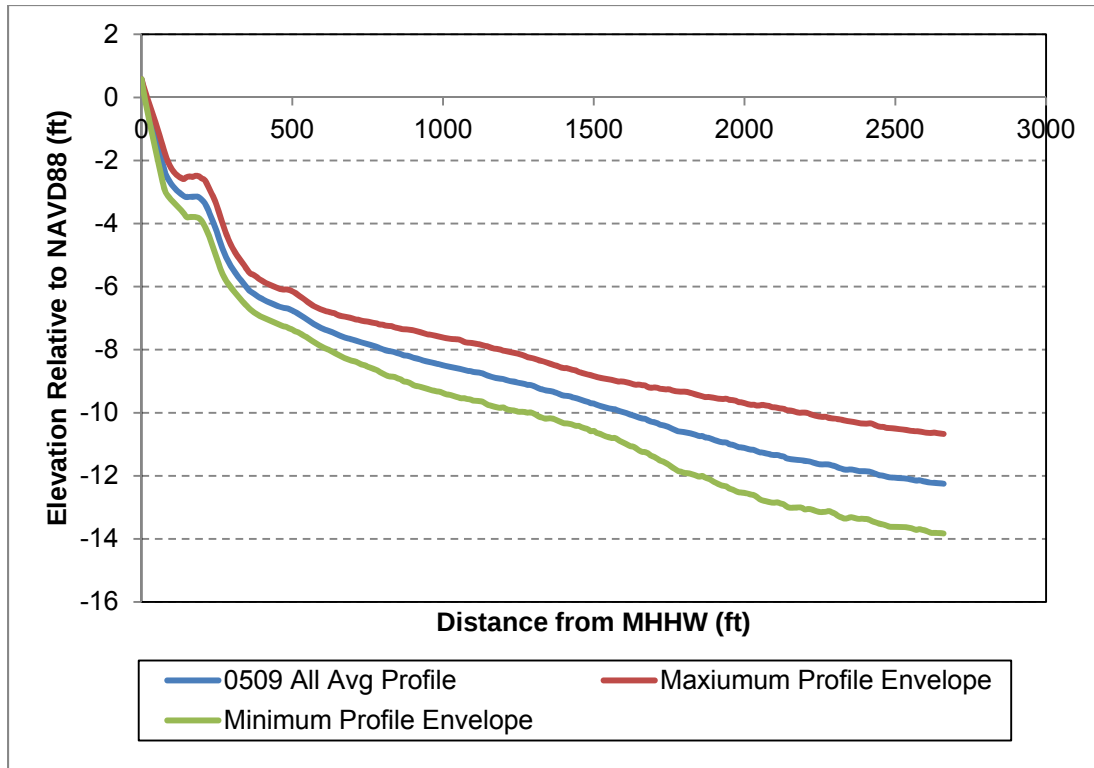
Figure 28. Spatially Averaged Profile from 0509 Surveys. Note the large offshore deviation from the average profile.

Profile averaging similar to that conducted by Larson and Kraus (1992a) was attempted (Figure 28). However due to highly variable offshore bathymetry, likely controlled by regional geology, large standard deviation about the mean occurred along the offshore portion of the profile. This contrasts the typical trend observed for profile averaging, with profiles converging in the offshore region (Wang and Davis, 1999; and Wang and Davis, 1998). Therefore, no representative spatially averaged profile can be obtained for the entire study area.

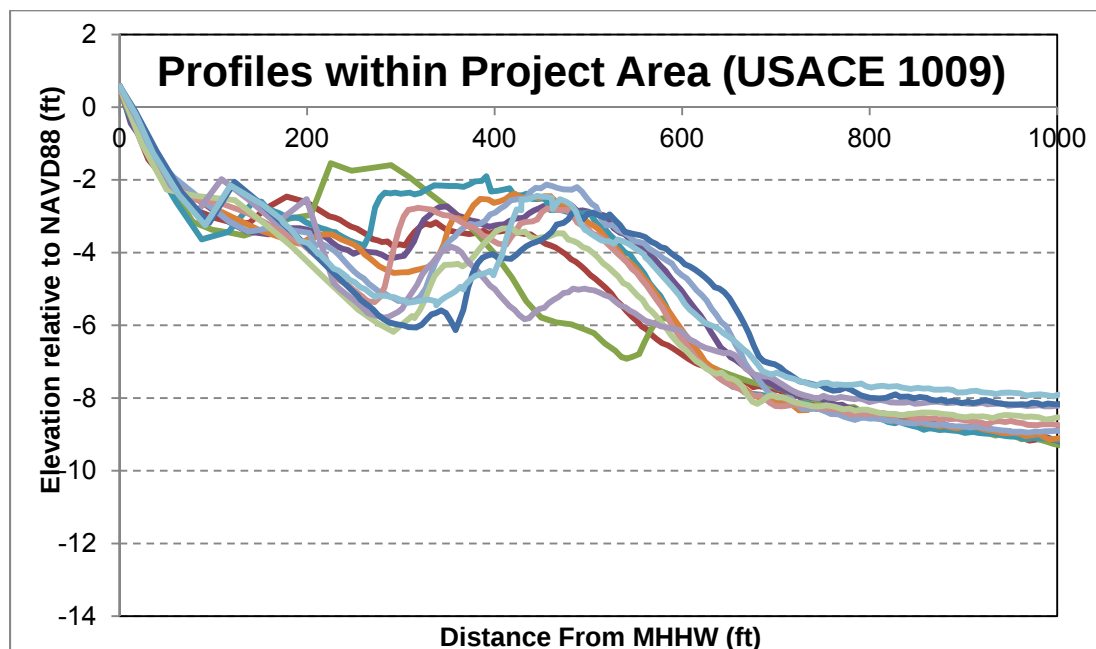
Figure 29. Longshore Variation of Profiles Within Project Area (1009). The profile was highly variable in every aspect, including foreshore slope, location and depth of the trough, distances to berm crest, berm heights, berm elevations, and berm widths, as well as the depth and slope of the seaward flank of the berm.

flank. Table 3 summarizes the characteristics of the berm profiles just after construction and emphasizes the longshore variability. Distance from the MHHW line to the berm crest varied between 124 ft to 321 ft. Height (defined here as the difference between crest and trough) and elevation (defined here as the elevation of the berm crest) of the berm varied by approximately 2.7 ft and 2.4 ft, respectively. Width of the berm ranged from 377 ft to 599 ft. This substantial longshore variation has considerable influence on the evolution of the artificial berm.

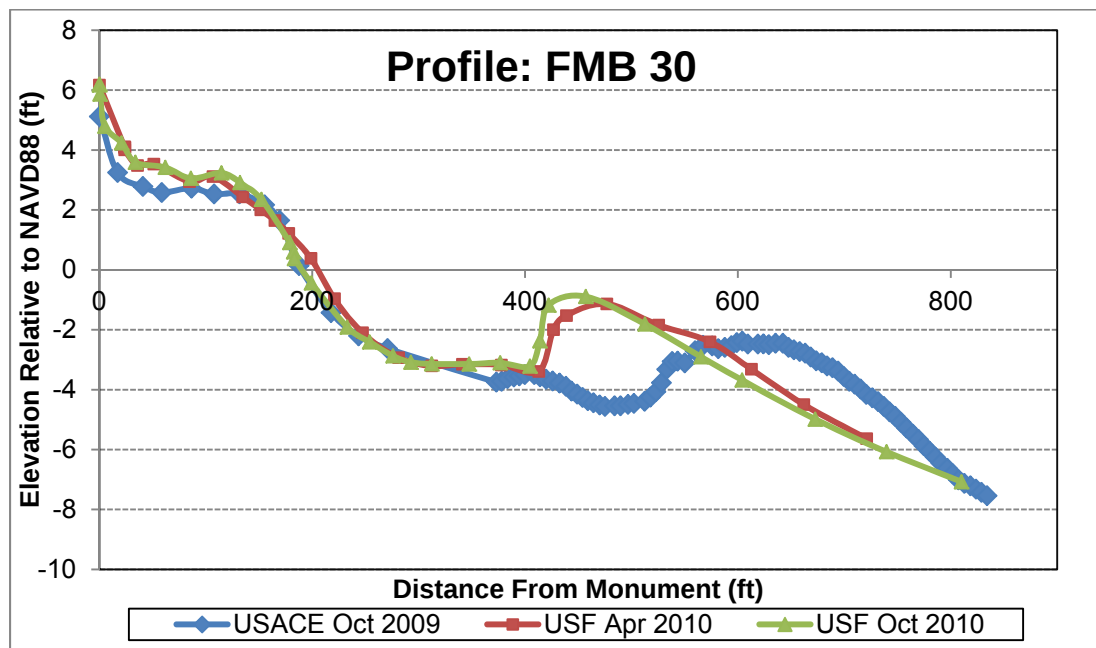
Figure 31. Time Series Beach Profile at FMB 30

erosion on the seaward slope and deposition in the prior trough location. The landward migration continued during the second 6 months, but at a much reduced rate, while maintaining the skewed shape of the berm. The beach and nearshore area landward of the artificial berm remained stable over the first year after the construction.

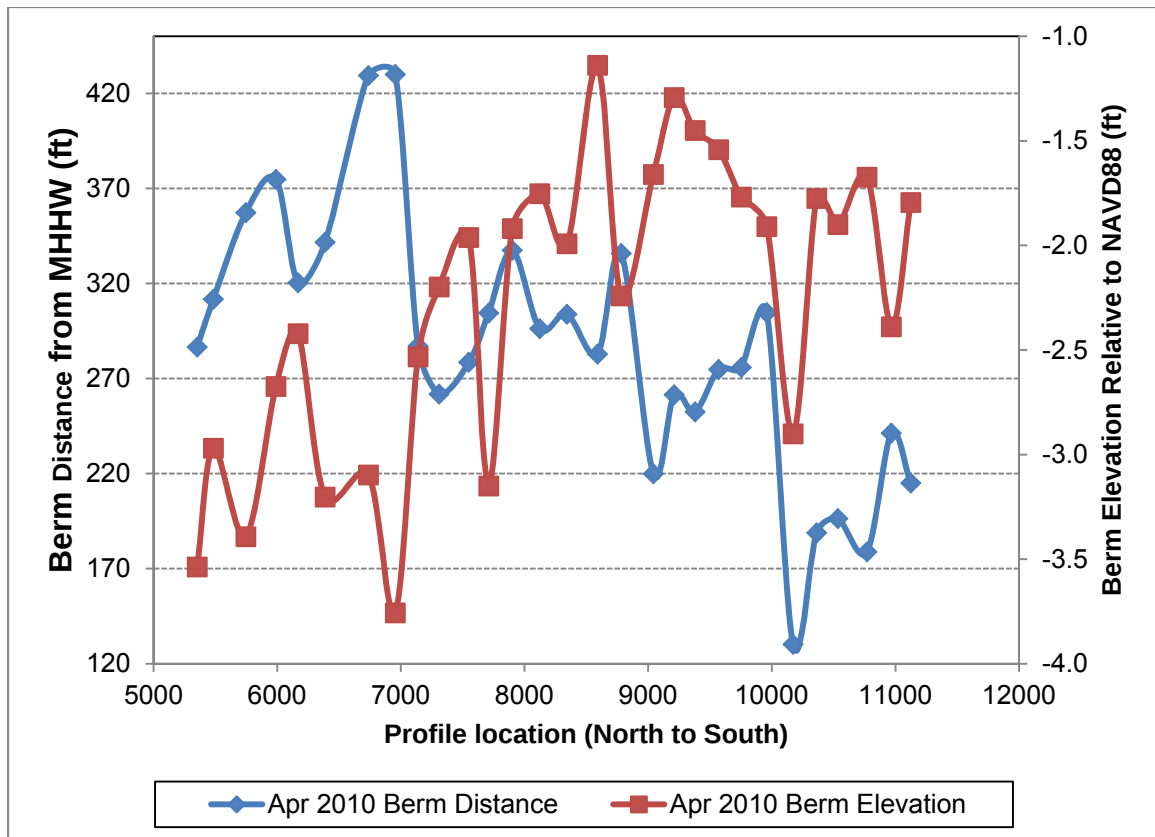
Figure 35. Longshore Variation of the Distance of the Berm Crest to MHHW and Berm Crest Elevation. Profile location is referred to the distance from the northwestern most profile.

Along with the variability in the longshore, several trends were also identified. A relationship between the distance of the berm crest to the location of MHHW was evident. Lower berm crests correspond to a longer distance to MHHW, while an increasing berm elevation corresponds with decreasing distance to MHHW (Figure 35). This relationship is qualitative, however. For example, a similar berm height does not necessarily correspond to similar distance to MHHW at a different longshore location. Figure 35 also illustrates the location of the previously mentioned gaps that were created during construction. The gaps are not exactly equally spaced, but do not appear to be random either, and vary in elevation.

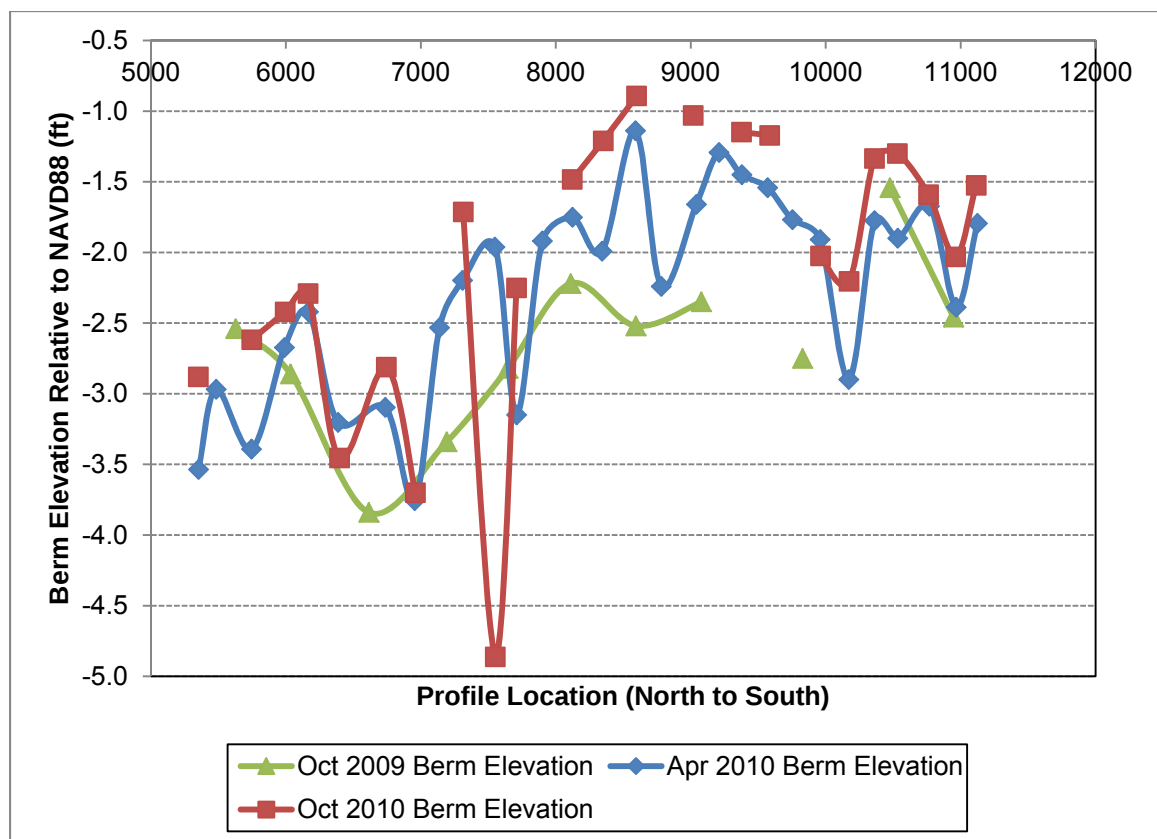
Figure 36. First Year Berm Elevations. Note the overall trend of an increase in berm elevation for the 6 month period.

37 also reveal that the surface of the berm was not uniform in terms of elevation, rather it undulates approximately 0.5 ft to 1 ft. The previously mentioned gaps are also illustrated, however, these simplified 1-D plots do not provide an accurate representation of the 3-D gaps as many of them are at an oblique angle to the shoreline (Figure 38), and need to be further illustrated and explained using beach profiles and contour maps.

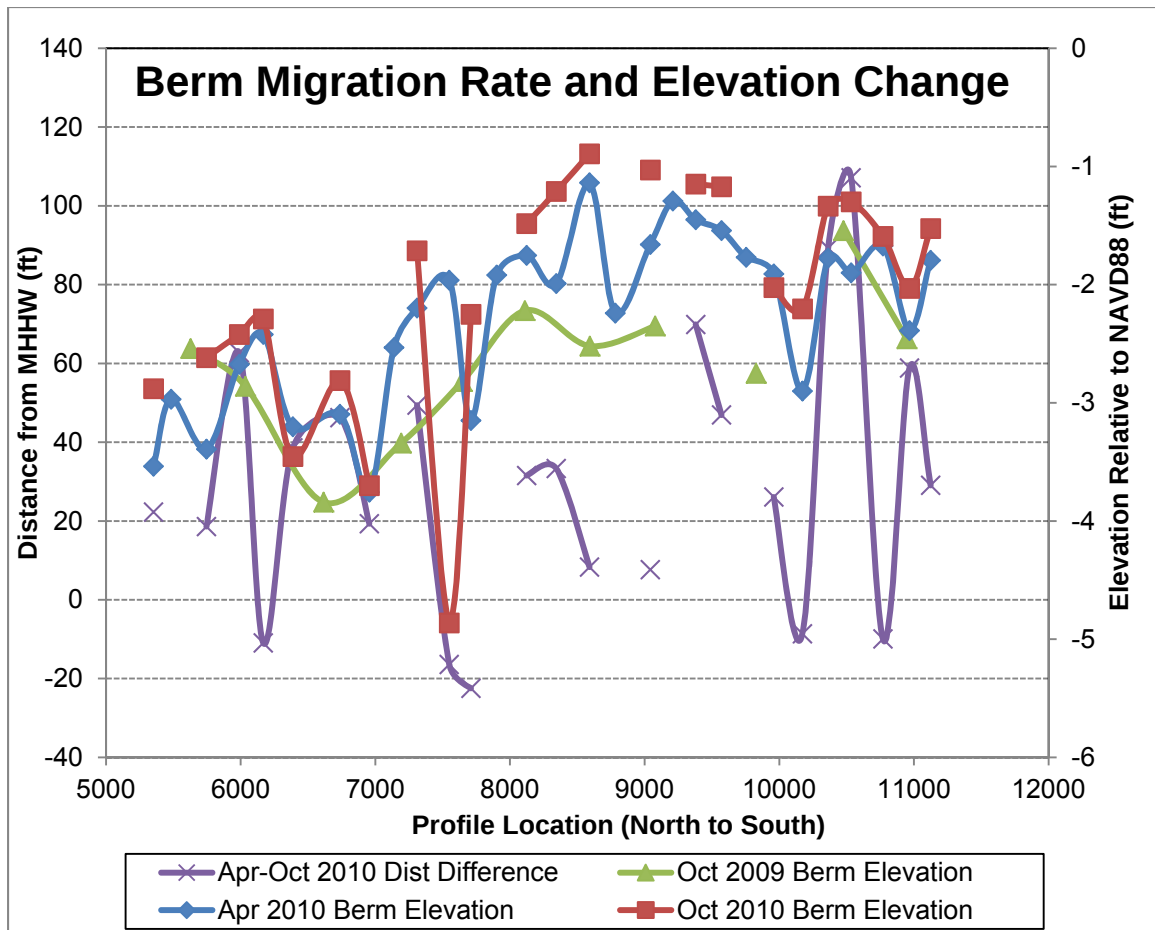
Figure 37. Longshore Variations of Berm Crest Elevation and Berm Migration Rate. Profile location is referred to distance from the northwestern most profile. Note the overall berm elevation increase for the first year. During the second 6 months, the artificial berm moved onshore, mostly less than 50 ft, with considerable longshore variations.

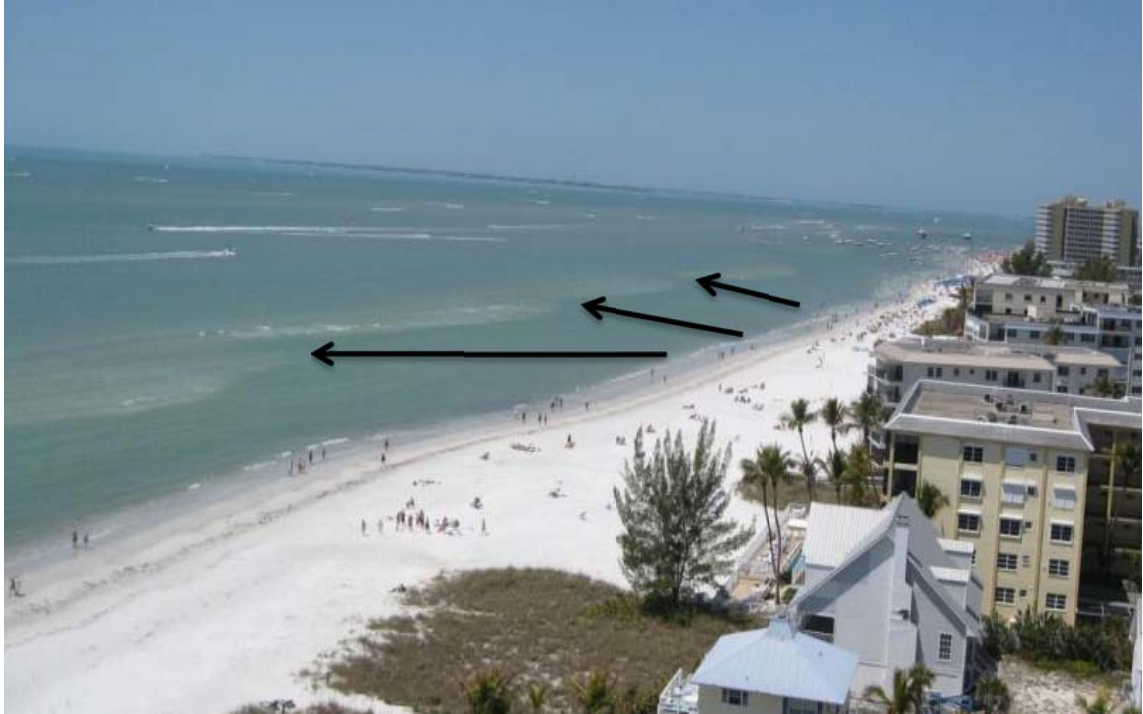
Figure 38. Longshore Variations in the Berm (March 2010). Notice that the gaps in the berm are at an oblique angle to the shoreline.

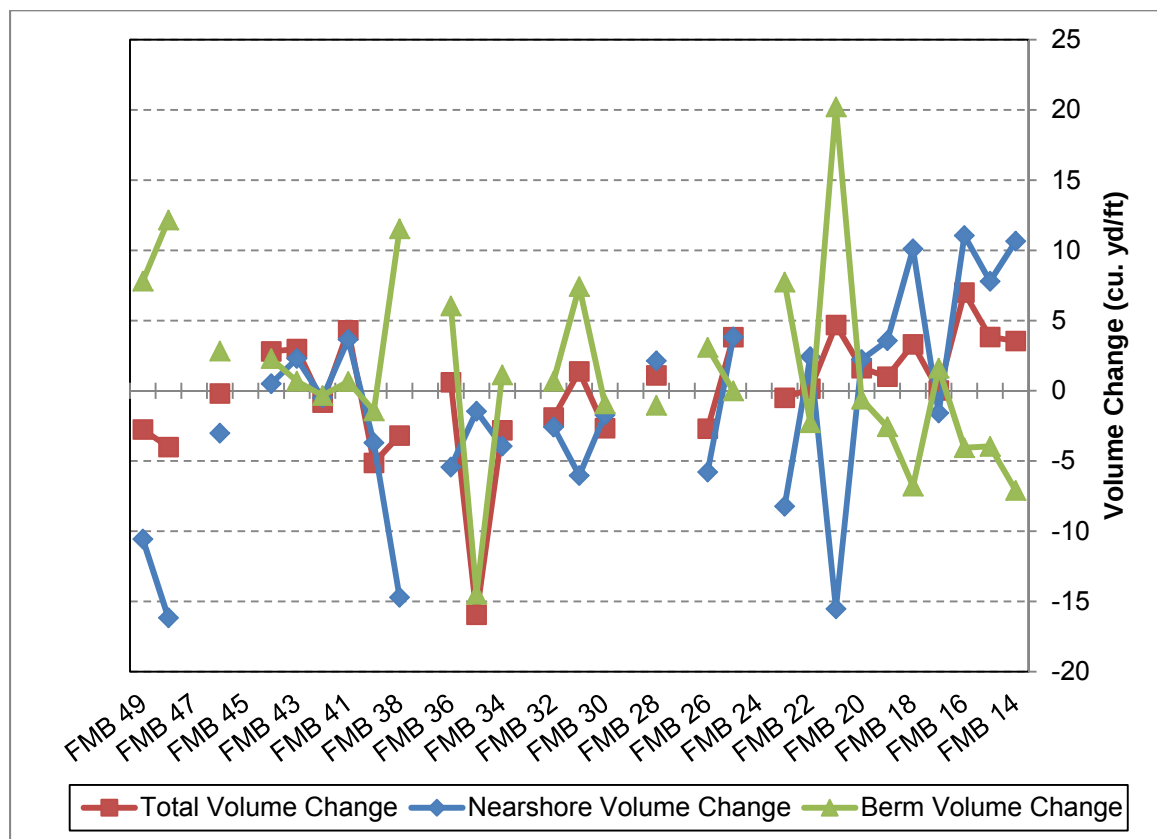
Figure 43. Volume Change Across Berm Profiles.

nearshore berm, reduced within the sheltered region of the berm, thereby reducing sand transport to the beaches north of the berm. Placement of the berm may be functioning as a submerged breakwater to decrease the longshore transport along the shoreline similar to what was documented in a study by van Duin, et al. (2004). Through these calculations it was also discovered that the length of the project area has increased to approximately 5840 ft, indicating that the bar has diffused in the longshore, which has been seen in several prior studies (Otay, 1995; Work and Otay, 1996).

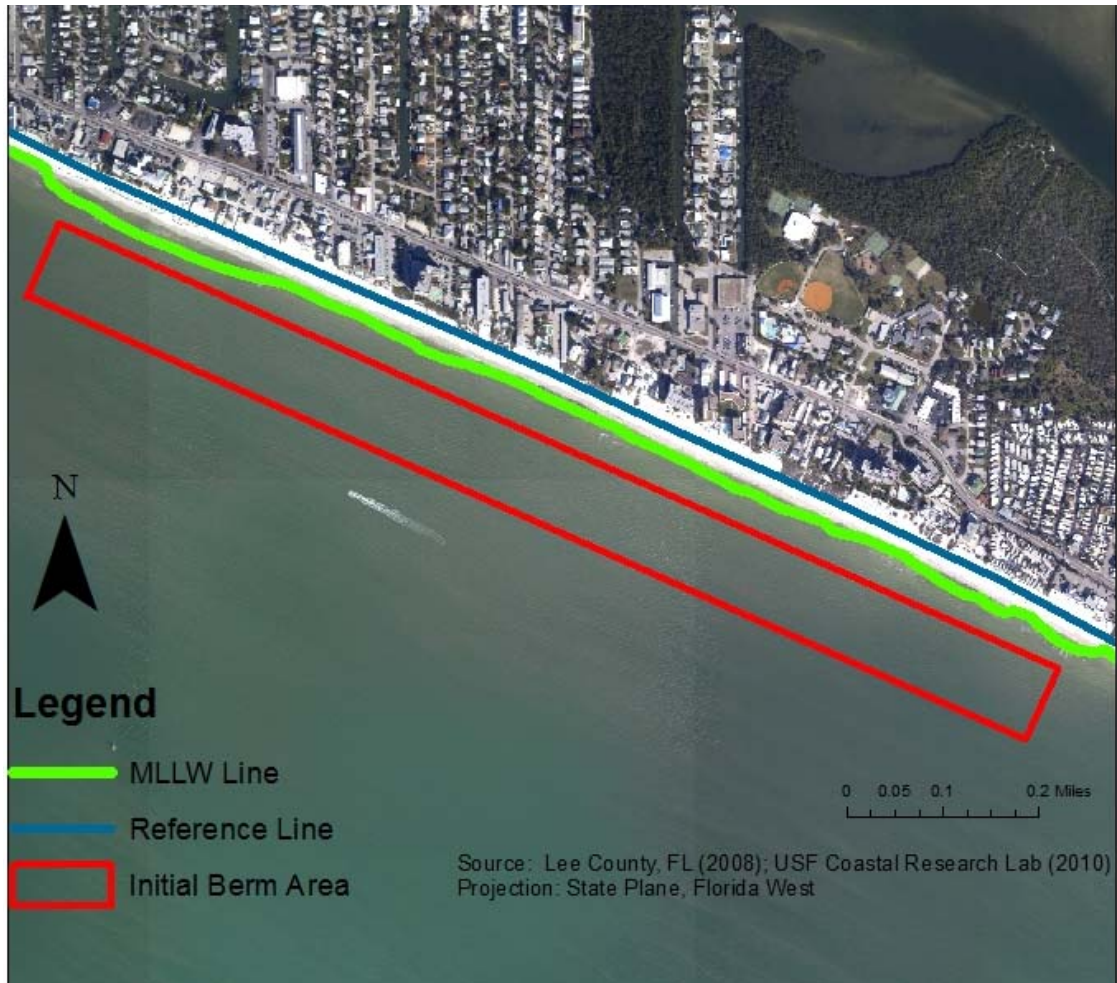
Figure 44. Map of the Berm Area and Shoreline in April 2010. The aerial photograph was taken in 2008, before the berm was placed. The green line follows the MLLW line. Note the salient that has formed in the northwest portion of the berm project area.

Since the construction of the berm in October 2009, it is apparent based on field observations that a salient has formed behind the northwestern portion of the berm. Figure 44 is a map that was created using shoreline survey data at the MLLW line in April 2010, as compared to a reference line that follows the trend of the overall shoreline, and illustrates a salient that formed at the northwestern end of the berm area immediately after placement, although it is not known what the shoreline morphology was immediately prior to berm placement. The formation of a salient may indicate that the berm was acting as a submerged breakwater (Zwamborn, Fromme, and Fitzpatrick, 1970).

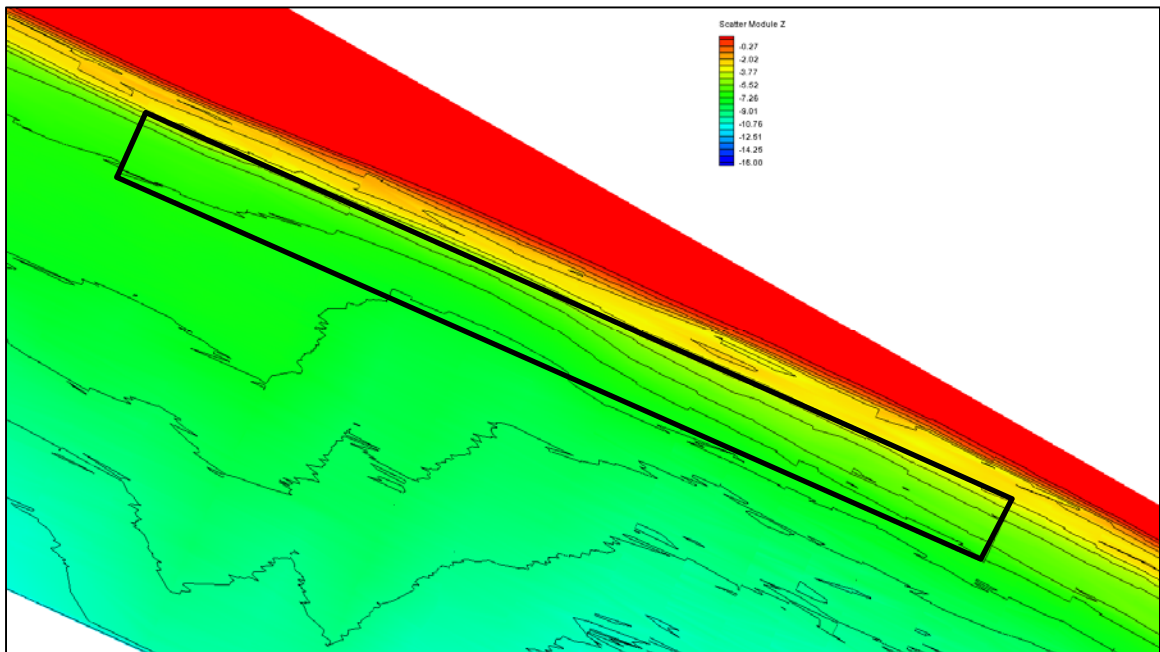
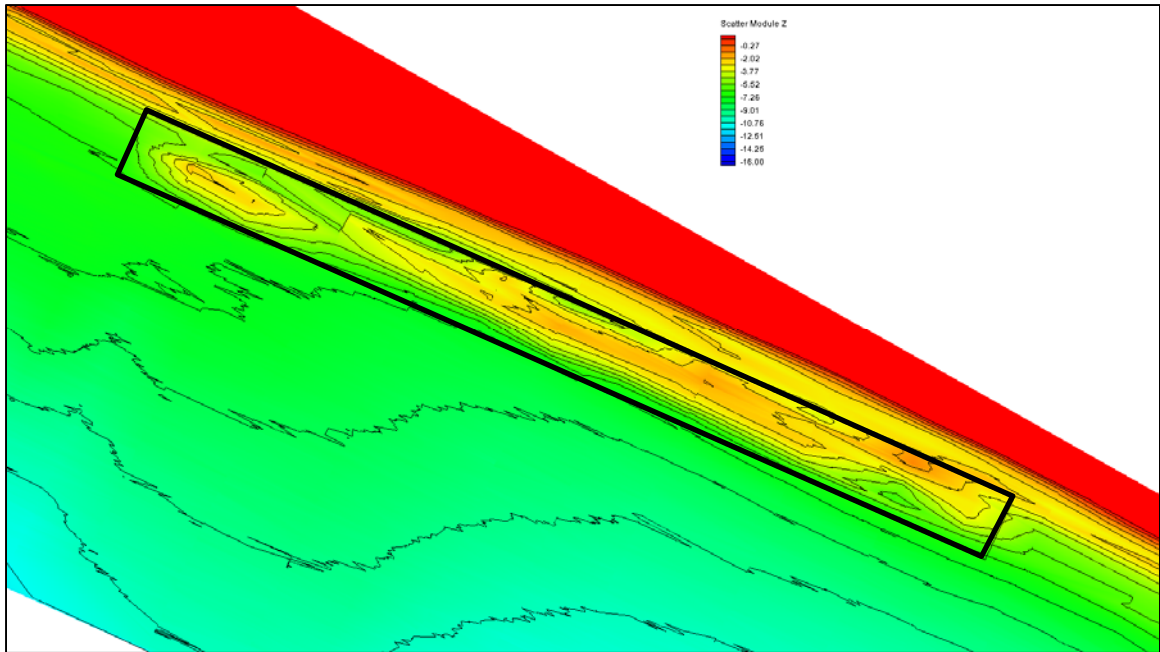
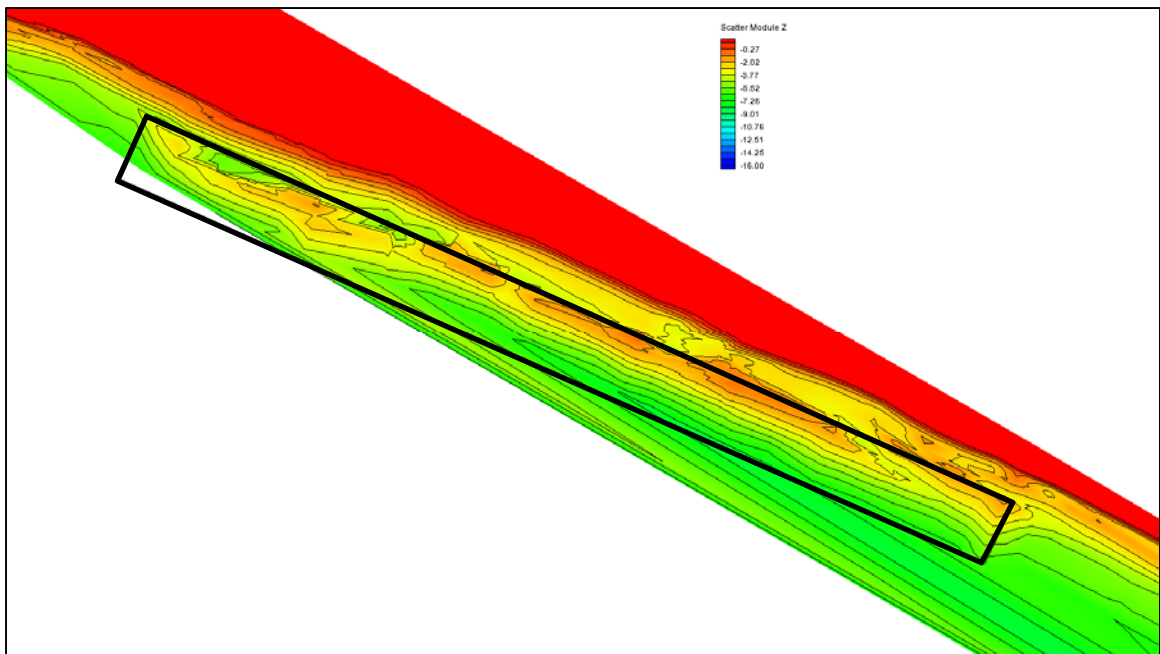
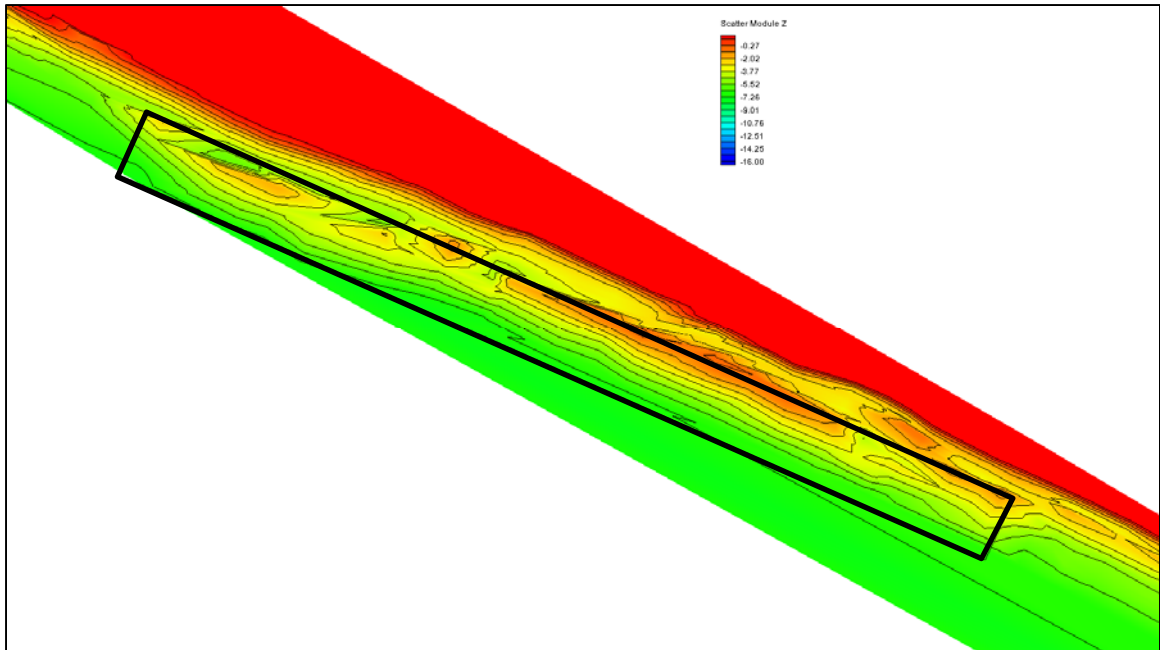
Figure 45. Contour Map of the Project Area Pre-Construction May 2009.

Figure 46. Contour Map of the Project Area Post Construction October 2009.

Figure 47. Contour Map of the Project Area April 2010.

Figure 48. Contour Map of the Project Area October 2010.

USF in October 2010, shows the less rapid onshore migration during the second 6 months. The gaps are still maintained during this time period, although at slightly different locations.
