# **Acoustic Nondestructive Evaluation of Aircraft Paneling Using Piezoelectric Sensors**

**ARL-MR-834**

**December 2012**

**Eddie Elburn and Ryan C. Toonen**  
**Weapons and Materials Research Directorate, ARL**

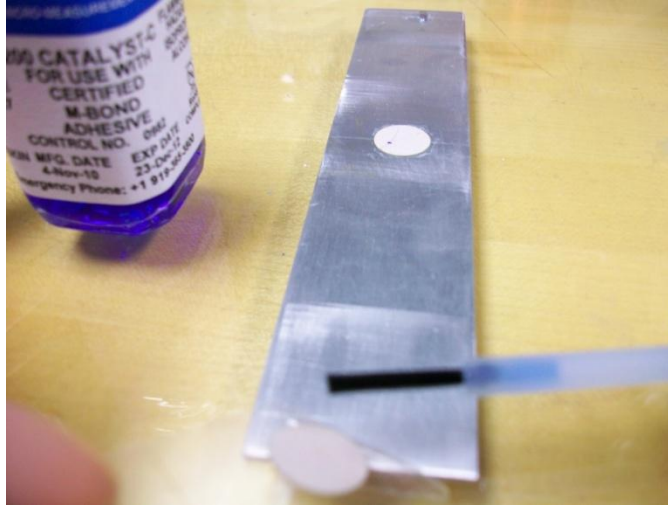
Figure 1. M-bond catalyst is applied to a PWAS for bonding procedure.

To implement the PWASs in a nondestructive evaluation application, these sensors are bonded to the medium one wishes to monitor. Figure 1 shows a photograph of a PWAS being bonded to a strip of aircraft-grade aluminum. One of the PWASs is connected to an arbitrary waveform

The first procedure is bonding the commercial-off-the-shelf PWAS (10-mm diameter, 0.2 mm thick) (4) to an aircraft-grade high-strength aluminum (alloy 2024) 0.063-in-thick  $\times$  12-  $\times$  12-in plate. In order to bond the sensors to the aluminum, we used strain gauge adhesive (Vishay Precision Group M-Bond 200) (5). Once we bonded the sensors to the aluminum, they were soldered to 134-AWP solid copper wires (Vishay PG P/N F006484) and/or 22-AWG PVC-cladded stranded hook-up wires (Belden 8524). This completed the bonding and soldering process. The sensors held to the aluminum for roughly 1 week before the adhesive started to wear off, yet some sets stayed connected for over a month. With a more in-depth research of the topic, the bonding could have lasted for a longer period.
