# Final Report-Phase II

## Evaluation of Alternative Causes of Wide-Spread, Low Concentration Perchlorate Impacts to Groundwater

SERDP Project ER-1429

July 2011

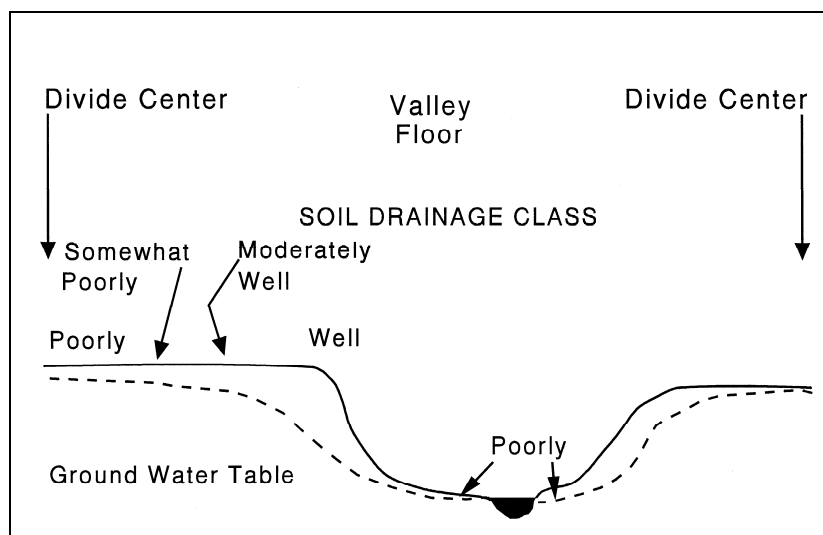
**Figure 2-C** Relationship of Soil Drainage Class to Topography and Groundwater Depth in the Coastal Plain of North Carolina.

The geomorphology of the Coastal Plain region of North Carolina is complex, consisting of a series of scarps and deposition events across recent geologic time and accompanying changes in sea level (Aull et al., 1978b). Understanding soil position on the landscape in the Coastal Plain of North Carolina requires understanding drainage of the surrounding land by bisecting streams. Because precipitation exceeds evapotranspiration, the resulting water table under the soil surface varies with distance away from bisecting streams. As such, soil drainage class, which is a dominant factor in soil formation on the Coastal Plain, changes across the landscape with the most well-drained soils occurring at the upper slope position near streams, and more poorly drained soils occurring both in the alluvial areas next to streams and in the broad, nearly level surfaces between streams (Figure 2-C). This is the reverse from what is often expected in more upland situations, such as in the Piedmont or Mountain regions of North Carolina.

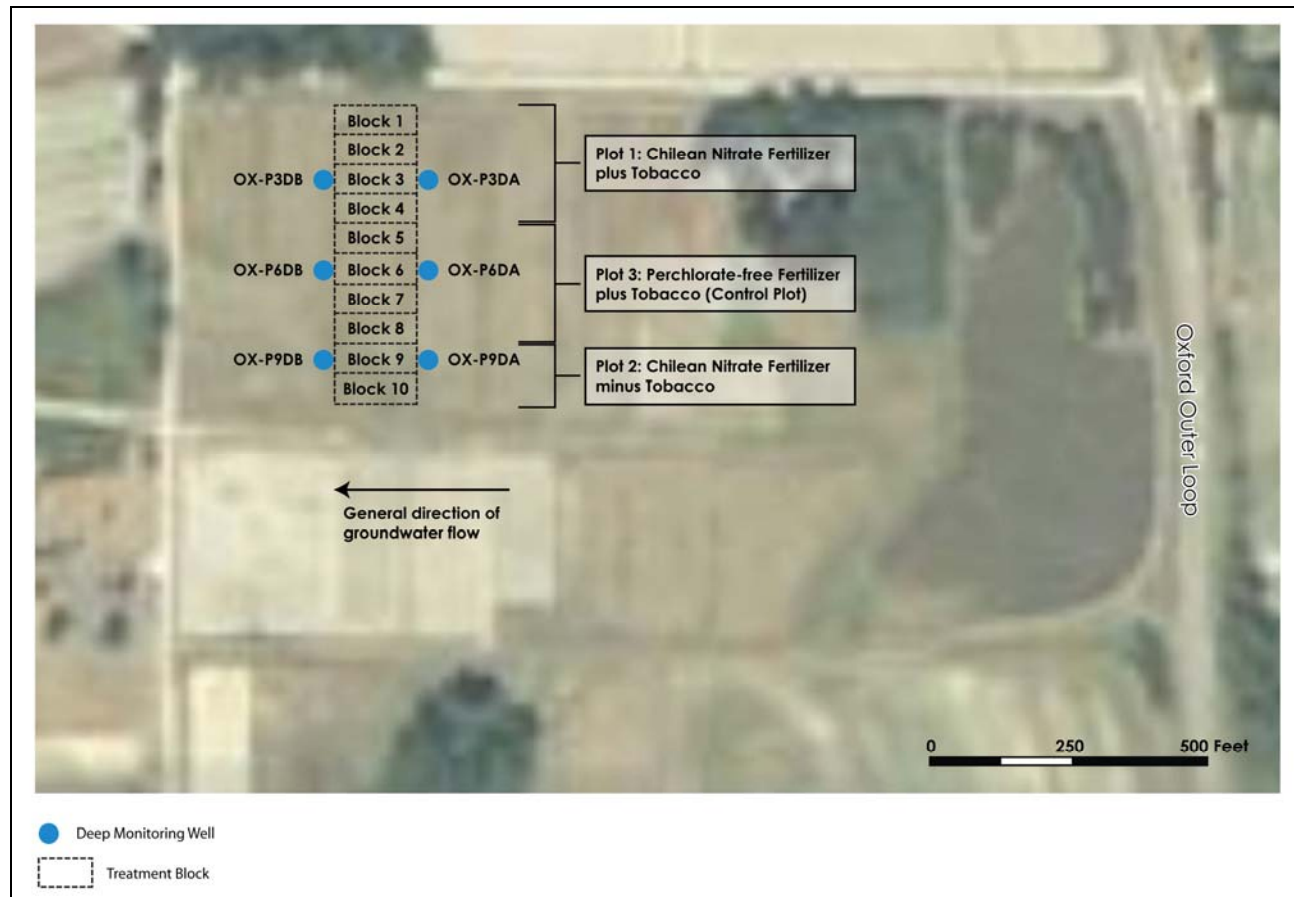
**Figure 3-A** Layout of Test Plots at the Oxford Station. (Image courtesy of Microsoft Corporation, 2010)

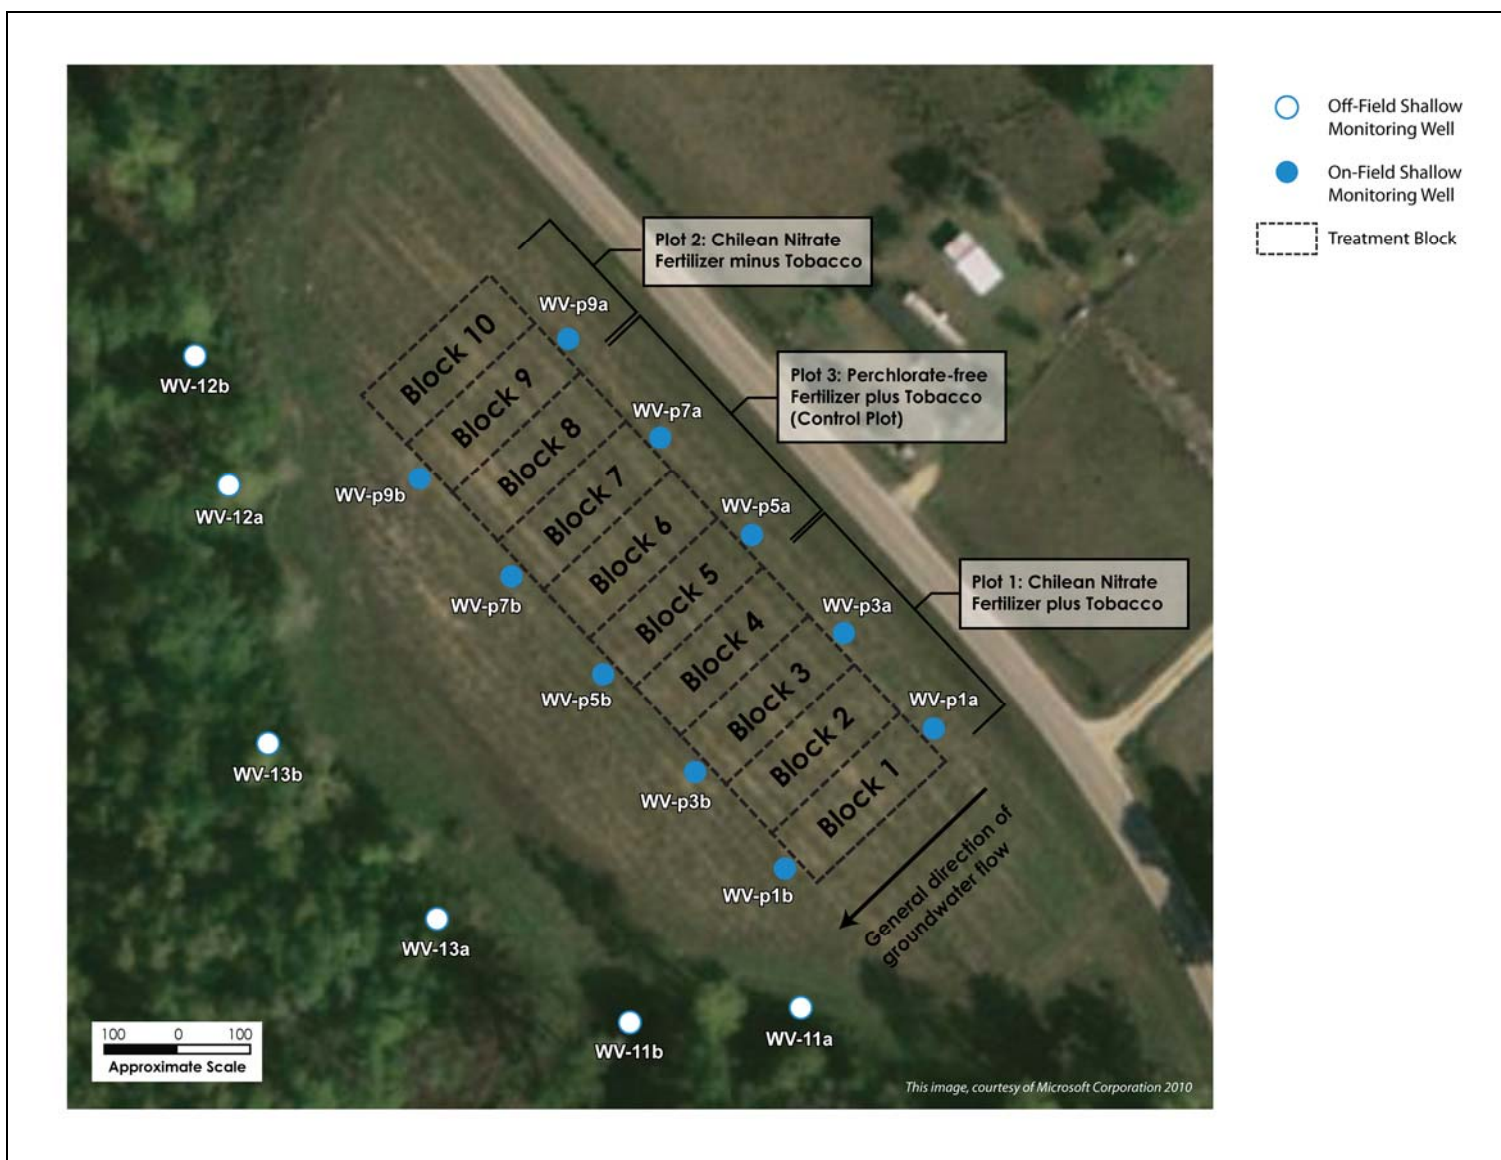
**Figure 3-B** Layout of Test Plots at the Whiteville Station. (Image courtesy of Microsoft Corporation, 2010)

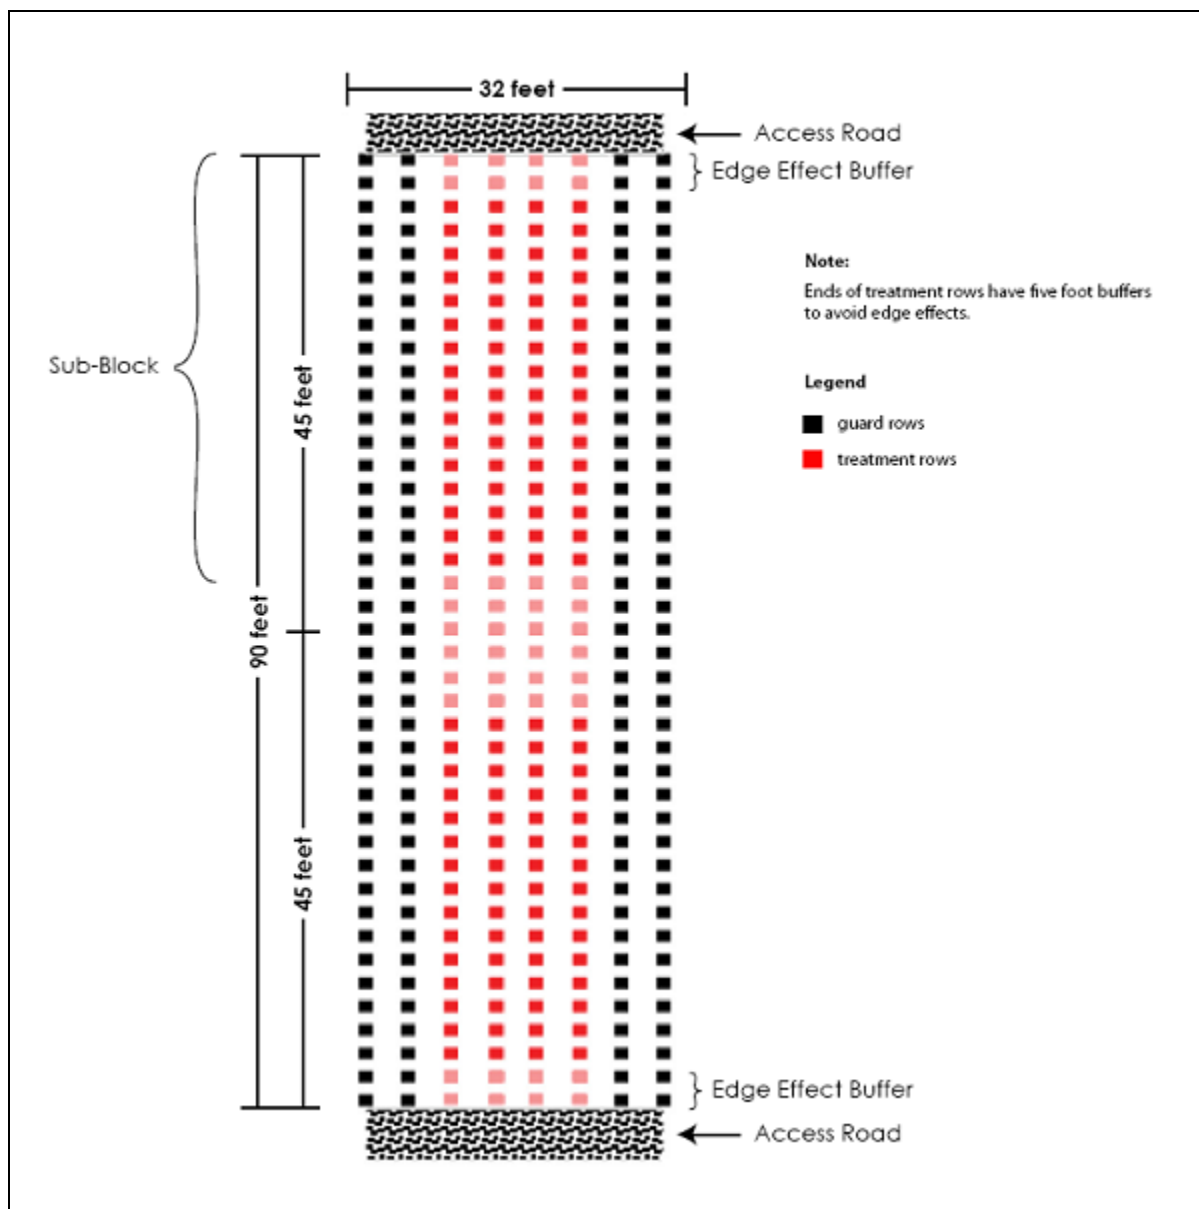
**Figure 3-C** Layout of Single Treatment Block

Within a given treatment block, the total area available for sampling was corrected for edge effects at end of rows. A 5-foot buffer was allowed for edge effects, thus reducing the effective length of each row to 80 ft. This translates to an effective study area in each treatment block of 1,280 ft<sup>2</sup> (each treatment block composed of two sub-blocks each with an effective study area of 640 ft<sup>2</sup>).

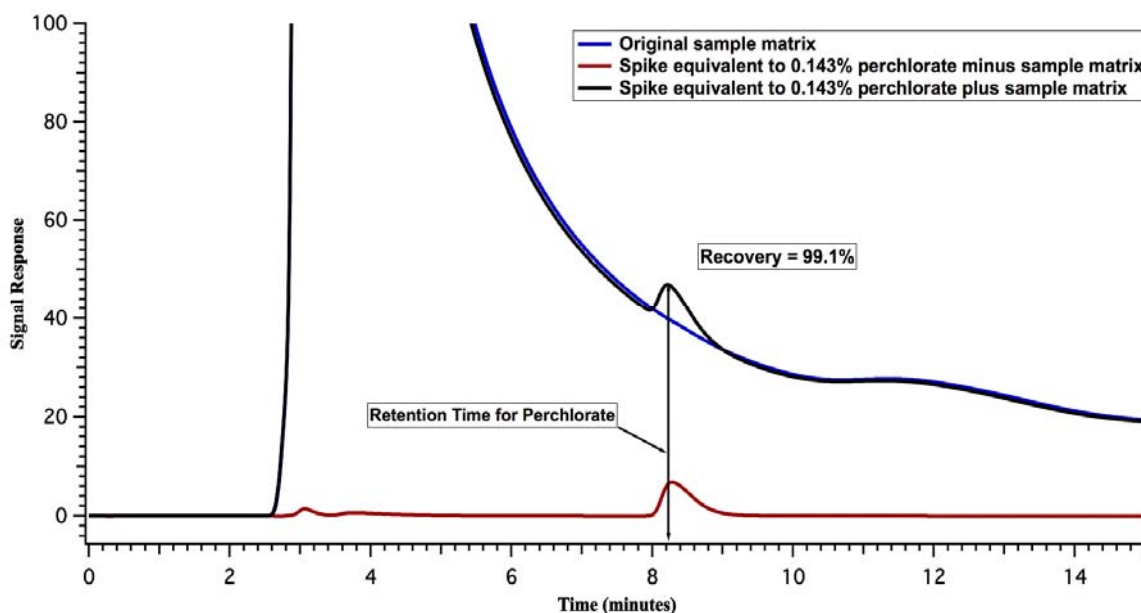
**Figure 6-A** Example of Chromatogram Obtained in the Analysis of Potassium Nitrate Fertilizer for Perchlorate using Ion Chromatography. (Sample loop 50 microliters, AG-16+AS-16 columns, 40 mM NaOH, 1 mL/min, conductivity detection after suppression with ASRS-300 in recycle mode).

Analysis of the potassium nitrate product was originally carried out at North Carolina State University by the principal investigators using water extracts (1:10 solid:solution ratio) and ion chromatography (Collette et al., 2001). The resultant chromatograms displayed the typical shape observed for solid substrates containing primarily soluble salts (Figure 6-A). However, no perchlorate was detected in the extracts using ion chromatography. Addition of spikes of perchlorate to the extracts confirmed that the presence of the high amounts of nitrate were not overloading the analytical column and not inhibiting the detection of perchlorate in the extracts (Figure 6-B). Based on detection limit values, it was estimated that the potassium nitrate product contained somewhere between 0.003 and 0.005% (30 to 50 mg/kg) of perchlorate.

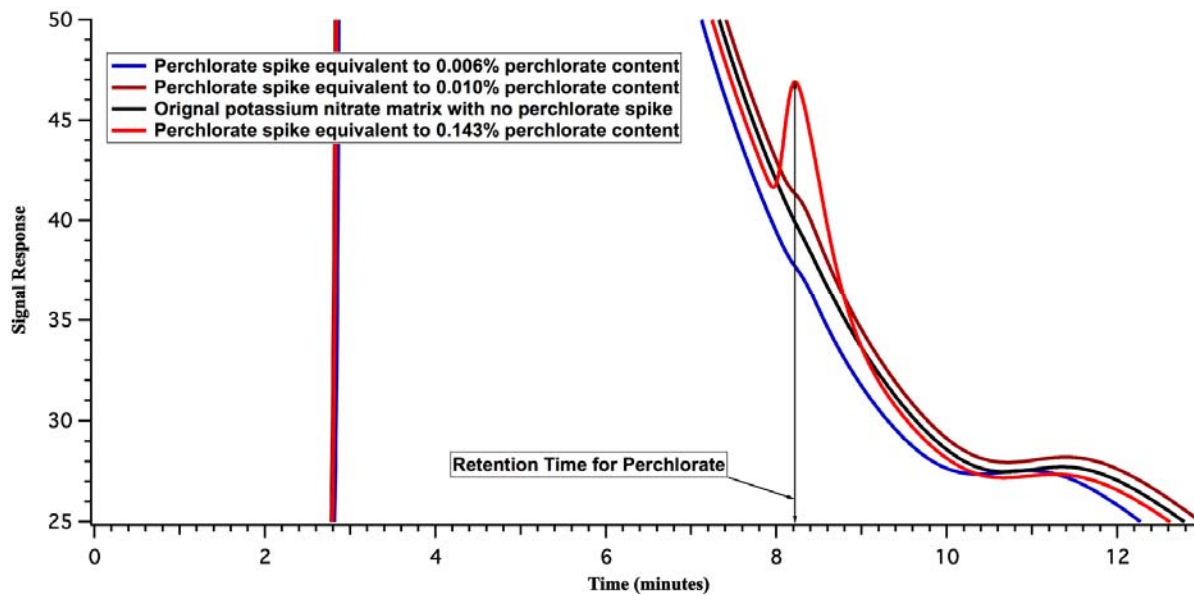
**Figure 6-B** Example of Chromatogram Obtained in the Analysis of Spiked Potassium Nitrate Fertilizer for Perchlorate using Ion Chromatography. (Sample loop 50 microliters, AG-16+AS-16 columns, 40 mM NaOH, 1 mL/min, conductivity detection after suppression with ASRS-300 in recycle mode).

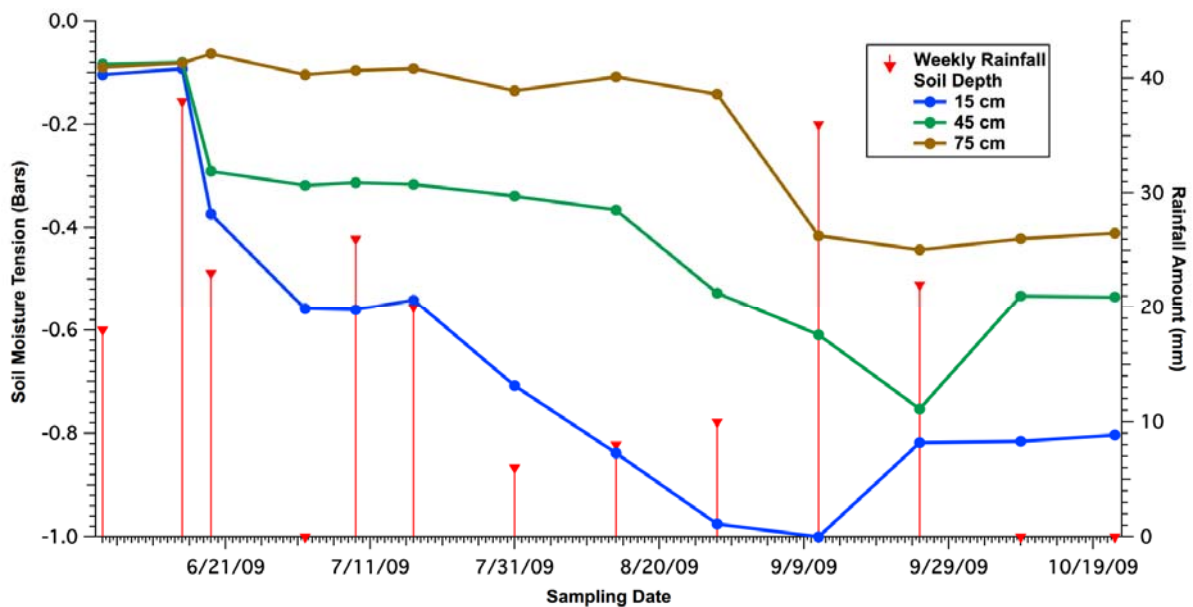
**Figure 6-H** Mean Soil Tensiometer Readings for Blocks 9-10 as a Function of Date and Soil Depth Together with Weekly Rainfall Amounts, Oxford Station. (Soil depths are referenced to the top of the soil mounds).

Soil tensiometer readings in Blocks 9-10 (bare soil plots) as a function of date and soil depth are shown in Figure 6-H. Initial readings in early June reflect high soil water content under well drained conditions ( $\sim -0.1$  Bar). This status does not change despite a large rain event during the week of June 18th. However, the surface 15cm (soil mound) begins to dry noticeably following the week of June 18th. More rainfall during the weeks of July 10th and 17th appear to maintain the mound water content, but then the soil continues to dry till late September.

The next soil depth increment (45 cm) appears to mimic the pattern at the 15 cm depth somewhat with a noticeable decline after August 1. A mild decline is also observed at the 75 cm depth starting in mid-August. There is some recovery near the end of the study period in the

upper two depths in October. Blocks 9-10 contained no plants, thus the increase in soil tension over time reflects water loss through evaporation, despite several rain events. Failure to see recovery following a rain event probably reflects formation of surface crusts on the bare soil, which limited infiltration and favoured lateral surface runoff. Under conditions of relatively high soil water tension, there would be little to no significant vertical transport of water or solutes except as wetting fronts as water moved into the dry soil. A similar pattern in soil tension readings was observed in Blocks 1-8, which did contain tobacco plants. The mean soil tension readings as a function of date and soil depth for Blocks 1-8 are shown in Figure 6-I.

Both Figures 6-H and 6-I illustrate that despite the recorded rainfall during the summer of 2009 at the Oxford station, the soil within the research plots began drying and stayed dry throughout much of the study period, and did not begin to recover until September. The presence of the tobacco plants appeared to enhance soil water infiltration as compared to bare soil, promoting both vertical and perhaps lateral transport of water. Vertical transport is reflected in the eventual decrease in soil water tension at the 75 cm depth in late September and the steady decrease in soil water tension at the 45 cm depth. The decrease in soil water tension at the 15 cm depth may reflect lateral movement of water into the soil mound from the surrounding excavated inter-rows. It is anticipated that soil nitrate (and perchlorate) concentrations under these soil moisture conditions would remain relatively static with soil depth, and decrease only due to plant uptake over time.

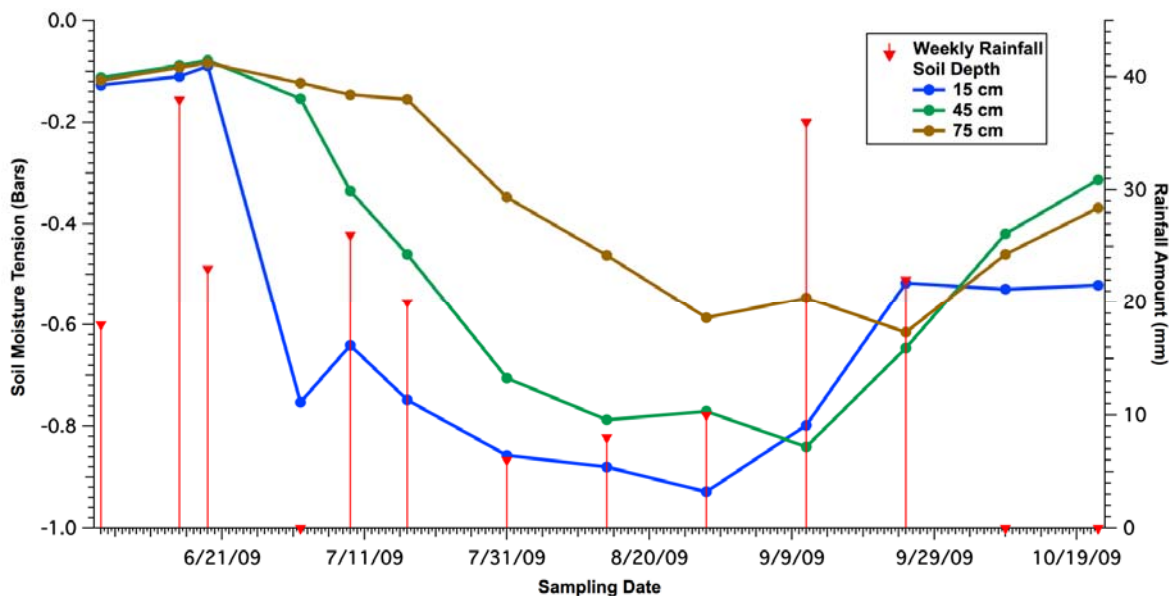
**Figure 6-I** Mean Soil Tensiometer Readings for Blocks 1-8 as a Function of Date and Soil Depth Together with Weekly Rainfall Amounts, Oxford Station. (Soil depths are referenced to the top of the soil mounds).

With the presence of tobacco plants, the soil in Blocks 1-8 dried relatively faster than the bare soil, with the 75 cm depth beginning to show an increase in soil tension by the first week in July. Driest conditions were reached in early to mid-August across all three soil depths monitored. As illustrated in Figures 6-F and 6-G, the tobacco plants had reached substantial size by mid-July, and continued to increase in leaf area and mass through mid-August, maintaining a substantial transpiration demand on the soil. Recovery of soil water began in the upper two depths following a relatively large amount of rainfall during the week of August 11th. Due to the size and presence of the plants on the beds, their leaves would act to limit the impact of raindrops forming surface crusts on the soil, and the leaves would also redirect the rain to the inter-rows, which are below the original surface of the soil. The increase in soil water content in the upper two soil depths, especially compared to the bare soil, reflect the ability of the plants to influence soil water infiltration. Apparently the upper soil depths become wet enough by September 25th that the second substantial rain event during this period begins to promote

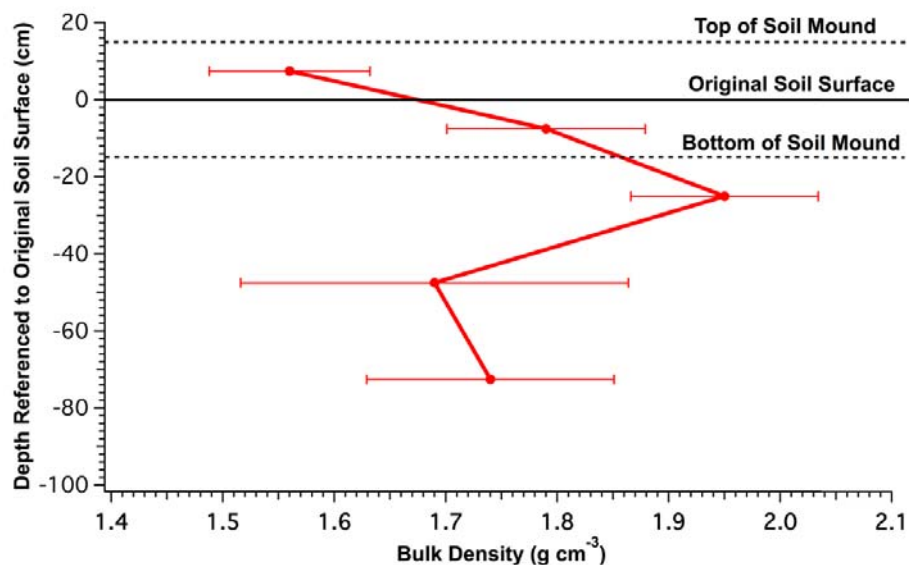
**Figure 6-J** Mean Soil Bulk Density and Standard Deviation for Block 1-10 as a Function of Soil Depth Relative to the Top of the Soil Mound, Oxford Station.

Soil bulk density values as a function of depth were relatively consistent across all 10 blocks. Lowest soil bulk density was measured in the soil mound, which is consistent with being formed by excavation of the surrounding soil earlier in the season. Maximum soil density is observed at a depth of approximately 30 cm below the original surface of the soil (Figure 6-J). This is symptomatic of the presence of a plow pan at approximately 8-12 inches deep in the soil. Such plow pans restrict both water and root movement. The presence of the pan was readily apparent when obtaining soil bulk density samples, offering substantial resistance to penetration of sampling equipment if the soil at this depth was dry, as noted in Figures 6-H and 6-I. Thus the presence of this more dense soil layer would also act to restrict vertical transport of soil nitrate (and perchlorate) in these soils.

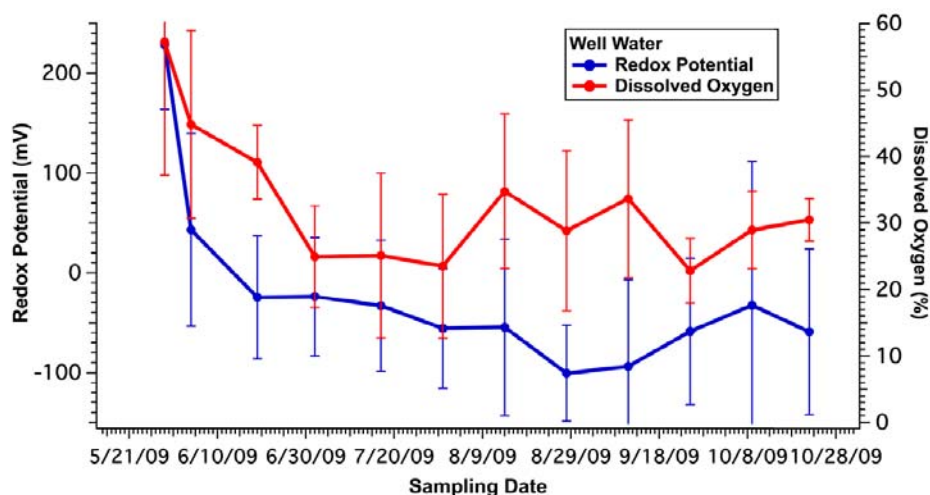
**Figure 6-K** Average Redox Potential and Dissolved Oxygen Content as a Function of Date for Groundwater from Wells Installed at the Ends of Blocks 3, 6, and 9, Oxford Station. (Vertical lines represent one standard deviation).

Both redox potential and dissolved oxygen followed the same trend throughout the growing season (Figure 6-K). After installation of the wells, both dissolved oxygen and redox measurements indicated a relatively well-oxygenated environment. To what extent this is an artifact of well installation is not known. It is apparent that even as the groundwater depth increased, reaching a average height of 0.75 m bgs, both the redox potential and dissolved oxygen continued to decrease until reaching relatively constant values between June 20th and July 4th 2009. The steady decline in redox potential and dissolved oxygen content is not necessarily consistent with input of surface waters during the period of increase in groundwater elevation.

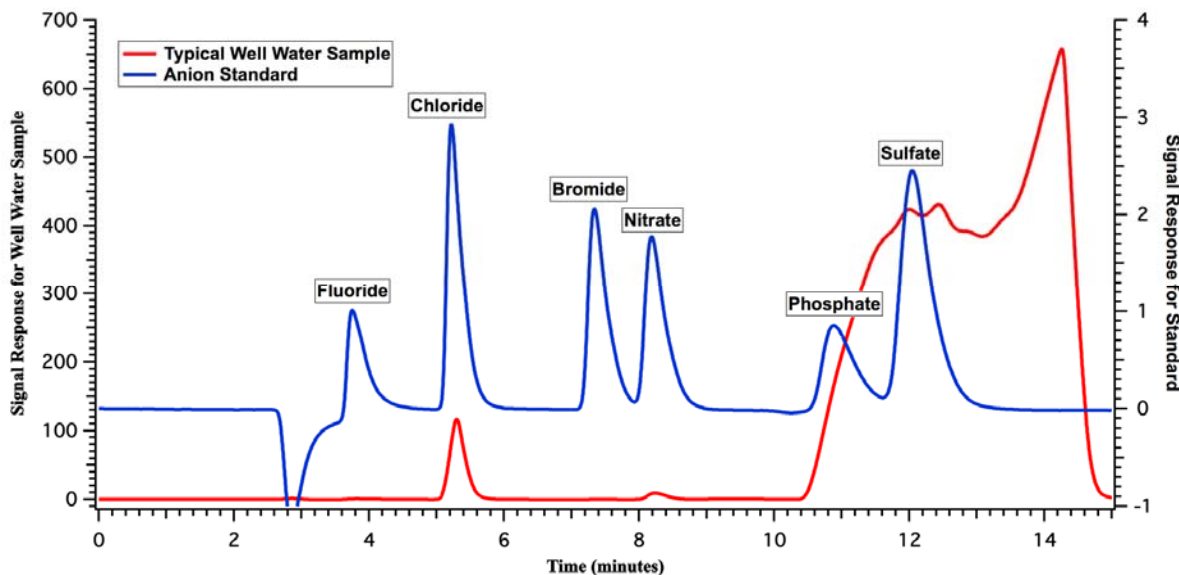
**Figure 6-L** Standard Anion Analysis of a Typical Well Water Sample Compared to an Anion Standard Using Ion Chromatography, Oxford Station.

Analysis of the groundwater samples from the deeper wells for perchlorate, chloride and nitrate were carried out using ion chromatography. A qualitative assessment of the presence of sulfates and phosphates in the well water samples was also conducted using ion chromatography. No perchlorate was detected in any of the water samples collected, although the presence of other anions in the water samples was more variable than expected. Figure 6-L illustrates a typical result for anion analyses (chloride, nitrate, phosphate and sulfate) of the water samples.

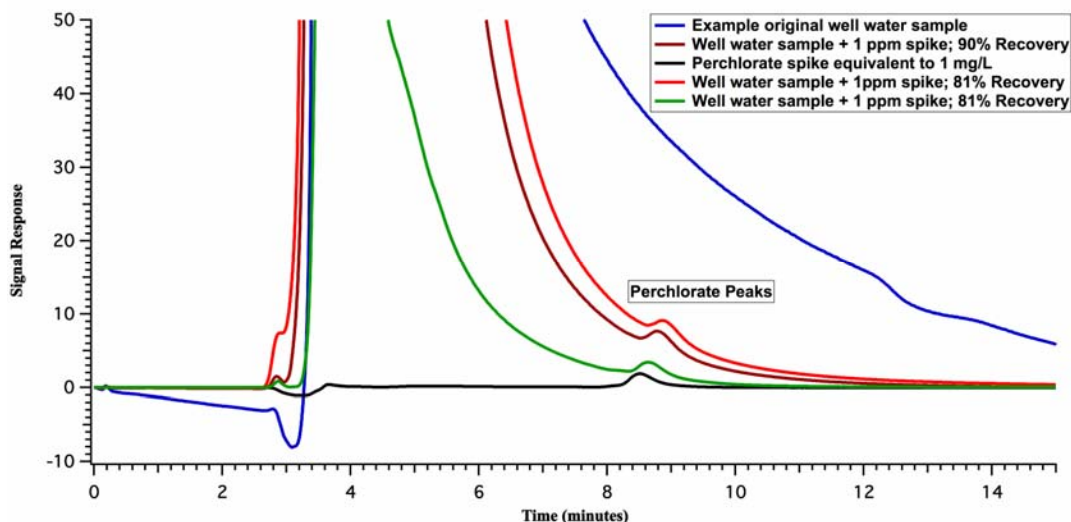
**Figure 6-M** Example Chromatogram and Spiked Recoveries for Several Well Water Samples for Perchlorate, Oxford Station.

As noted, no perchlorate was detected in the water samples collected during the study using ion chromatography. A small subset of water samples was sent to CAS to confirm analyses of the water samples by ion chromatography (Table 6-C). The method reporting limit for analyses by CAS was 0.2 ppb. Of the 9 separate samples submitted, no perchlorate was detected in 7 samples, 1 sample had a reported value of 1.4 ppb perchlorate, and 1 sample submitted in duplicate yielded a value of 32-36 ppb perchlorate in solution (which exceeded the calibration range of the instrumentation) (Table 6-C). Visual inspection of the chromatograph derived from ion chromatography for the positive detection of perchlorate (sample OX-P9DA) did not indicate the presence of perchlorate, which is not inconsistent with the elevated detection limit using ion chromatography due to the presence of relatively high salts in the water samples. It is not known to what extent these high salts may have impacted the analyses conducted by CAS.

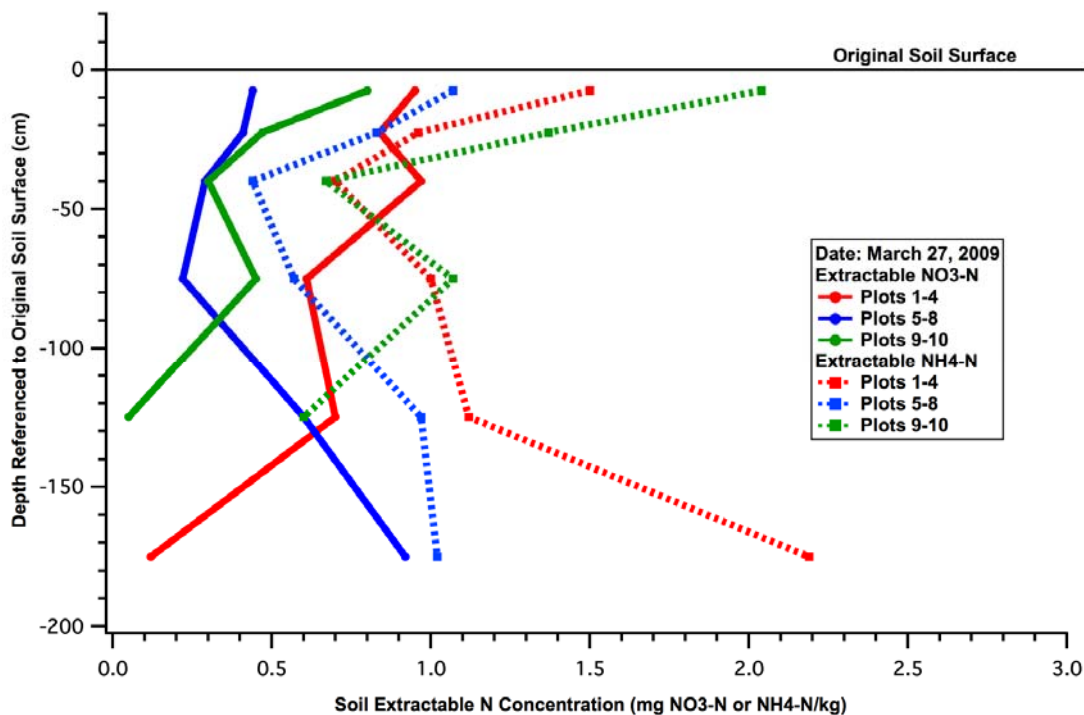
**Figure 6-N** Mean Soil Extractable  $\text{NO}_3\text{-N}$  and  $\text{NH}_4\text{-N}$  Concentrations as a Function of Sampled Depth Increment for Blocks 1-10, Oxford Station. (March 27, 2009. Mean values are plotted at mid-point of depth increment sampled).

All 454 soil samples obtained from the Oxford station were analyzed for extractable  $\text{NH}_4\text{-N}$  and  $\text{NO}_3\text{-N}$ . Pre-plant soil samples obtained on March 27, 2009 had very low background levels of extractable  $\text{NO}_3\text{-N}$  and  $\text{NH}_4\text{-N}$  (Figure 6-N). This was consistent throughout the 0-200 cm sampling depth. Overall, no significant differences in pre-plant soil concentrations of  $\text{NO}_3\text{-N}$  or  $\text{NH}_4\text{-N}$  were determined to exist, and the grand mean from Blocks 1-10 as a function of depth increment sampled was used to compare to results from post-planting soil samples.

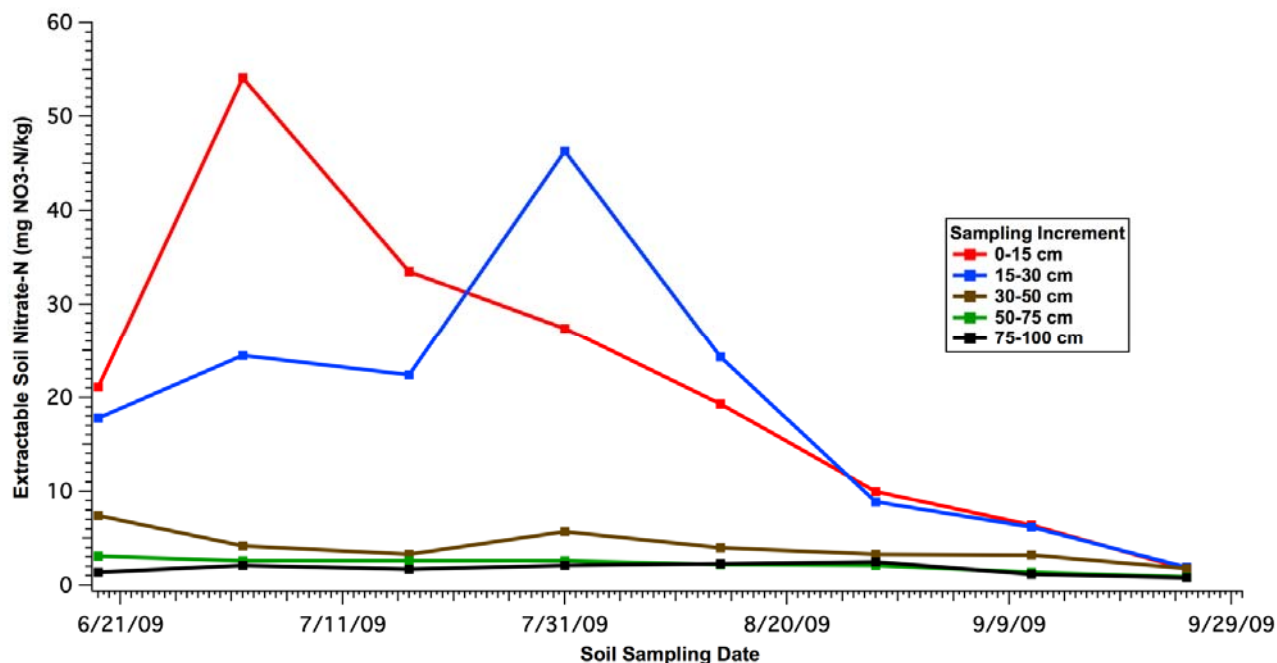
**Figure 6-O** Mean Concentrations of Soil Extractable NO<sub>3</sub>-N for Blocks 1-8 as a Function of Sampling Date and Sampling Depth Increment, Oxford Station. (Sampling depth increments are referenced to top of soil mounds).

The similar patterns observed in soil NO<sub>3</sub>-N concentration as a function of date and sampling increment support the conclusion that nitrate supplied by the two different sources used in this study (potassium nitrate for Blocks 1-4 and calcium nitrate for Blocks 5-8) behaved similarly and was not influenced by the differences in the associated cations of the two nitrate salts (monovalent potassium versus divalent calcium). The mean values as a function of date and sampling increment for Blocks 1-8 were therefore calculated and plotted in Figure 6-O to facilitate comparison to the soil NO<sub>3</sub>-N patterns observed for the bare soil plots (Blocks 9-10; Figure 6-P).

A consistent theme across all 10 blocks was the apparent stability of the soil NO<sub>3</sub>-N concentrations at the 50-75 and 75-100 depth increments. The NO<sub>3</sub>-N concentrations at these deeper soil depths appeared to remain constant or decrease slightly during the growing season (Table 6-G, Figures 6-O and 6-P).

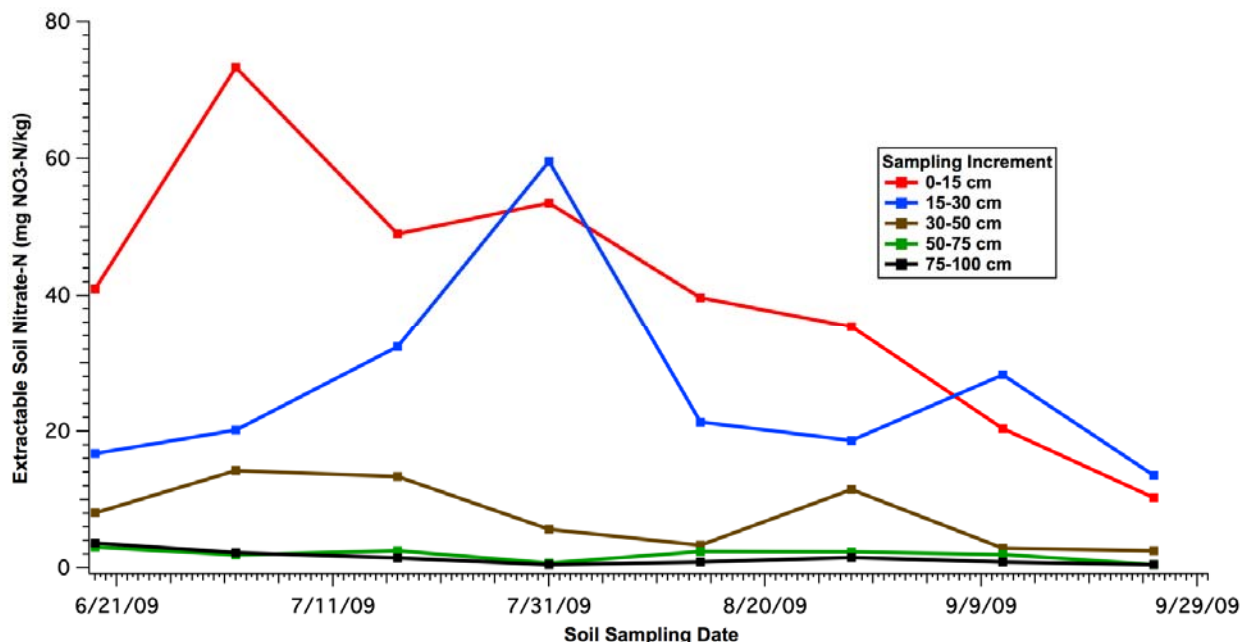
**Figure 6-P** Mean Concentrations of Soil Extractable  $\text{NO}_3\text{-N}$  for Blocks 9-10 as a Function of Sampling Date and Sampling Depth Increment, Oxford Station. (Sampling depth increments are referenced to top of soil mounds).

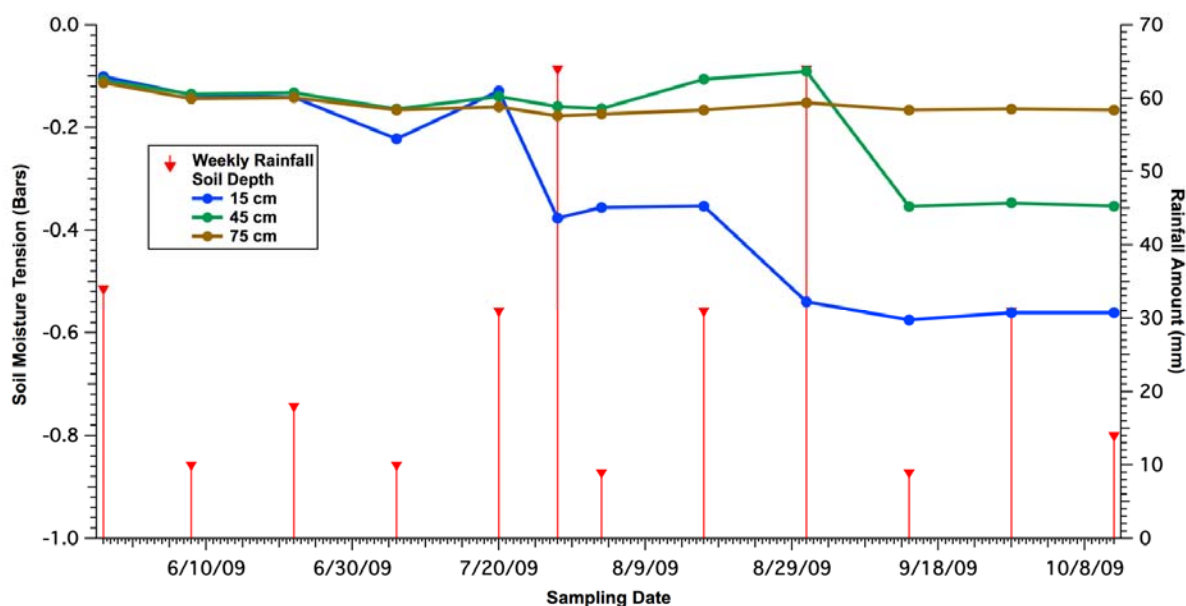
**Figure 6-V** Mean Soil Tensiometer Readings for Blocks 9-10 as a Function of Date and Soil Depth Together with Weekly Rainfall Amounts, Whiteville Station. (Soil depths are referenced to the top of the soil mounds).

Soil tensiometer readings in Blocks 9-10 (bare soil plots) as a function of date and soil depth are shown in Figure 6-V along with rainfall amounts for given precipitation events. From May through about mid-July, the soil moisture content across the top 75 cm of the soil as measured from the top of the soil mound remained fairly uniform, showing a slight decrease with time. This is probably a result of adequate rainfall amounts, especially in April and in May. After July 15, the top 15 cm of the soil mound began to dry out, probably due to an increase in evapotranspiration demand with increased air temperatures. This dry down of the top 15 cm of the soil mound continues despite a large rain event between July 22 and 29, 2009. The top 15 cm of the soil mound eventually becomes very dry in mid-August and remains so through September.

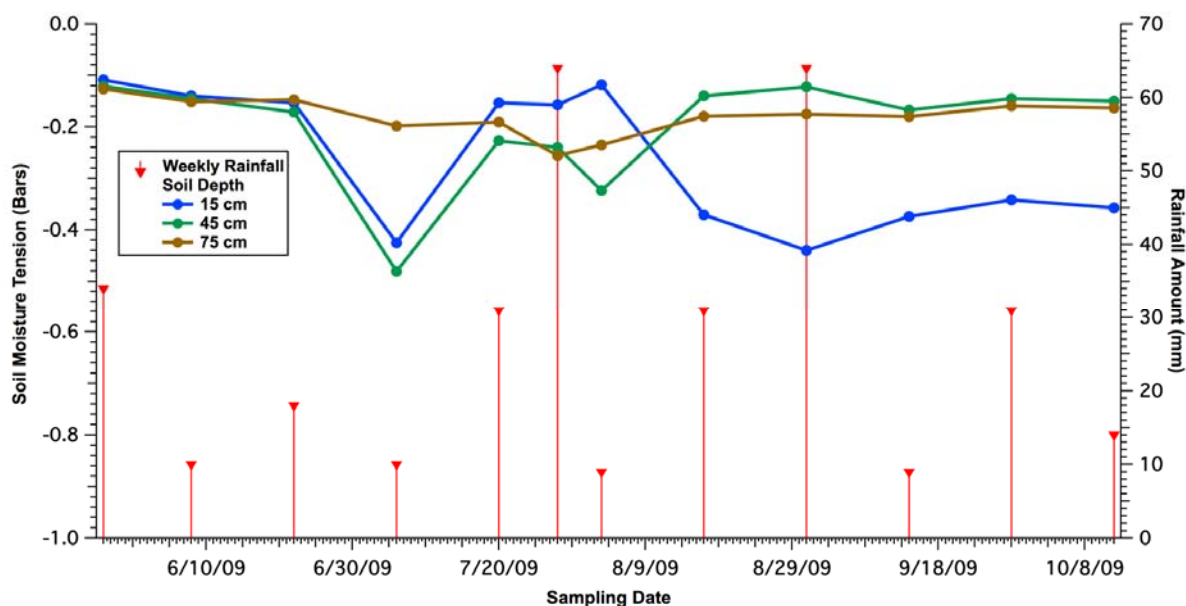
**Figure 6-W** Mean Soil Tensiometer Readings for Blocks 1-8 as a Function of Date and Soil Depth Together with Weekly Rainfall Amounts, Whiteville Station. (Soil depths are referenced to the top of the soil mounds).

After August 5, 2009, the top 15 cm depth declined to an apparent steady state for the rest of the growing season. At the 75 cm depth, the soil moisture content showed a steady decline until the relatively large rain event between July 22, 2009 and July 29, 2009. After this event, the soil moisture content at the 75 cm depth appeared to remain constant, or at least achieve a steady state.

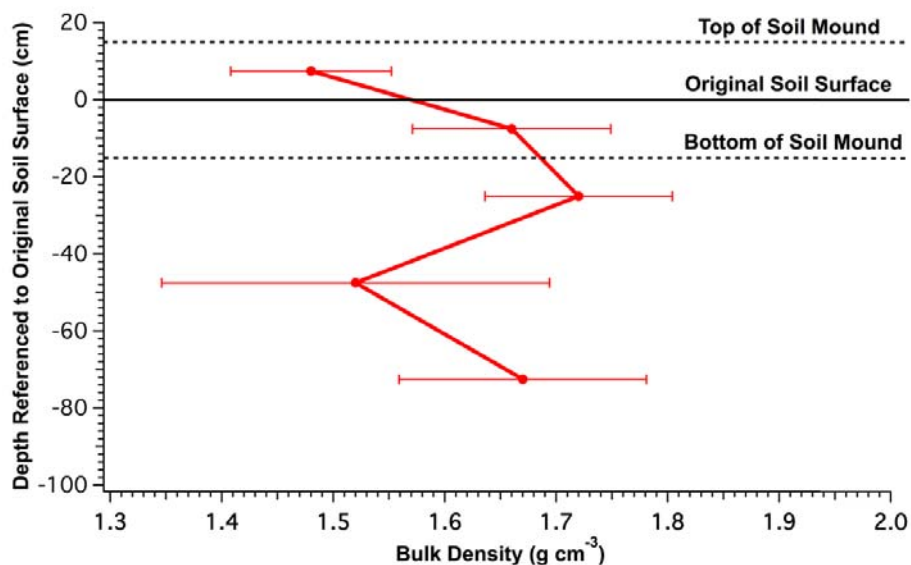
**Figure 6-X** Mean Soil Bulk Density and Standard Deviation for Blocks 1-10 as a Function of Soil Depth Relative to the Top of the Soil Mound, Whiteville Station.

The average bulk densities measured for Blocks 1-10 were generally consistent, and illustrated a general uniformity in soil physical structure across the research site. The presence of a restricted layer was suggested at the 30-50 cm depth increment relative to the top of the soil mound. This is evident by both the increase in bulk density to ~1.7 grams per cubic centimeter, and a corresponding decrease on soil porosity. However, unlike the presence of the restricted layer at the Oxford station, the restricted layer is still rather porous and probably not a major impediment to vertical transport of water.

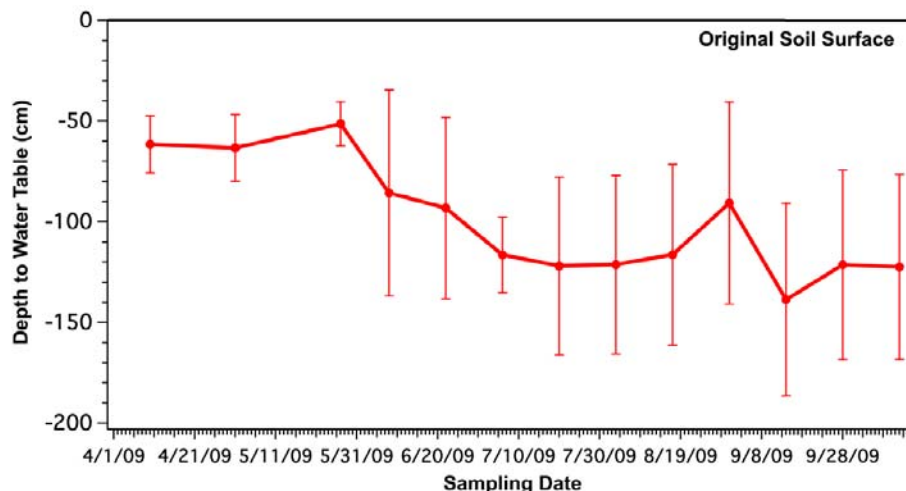
**Figure 6-Y** Average Depth to Groundwater as a Function of Date for Off-Field Wells, Whiteville Station. (Vertical lines represent one standard deviation).

to October, with two noticeable recharge events occurring in late May and late August. These coincide with a 32 mm (1.3”) event on May 26, 2009 (data not shown) and a 30 mm (1.2”) event on August 30, 2009 (Figure 6-W). There is a suggestion of an impact from a relatively large event at the end of June, 2009 (Figure 6-W) as well.

The transient rise in water depth observed for the two rain events suggests that the shallow water table at these locations responds relatively rapidly to large rainfall events capable of generating sufficient soil water infiltration to produce vertical transport and possibly sub-lateral flow. However, the observations in Figure 6-Y are only based on bi-weekly observations and it would appear the elevations in water table height were of short duration. This may explain why no apparent changes in height were observed for other large rainfall events such as occurred towards the end of July 2009 (Figure 6-W). The observed water table depths are also probably closely tied to the level of stream flow in the nearby creek, which would explain the gradual lowering in water table depth during the growing season as stream flow receded and the surrounding marsh land drained. The average water table depth at the Whiteville site remained relatively unchanged from July to October 2009, except for transient inputs from rain events at least 25 mm (~ 1”) in total.

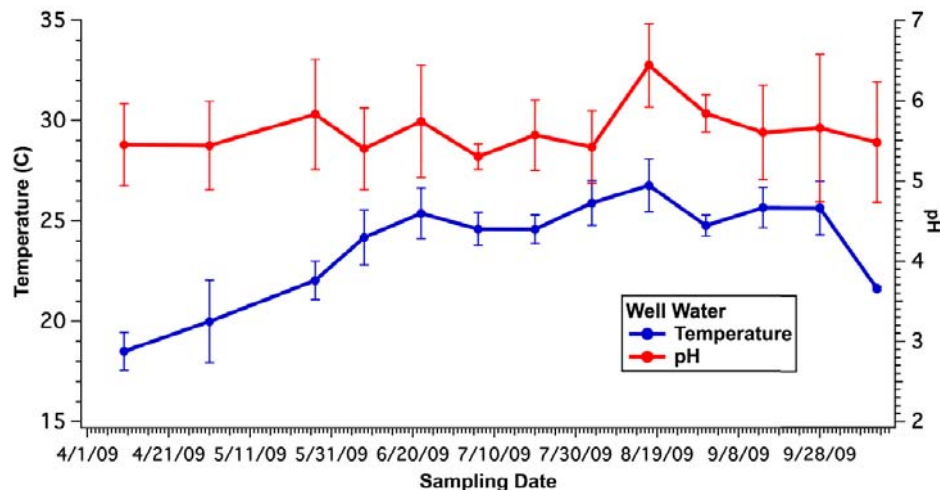
**Figure 6-Z** Average pH and Temperature as a Function of Date for Off-Field Wells, Whiteville Station. (Vertical lines represent one standard deviation).

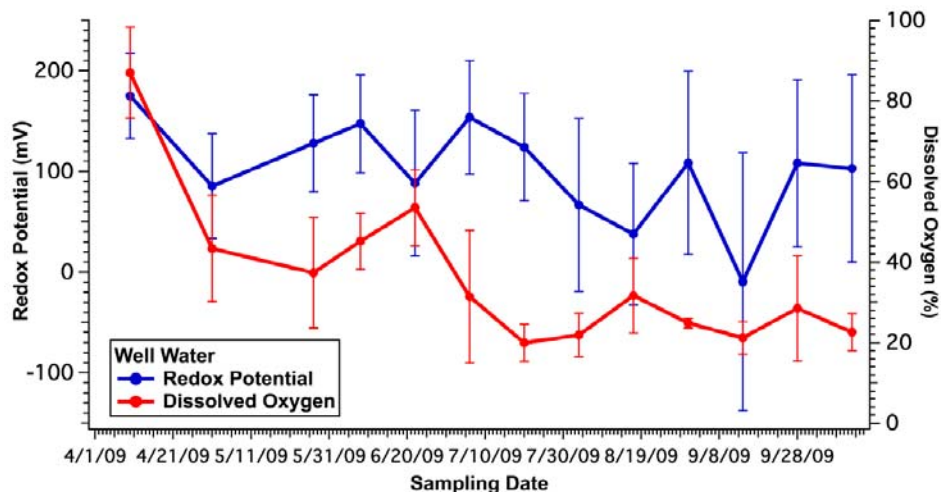
**Figure 6-AA** Average Redox Potential and Dissolved Oxygen Content as a Function of Date for Off-Field Wells, Whiteville Station. (Vertical lines represent one standard deviation).

The measured ORP for the shallow groundwater was variable and displayed a cyclic pattern during the study period (Figure 6-AA). The highest ORP was observed right after well installation. There was no consistent trend between the cyclic pattern in the ORP readings and rainfall events (Figure 6-Y).

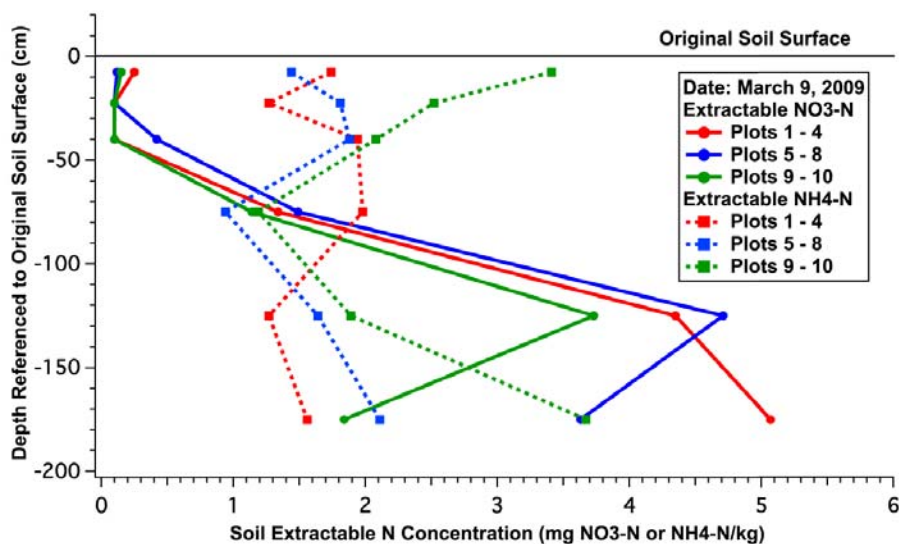
**Figure 6-BB** Mean Soil Extractable  $\text{NO}_3\text{-N}$  and  $\text{NH}_4\text{-N}$  Concentrations as a Function of Sampled Depth Increment for Blocks 1-10, Whiteville Station. (March 9-11, 2009. Mean values are plotted at mid-point of depth increment sampled).

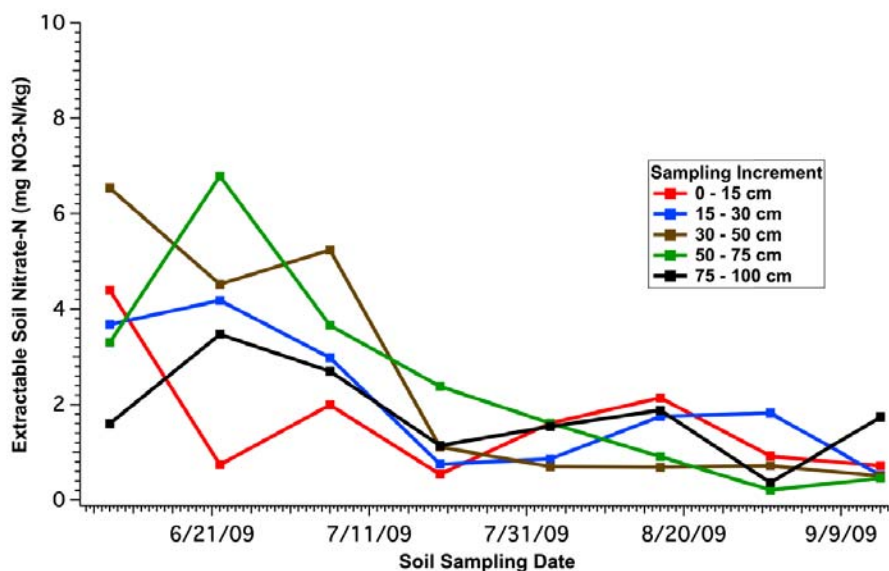
**Figure 6-CC** Mean Concentrations of Soil Extractable  $\text{NO}_3\text{-N}$  for Blocks 1-4 as a Function of Sampling Date and Sampling Depth Increment, Whiteville Station. (Sampling depth increments are referenced to top of soil mounds).

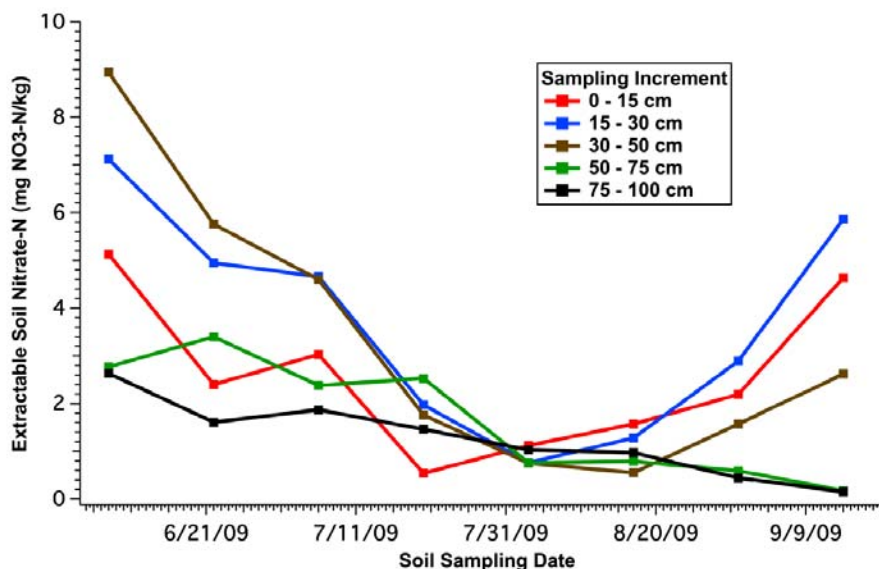
**Figure 6-DD** Mean Concentrations of Soil Extractable  $\text{NO}_3\text{-N}$  for Blocks 5-8 as a Function of Sampling Date and Sampling Depth Increment, Whiteville Station. (Sampling depth increments are referenced to top of soil mounds).
