# Final Report-Phase II

## Evaluation of Alternative Causes of Wide-Spread, Low Concentration Perchlorate Impacts to Groundwater

SERDP Project ER-1429

July 2011

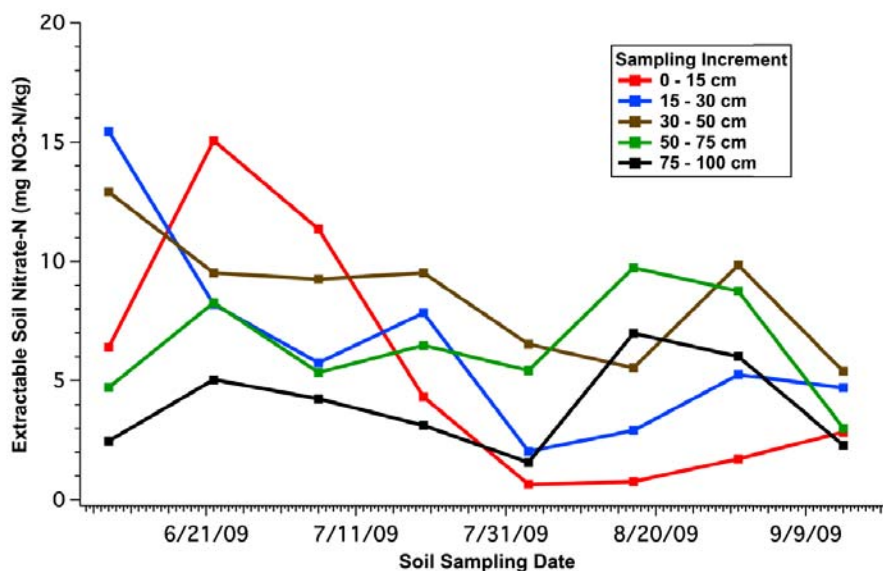
**Figure 6-EE** Mean Concentrations of Soil Extractable NO<sub>3</sub>-N for Blocks 9-10 as a Function of Sampling Date and Sampling Depth Increment, Whiteville Station. (Sampling depth increments are referenced to top of soil mounds).
