NESDI Project #451

Navy Demonstration of Cadmium and Cr⁺⁶ Compliant Electrical Connectors with Hermetic Seals

ASETS Defense – San Diego, CA
27 August 2012

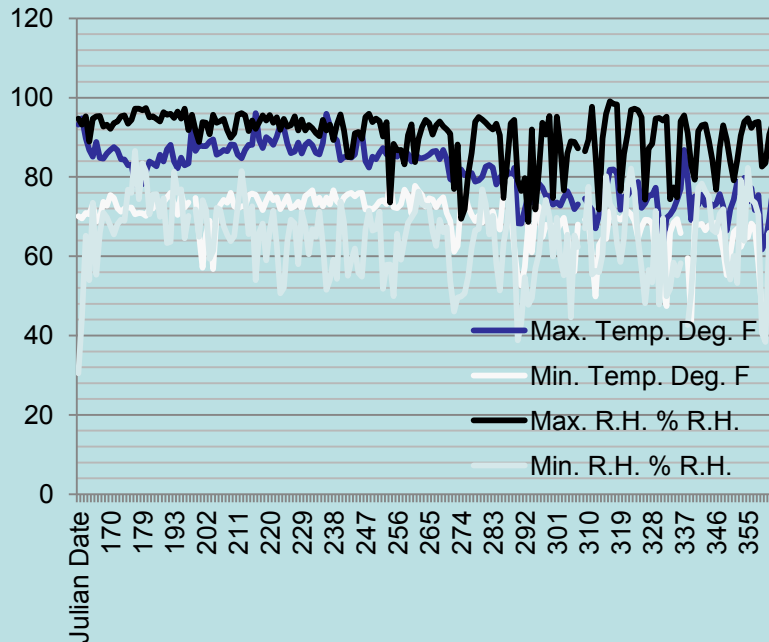
Actual weather data, 1st six months of testing at KSC

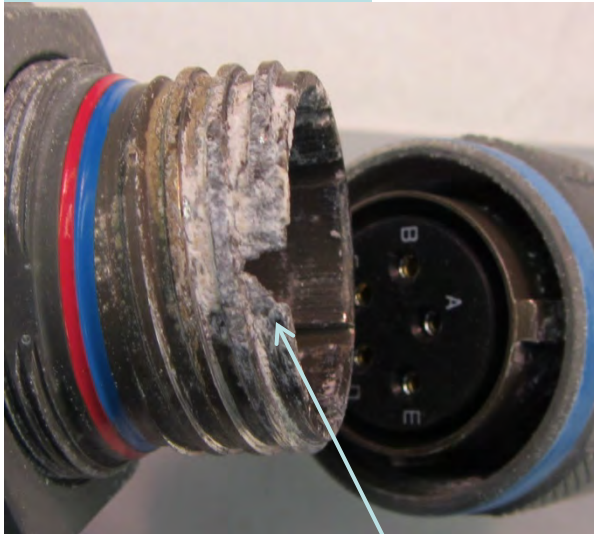
Class W Cadmium

- Significant salt & corrosion product especially on one couple, difficult to open:
 - Class W cadmium/Cr⁺⁶ had corrosion 'chip' at receptacle keyways

Spread of resistance values
observed: 1, 3, 25, 65 m-
ohm (23 m-ohm avg.)

Corrosion 'chips' at keyways on three (3) of
four Cad on Al connectors (WW-x-AL). Test
method reproduced observations in Fleet

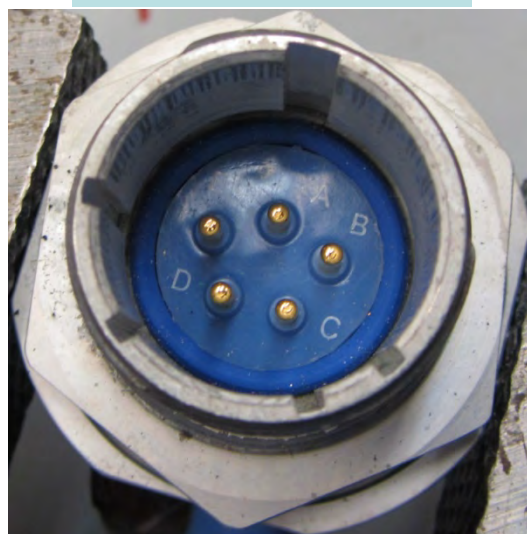
JP-2-AL, coupled to composite plug

- Interior conditions:
 - Class P has some scoring on receptacle I.D. (EMI finger ring witness marks)
 - Slight corrosion spots on jam nuts

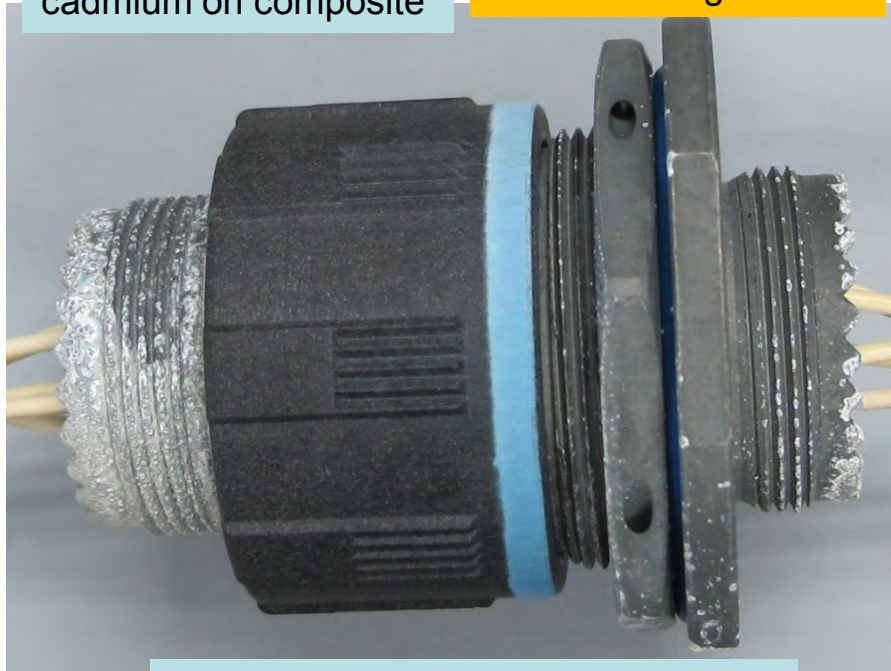
JJ-2-comp, Class J
cadmium on composite

Resistance 5.8 m-ohm
average

Cadmium corrosion product is evident especially on threads

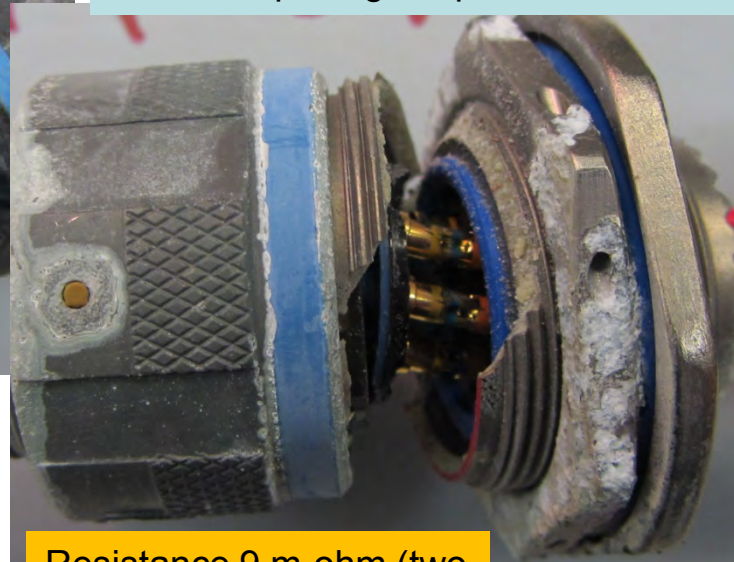
Broken Class M, Ni-on-composite receptacle in Class W plug – dissimilar plating couple

Resistance 9 m-ohm (two replicates)

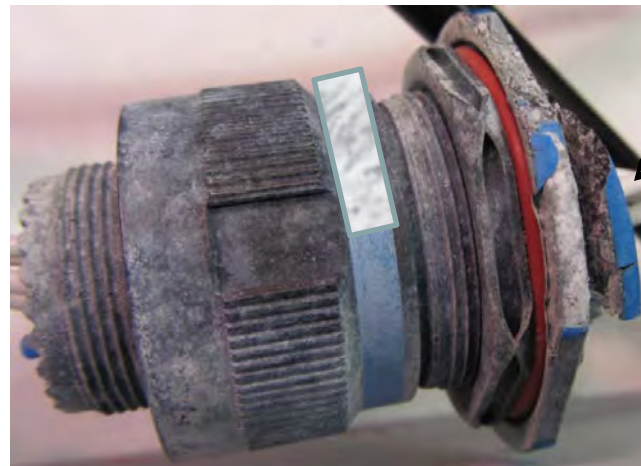
ZZ-1-AL#2

- One Class Z (Zn-Ni) product developed a sacrificial corrosion layer
 - Reportedly, the company uses a hex-Cr post-treatment which meets the European RoHS guidelines threshold for 0.1 wt.% of the part
 - No corrosion ‘chip’ as seen on Cad plating

Plating flaking seen on several receptacle backsides

Elevated 150-300 m-ohm resistivity values

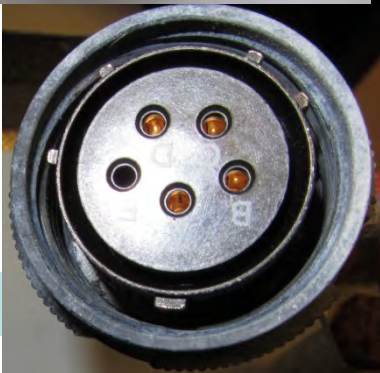
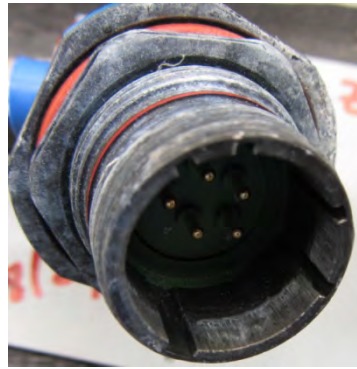
Plug ZZ-1-AL#2

Internals, keyways are in good shape

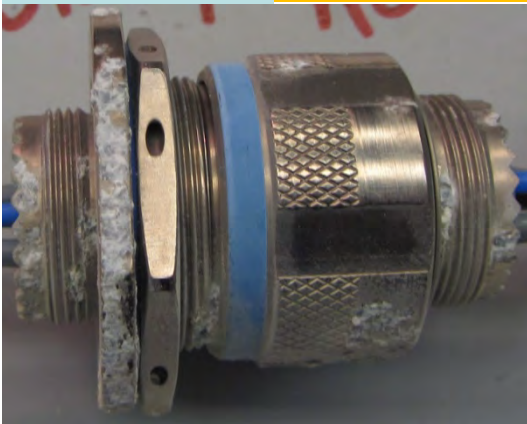
ENEN-1-AL

- Electroless Nickel; Corrosion pitting especially where connector wrenches were used
 - Resistance values exceptional for two couples; one moderate, one high
 - Could not open, seized

Two resistance values still pass spec @ 0.3, 0.5 m-ohm [+ 14.6, one high]

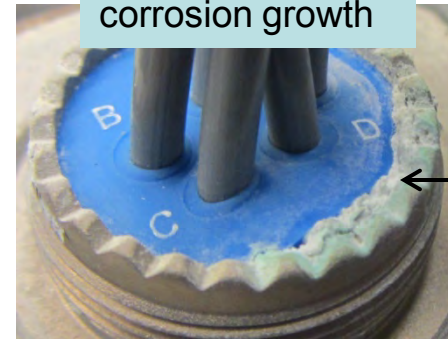
ENEN-2-AL

Buckled sealing grommet due to corrosion growth

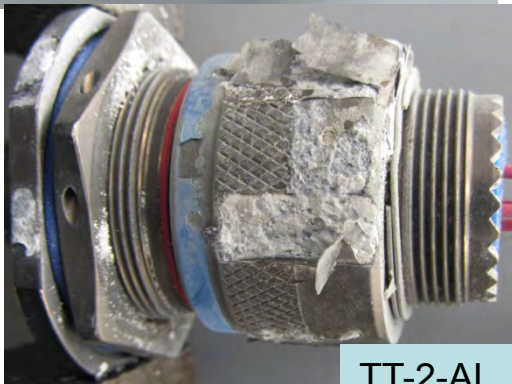
TT-2-AL

Buckled sealing grommet of connector caused by corrosion growth on inner surface

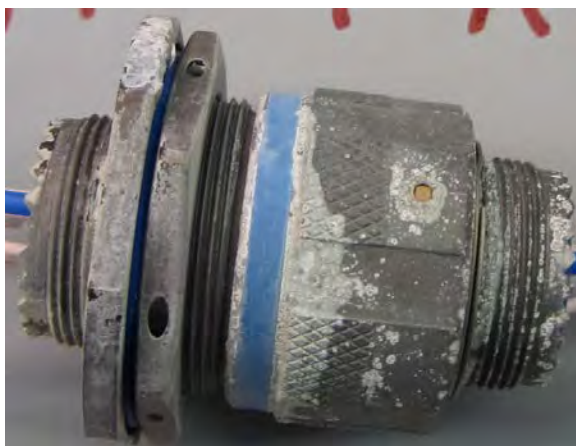
WT-4-AL, Class T on Al to Cad

- Class T Ni-PTFE to Cad:
 - Largest 'wave' of sacrificial Cad corrosion on plug shown below

Higher Cad corrosion rate – discoloration on plug

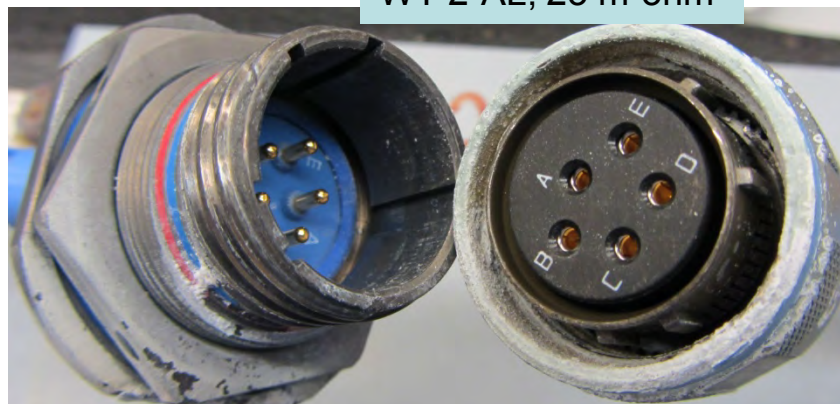
WT-2-AL, 23 m-ohm

Resistance range 23-3100 m-ohm

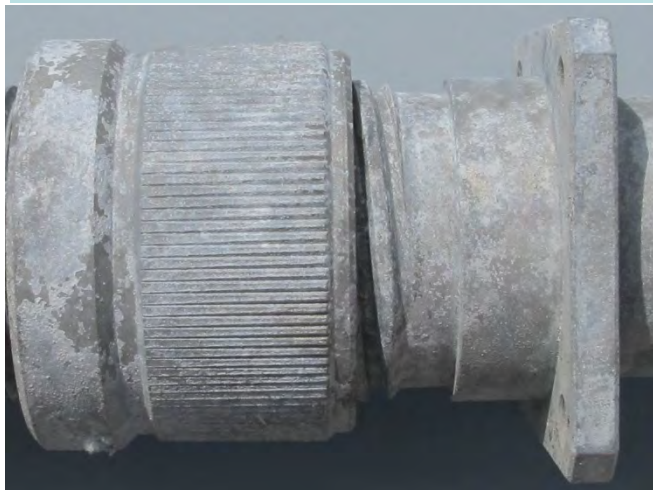
Tin-Zinc plating was applied to blank aluminum shell components

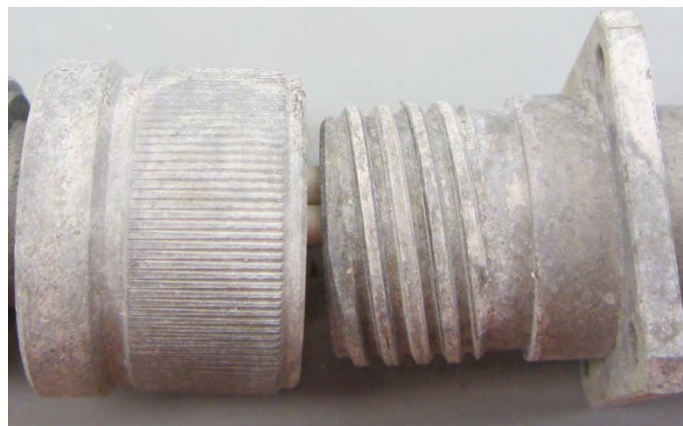
Resistance range 100-300 m-ohm –
not pinned -38999 connectors like
other plating systems
