**Missouri River Flood 2011  
Vulnerabilities Assessment Report  
Volume I: Summary**

**Northwestern Division  
US Army Corps of Engineers**

**October 2012**

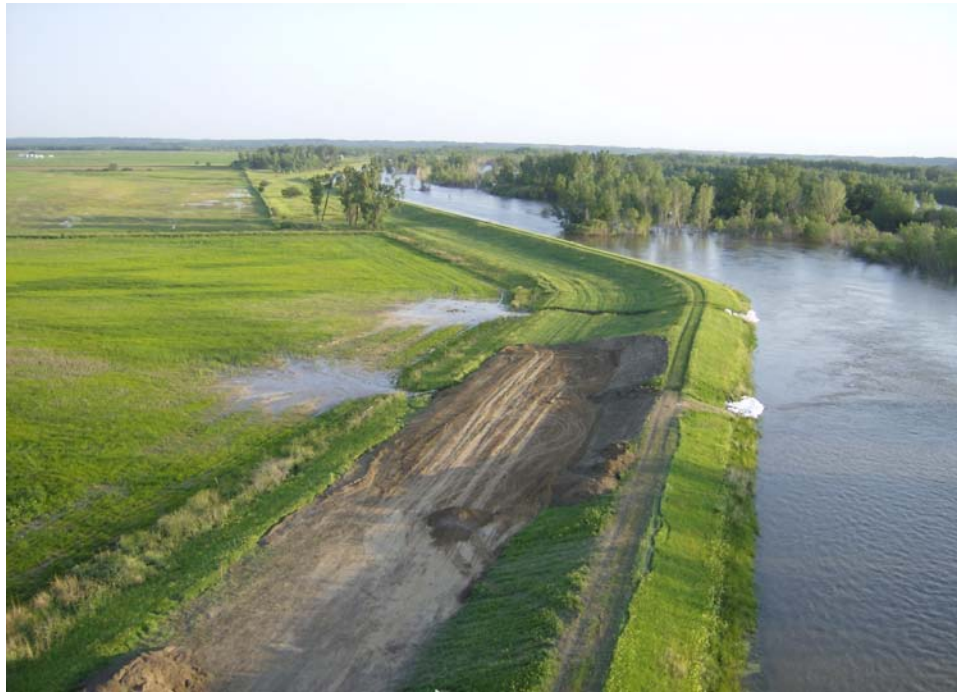
Levees are typically designed and constructed to withstand water loading for a few days or weeks during a year. The 2011 flood subjected the Missouri River levees to months of loading, well beyond the envisioned flood duration. All told, the event caused moderate to extensive damage to roughly 75 federal levees (and many more non-federal levees) within the basin due to overtopping, erosion, and underseepage. (Figure 5) Significant efforts to assess and repair are on-going under the authorities of the Public Law (PL) 84-99 program<sup>1</sup>.

**Figure 5. The levees along the Missouri River were subjected to prolonged water loading. Consequently, many suffered from erosion and underseepage, necessitating extensive repairs. (Photo taken June 2011 of levee L575 near Hamburg, Iowa.)**
