| SIO Shipyard Representative Bi-Weekly Progress Report | | |
| <b>Project: AGOR 28</b> | <b>Contract No.: N00014-12-C-0305</b> | <b>Shipyard: Dakota Creek Industries</b> |
| <b>Distribution Statement A:</b> Approved for public release; distribution unlimited. | | <b>Report No. A002.033</b> |

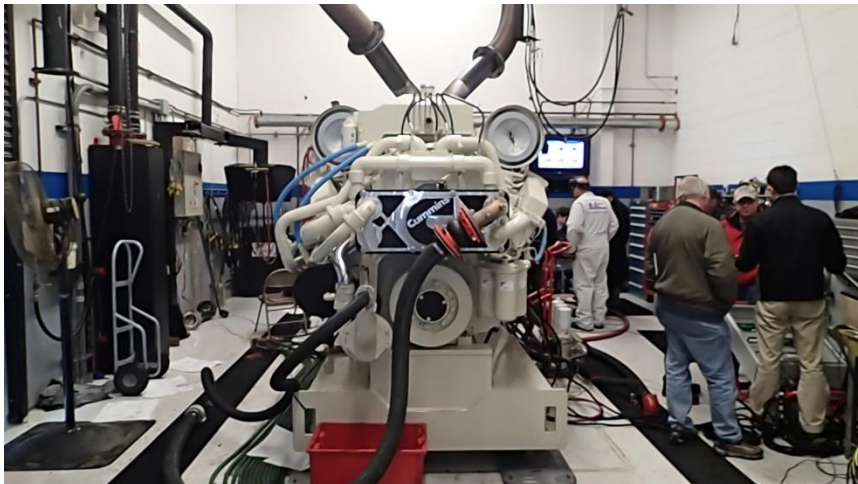
Neil Armstrong Forward Mounts:

- ✓ The Genset mounting arrangement had a significant change from how Neil Armstrong Genset's forward mounts were attached to the test bed from those of Sally Ride. For Neil Armstrong, the forward mounting feet extend beyond the isolated slab. For the Sally Ride, all the mounting feet are within the isolated slab boundary. The boundary is the light gray outline. Other photo's, while not as clear, indicate that this was not an issue with the aft mounts (generator end) for either vessel.

- ✓ At this time it is not known what affect this will have on the noise and vibration readings. There were some anomalies on the sole set of readings taken for Neil Armstrong, so differences are to be expected.
