| SIO Shipyard Representative Bi-Weekly Progress Report | | |
| <b>Project: AGOR 28</b> | <b>Contract No.: N00014-12-C-0305</b> | <b>Shipyard: Dakota Creek Industries</b> |
| <b>Distribution Statement A:</b> Approved for public release; distribution unlimited. | | <b>Report No. A002.037</b> |

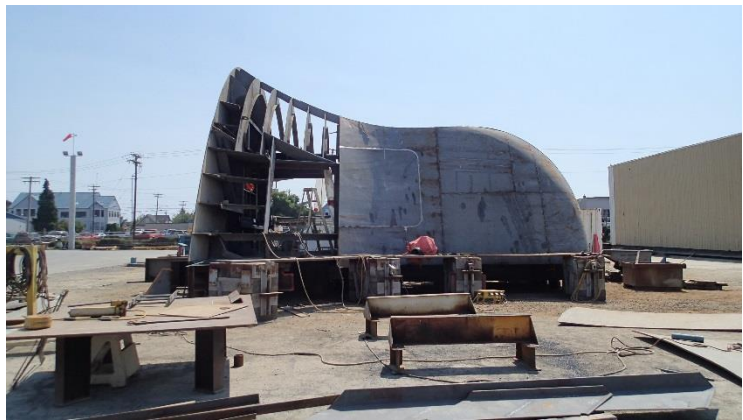
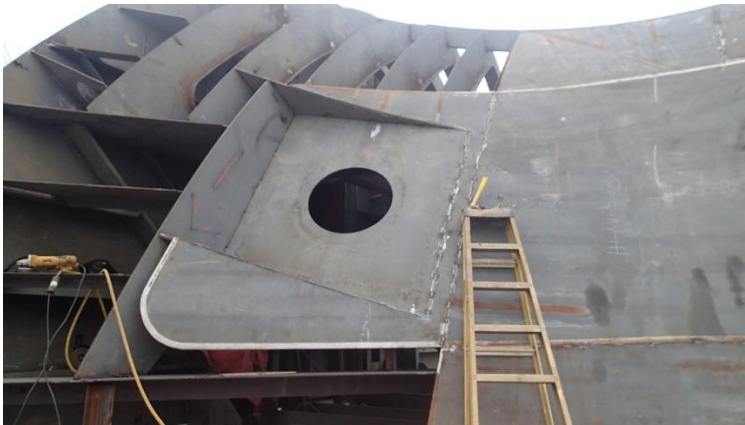
- VRS Buy-list – The buy-list has been delayed because it exceeded 1-million dollars for both ship sets and must now undergo an additional review at Bath. There is a minor risk that some of the vendor quotes will expire before this review can be completed. The ACO review board at Bath is expected to meet Tuesday or Wednesday of next week.
- Pilot House Console Face Arrangements – Rev. F was released for review and approved by the operators.
- Ship Stores Refrigeration – Operators are waiting for revised diagrams and calculations from DCI and the vendor. No other information has been provided for this reporting period.
- Sally Ride Mod 1 Stem – Fabrication of the forward bow sub-assembly continues with anchor pocket fabrication.

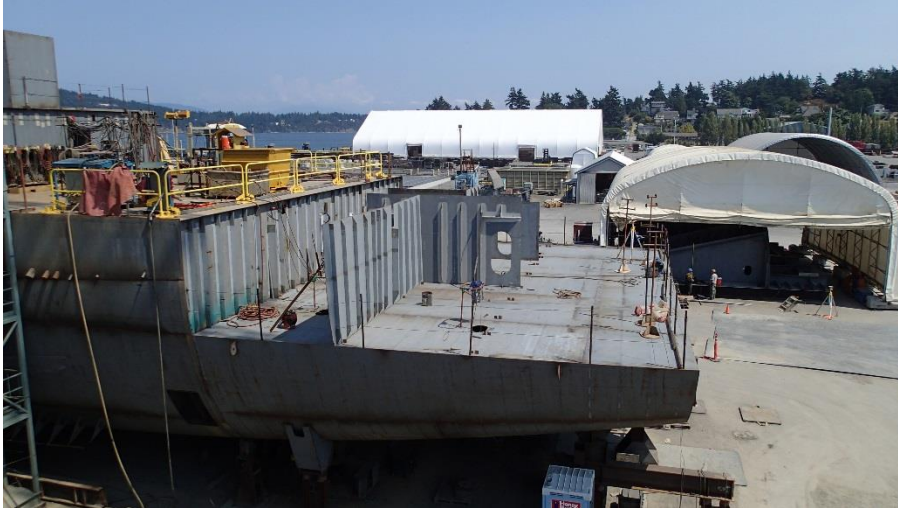
*Sally Ride Mod 5 1<sup>st</sup> Platform Deck*

- Sally Ride Mod 5 – Aft Science and Engine Room Stores bulkheads landed.

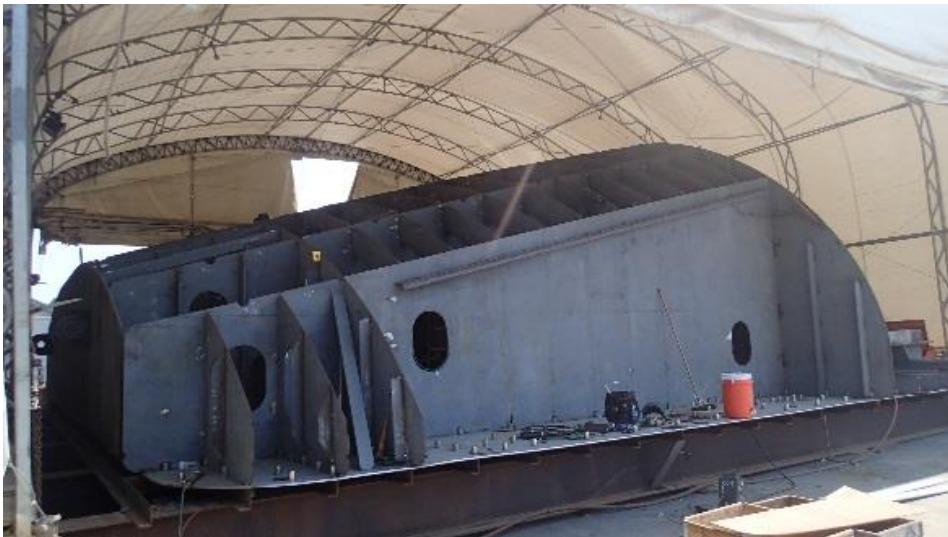
- Sally Ride Mod Stern Section Progress

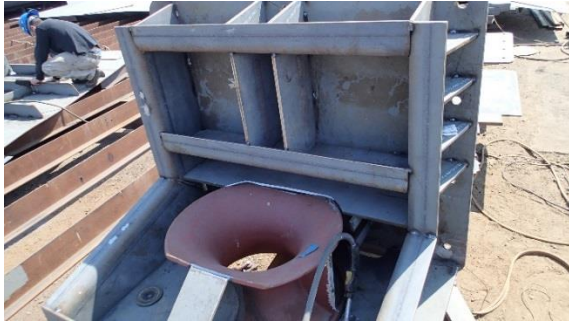
- Portable Panama Chocks – Robust to say the least.

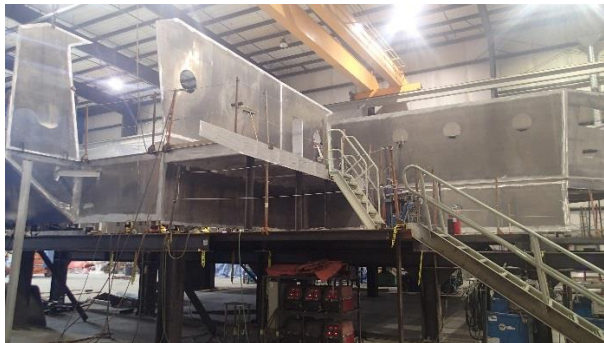
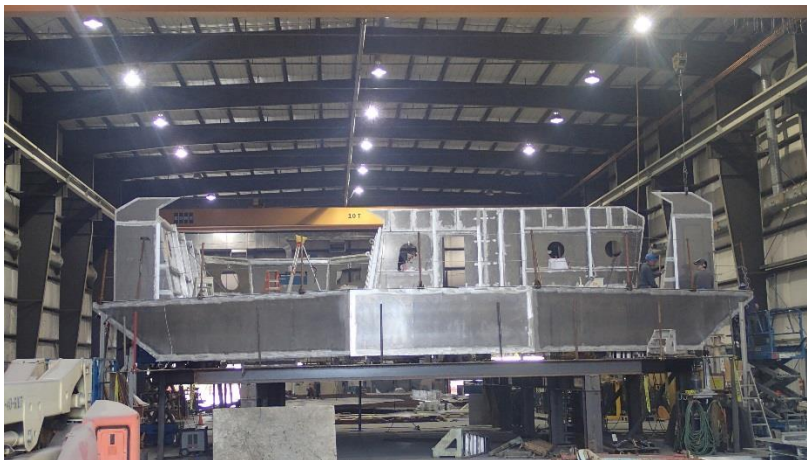
- Sally Ride Pilot House – With the departure of Armstrong's pilot house, work begins in earnest on Sally Ride's. A large amount of prefabricated panels are stacked and ready for installation.

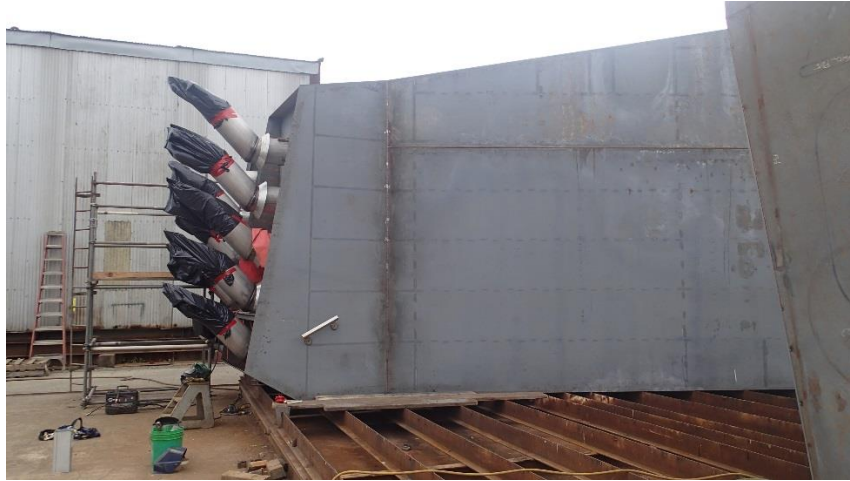
- Sally Ride Stacks – DCI is installing the exhaust piping while the stack is in the horizontal on its erection stand.

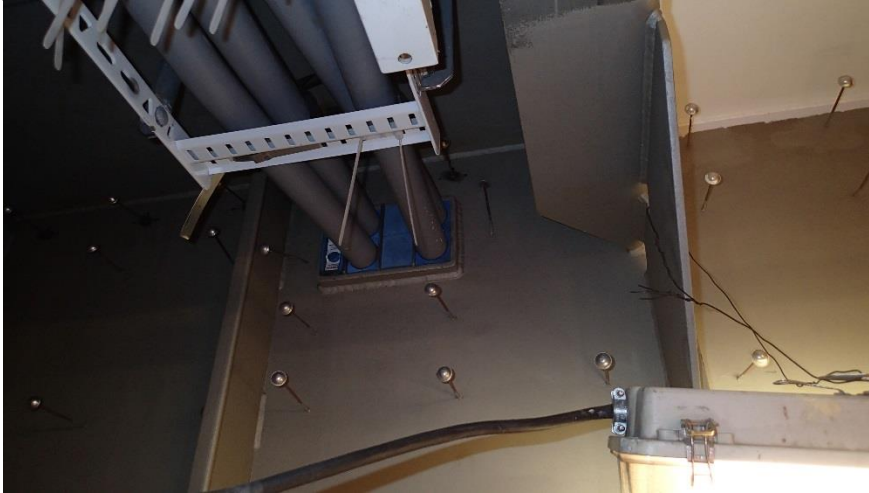
- Neil Armstrong – Observing the running of cables between the switchboards and generator sets with interest. In particular how the cables are passed through the transits and cable trays. At this juncture there are no issues with the work.
