Navigation Systems Research Program

Underwater Inspection of Navigation Structures with an Acoustic Camera

Final report

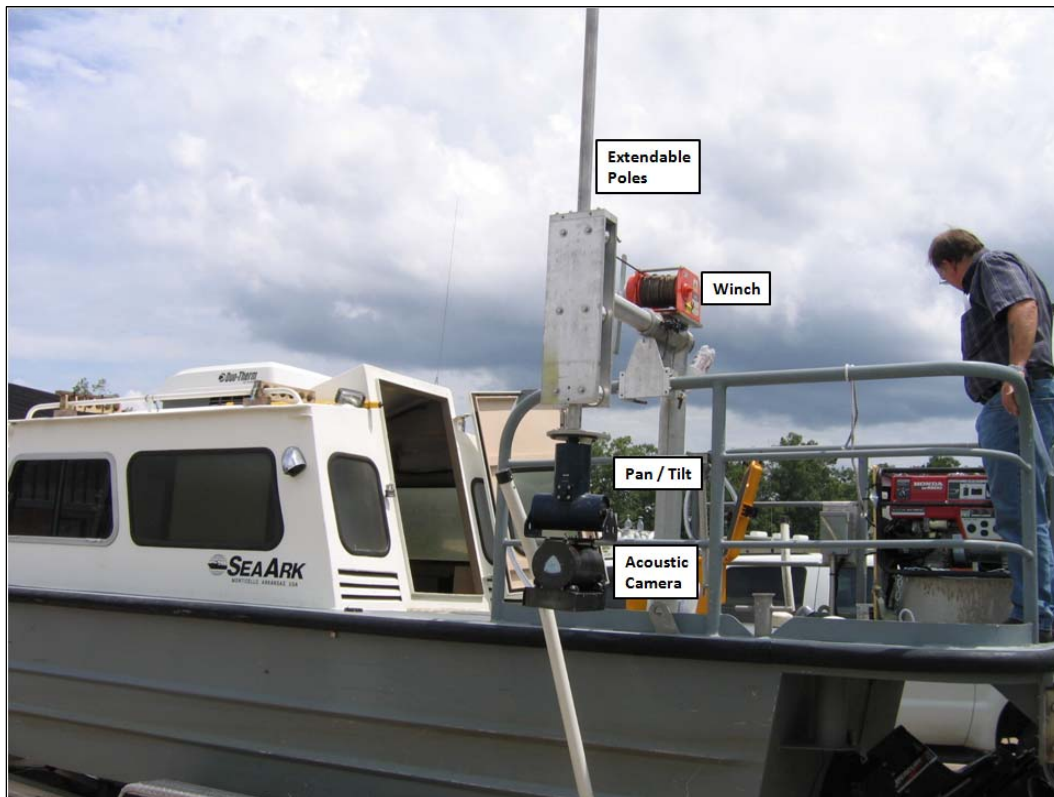
Figure 1-2. Acoustic camera mounted on a survey boat.

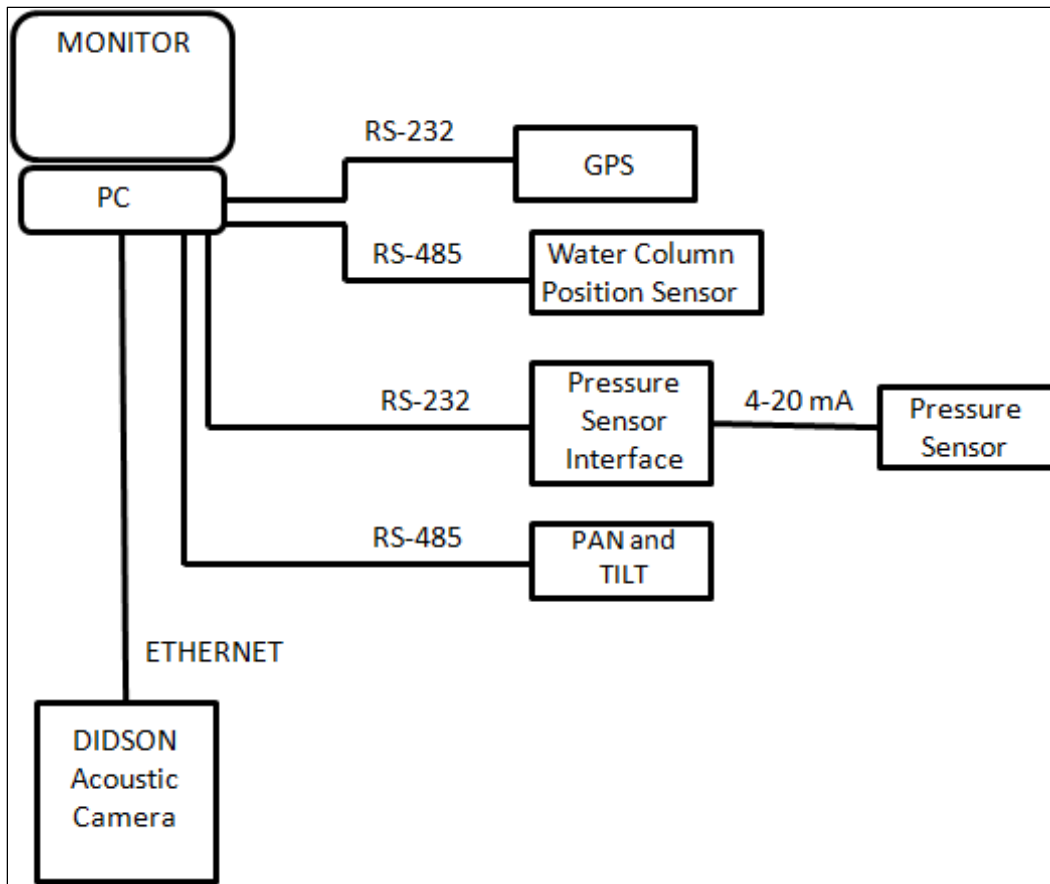
Figure 1-3. Block diagram of boat-mounted acoustic camera system.

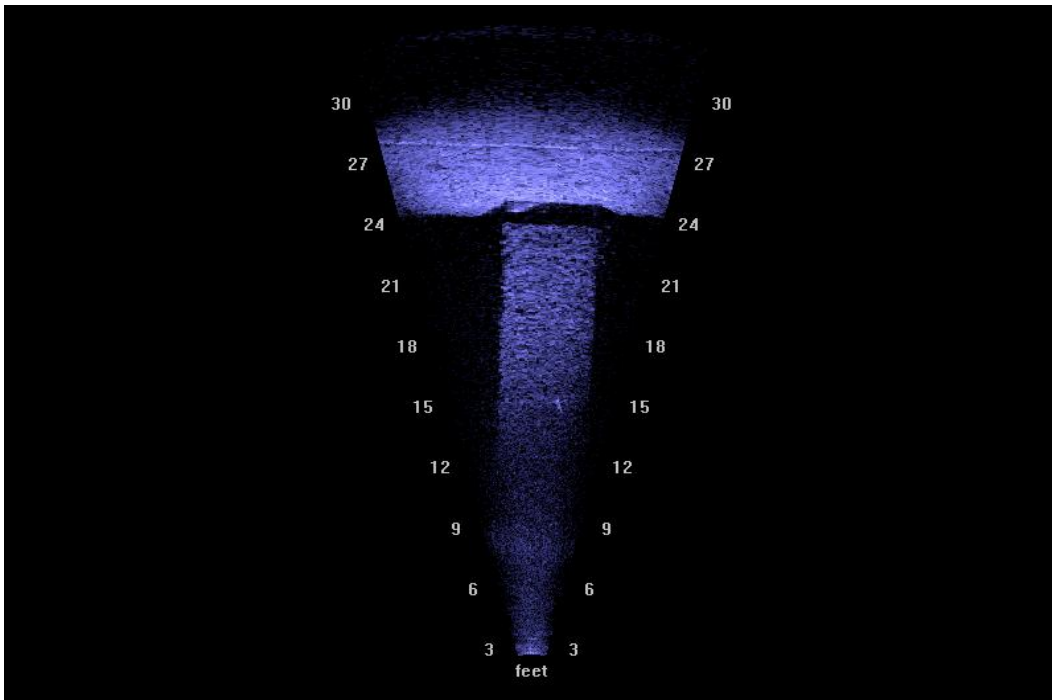
Figure 2-1. Sample acoustic camera image of the stilling basin end sill and riverside lock wall at Lock and Dam 9 on the Arkansas River.

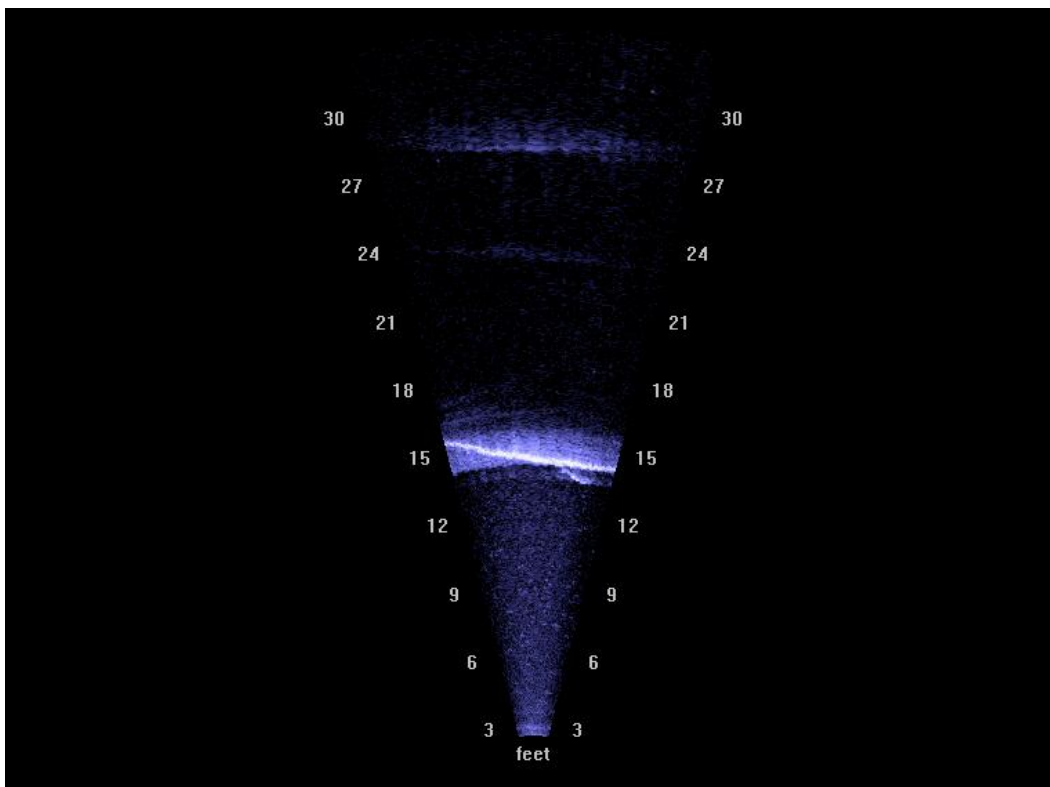
Figure 2-4. Acoustic camera image obtained with a 90° grazing angle.

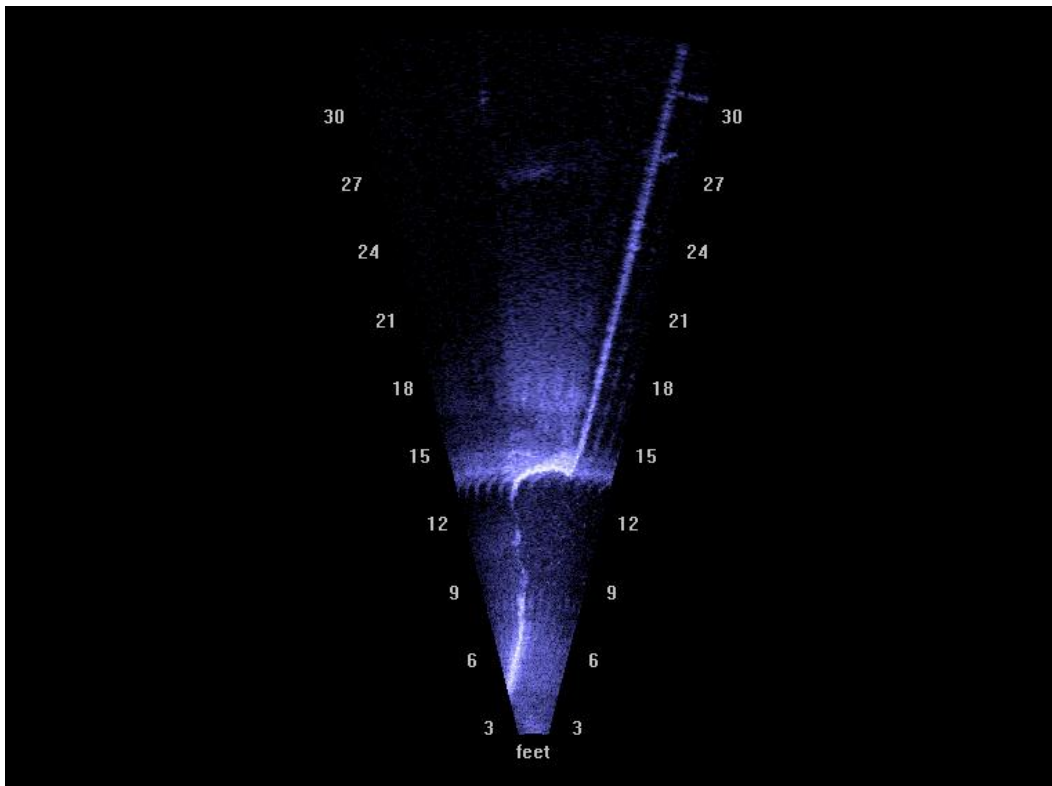
Figure 2-5. Acoustic camera image of a lock wall scour hole outline obtained with a 90° grazing angle.

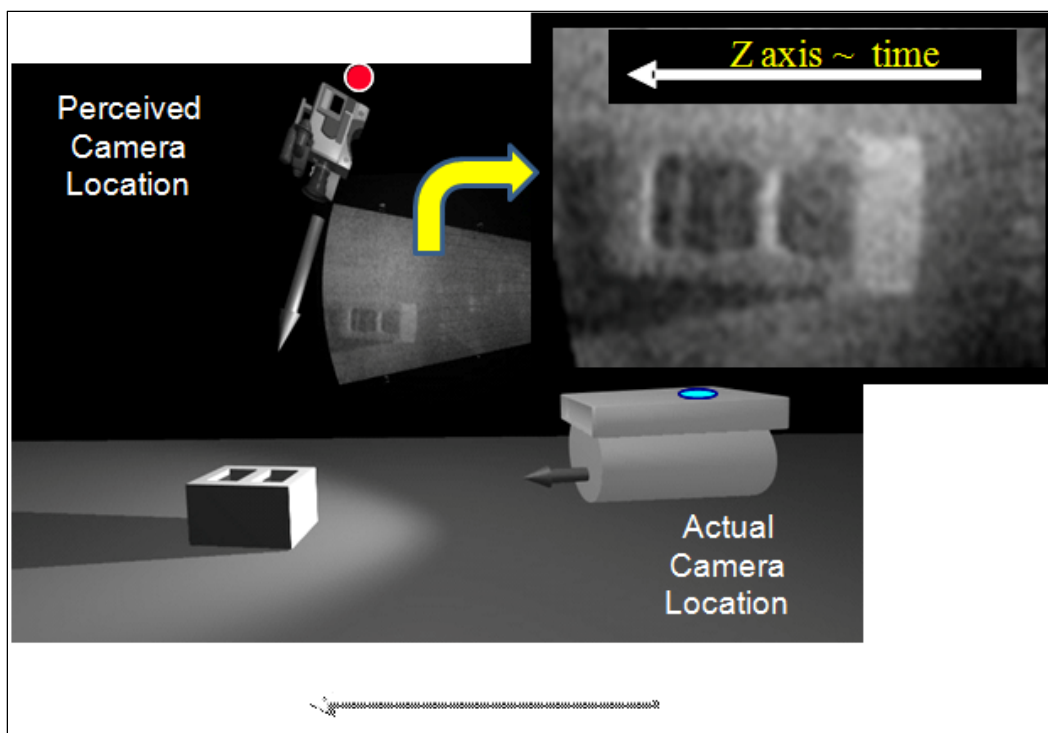
Figure 2-6 shows how the DIDSON's output has a perspective shift. This shift is due to the depth, or z-axis, actually being time. The image above shows that, when the DIDSON is near the floor, looking at the cinder block, the output appears as if someone is looking down on the cinder block.

Figure 2-6. Acoustic camera output perspectives.

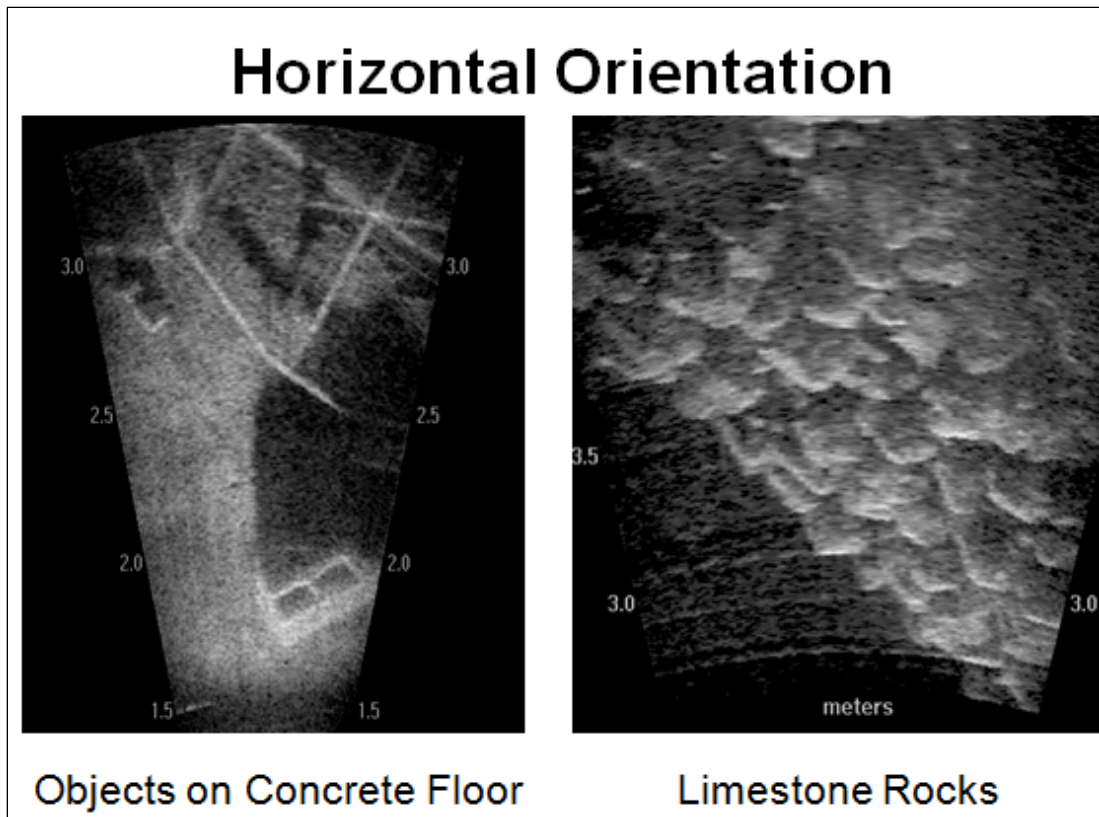
Figure 2-8. Horizontal and vertical surfaces imaged by the DIDSON.

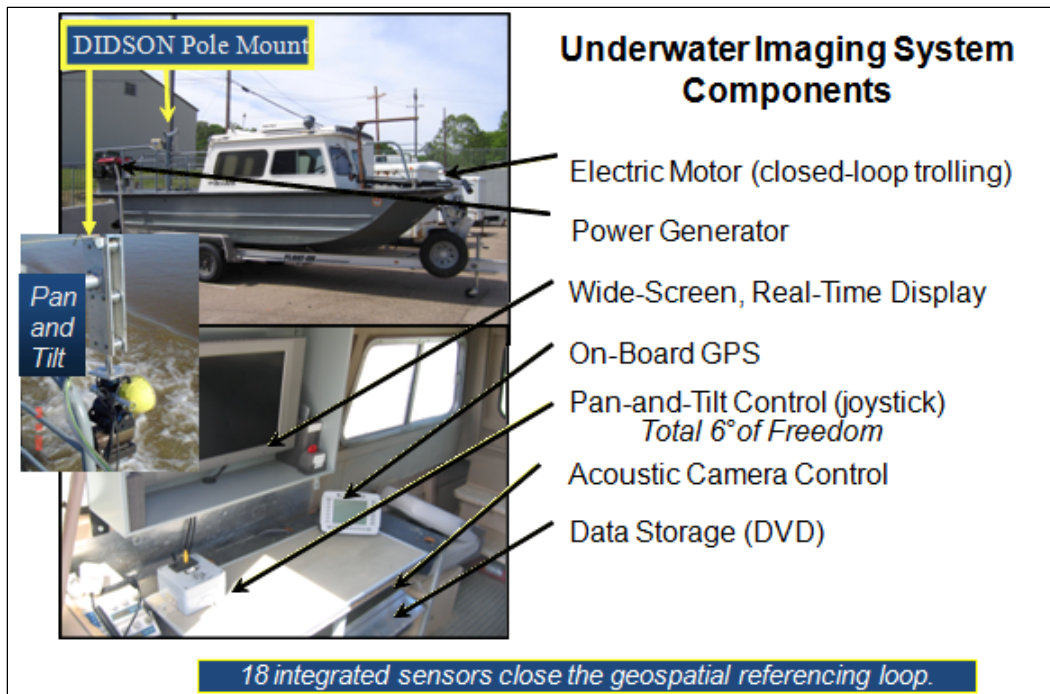
Figure 3-2. Boat with pole-mount deployment system.

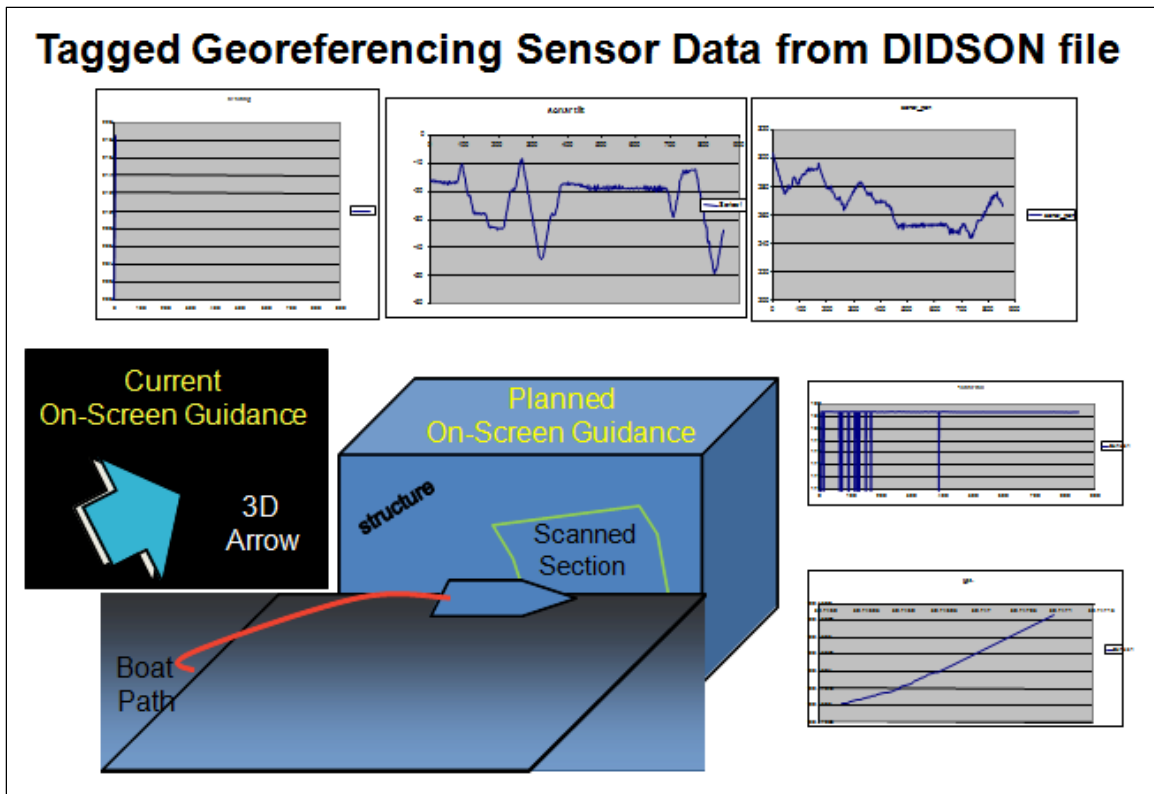
Figure 3-3. Typical measurements provided by the acoustic camera system sensors.

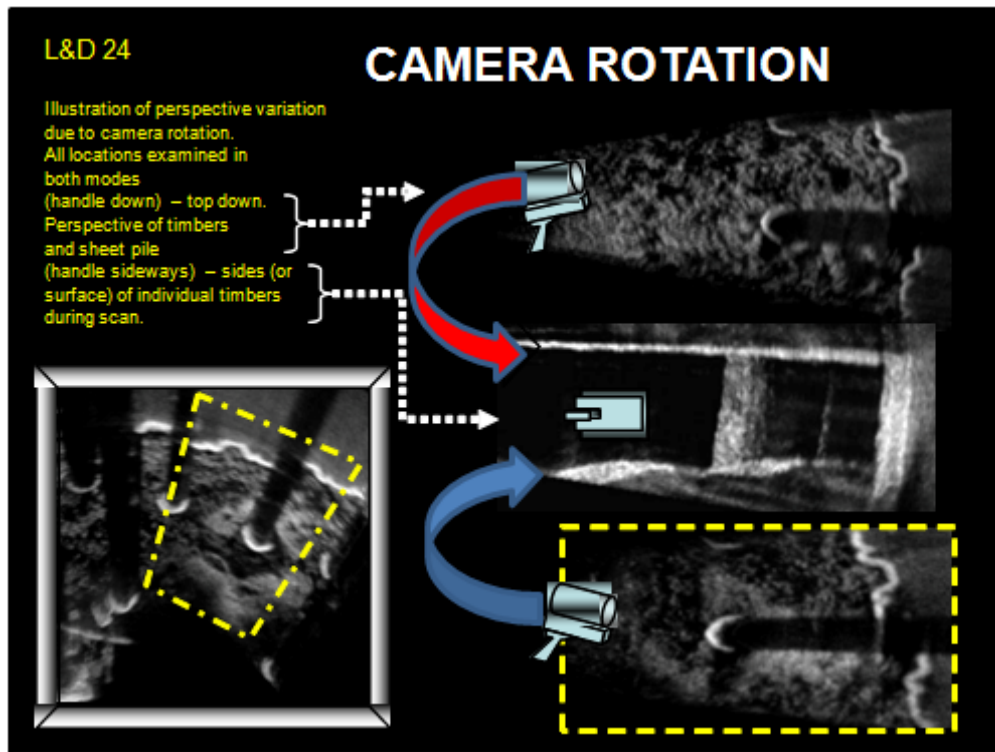
Since then, heads-up display capabilities have been pursued and accomplished with some success. The barge lift gate shown in Figure 3-5 was the result of a deployment in which the only means of access was a qualified diver.

Figure 3-5. Images of a barge lift gate at Lock and Dam 24 on the Mississippi River.

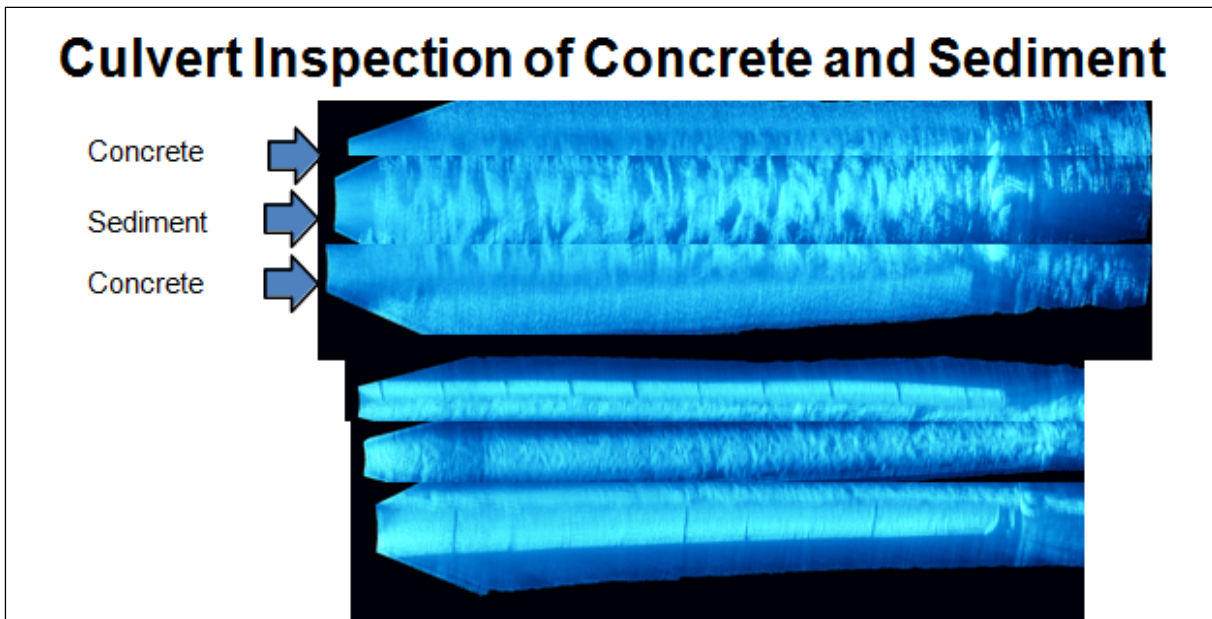
Figure 3-7. Resultant mosaic images from culvert inspections.

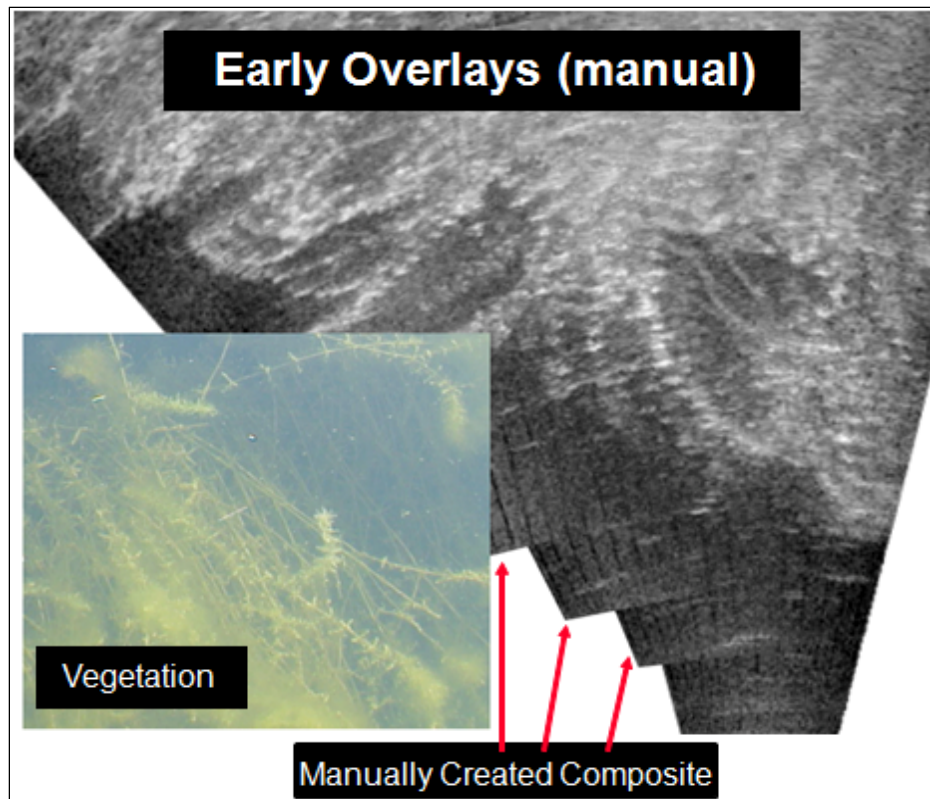
Figure 3-8. Manually created mosaic image.

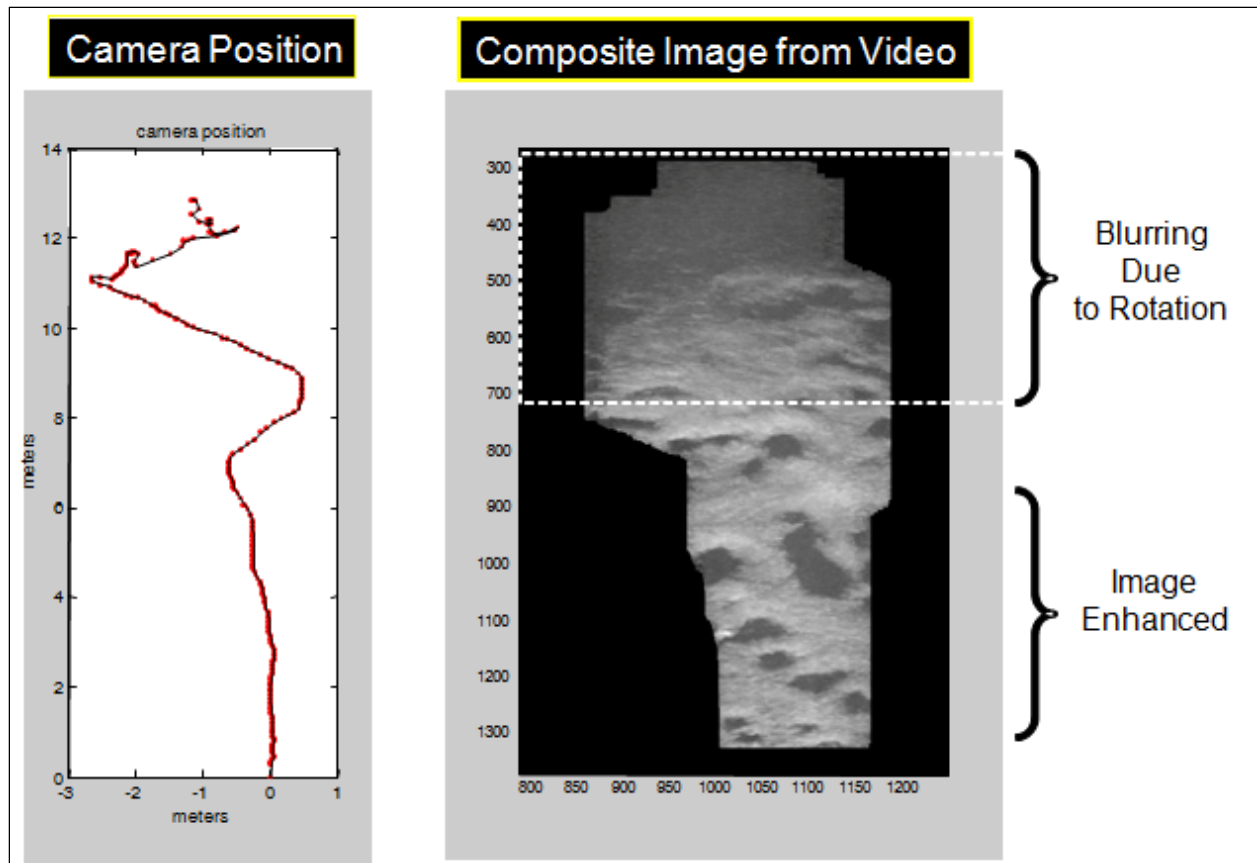
Figure 3-9. Mosaic generated using a least mean square search.

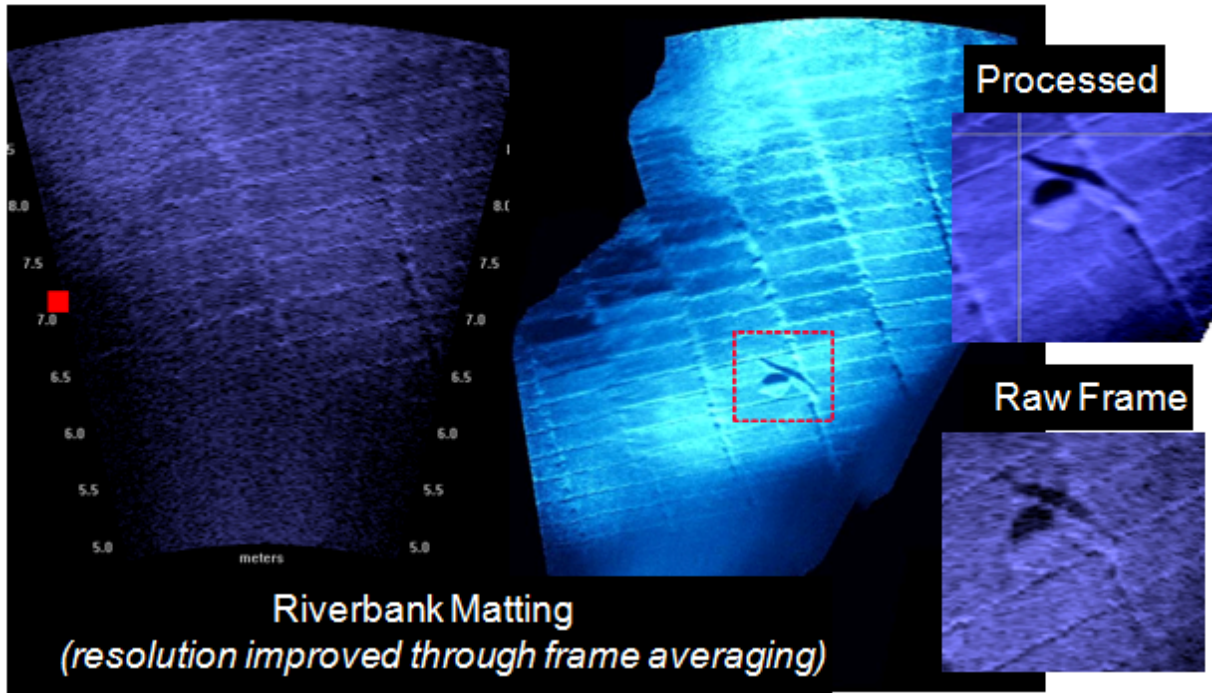
Figure 3-10. Image enhanced using the SIFT algorithm.

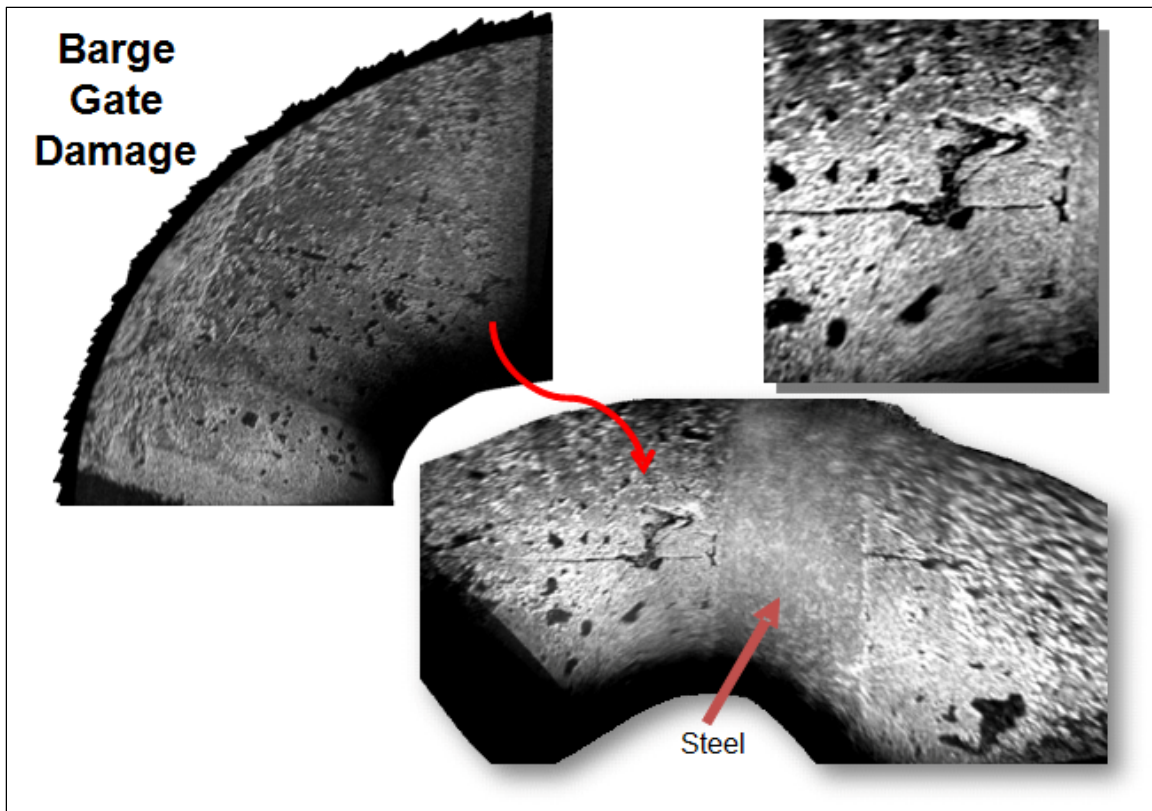
Figure 3-11. Images of the bottom of a concrete barge gate.

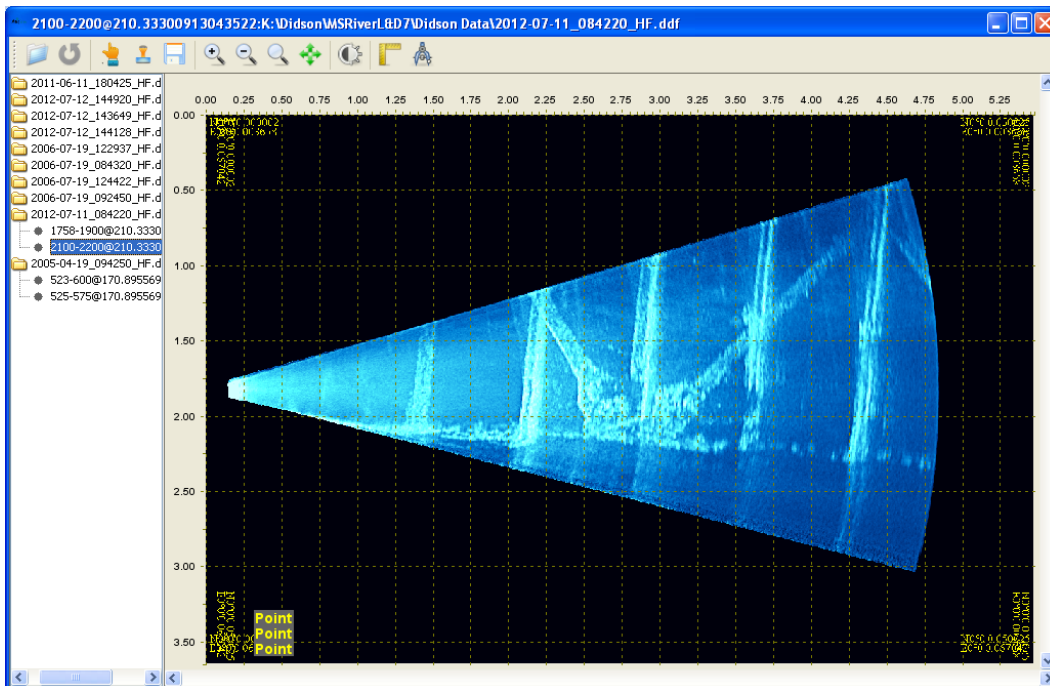
Figure 3-12. ClearSight user interface window.

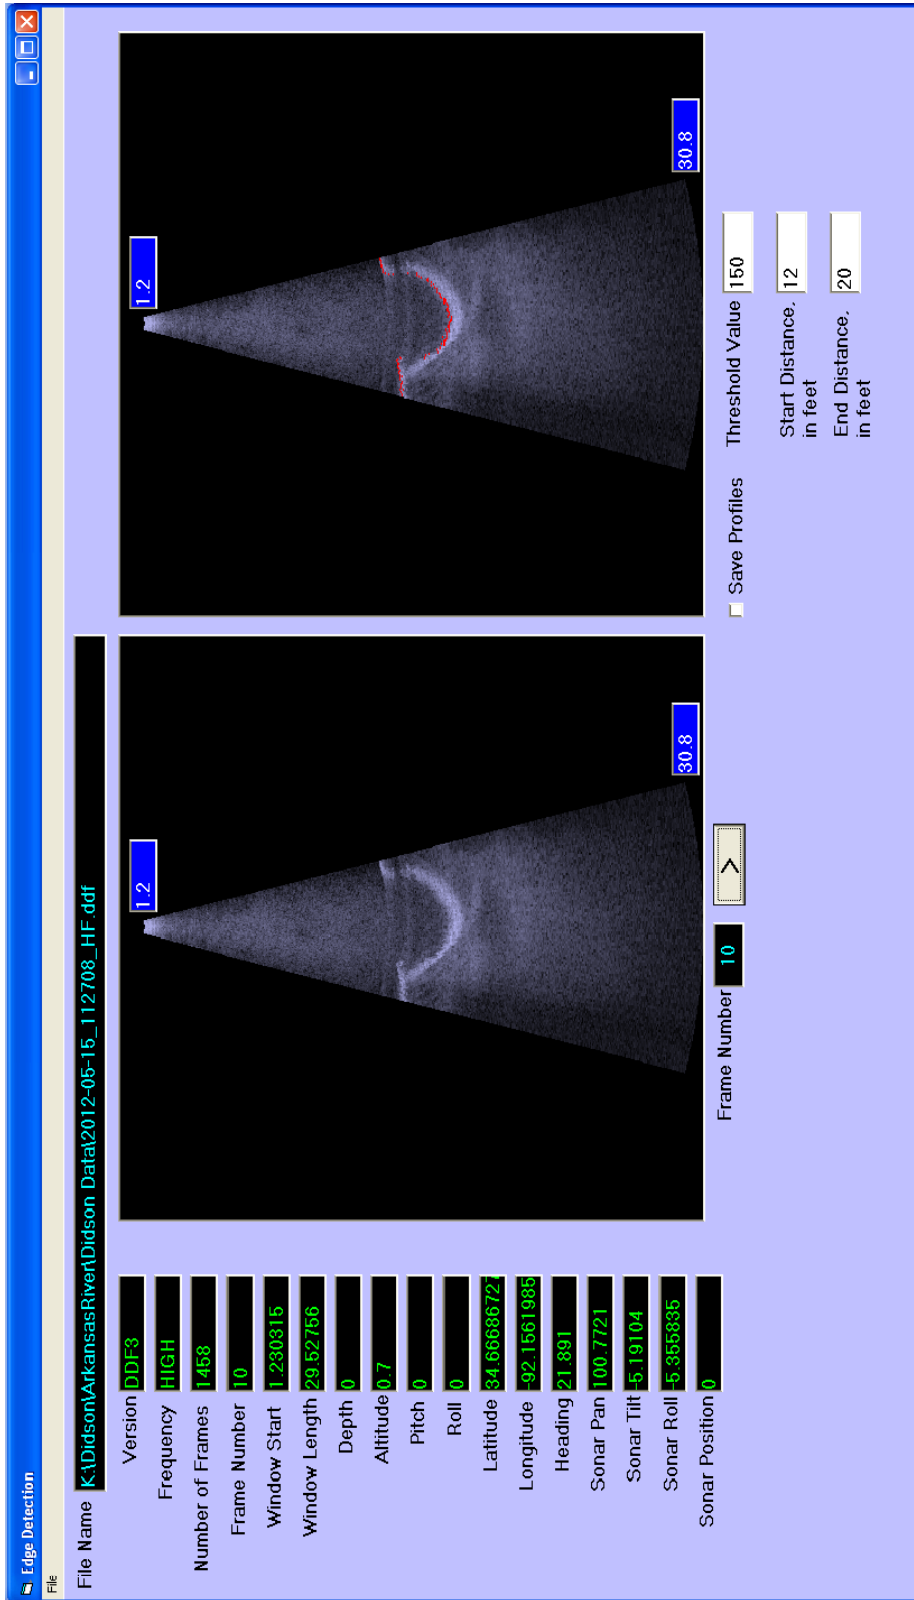
Figure 3-13. EdgeDetect window.

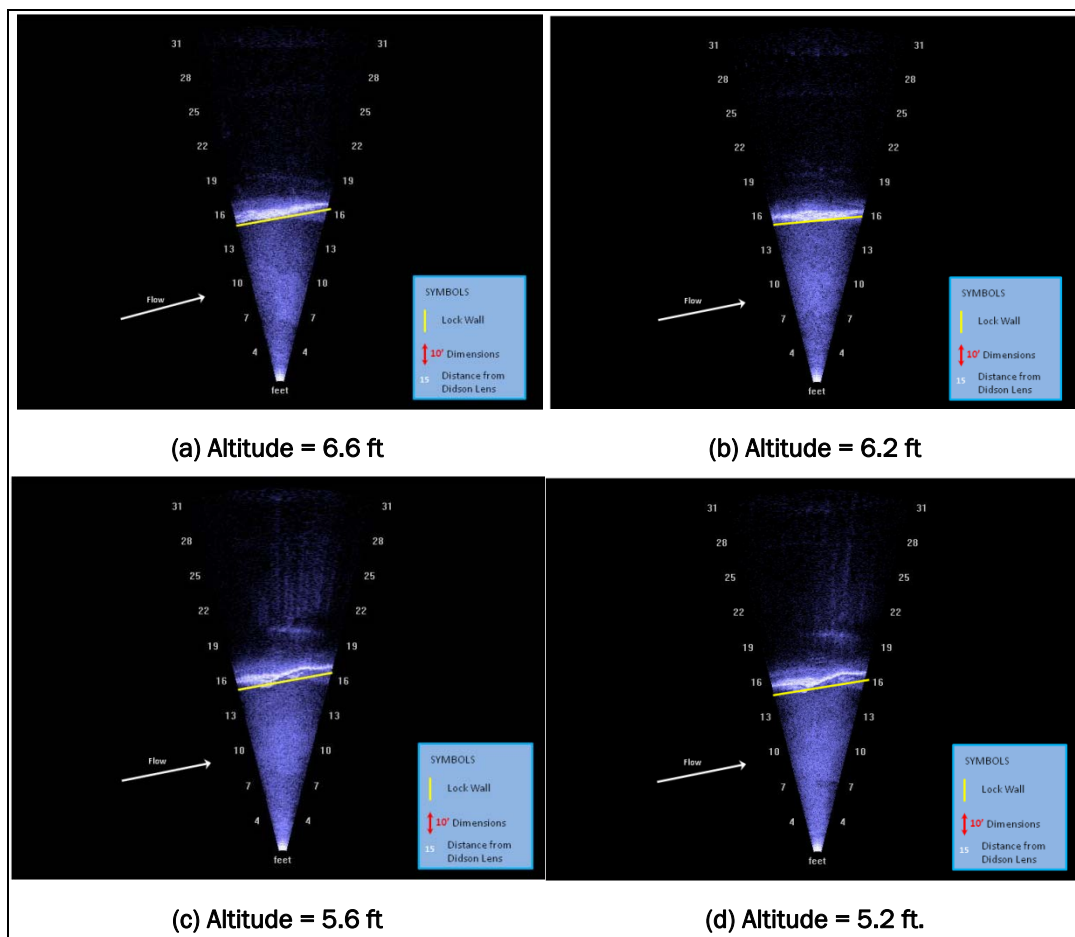
The EdgeDetect program generated a set of contours using the images in Figure 4-1. The contour points were loaded into MATLAB, and a surface was generated (Figure 4.2).

Figure 4-1. Lock and Dam 6 on the Arkansas River. (continued)

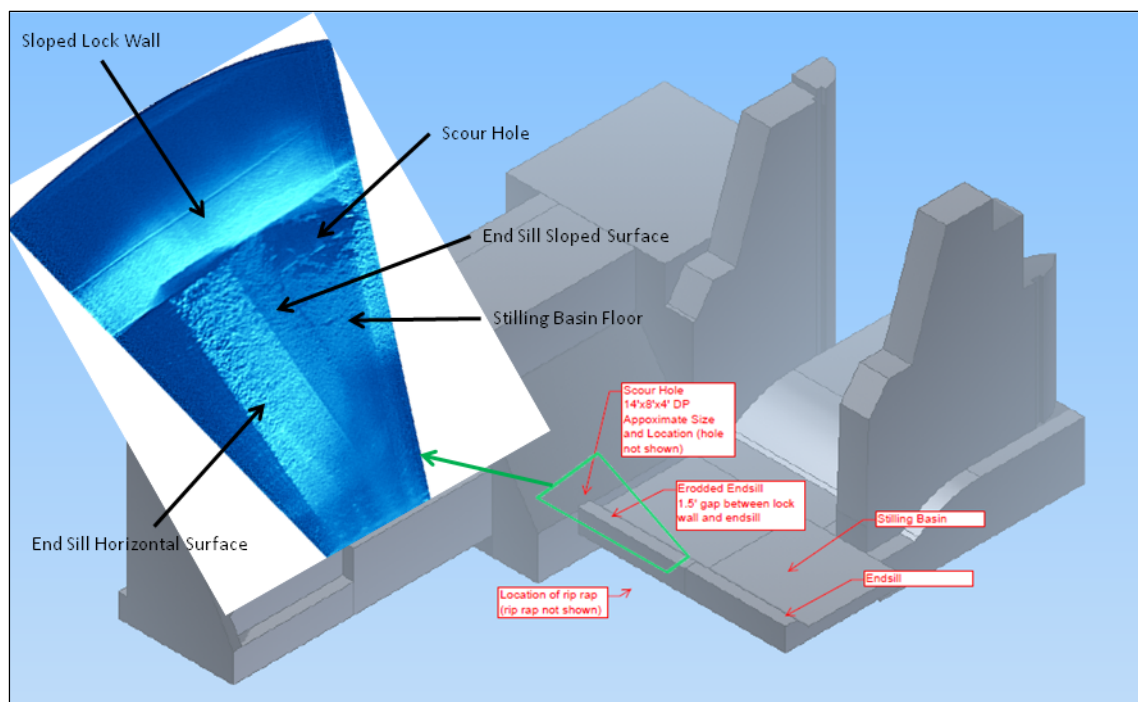
The size of the scour hole (maximum depth, width, and length) was determined by reorienting the acoustic camera so the outlines of the hole could be observed.

Figure 4-3. Mosaic image of the scour hole at Lock and Dam 9 on the Arkansas River.

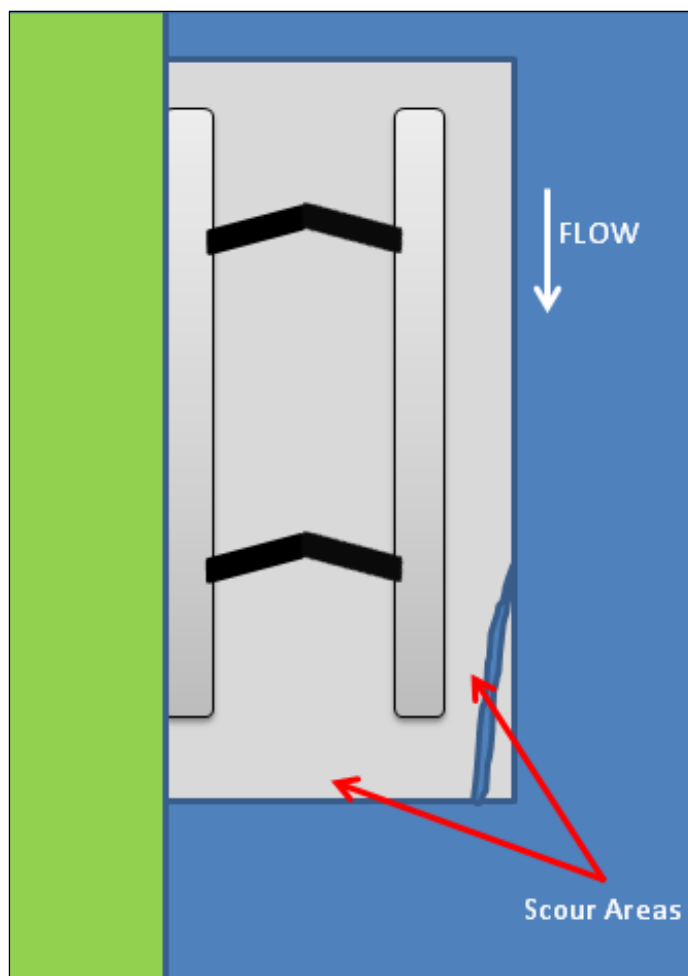
At this lock and dam near Winfield, Missouri, scour had developed under the downstream riverside lock wall. The scour was so vast that a large section of concrete that normally rests on the riverbed had broken, and the void continued well under the remaining lock wall. Figure 4-4 provides a not-to-scale plan view representation of the lock, and shows the location of the broken concrete section. Dive crews had probed beneath the lock wall with poles as long as 10 ft, according to verbal reports, and had not been able to locate the end of the scour hole. For safety purposes, divers were not permitted to go under the lock wall and into the scour area. It also was known that there was a smaller scour area under the lock floor concrete at the downstream end of the lock. Figure 4-4 shows an indication of the scour locations.

Figure 4-4. Lock and Dam 25 on the Mississippi River and areas damaged by scour.

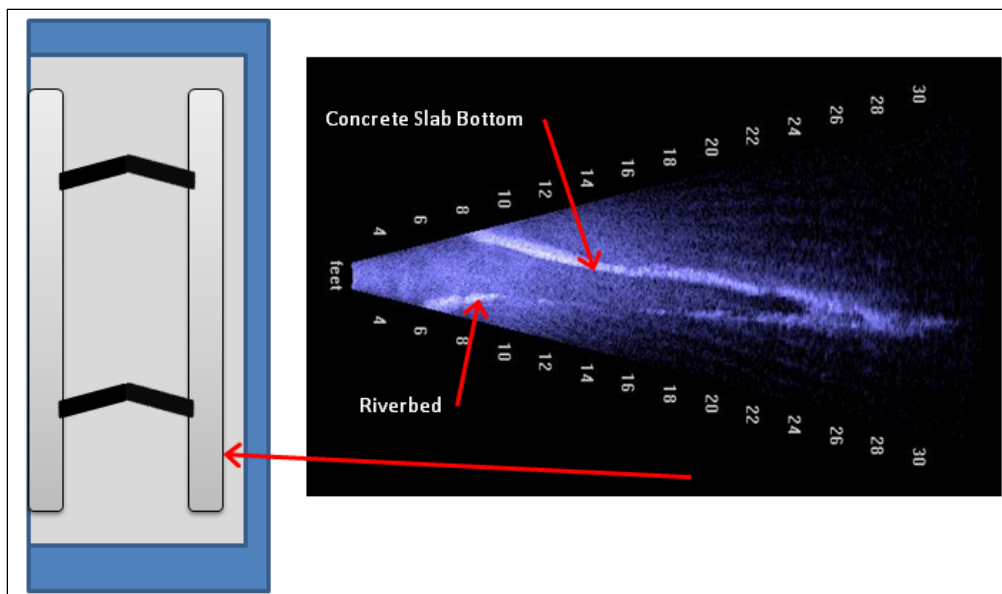
To measure the depth of the scour hole beneath the riverside of the lock wall, the diver positioned himself in the area between the intact lock floor slab and the section of broken concrete. By pointing the acoustic camera in a vertical orientation, the outlines of the underside of the lock floor slab and the riverbed could be obtained. The depth of the scour hole was determined by the distance to the intersection of the riverbed and the underside of the concrete slab. The result obtained was a depth of approximately 22 ft and a height of approximately 6 ft at the location indicated in Figure 4-5. These are the best estimates from the images obtained. More accuracy could have been obtained if the diver could have backed far enough away to get the vertical edge of the concrete slab in the image, but he couldn't because a portion of the broken slab was in the way.

Figure 4-5. Scour hole outline under the downstream riverside lock wall.

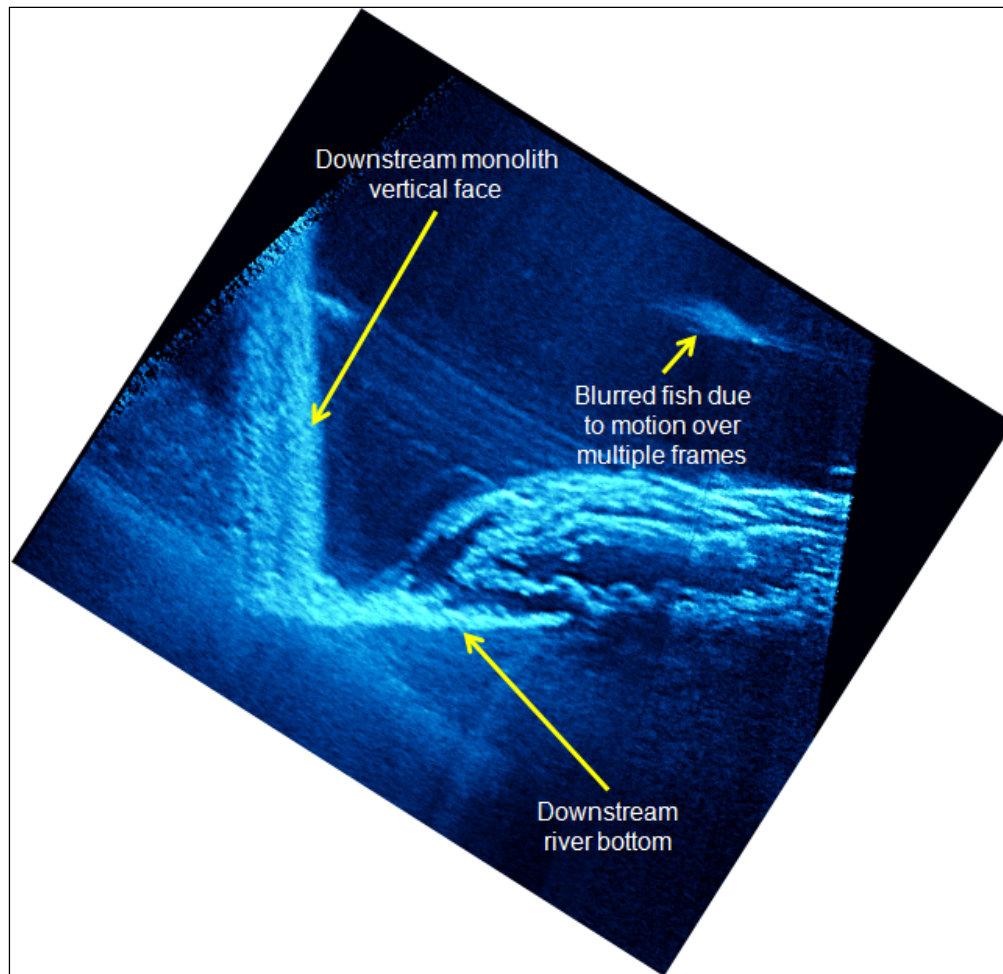
Depth soundings that had been taken at Starved Rock Lock and Dam near Ottawa, Illinois, indicated holes of sufficient depth to cause some concern. The holes were near the dam and raised the question of whether scour holes were developing under the structure. Acoustic camera scans along the downstream side of the dam monoliths revealed no scour beneath the dam. The vertical face of the monolith met the river bottom the length of the dam. The mosaic in Figure 4-7 is representative of the images viewed.

Figure 4-7. Starved Rock Lock and Dam, Illinois River, dam and river bottom intersection.

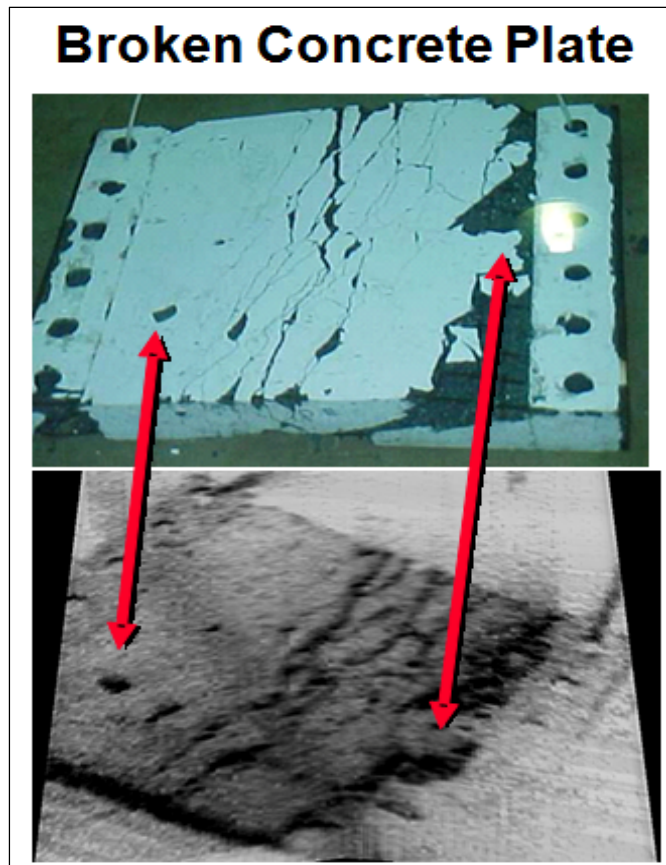
Figure 4-8 shows damaged concrete. The acoustic image (bottom) is a single-frame grab that has been high-process filtered and histogram equalized. The macroscopic cracks are of significant size to affect reflected acoustic energy from the plate's surface. When imaging cracked concrete, it is important to be aware of silt and biological materials that can coat the surface. Cleaning before scanning depends on age and environment.

Figure 4-8. Damaged concrete section.

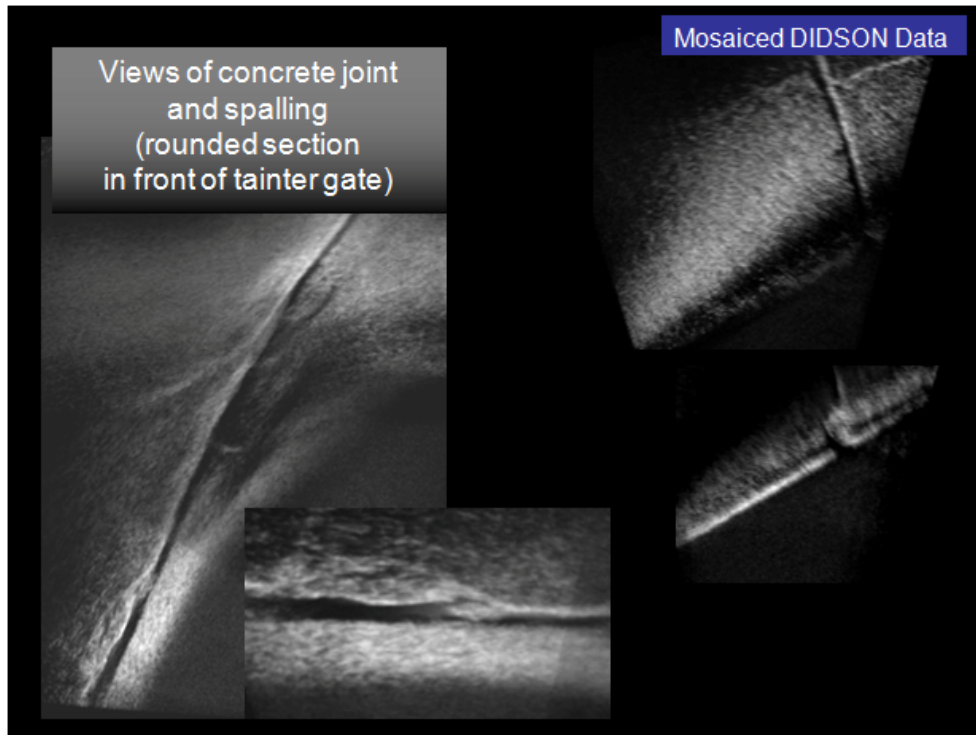
Figure 4-9 shows a large concrete joint between two curved monoliths. Small spalling is detected and shown in the insets. Current methods use edge detection to get objective volume maps. This image was collected from diver-based deployment; however, boat deployment also is feasible here.

Figure 4-9. Example of concrete structure imaging.

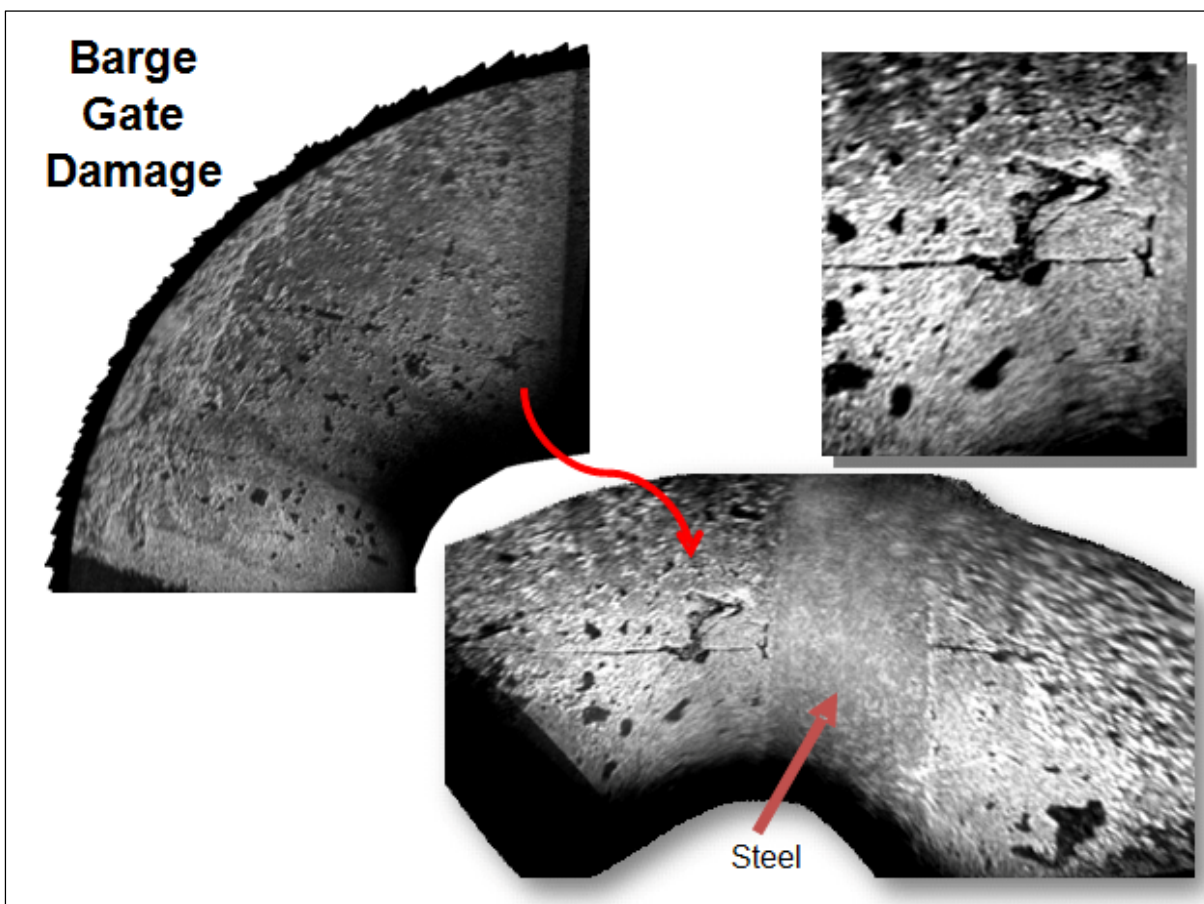
The New Orleans Barge Lift Gate's concrete floor was damaged when it was sunk on a piece of vertical scrap I-beam. Biological growth and silt were blown or wiped away, and the image was collected from diver-based

deployment. This deployment method was used due to accessibility of this section of the structure. The steel skid pad shows up due to its different acoustic impedance. This is shown in the bottom image of Figure 4-10.

Figure 4-10. Damaged section of the underside of a concrete barge gate in New Orleans.
