Navigation Systems Research Program

Underwater Inspection of Navigation Structures with an Acoustic Camera

Final report

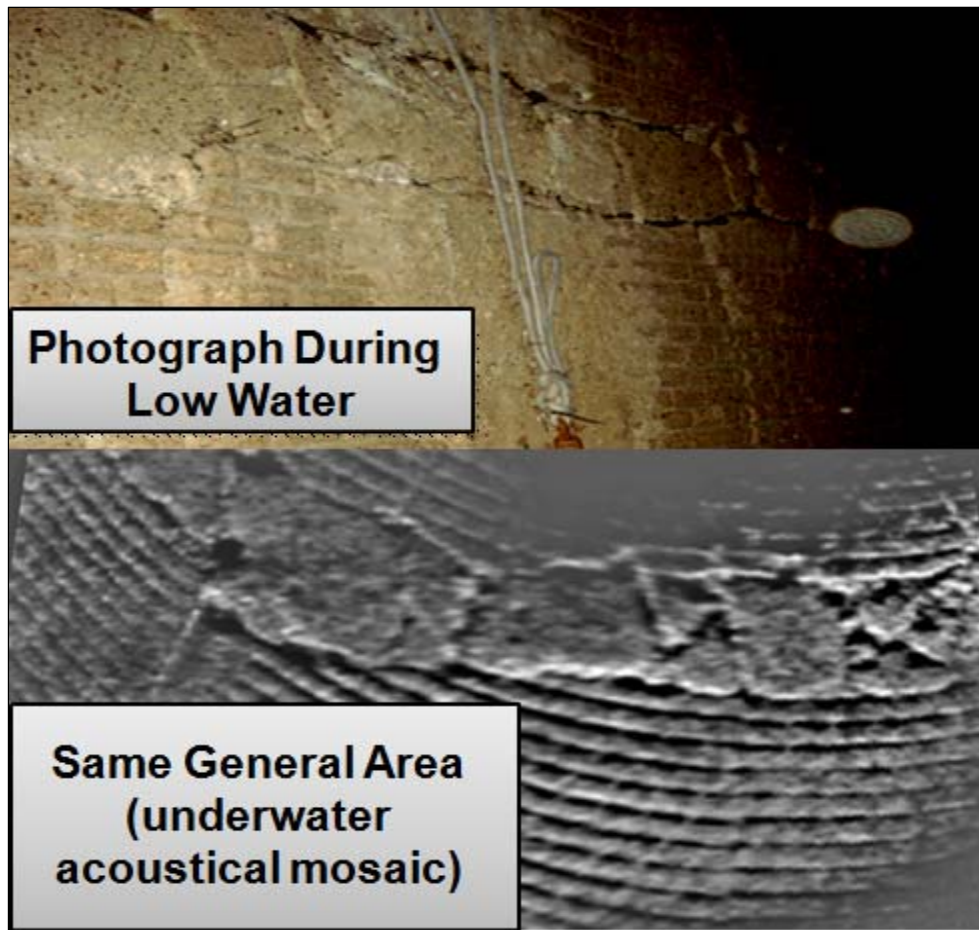
The photo in Figure 4-11 of the damaged stamped concrete at the river landing in downtown Vicksburg, Mississippi, was taken during low water. During high water the broken areas were rescanned with the underwater acoustic camera, and a mosaic was created. The large damage at this scale appears clearly captured in the mosaic output. Distance from the camera to the targets was 15 to 30 ft.

Figure 4-11. Masonry wall comparison of visible image and acoustical image, downtown landing, Mississippi River, Vicksburg.

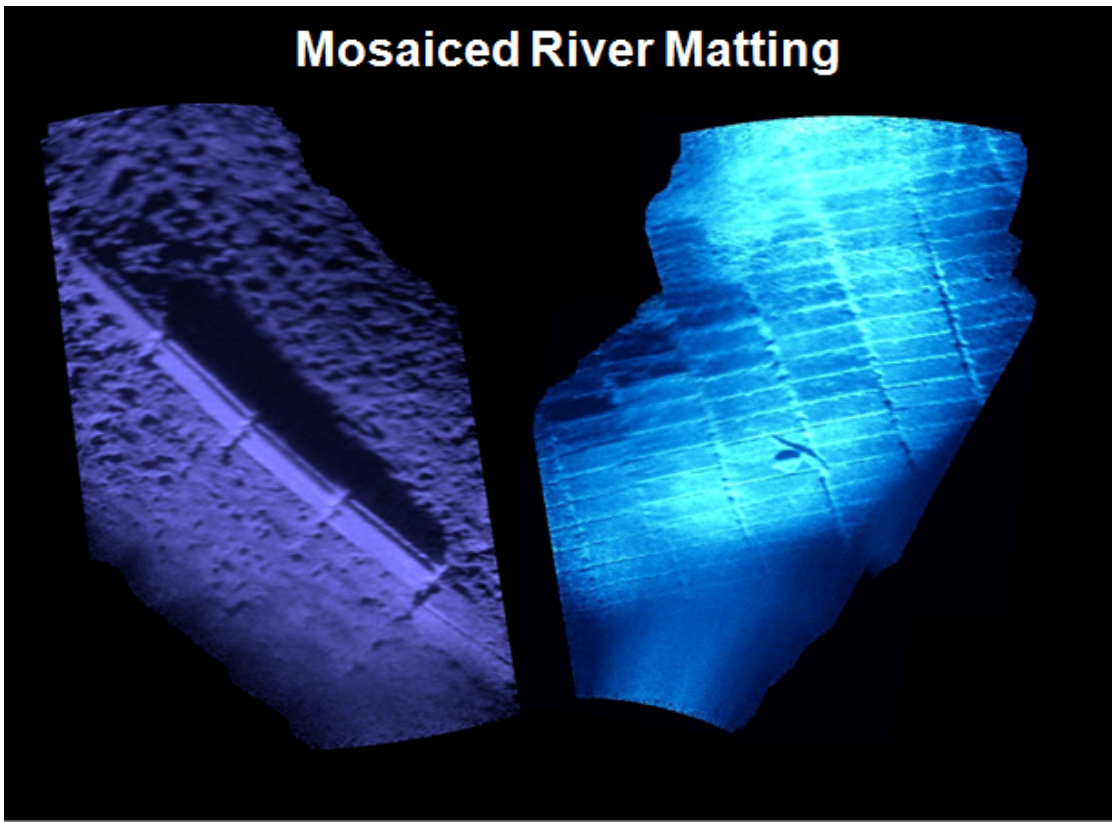
Matting for erosion protection has been placed along large sections of the Mississippi River. These are shown in several scales in Figure 4-12. The image on the left shows edge penetration for the sediment on the river bottom. The image on the right is a large mosaic. For scale, the mats are 4 ft long and 1.5 ft wide. Performance issues with repetitive patterns and low-contrast surface were addressed in early automated mosaic software efforts.

Figure 4-12. Mosaics of river matting.

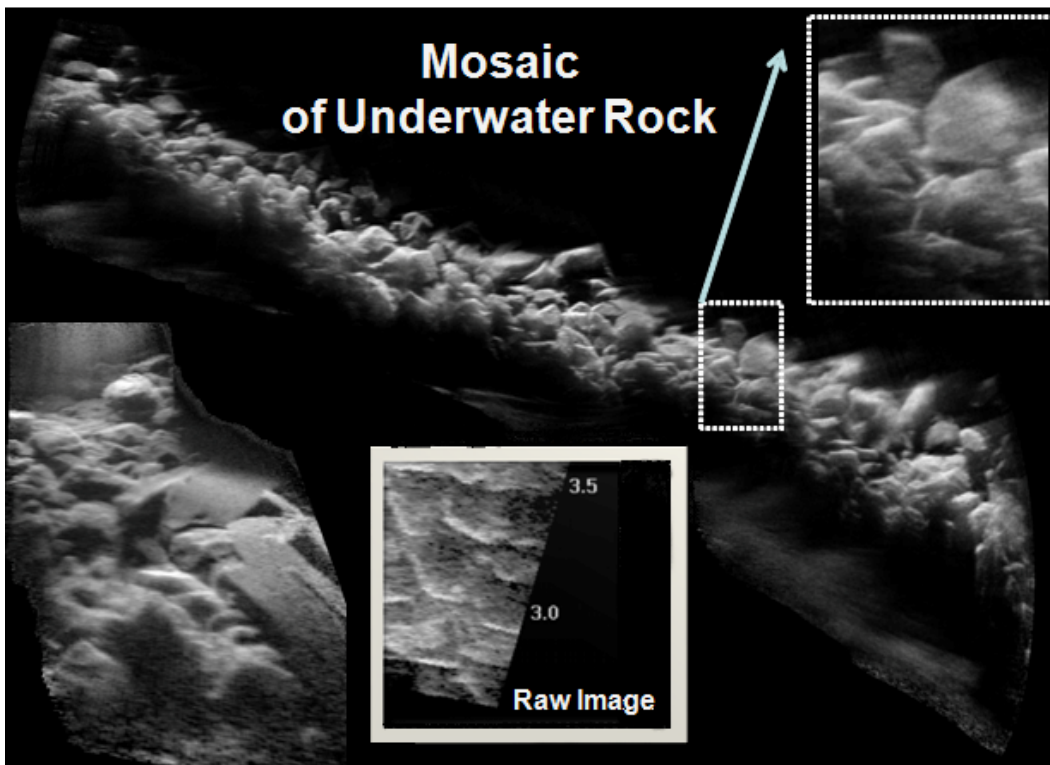
Figure 4-13. Underwater riprap section mosaic created from acoustical camera frames.

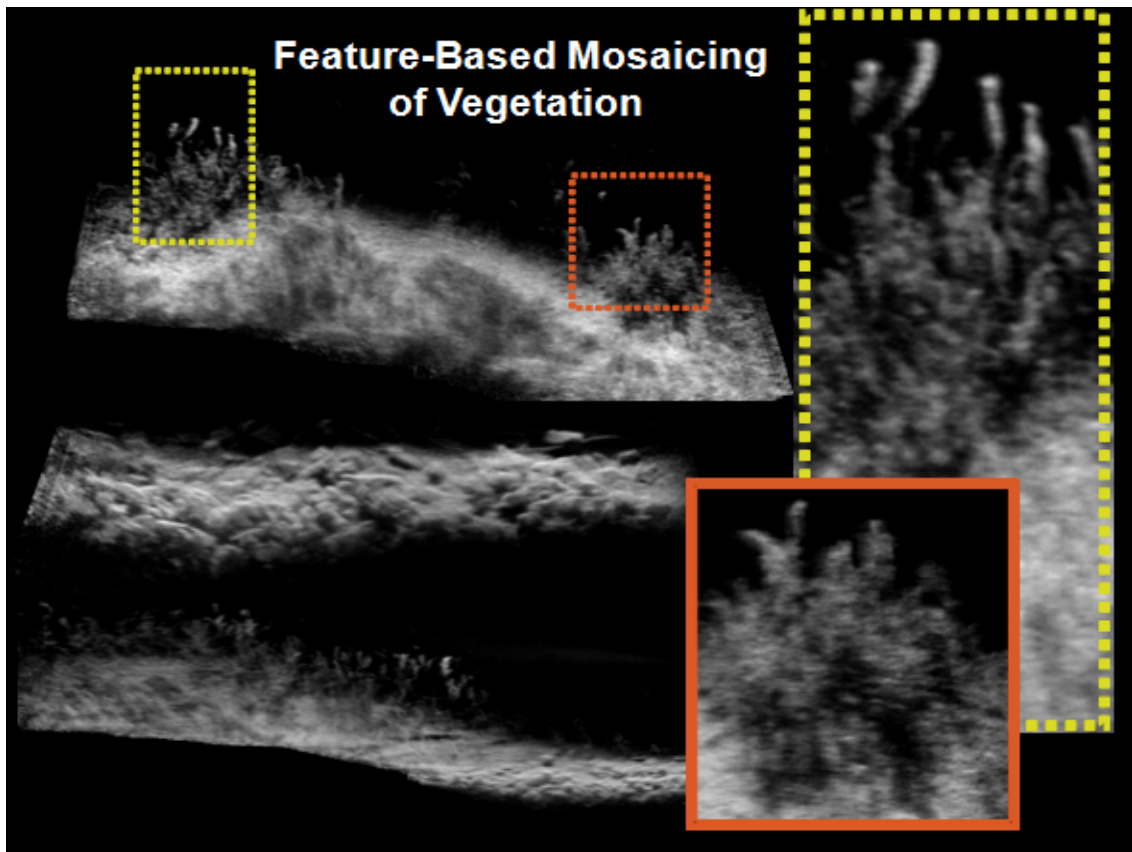
Figure 4-14. Vegetation mosaic created from acoustical camera images.

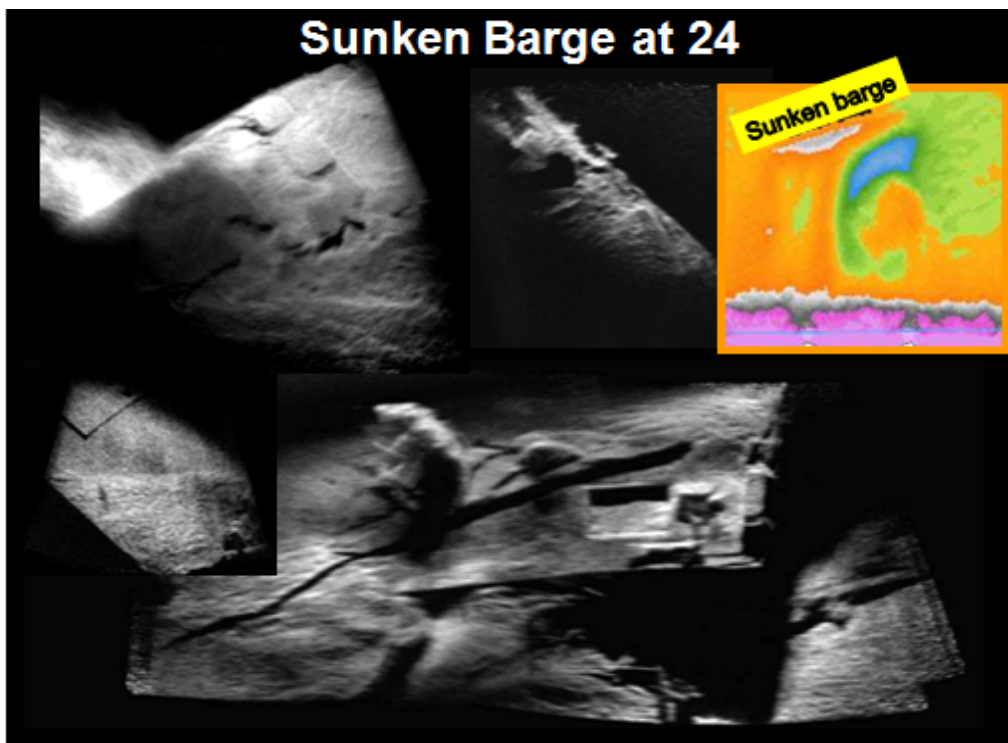
Figure 4-15. Sunken barge visible in river bottom silt.

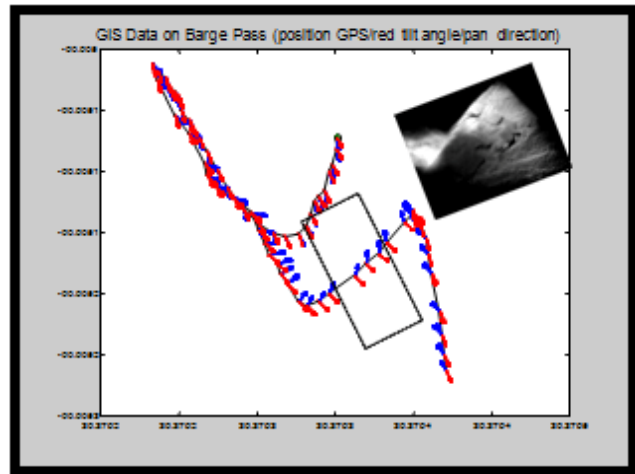
The graph in Figure 4-16 shows collected GPS-based position, camera direction, and orientation.

Figure 4-16. Graph of the camera track in acquiring acoustic camera images of sunken barge.

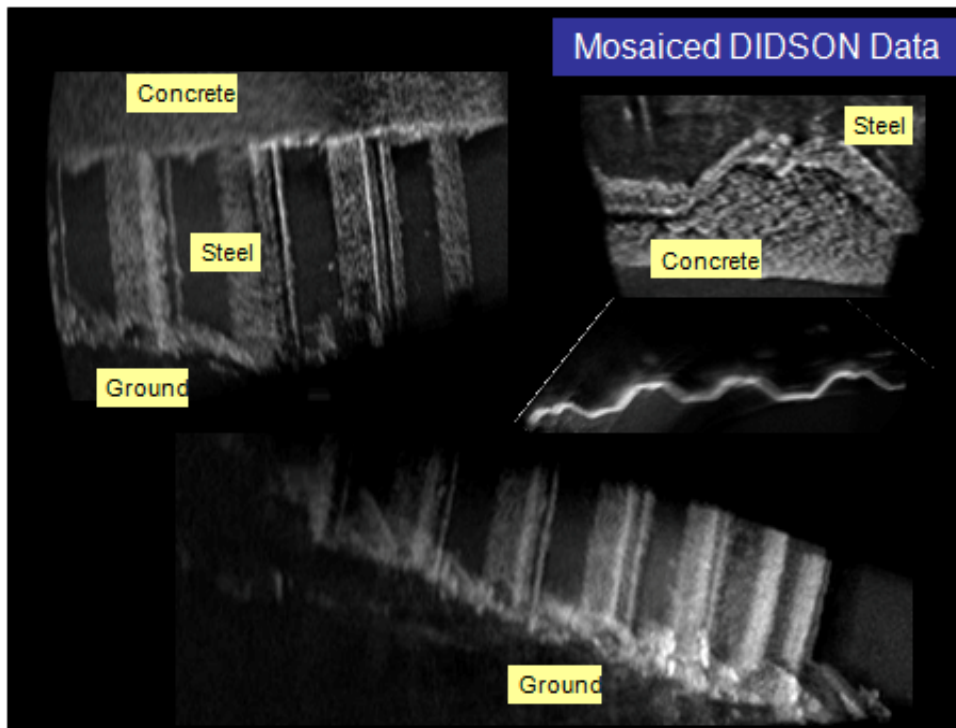
Figure 4-20. Acoustical camera images of the interfaces of structural components.

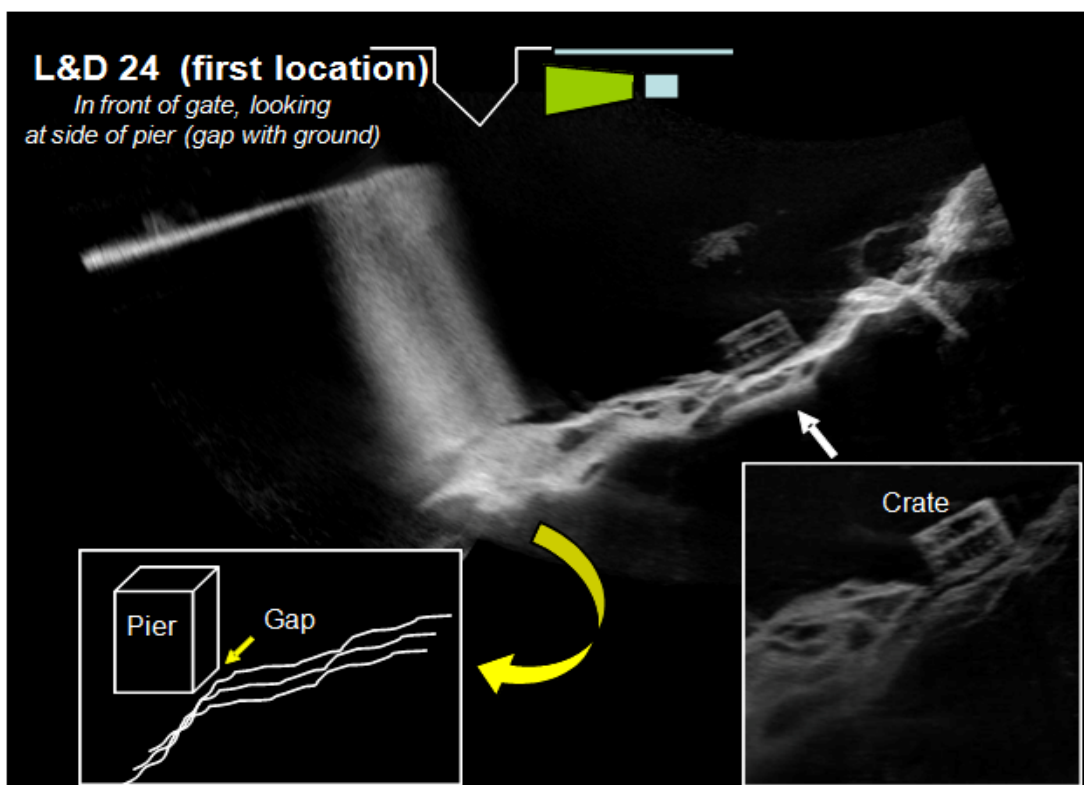
The image in Figure 4-21 shows scour starting between the riverbed and the concrete structure.

Figure 4-21. Mosaic of a scour hole at the intersection of a lock or dam wall and the river bottom.

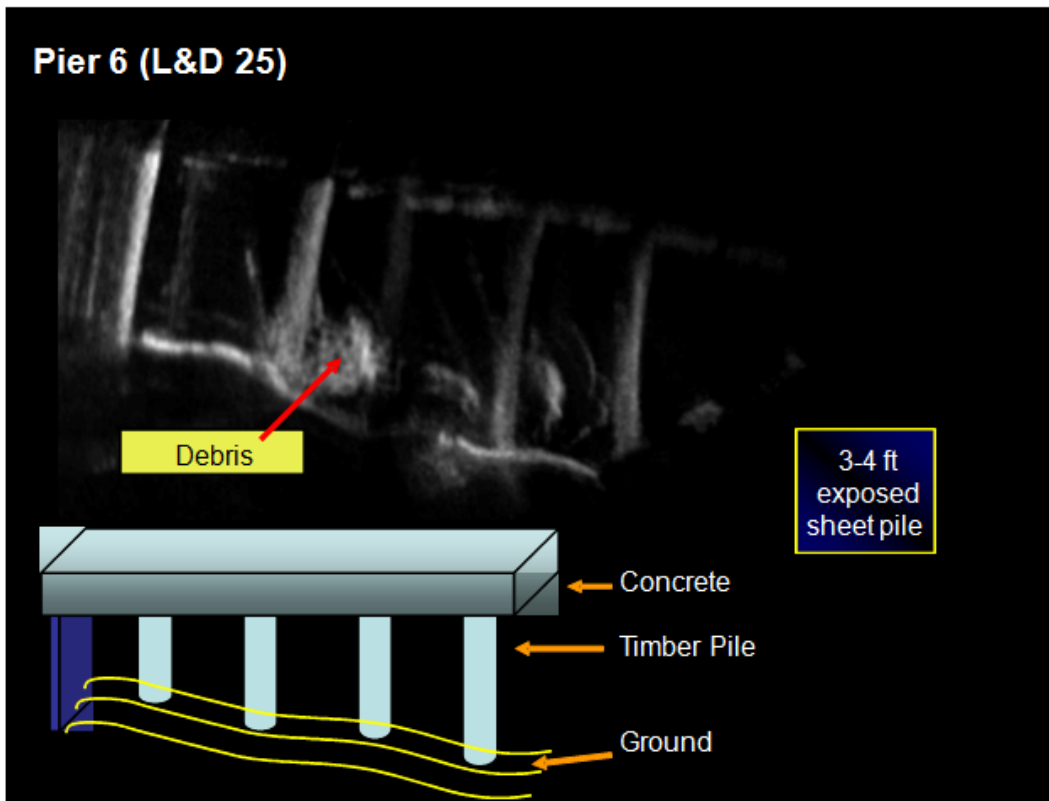
Figure 4-22. Image of organic material in a scour area.

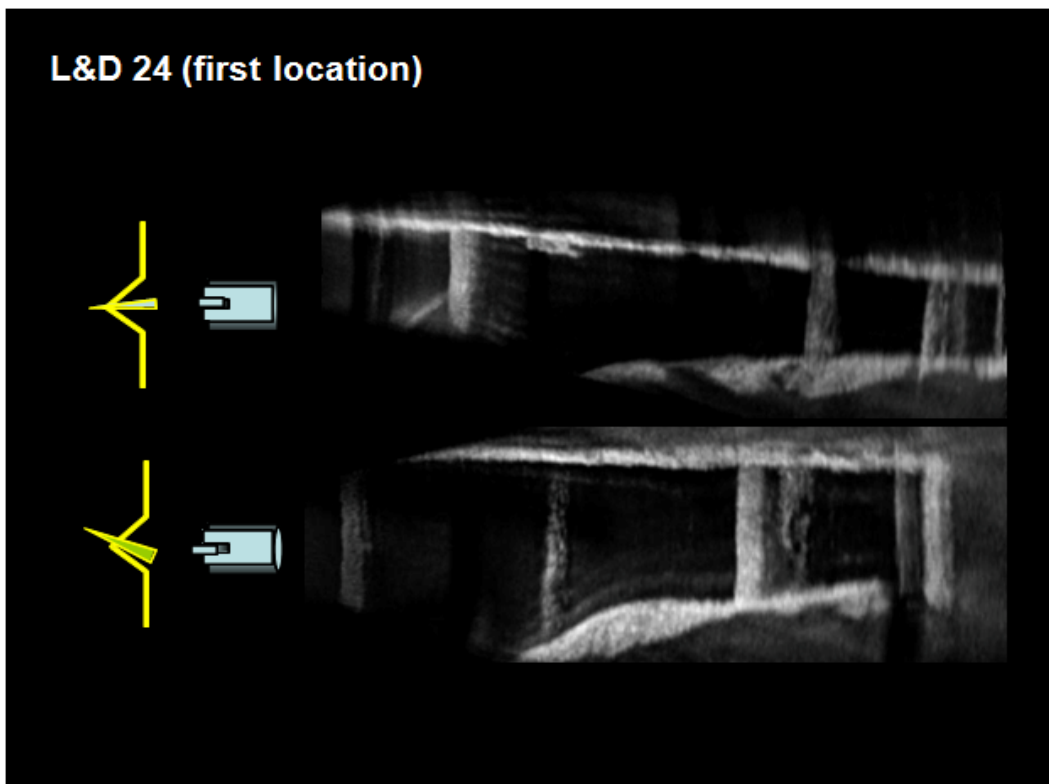
Figure 4-23. Exposed pilings in a scour area under a structural component.

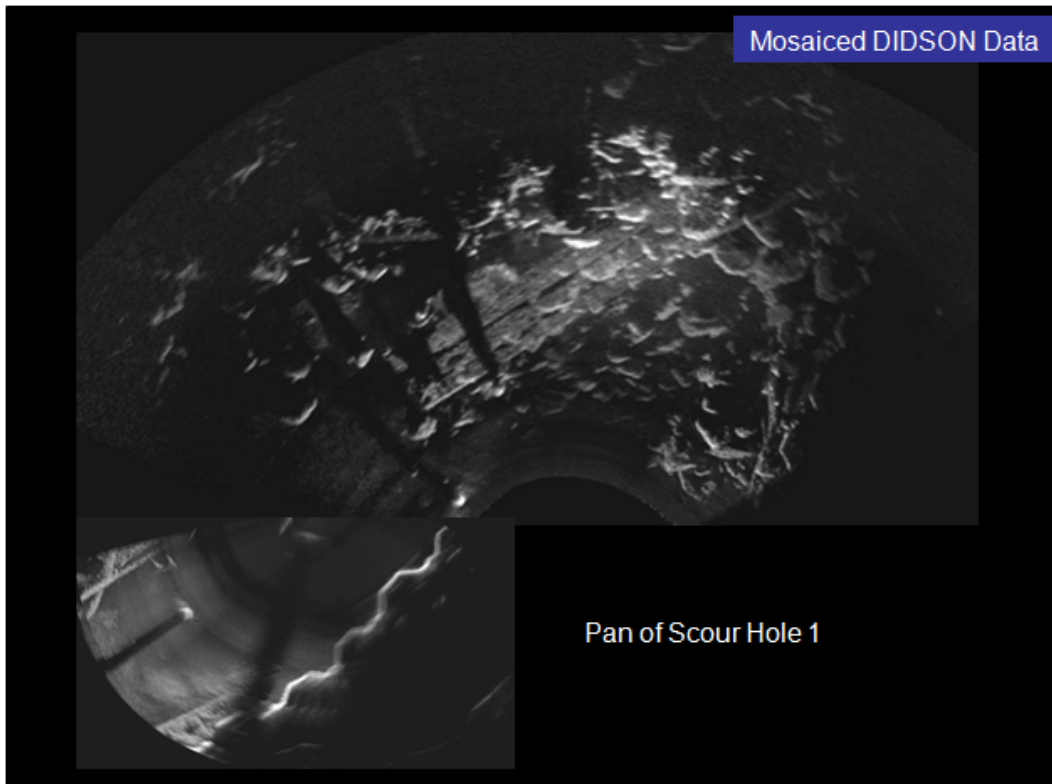
Figure 4-24. Scour hole mosaic.

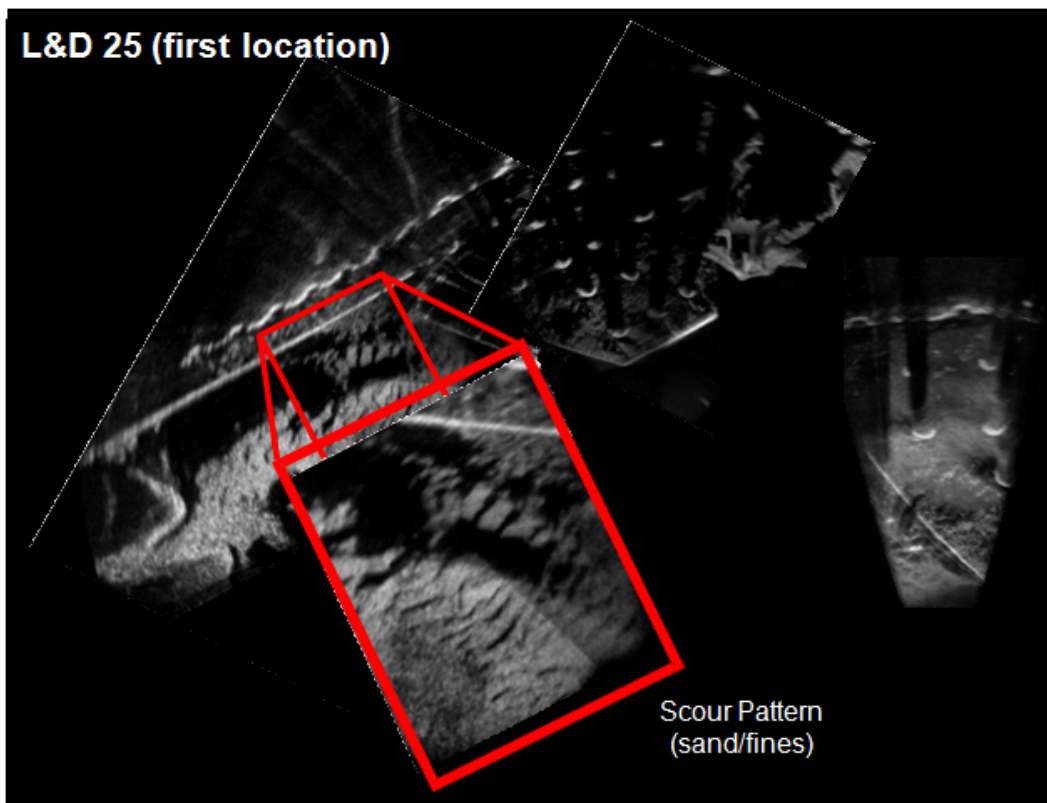
Figure 4-25. Mosaic image of scour patterns.

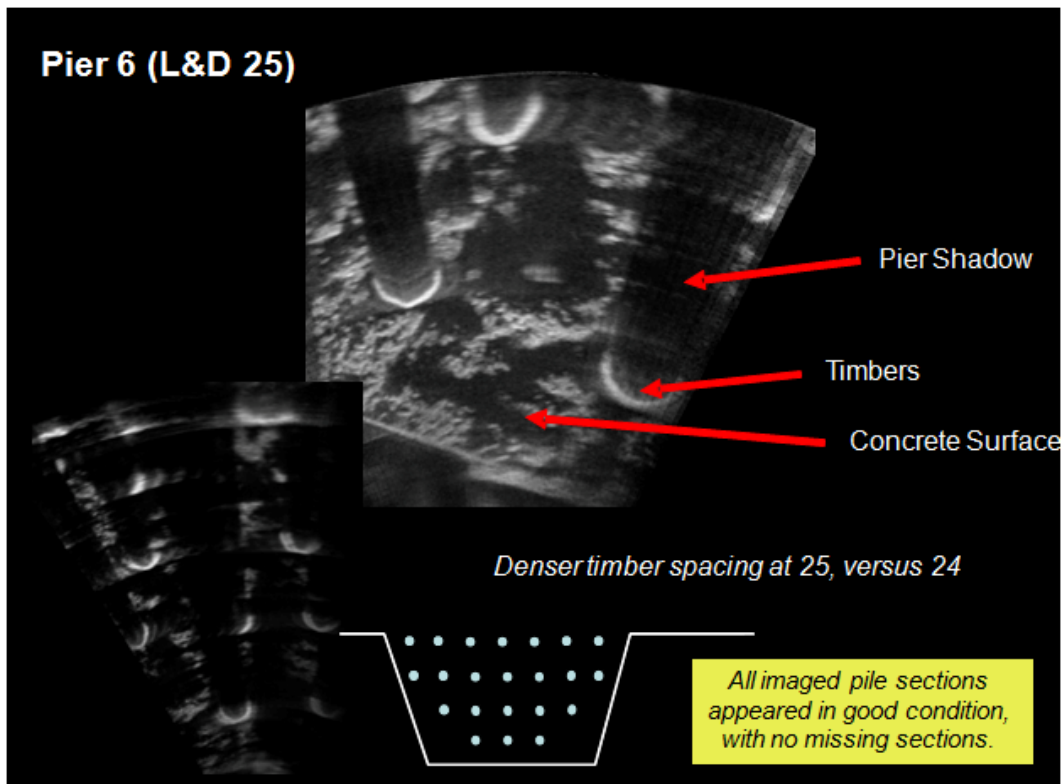
Figure 4-26. Mosaic image of timber piles.

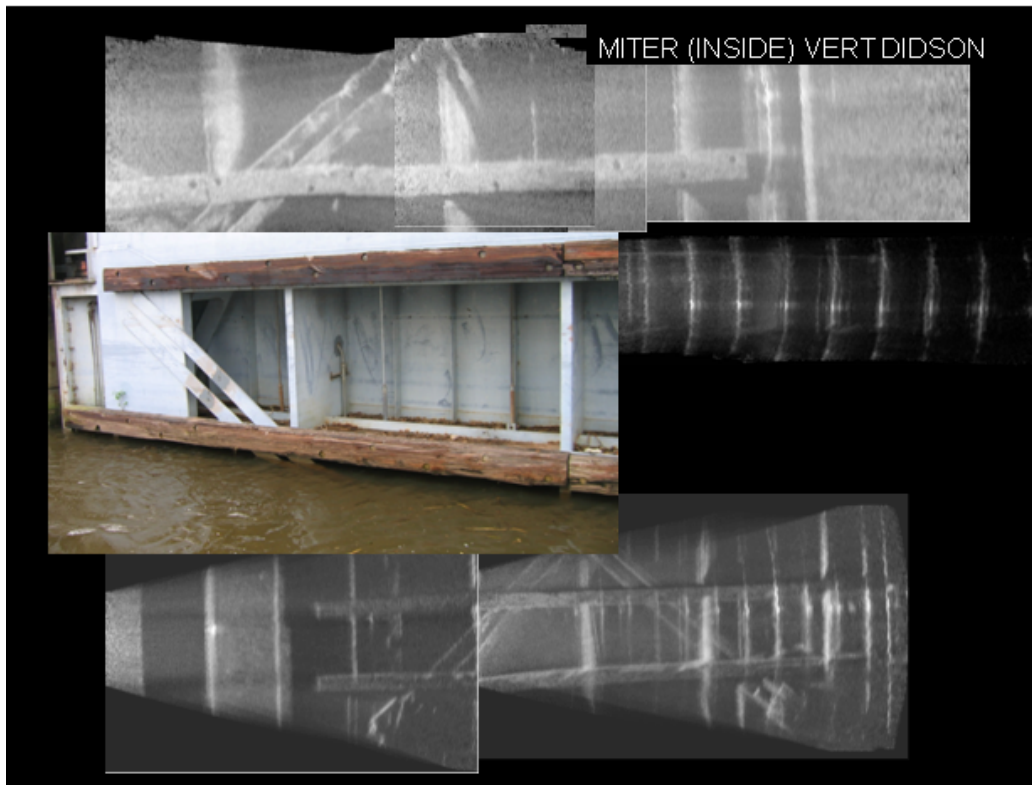
The inside of the same miter gate is shown in Figure 4-28. The images below show the gate structure scanned at various incidence angles. Depending on angle of sound beam incidence with the gate structure, the shallow, the deep, or a combination of the two can be obtained. The inset shows the hinge or pentel section.

Figure 4-28. Downstream side of the miter gate.

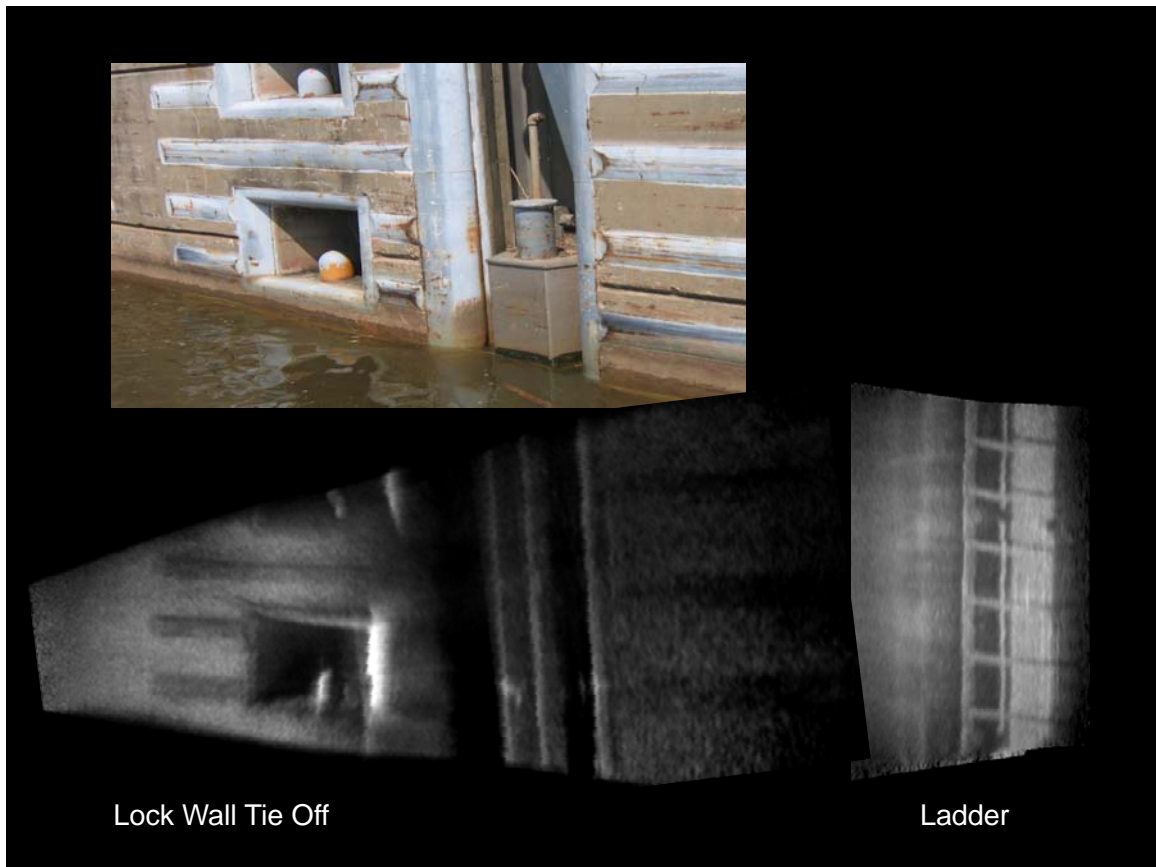
Figure 4-29. Acoustic camera mosaics of underwater lock components and a corresponding visible image.

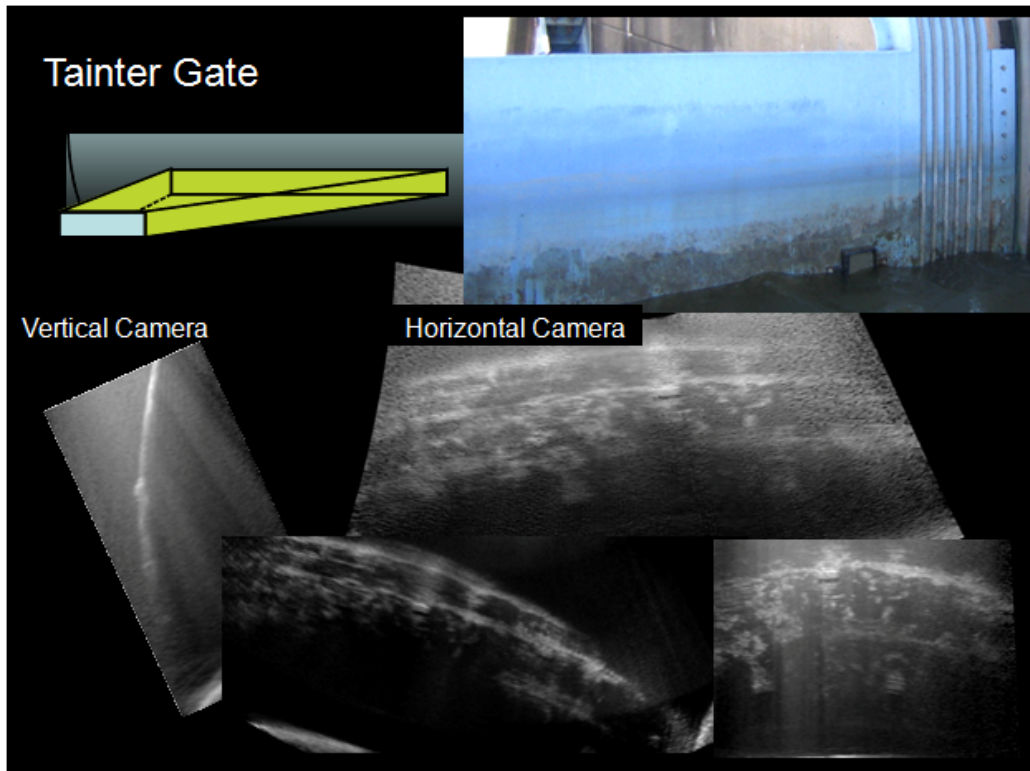
Figure 4-31. Acoustical images of a tainter gate.

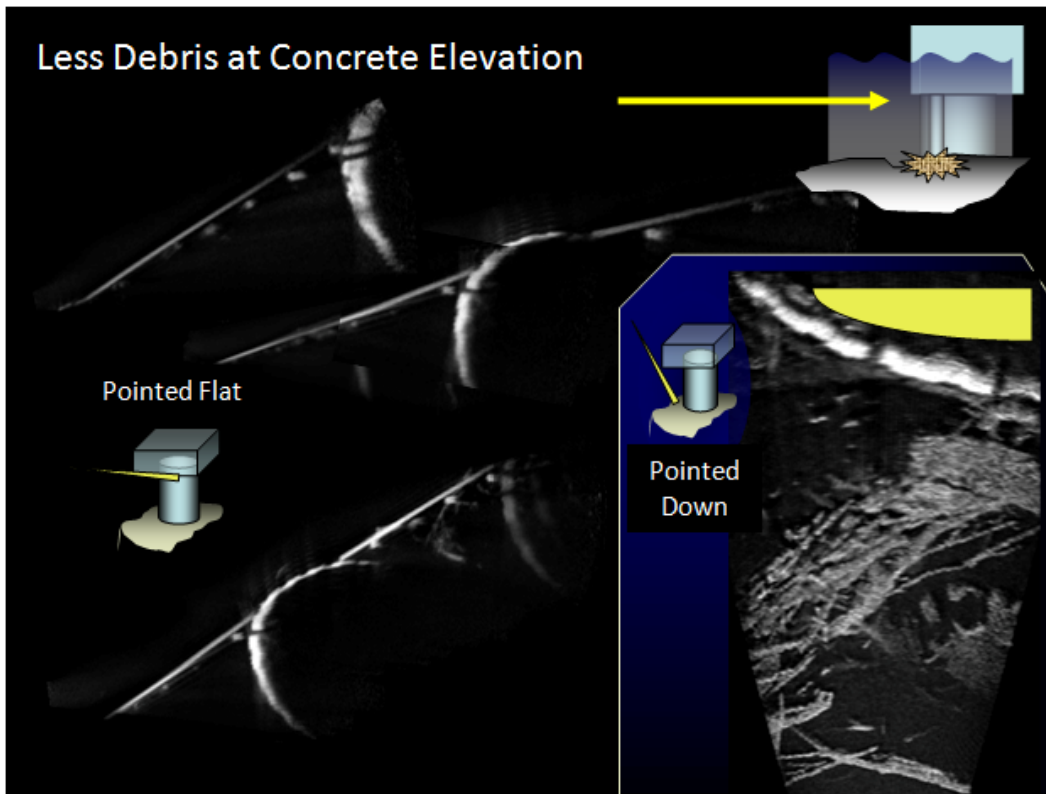
Figure 4-33. Images that indicate the location of debris.

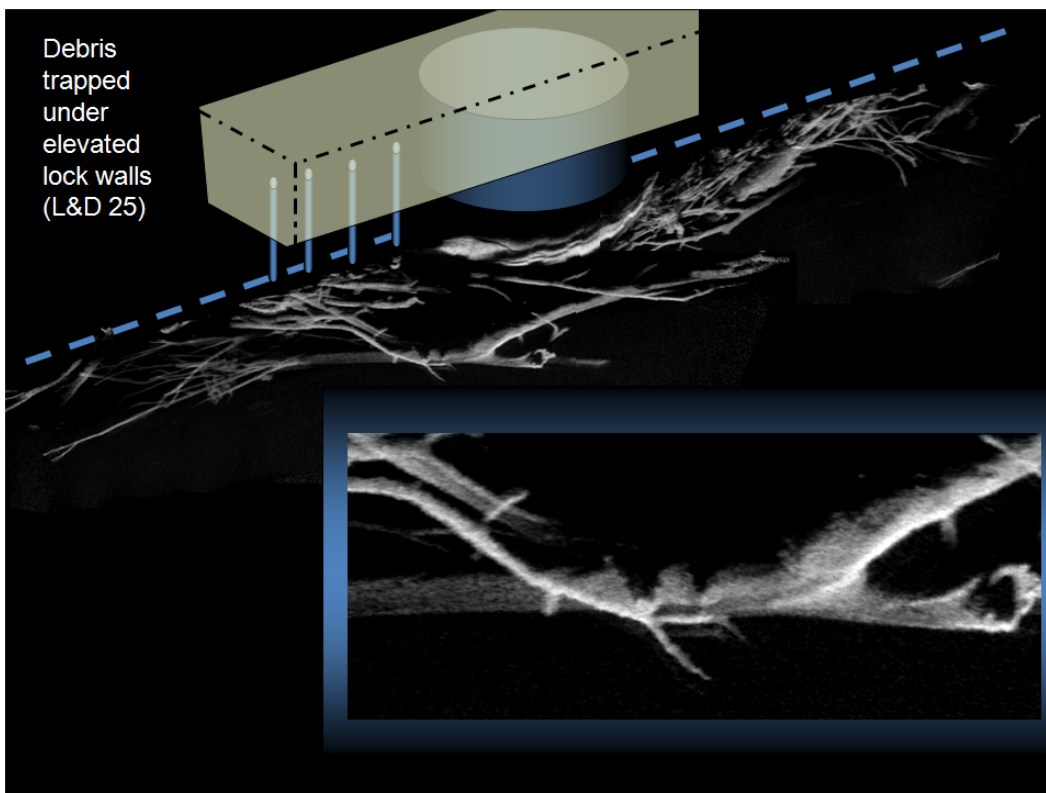
Figure 4-34. Images showing intertwined debris and lock wall pilings.

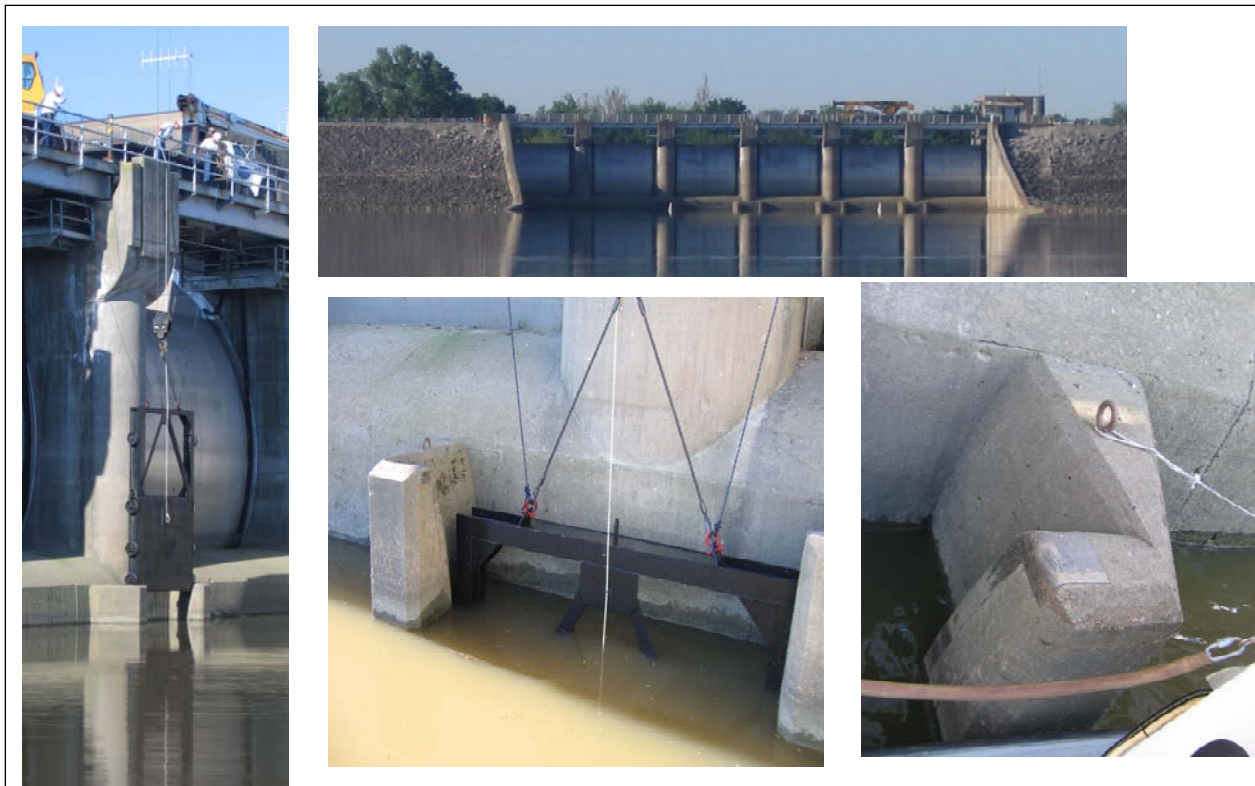
Figure 4-35. Steel service gate with binding issues.

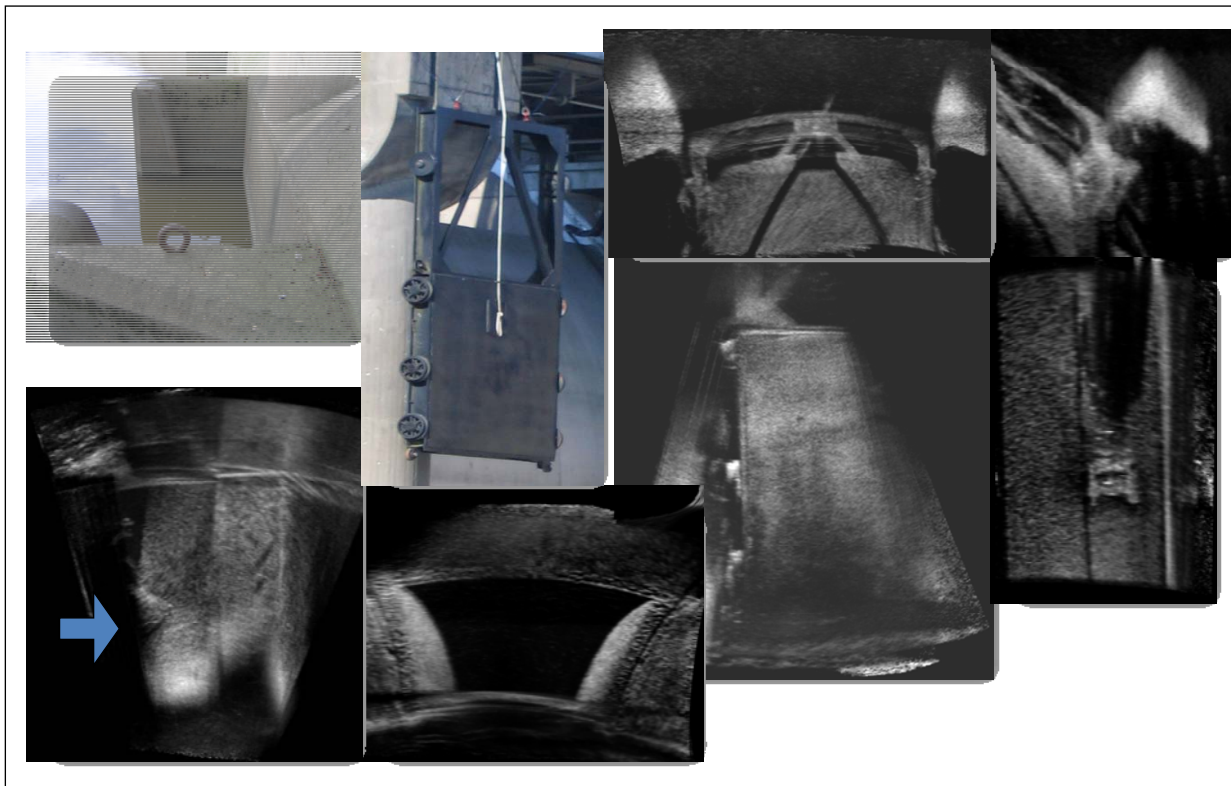
Figure 4-36 shows a number of views of the gate, the gate channel, and concrete at the Delaware Dam. A few concrete pop outs or spalls were detected, and those were on the outside of the guide surface. Boat deployment was employed, while overhead cranes lowered and raised the gate. Video showed gate motion within the track and track condition during translation.

Figure 4-36. Acoustical images of service gate and guideway at Delaware Lake.

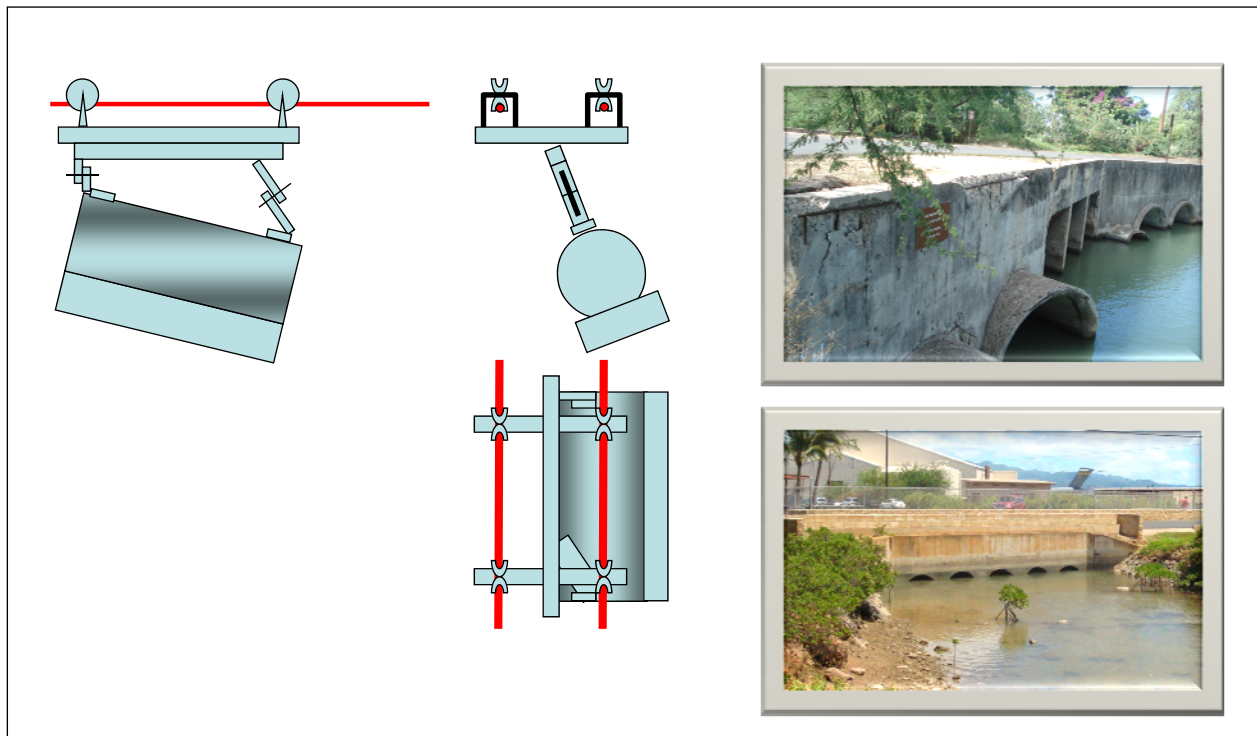
Figure 4-38. Deployment mechanism for conduit inspections.

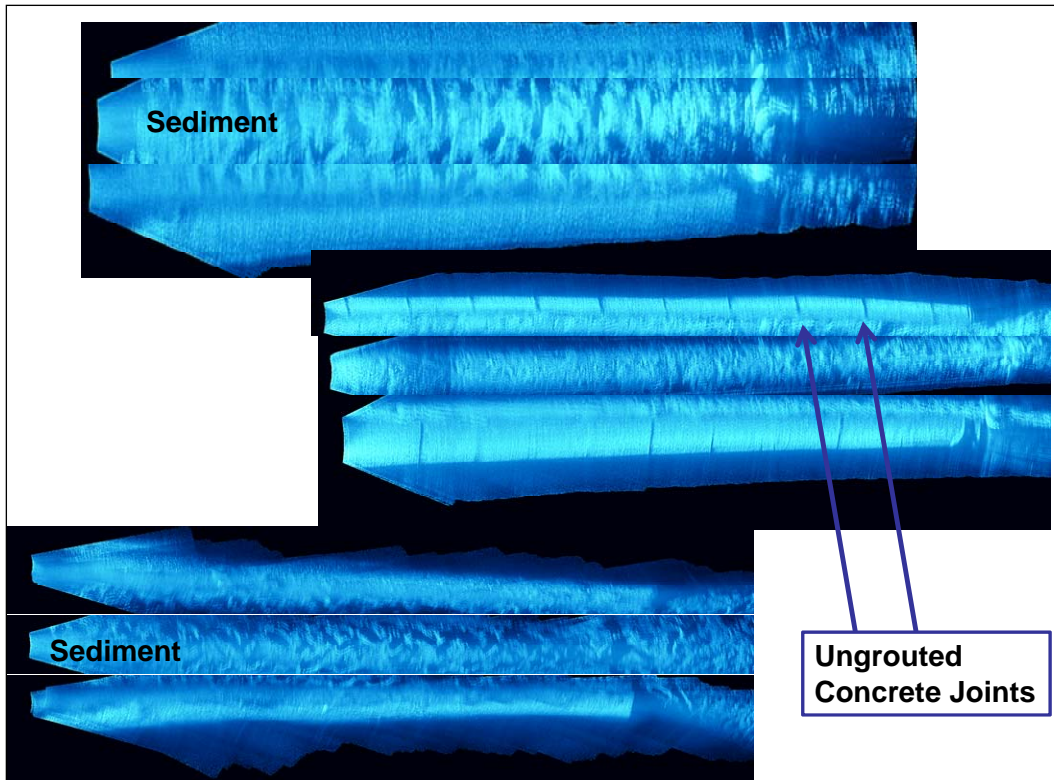
Figure 4-39. Mosaics from acoustic camera culvert scans.

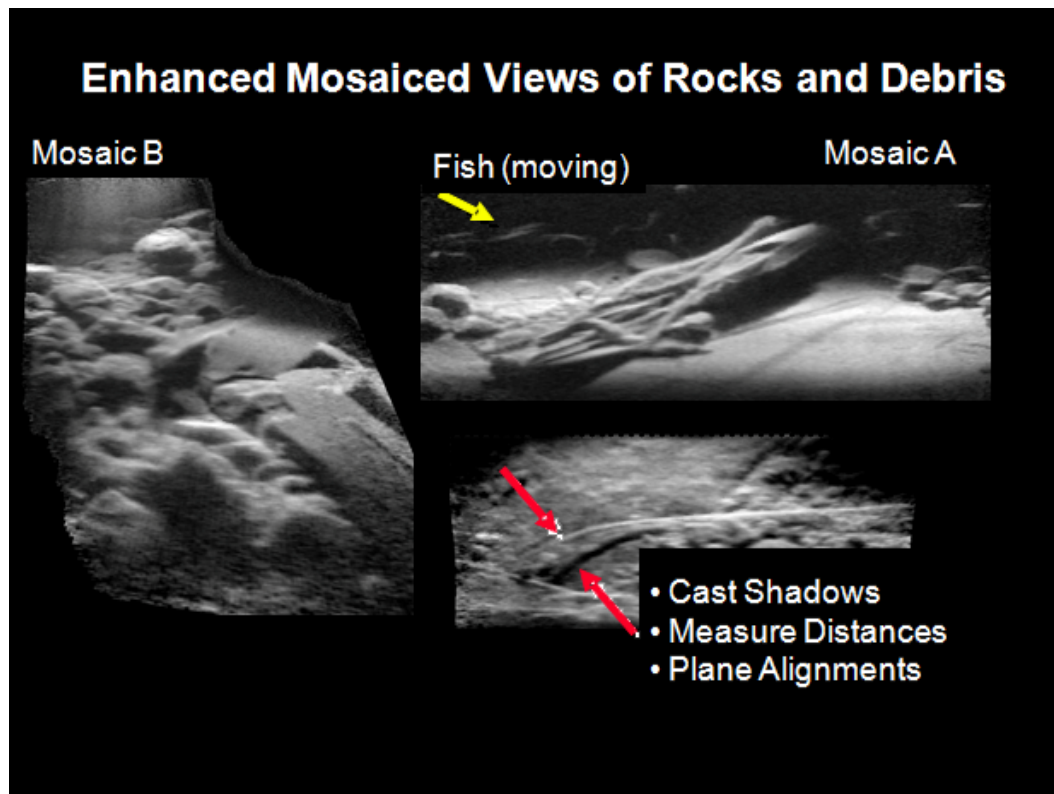
Figure 4-40 shows miscellaneous objects. Note that shadows, even those from moving fish, have been used to estimate surface depth or position (bottom right).

Figure 4-40. Miscellaneous objects encountered during scans.

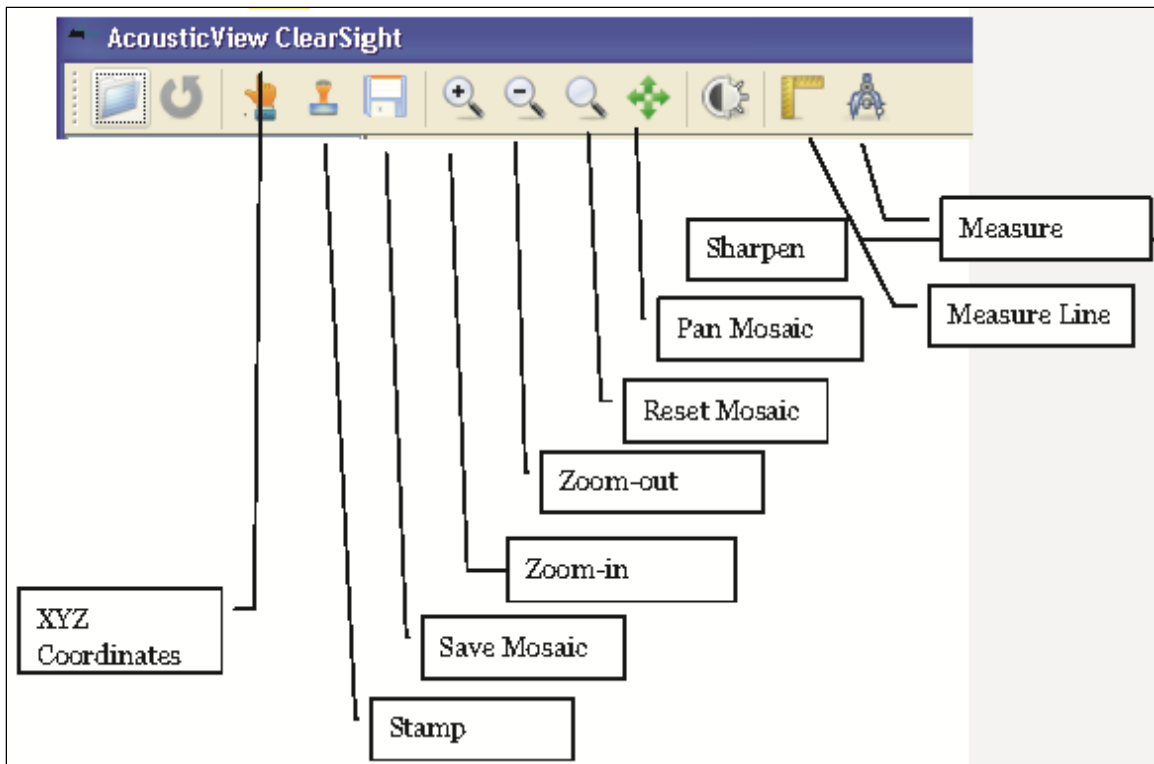
Figure A-3. Mosaic tools available in the Viewer pane.

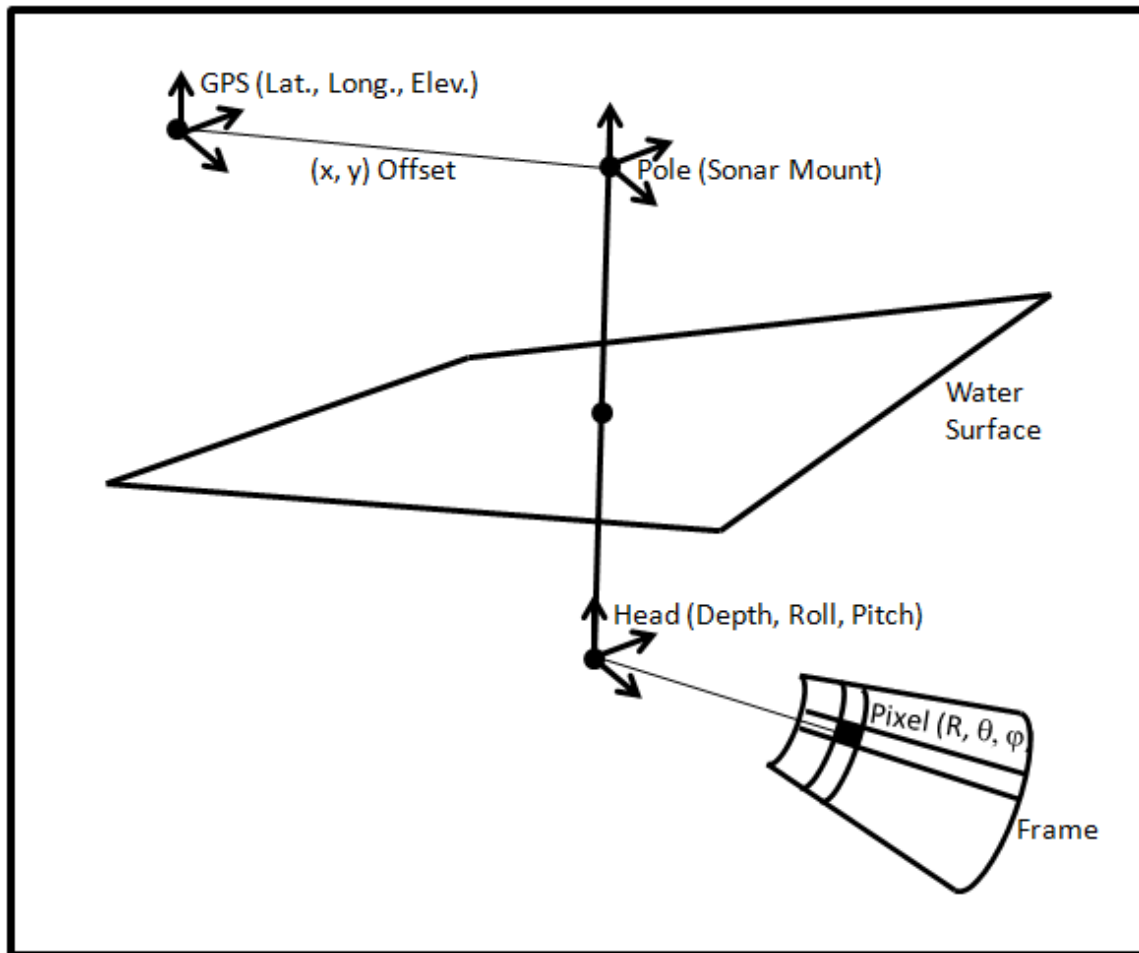
Figure A-5. The transition from GPS coordinates to pixels.

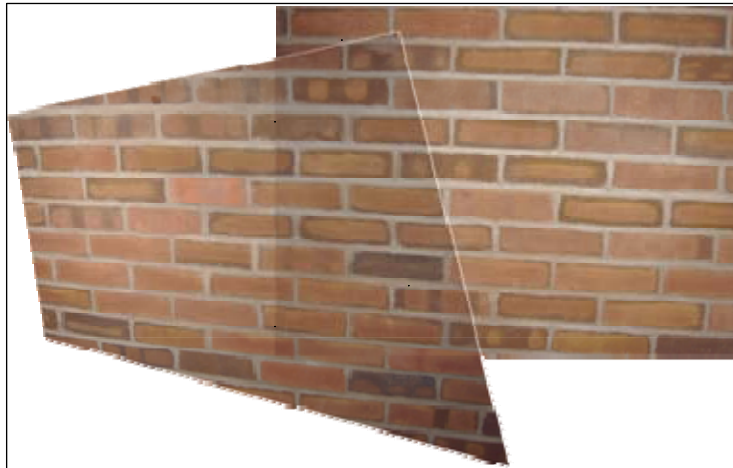
Using the above geometry modeling, two sonar frames are mapped between each other to obtain the same coordinate system between them. Then anchor points are found in both images so registration can take place and the two frames can be combined, as illustrated in Figure A-9.

Figure A-9. Mosaic created by applying a coordinate system transformation to align images.
