Navigation Systems Research Program

Underwater Inspection of Navigation Structures with an Acoustic Camera

Final report

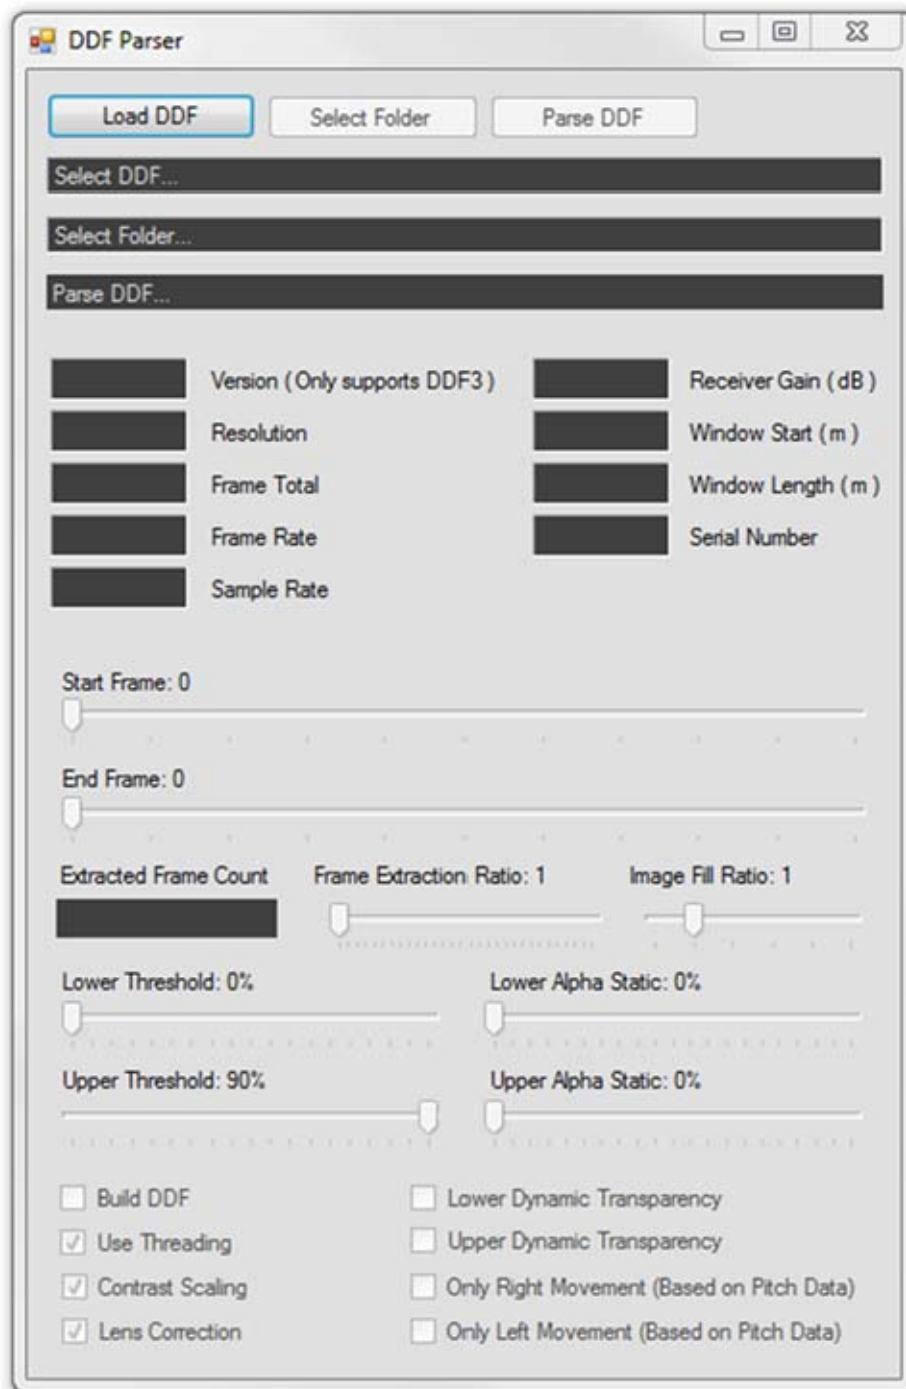
Figure B-1. DDF Parser (no file selected).

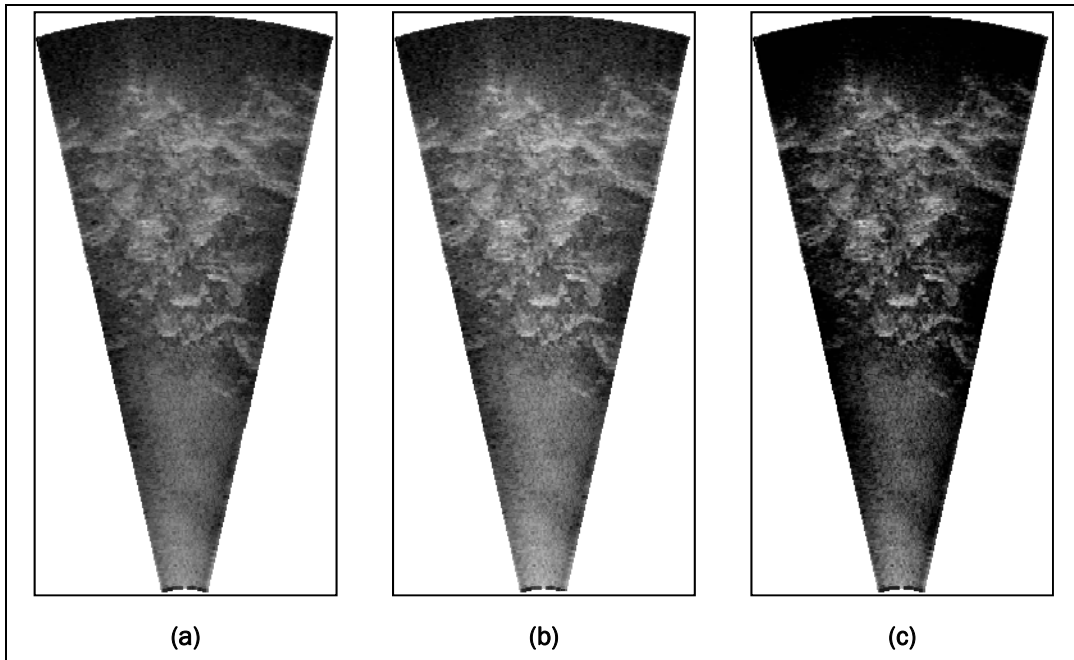
Figure B-2. (a) Original image; (b) contrast scaled image; (c) contrast scaled image with low threshold: 20% and lower alpha static: 100%.

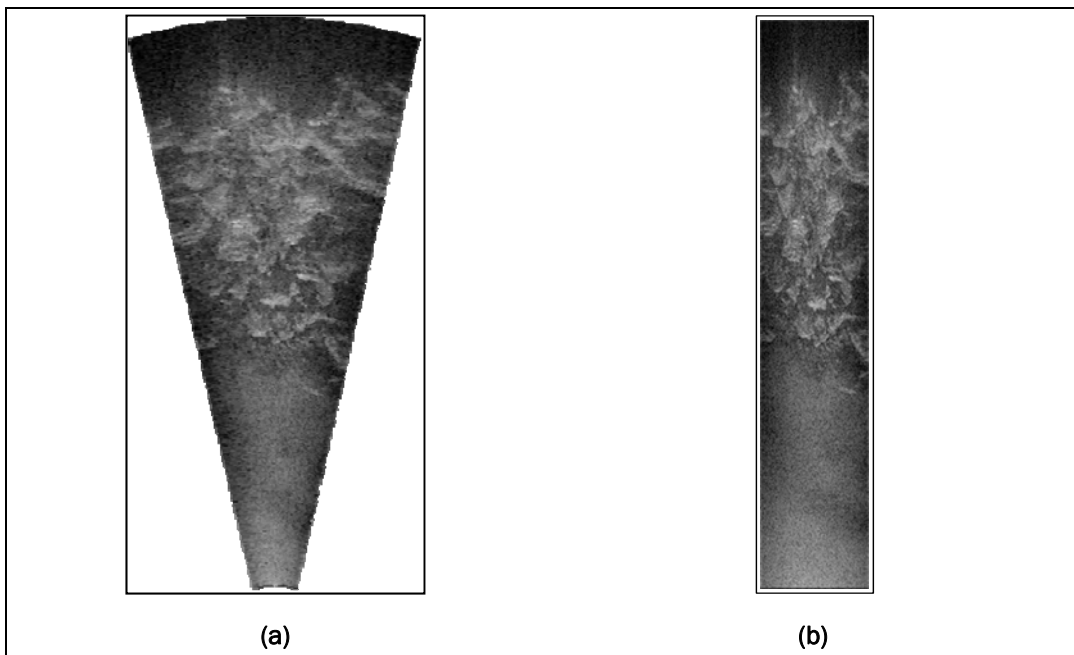
Figure B-3. (a) Using lens correction; (b) original image stored in .ddf.

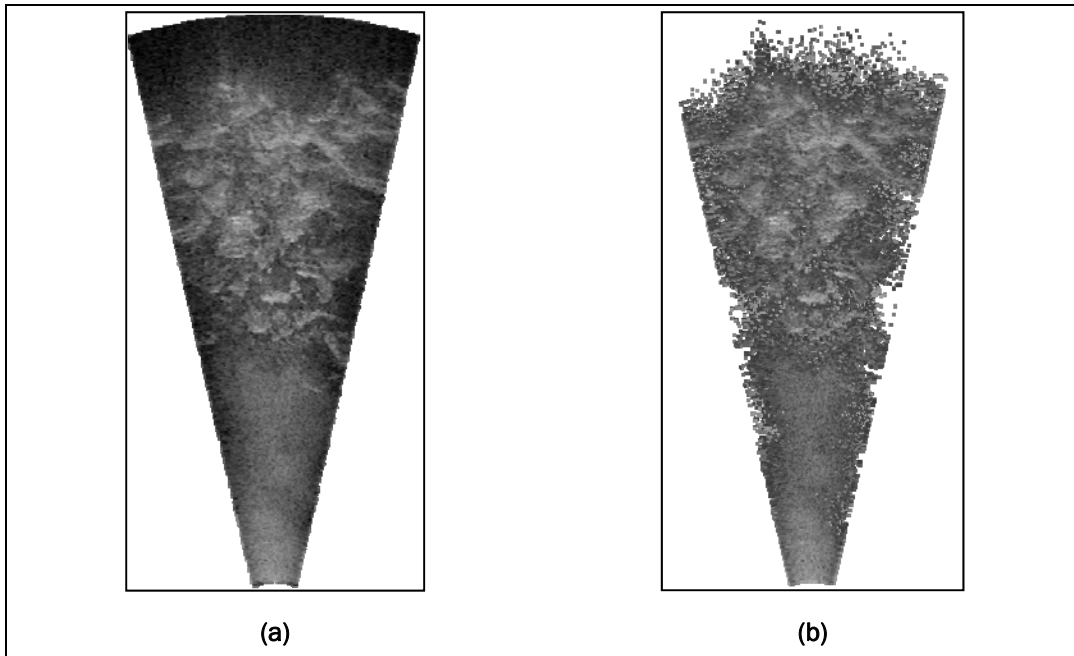
Figure B-5. (a) Low threshold: 0%; (b) low threshold: 20%.

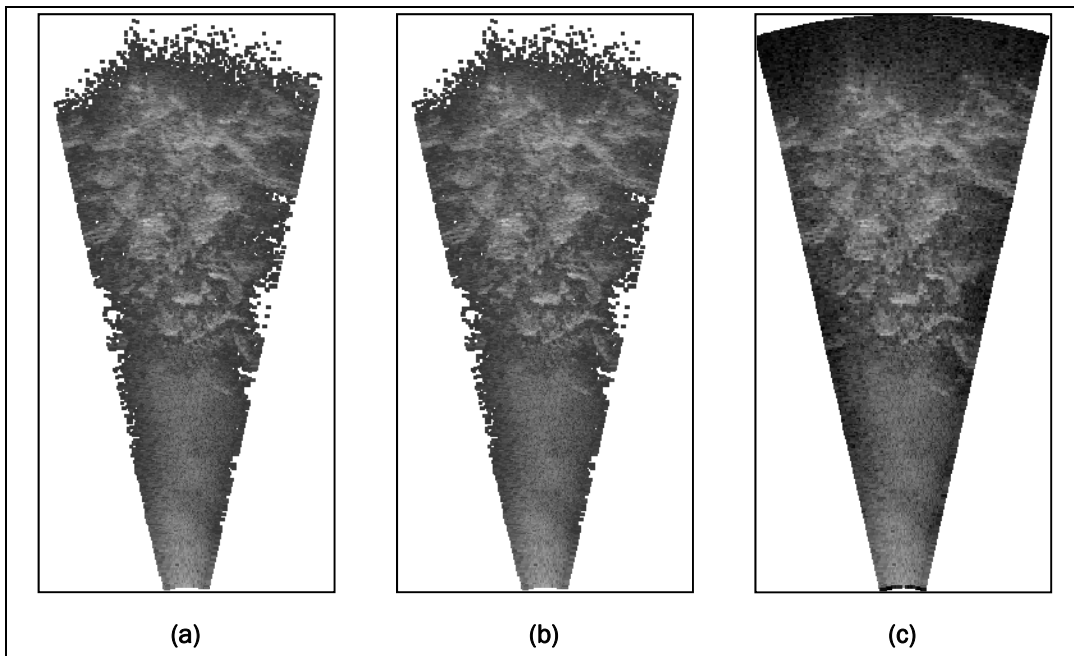
Figure B-6. Each image has a low threshold value of 20%; (a) lower alpha static: 0%; (b) lower alpha static: 50%; (c) lower alpha static: 100%.

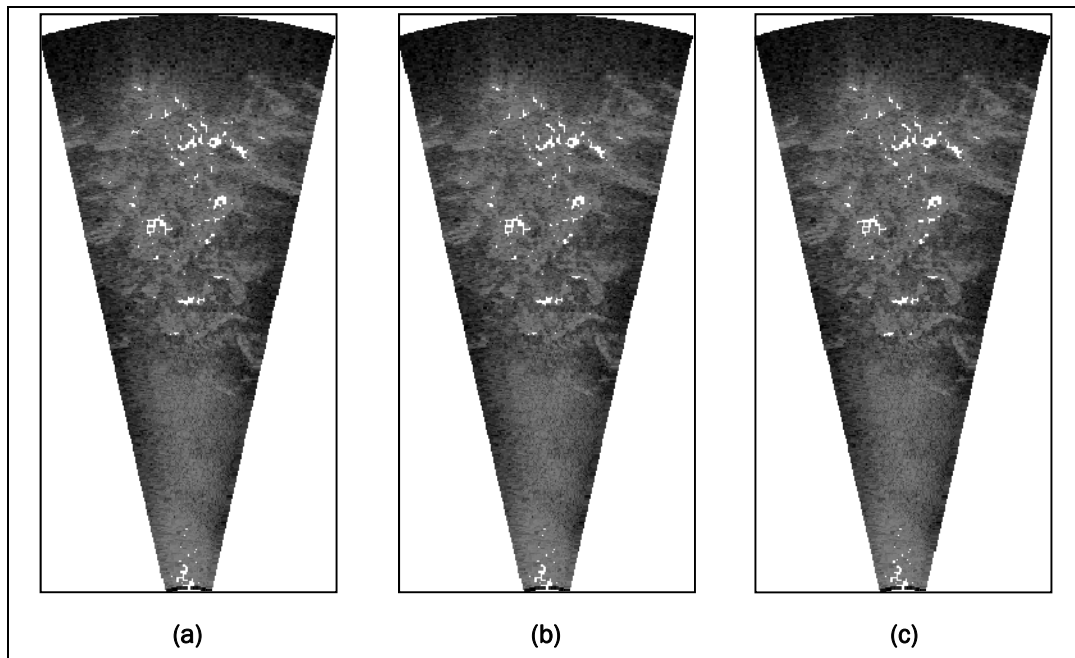
Figure B-10. Each image has a high threshold value of 50%; (a) upper transparency dynamic: 0%; (b) upper transparency dynamic: 50%; (c) upper transparency dynamic: 100%.

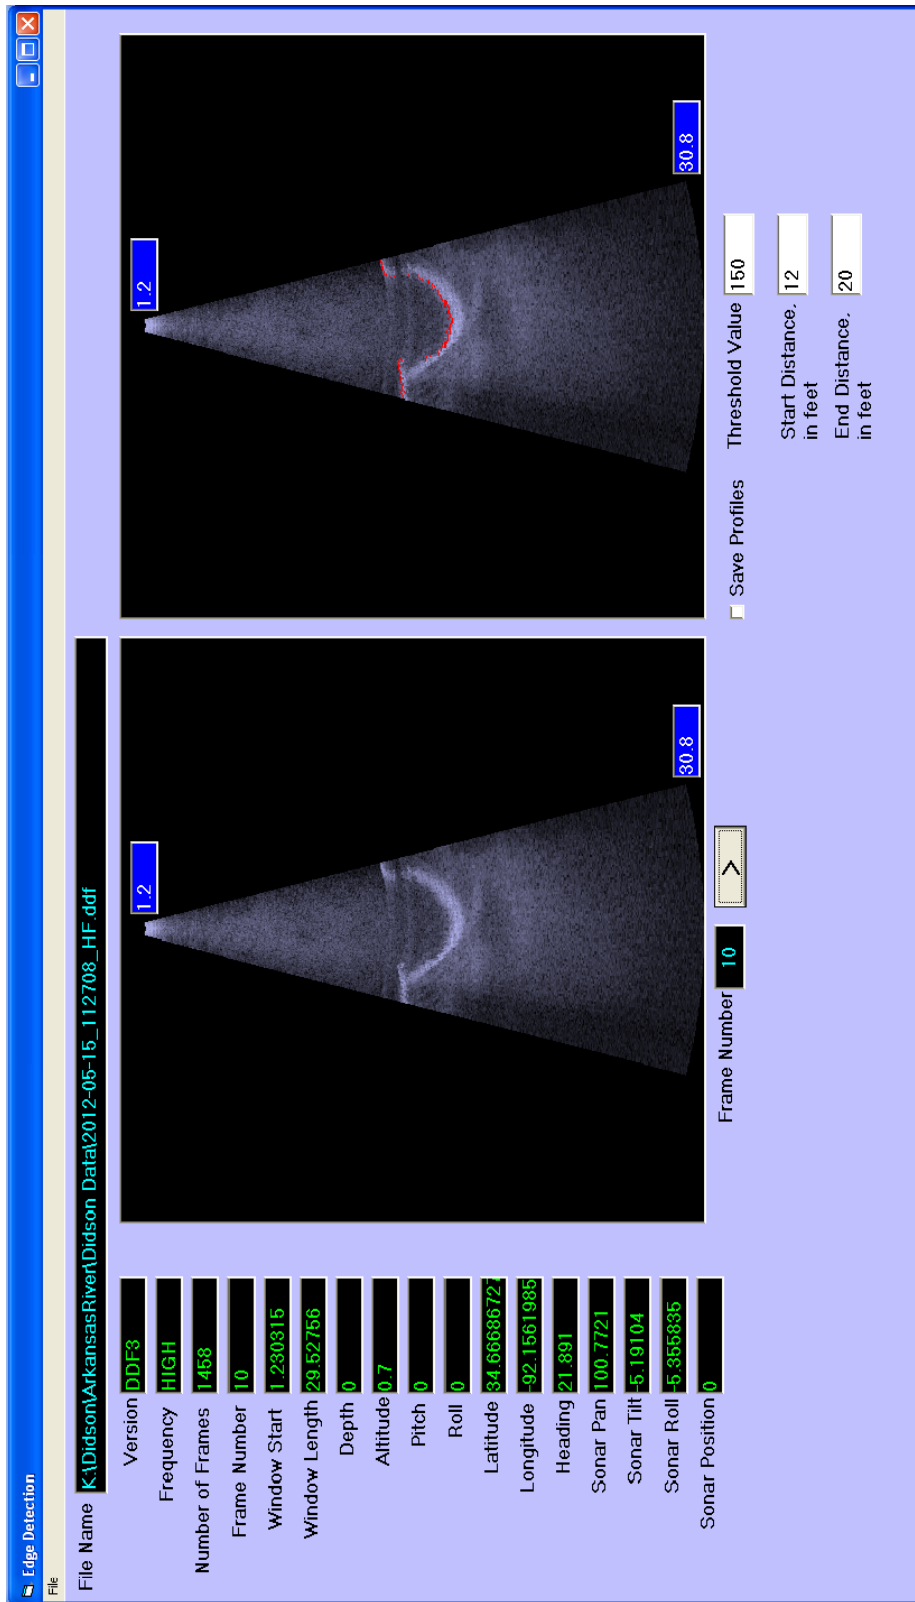
Figure D-1. EdgeDetect user interface window.
