## Technical Report ARAEW-TR-06002

# 60mm M225 FATIGUE TEST AND BURST TEST

August 2005

ARMAMENT RESEARCH, DEVELOPMENT AND ENGINEERING CENTER  
Armaments Engineering & Technology Center  
Weapon Systems & Technology

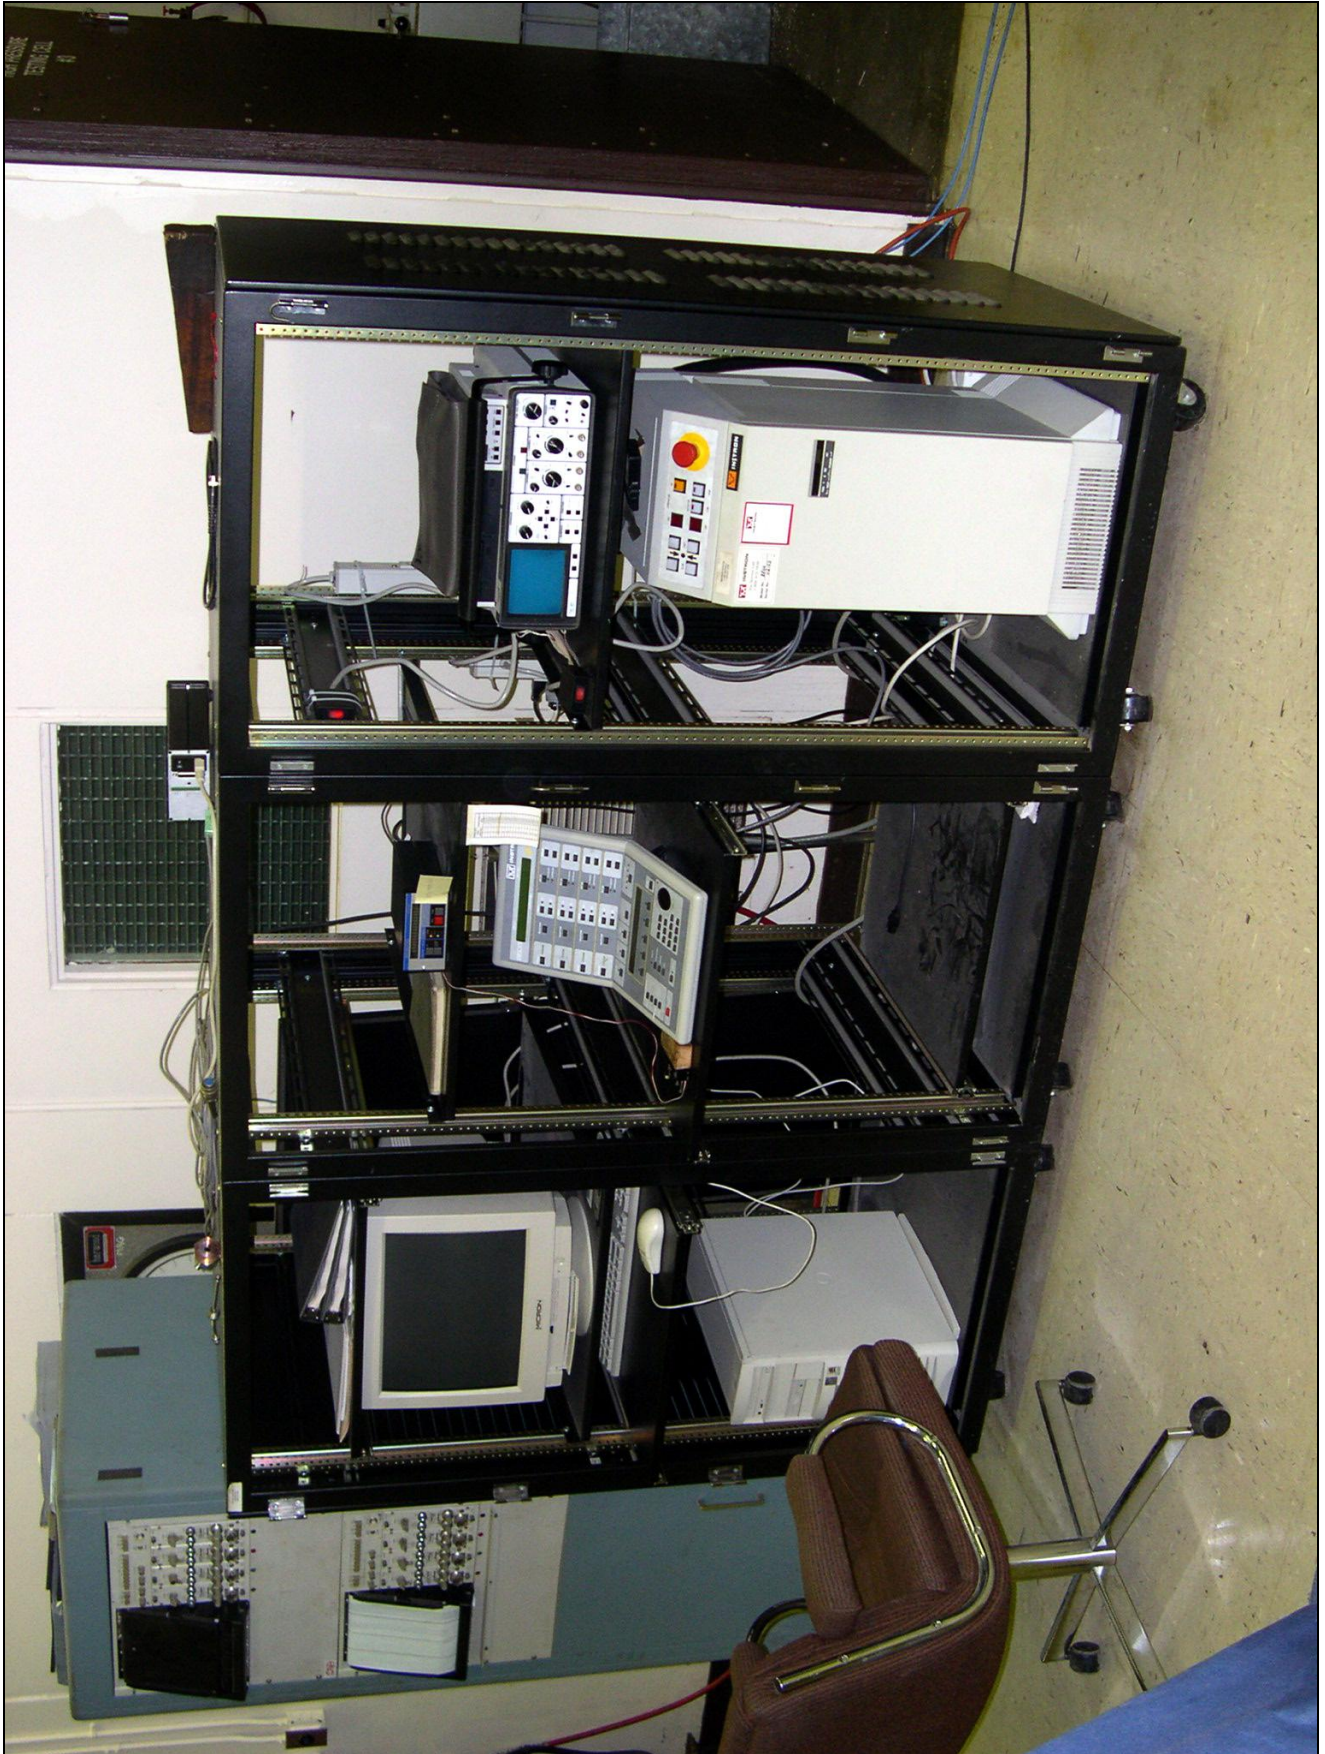
| 3. Control console for high pressure hydraulic test cell ..... | 8 |

that was just described. On the right side of this graphic is a cylinder and a ram. This figure depicts a M256 chamber section of a cannon tube and the hydraulic ram that is part of the 4.5 Million pound press that was used to generate the test pressure. The M256 chamber was used as a manifold to distribute the test pressure to all four mortar tubes simultaneously. In this schematic, the ram would be pushed into the M256 chamber and would compress hydraulic fluid within the chamber. The fluid would then flow from the manifold (M256 chamber), travel through four high pressure feed lines and enter the base of the four 60mm mortar tubes. Figure 3 is a photograph of the control console for the test cell. This is a closed loop computer control system where load and ram stroke can be monitored and adjusted by software to give repeatability during testing. Figure 4 shows the M256 chamber section in the 4.5 Million pound press with the four 60mm mortar tubes mounted on top of support columns. Figure 5 is a close up view of the 60mm mortar tubes that are mounted on top of the support columns with the M256 chamber section in the center. The inlet hole in the base of one of the 60mm mortar tube assemblies can be seen in this photograph. Figure 6 shows the test rig with all the high pressure lines feeding from the M256 chamber. The base cap of each 60mm mortar tube had a single strain gauge applied to it as shown in figure 7. The gauge was applied so that measurements of strain on the base cap during the test could be observed. The strain value was used to determine if permanent strain was forming under the base cap during the test. When the 10,080 psi test was complete, each of the mortar tubes were burst. Figure 8 shows the result of the burst test on one of the mortar tubes. Figure 9 – 15 show the results of the burst test on all four 60mm mortar tubes.

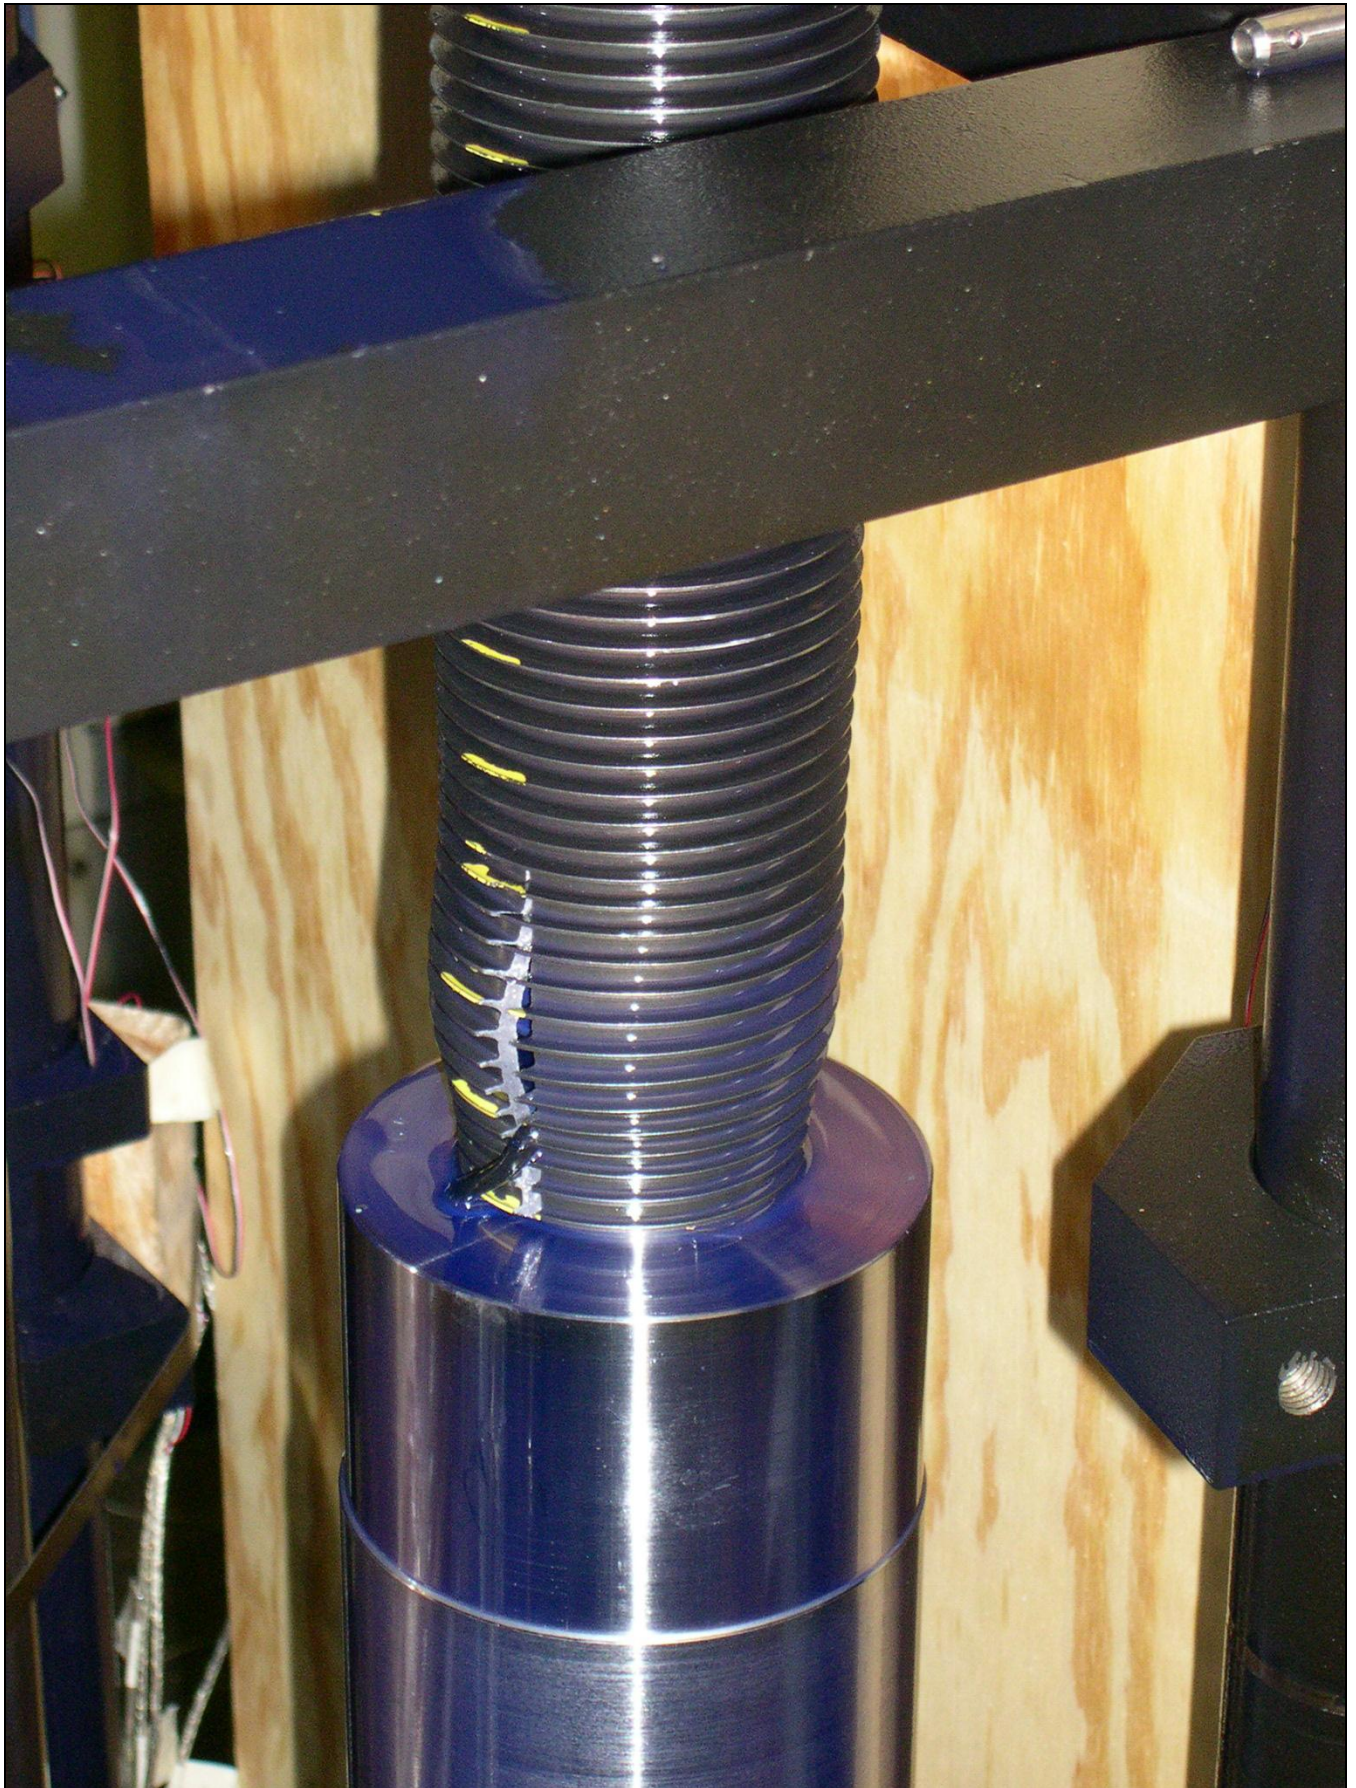
Figure 8

| 8. Photograph of a burst 60mm mortar tube ..... | 13 |

Each tube exhibited a fracture that is consistent with a ductile material. The fracture occurred at the extreme end of the tube (furthest from the base cap). On each tube, the failed area was bulged outwards and had a fracture that was between two and four inches in length. No shrapnel or other debris was observed during the burst failure. This is indicative of a good quality mortar tube material.

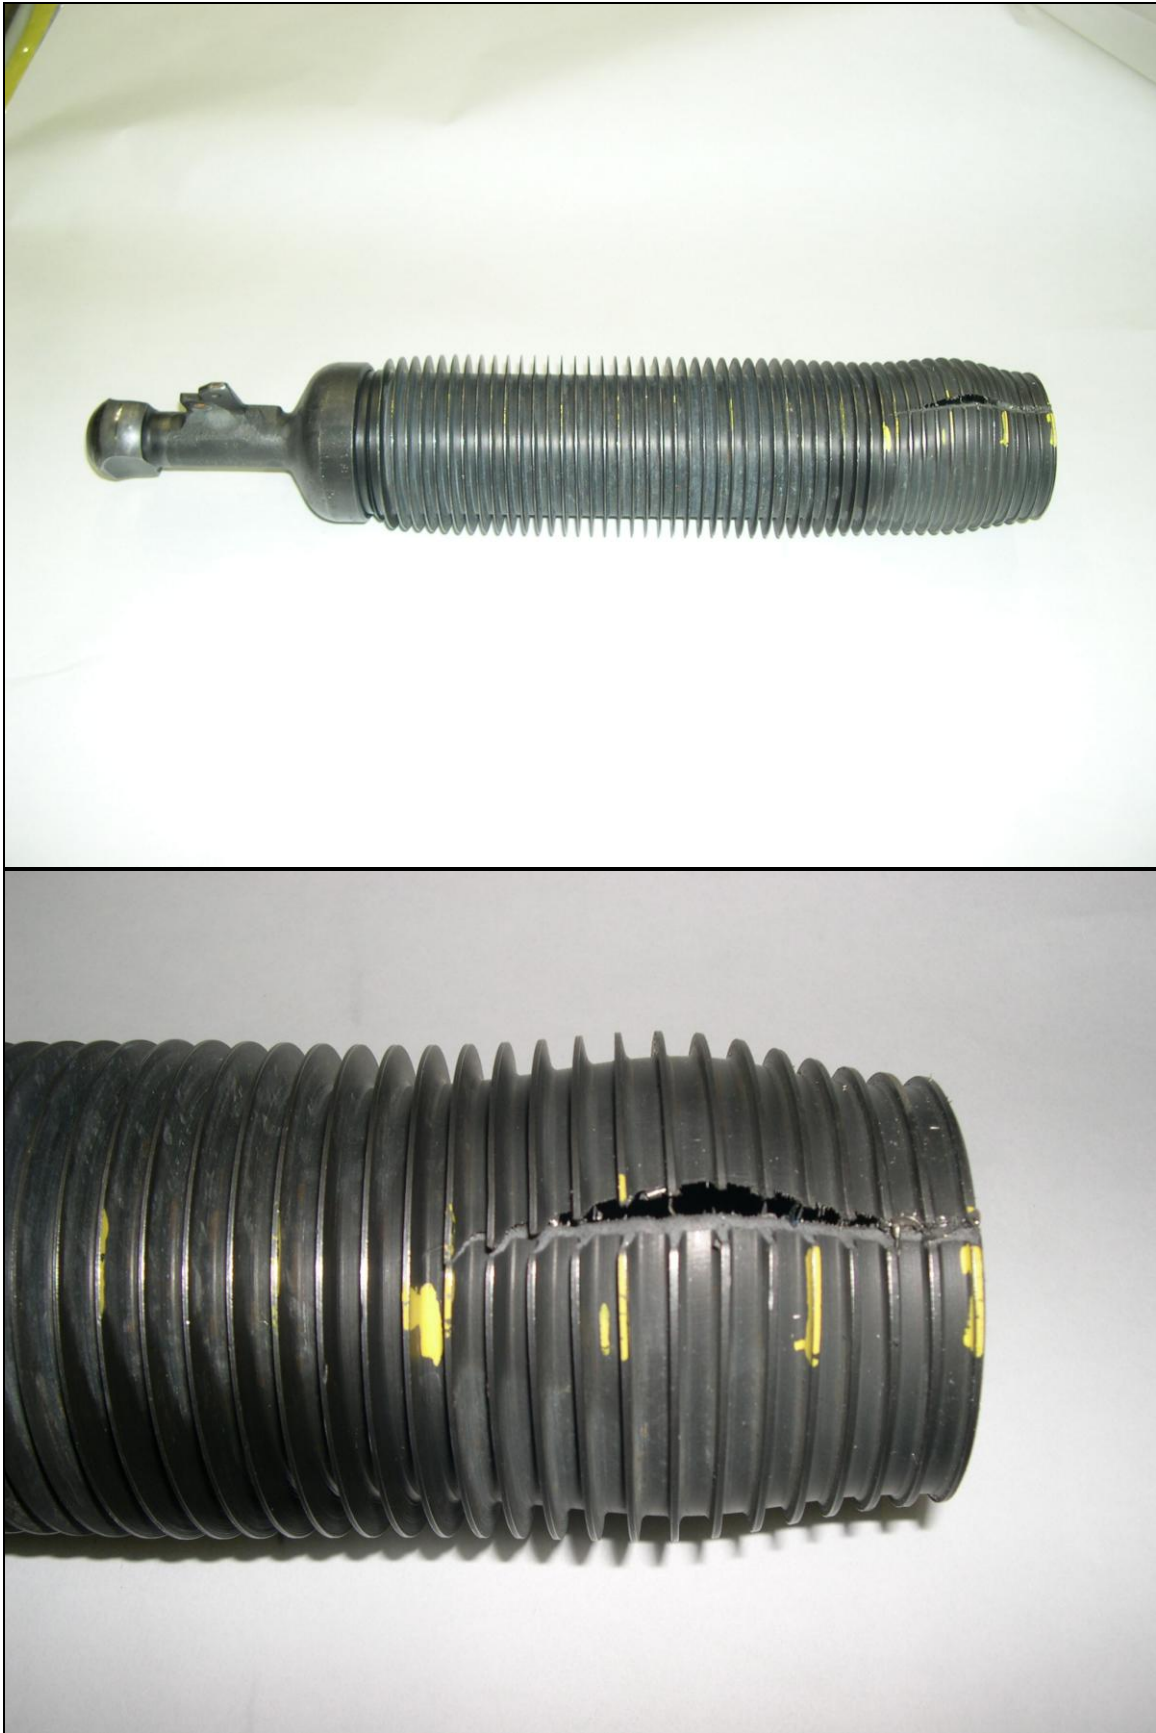
Tube 491  
Figure 11

The results for the burst test were consistent, with the fracture occurring at the muzzle end of the tubes and at locations that were consistent with one another. Each tube exhibited a fracture that is consistent with a ductile material. The fracture occurred at the extreme end of the tube (furthest from the base cap). On each tube, the failed area was bulged outwards and had a fracture that was between two and four inches in length. No shrapnel or other debris was observed during the burst failure. This is indicative of a good quality mortar tube material.

| Tube S/N | Burst Pressure |
|---|---|
| 491 | 26,343 psi |

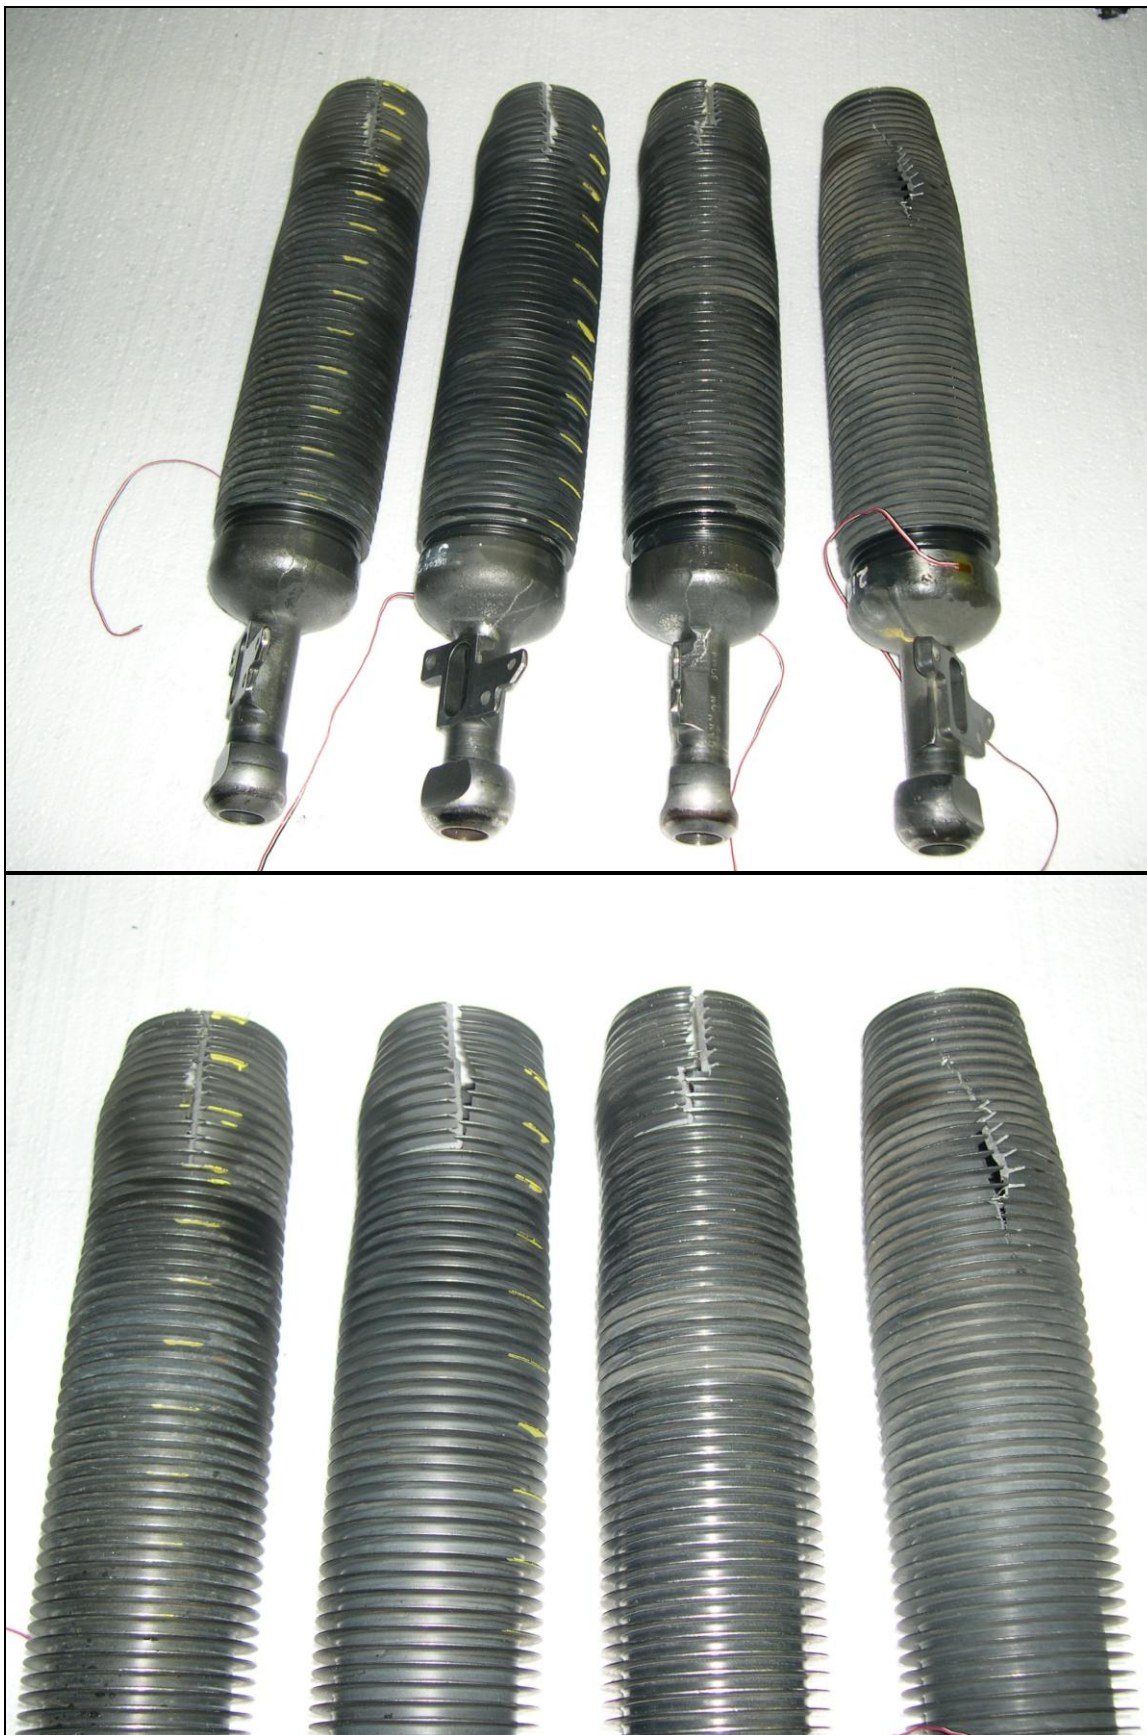
Tubes 491, 397, 1066, 210, from left to right.  
Figure 13

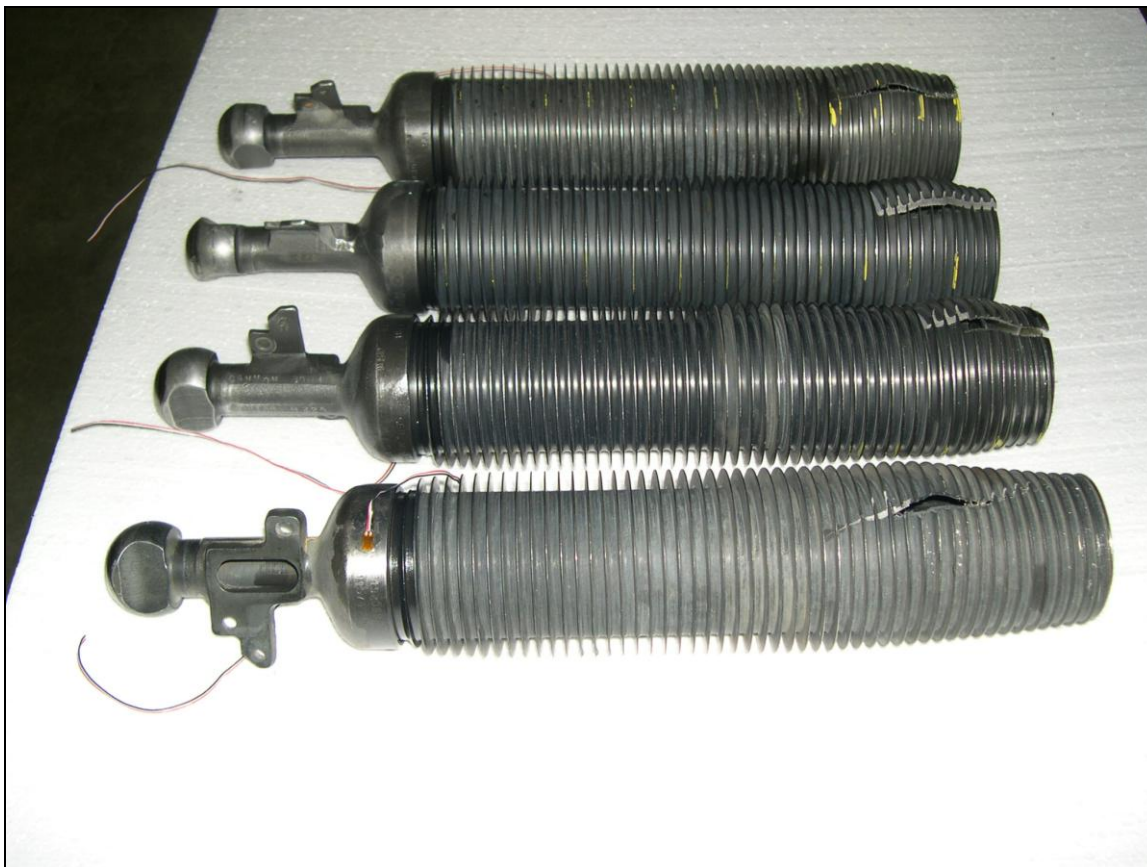
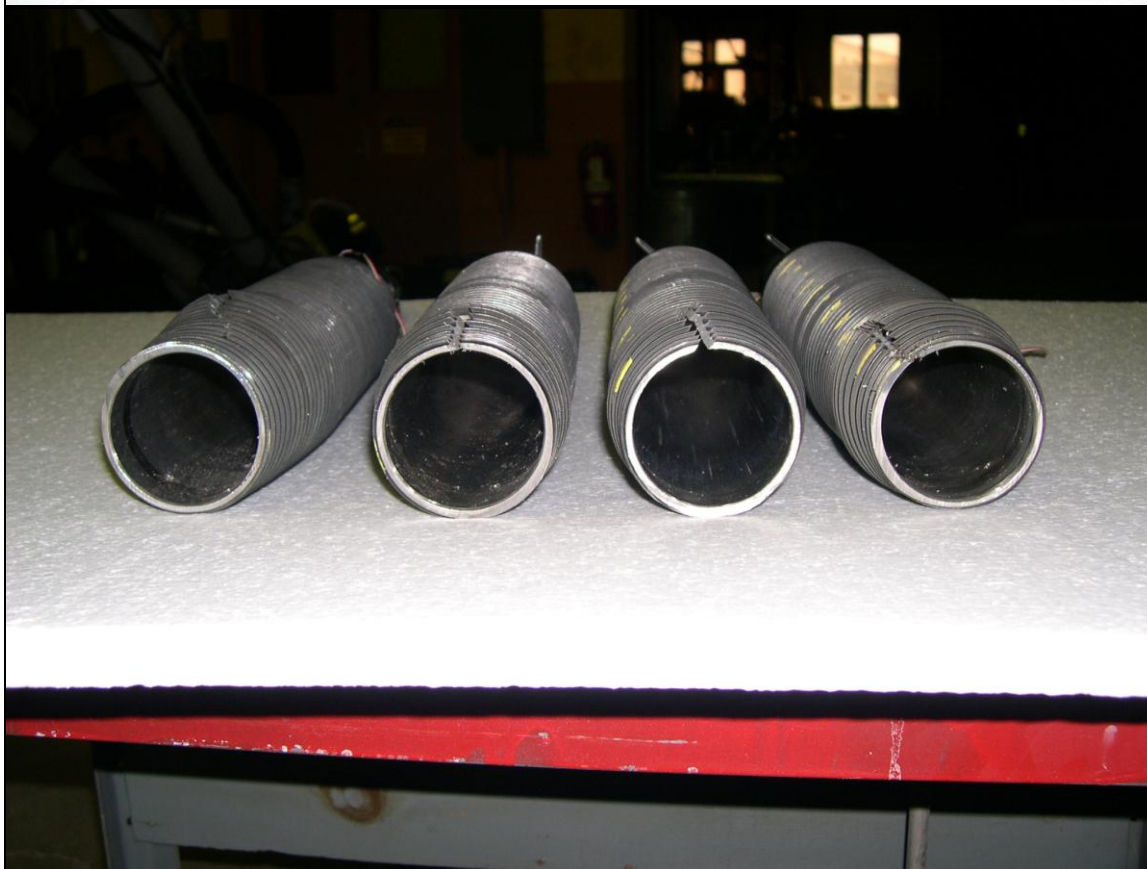
Tubes 491, 397, 1066, 210, from top to bottom (Top Photograph))  
Tubes 491, 397, 1066, 210, from left to right (Bottom Photograph)  
Figure 14

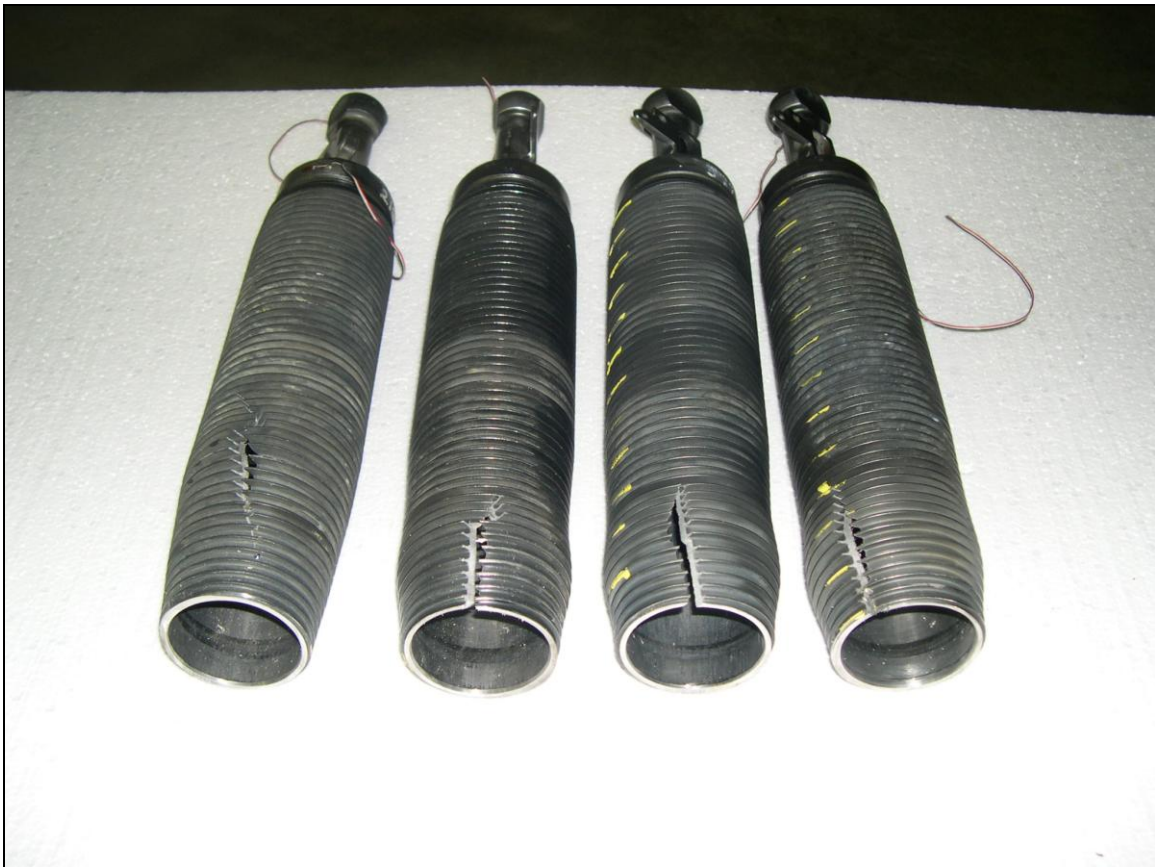
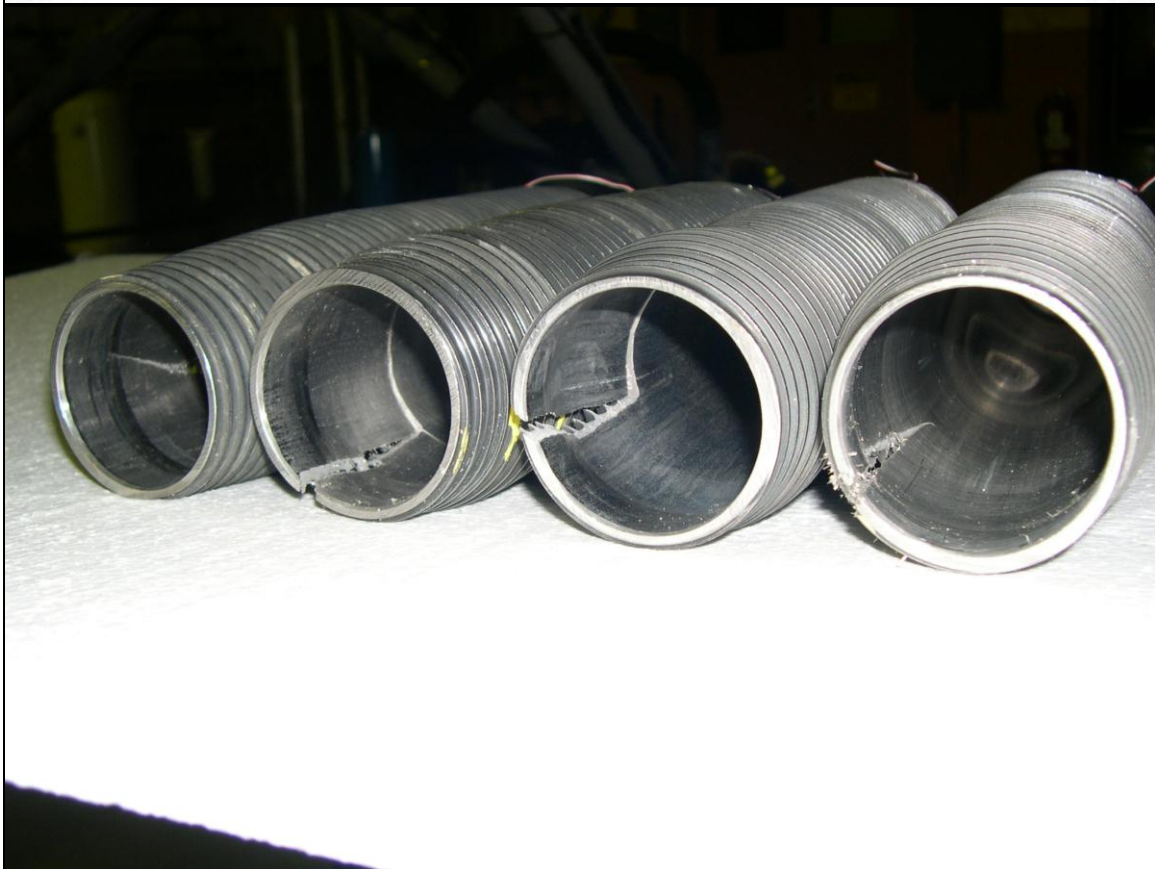
Figure 15

Tubes 491, 397, 1066, 210, from right to left.
