# Coastal Engineering Technical Note

CETN III-57  
6/95

## SEAWALL-BEACH INTERACTION: A Comparison of Monitoring Locations

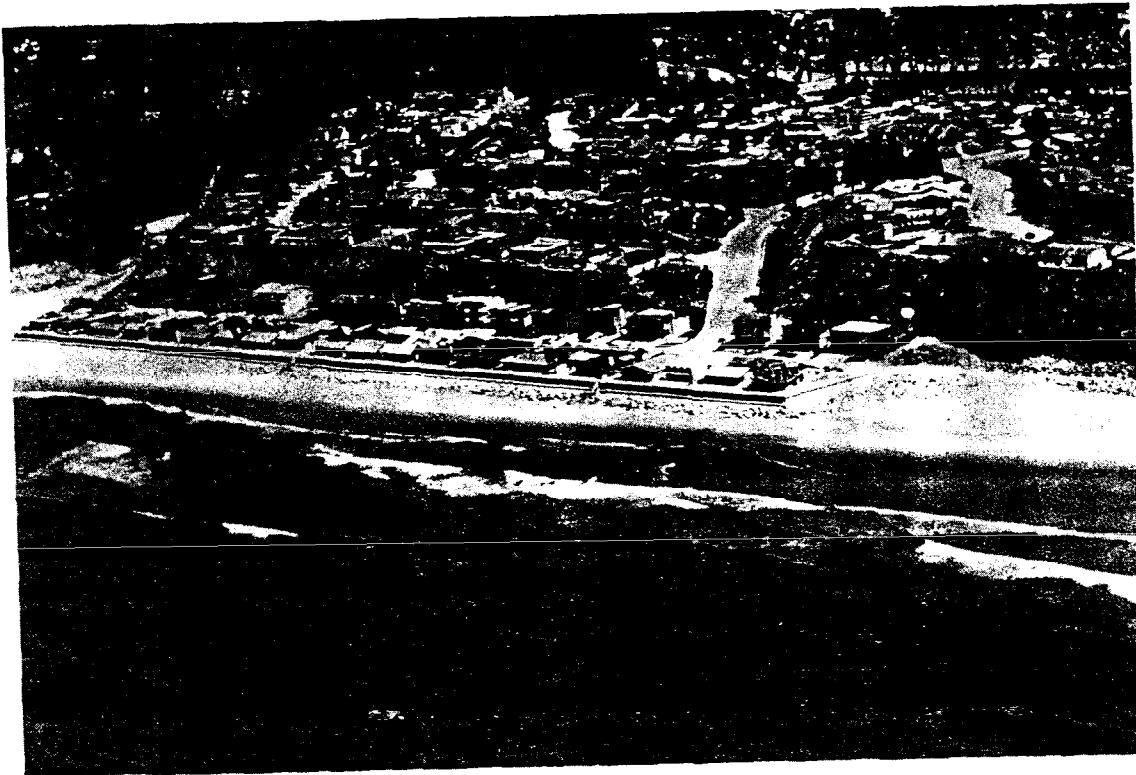
Figure 2. South Aptos Seascope Seawall (Griggs and Tait 1988)

Beach profiles to wading depth were measured at each of the four sites on a biweekly schedule from October 1986 to May 1989. Since 1989, monthly surveys have continued at the South Aptos Seascapes location shown in Figure 2. The 300-m-long structure at this site is a curved concrete seawall with riprap toe protection. The top of the structure is at +6.4 m mean lower low water (mllw) with toe protection placed on a 2:1 slope. The structure is approximately 75 m seaward from the base of a cliff and is constructed to protect a development of homes built on the back beach. Five lines were measured in front of the structure at 30-m spacings with a 90-m spacing at the structure end where control beach monitoring is conducted with three lines, again at 30-m intervals. Occasional nearshore surveys to the 9-m depth were also conducted with a boat and recording fathometer (Griggs and Tait 1988).

The South Aptos Seascape site at Monterey Bay could be classified as a Type I to Type III seawall depending on the season and storm condition. In the summer, the seawall is always landward of the berm crest (Type I) and, thus has no interaction with water level and wave runup. During the winter the seawall is in contact with the runup swash at most high tides (Type II), and during winter storms, the structure can be inundated by storm surge (Type III).

After 7 years of monitoring at the South Aptos Seascape site on Monterey Bay, Griggs, Tait, and Corona (1993) presented general conclusions on the impact of this structure on the beach. During the transition from a summer to a winter beach profile, the beach berm recedes faster in front of the seawall than on the adjacent control beach. Once the berm retreats beyond the seawall location, the profile is indistinguishable from the nearby unarmored beach. Scour is also observed during the winter at the downcoast end resulting from wave reflection from the end section. Transition from a winter to a summer beach profile shows no preference to the presence of a seawall. Recovery begins as the berm at the unarmored sections advances to the seaward edge of the seawall. At this point, berm growth progresses uniformly along the entire reach of shoreline. No long-term effects of the seawall have been observed during the 7-year monitoring period.

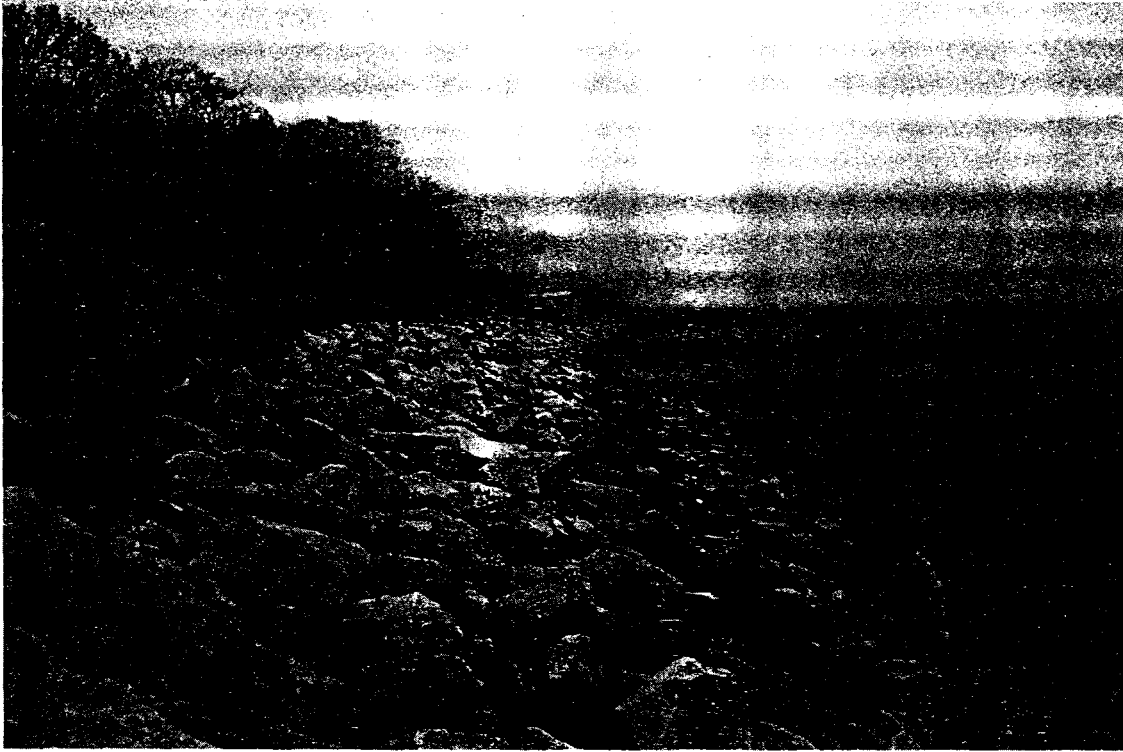
Figure 7. Duck Lake revetment

The Duck Lake structure is Type V because the structure toe is always submerged, and it is subjected to wave breaking during periods of storms. The Duck Lake revetment does not, however, project farther seaward than the adjacent sand beaches, thereby preventing classification as a Type VI.
