Encrypted Tracking System (ETS) Integration for  
Maryland Natural Resources Police (NRP) and the  
Maritime Tactical Operations Group (MTOG)

NRL/PU/8140--13-586  
October 2013

**NAVAL RESEARCH LABORATORY**

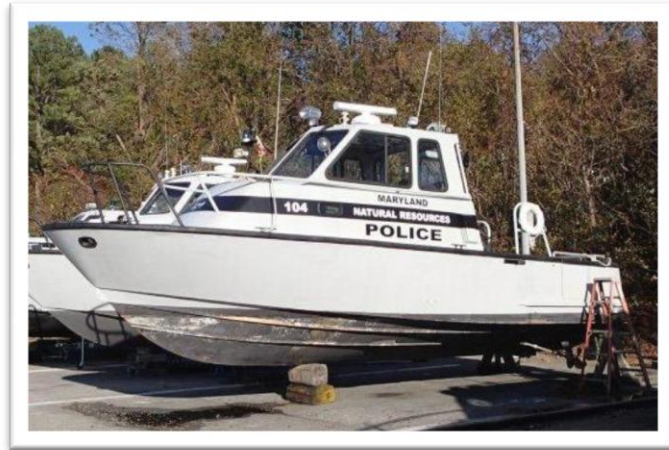
Figure 4.1.1 NRP 104, *Calvert*

This Boston Whaler was deemed too large for the garage, requiring work to be performed while dry docked outdoors (see Figure 4.1.1 NRP 104, *Calvert*). The vessel's mast was unsuitable for the antenna installation because its oval shape would not accommodate the cable clamps, and it did not have sufficient area to accommodate the two antenna mounts.

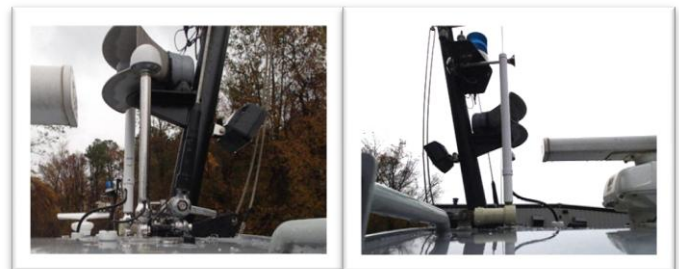
Figure 4.1.2 GPS and VHF Antennas

The GPS and Very High Frequency (VHF) antennas were installed on the roof of the vessel (see Figure 4.1.2 GPS and VHF Antennas). The vessel's internal cable ways were used for antenna cable routing (see Figure 4.1.3 Cable Access). The transponder was mounted on the console (see Figure 4.1.4 Transponder), and it was connected to the existing Garmin chart plotter.

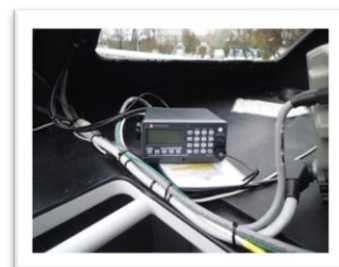
Figure 4.1.4 Transponder

The transponder was tested with the Garmin chart plotter. System operation was verified using an internet-based ship locator program.

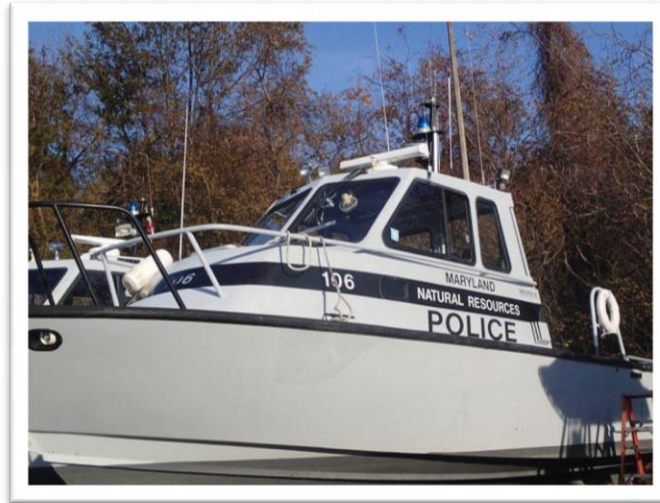
Figure 4.2.1 NRP 106, *St. Mary's*

This Boston Whaler was deemed to be too large for the garage, requiring work to be performed while dry docked outdoors (see Figure 4.2.1 NRP 106, *St. Mary's*).

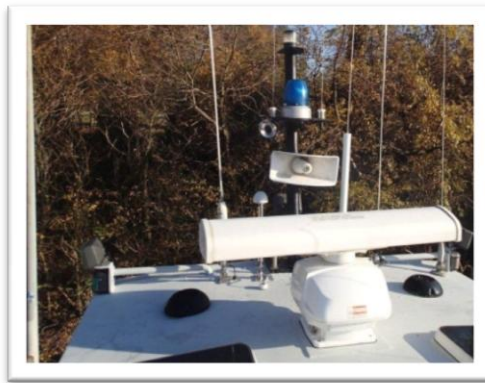
Antenna installation was similar to NRP 104 and no difficulties were encountered (see Figure 4.2.2 Antenna and Figure 4.2.3 Transponder). The GPS and VHF antennas were installed on the roof of the vessel. The vessel's internal cable ways were used for antenna cable routing. The transponder was mounted on the console (see Figure 4.2.4 Console), and it was connected to the existing Garmin chart plotter.

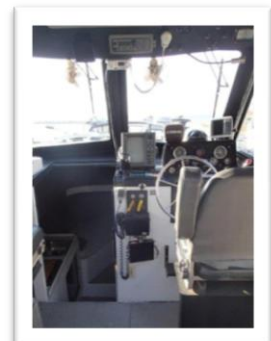
Figure 4.2.4 Console

The transponder was tested with the Garmin chart plotter (see Figure 4.2.4 Console). System operation was verified using another vessel with AIS capability.

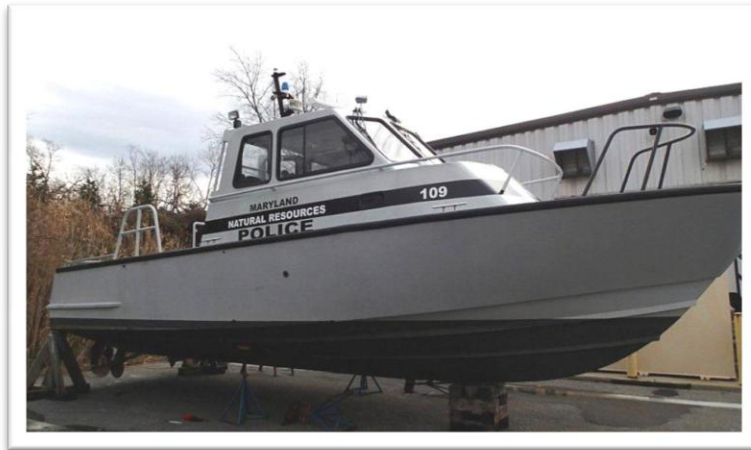
Figure 4.3.1 NRP 109, *Worcester*

This 36 foot Sea Ark required the installation of new cable clams to accommodate the VHF and GPS cables and to ensure water tight integrity (see Figure 4.3.1 NRP 109, *Worcester*).

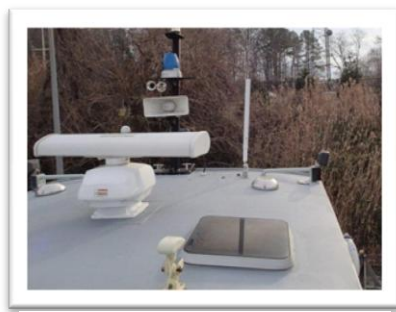
Figure 4.3.2 Antenna

The antenna mounts for the GPS and VHF antennas were mounted to existing antenna mounting locations (see Figure 4.3.2 Antenna). The transponder was located on the starboard dash and the cables were routed down the window channel with the radar control cable (see Figure 4.3.3 Transponder). Power and ground lines were run to the electrical panel. Power for the unit is provided by the Radar power switch.

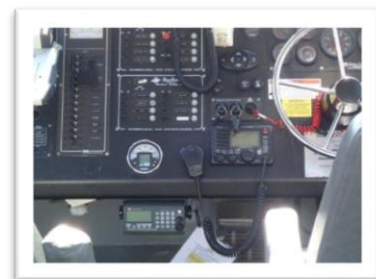
GPS and VHF Antennas were located on the mast and cable clams were installed in the mast to accommodate the cables (see Figure 4.4.2 Antenna). Cable routing was straight forward with no issues. The transponder was wired to the power panel. The transponder was mounted under the lower edge of the console and positioned to allow for sufficient space between the port passenger seat and the unit (see Figure 4.4.3 Console and Figure 4.4.4 Transponder). This location is preferred for ease of operation of the AIS unit.

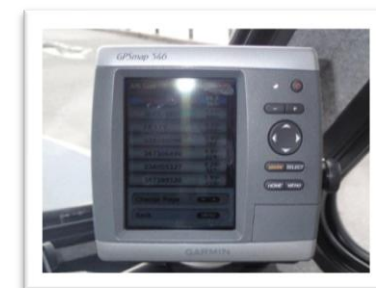
Figure 4.4.5 Garmin

The transponder was configured in accordance with the installation checklist. The integration of the chart plotter (see Figure 4.4.5 Garmin) was completed after troubleshooting indicated that Garmin uses a non-standard labeling for their communications wiring schematic, which caused delays in the integration of the system. Once the correct wiring scheme was identified, the integration was easily completed.

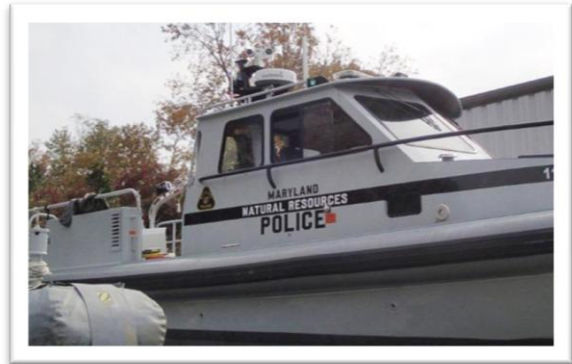
Figure 4.5.1 NRP 111, *Mattawoman*

This 45 foot Sea Ark (see Figure 4.5.1 NRP 111, *Mattawoman*) did not have sufficient space on the mast to install the GPS and VHF antennas. A roof mount would require cable routing to go through the lower galley and head in order to reach the console. There was no room on the NAV power switch to accommodate the AIS unit.

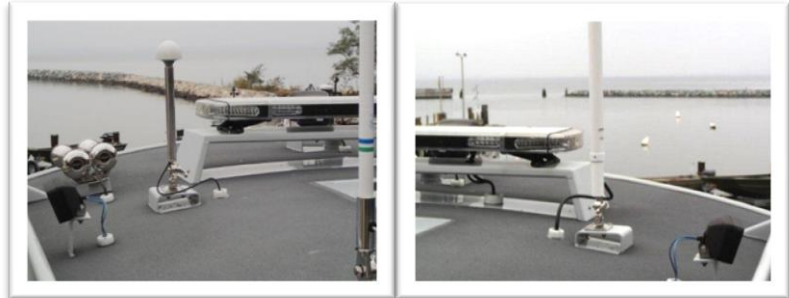
Figure 4.5.2 Antennas

Two antenna mounts forward of the mast were used for antenna installation (see Figure 4.5.2 Antennas). The transponder was located on the pilot side of the console toward the centerline, allowing for clearance of other equipment and ease of integration with the Garmin 7215 navigation system (see Figure 4.5.3 Transponder).

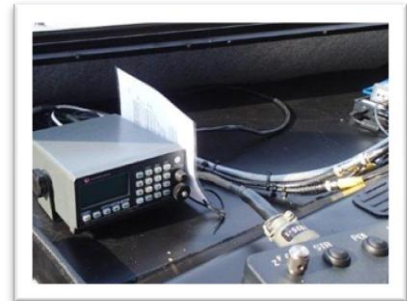
Figure 4.5.3 Transponder

Power for the transponder was taken from the main power panel switch. A terminal block was installed in the console to integrate the AIS unit with the Garmin Navigation system.

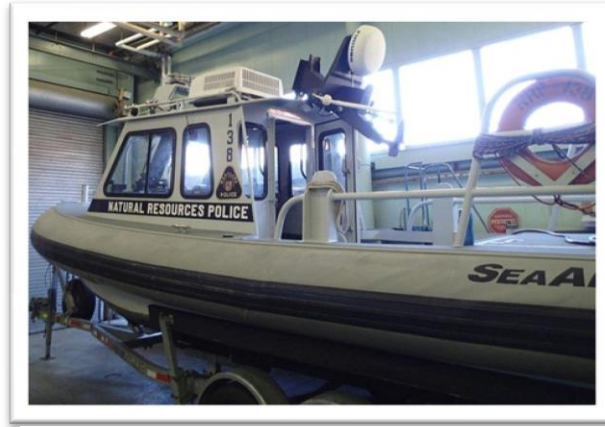
**Figure 4.6.1 NRP 138, *Piney Point***

This 25 foot Sea Ark had sufficient space for the antenna mounts and antennas to be mounted while still leaving clearance for the infrared camera (see Figure 4.6.1 NRP 138, *Piney Point*). A power source/switch for the transponder was identified on the power panel.

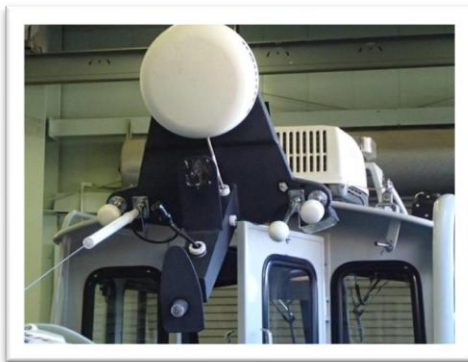
**Figure 4.6.2 Mast**

GPS and VHF Antennas were located on the mast and cable clamps were installed in the mast to accommodate the cables (see Figure 4.6.2 Mast). The transponder was wired to the power panel. The transponder was mounted to the lower edge of the console and positioned to allow for sufficient space between the port passenger seat and the unit (see Figure 4.6.3 Transponder). The integration of the transponder and Garmin chart plotter was completed and verified.

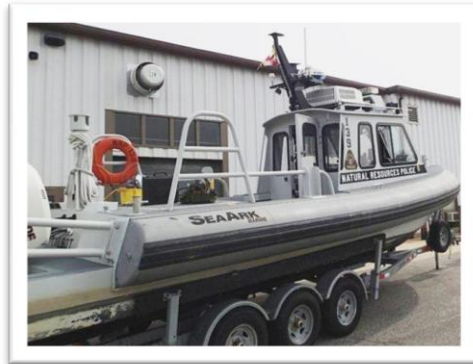
**Figure 4.7.1** NRP 139, *Talbot*

This is a 25 foot Sea Ark (see Figure 4.7.1 NRP 139, *Talbot*). The radar display and radio prohibited access to the cable chase. There was sufficient space in the console to flush-mount the transponder.

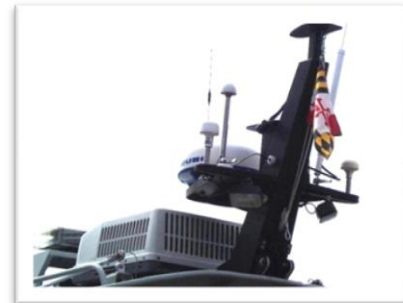
**Figure 4.7.2** Mast & Antenna

Antennas were installed on the mast (see Figure 4.7.2 Mast & Antenna and Figure 4.7.3 Mast) and antenna cables were routed through the overhead and down the cable chase in the center of the window (see Figure 4.7.4 Overhead). The Forward Looking Infrared (FLIR) camera laptop mount was attached on the deck amidships between the pilot and passenger (see Figure 4.7.5 Console). Power for the transponder was connected to the SPARE switch on the Direct Current (DC) power panel.

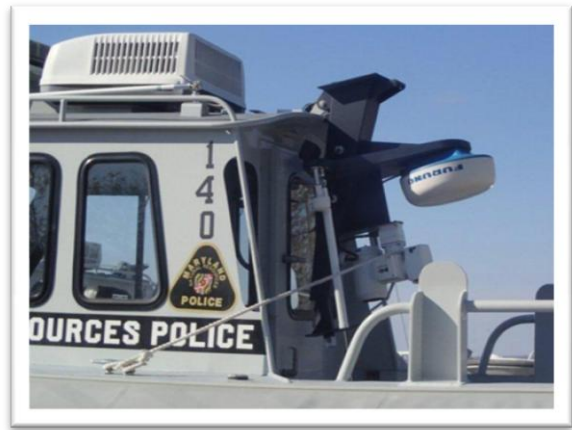
Figure 4.8.1 NRP 140, *Baltimore*

This 25 foot Sea Ark had sufficient space for the antenna mounts and antennas to be mounted while still leaving clearance for the infrared camera (see Figure 4.8.1 NRP 140, *Baltimore*). A power source/switch for the transponder was identified on the power panel.

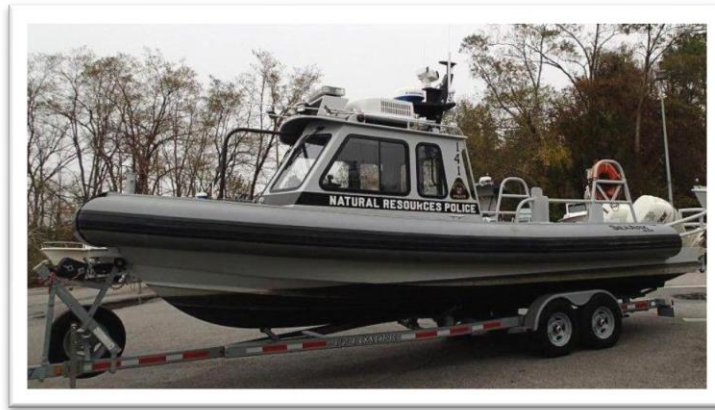
Figure 4.9.1 NRP 141, *City Dock*

This 25 foot Sea Ark had sufficient space for the antenna mounts and antennas to be mounted while still leaving clearance for the infrared camera (see Figure 4.9.1 NRP 141, *City Dock*). A power source/switch (Spare) for the transponder was identified on the power panel.

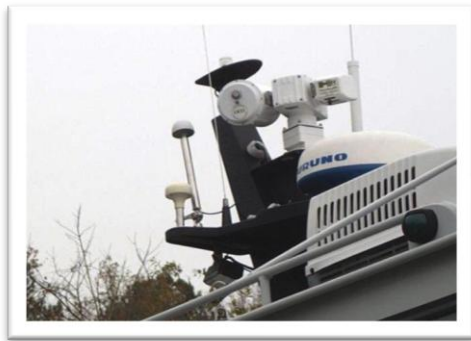
GPS and VHF Antennas were located on the mast and cable clams were installed in the mast to accommodate the cables (see Figure 4.9.2 Starboard Antenna and Figure 4.9.3 Port Antenna). The transponder was wired to the power panel. The transponder was mounted on the lower edge of the console and positioned to allow for sufficient space between the port passenger seat and the unit (see Figure 4.9.4 Transponder). This location is preferred for ease of operation of the AIS unit. The integration of the transponder and Garmin chart plotter was completed and verified.

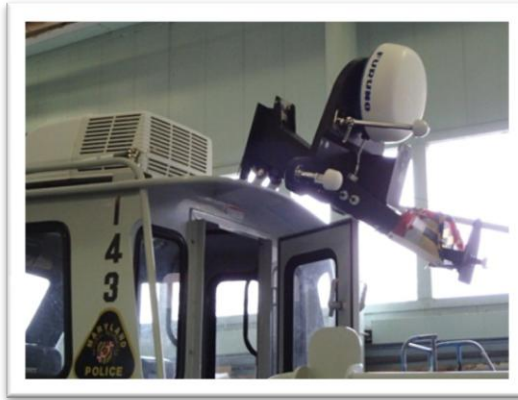
Figure 4.10.1 NRP 143, *Deal Island*

This 25 foot Sea Ark had sufficient space for the antenna mounts and antennas to be mounted while still leaving clearance for the infrared camera (see Figure 4.10.1 NRP 143, *Deal Island*). A power source/switch (Spare) for the transponder was identified on the power panel.

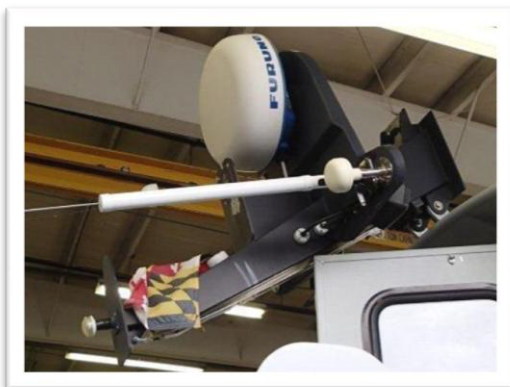
Figure 4.10.2 Mast & Antenna

GPS and VHF Antennas were located on the mast and cable clams were installed in the mast to accommodate the cables (see Figure 4.10.2 Mast & Antenna). The transponder was wired to the power panel. The transponder was mounted on the shelf below the port side console (see Figure 4.10.3 Console and Figure 4.10.4 Transponder). The integration of the transponder and Garmin chart plotter was completed and verified.

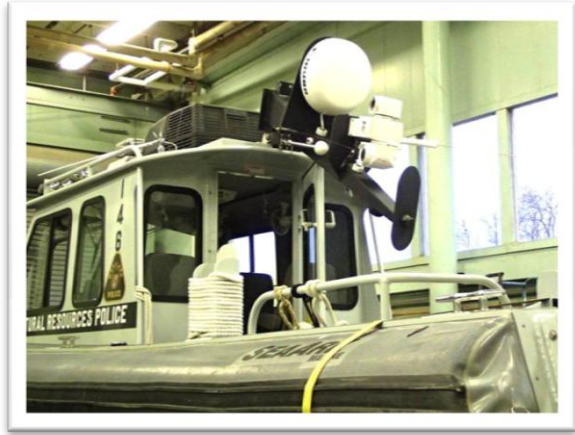
Figure 4.12.1 NRP 146, *Solomon's Island*

This 25 foot Sea Ark had sufficient space for the antenna mounts and antennas to be mounted while still leaving clearance for the infrared camera (see Figure 4.12.1 NRP 146, *Solomon's Island*). A power source/switch (Spare) for the transponder was identified on the power panel.

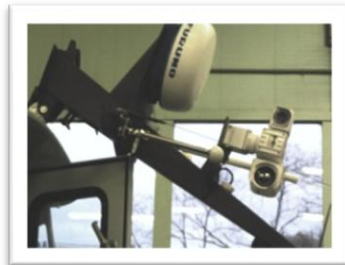
GPS and VHF Antennas were located on the mast and cable clamps were installed in the mast to accommodate the cables (see Figure 4.12.2 Mast and Figure 4.12.3 Antenna). The transponder was wired to the power panel. The transponder was mounted on the shelf below the console on the port side (see Figure 4.12.4 Transponder). The integration of the transponder and Garmin chart plotter was completed and verified (see Figure 4.12.5 Garmin).

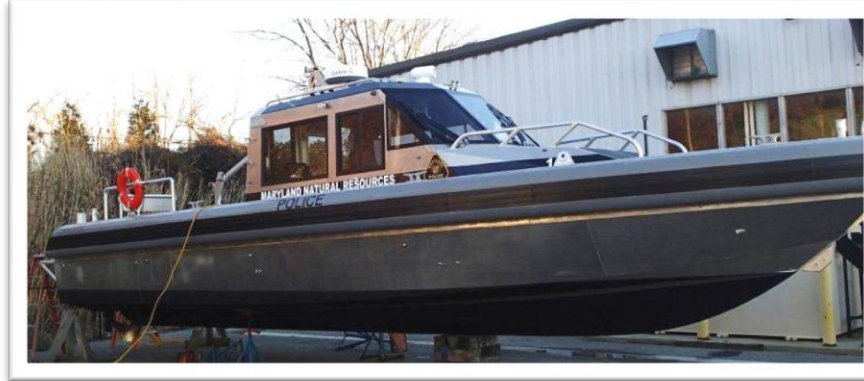
Figure 4.13.1 NRP 147, *Severn*

This 38 foot Metal Shark had an unused mounting cleat on the roof of the vessel (see Figure 4.13.1 NRP 147, *Severn*). A power source/switch (Spare) for the transponder was identified on the power panel.

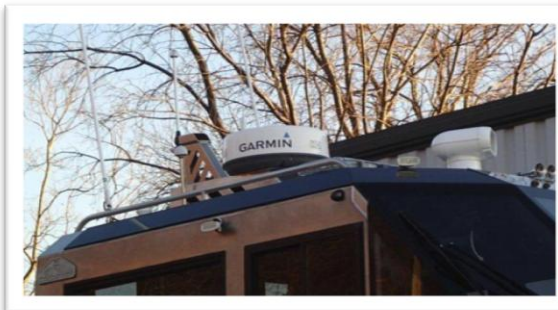
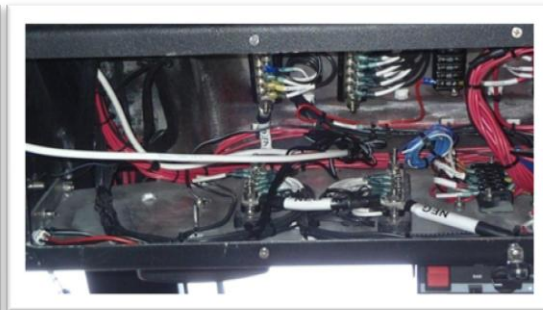
GPS and VHF Antennas were located on the mast and cable clams were installed in the roof to accommodate the cables (see Figure 4.13.2 Antenna and Figure 4.13.3 Wiring). The transponder was wired to the power panel. The transponder was installed onto the console and flush-mounted on the port side of the console (see Figure 4.13.5 Console and Figure 4.13.4 Transponder). The integration of the transponder and Garmin 7000 series chart plotter was completed and verified.

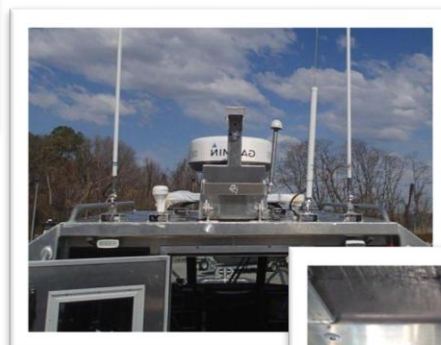
Figure 4.14.2 Antenna

The VHF antenna mount was installed to an available bracket next to the mast. The GPS antenna and mount were installed onto the side of the mast below the camera mounting area (see Figure 4.14.2 Antenna). Penetrations for the cables were made and the cable glands installed (see Figure 4.14.3 Overhead). A hole was cut into the port side console to flush-mount the transponder (see Figure 4.14.4 Transponder). Power and ground cables were routed from the transponder to the Starboard Side DC power panel. The circuit breaker and switch were then tested and the cables terminated. The cables for the GPS and VHF antennas were routed through the ceiling and down the windshield cable chase, terminated and connected to the transponder. All cables were secured into place and the ceiling panels were reinstalled.

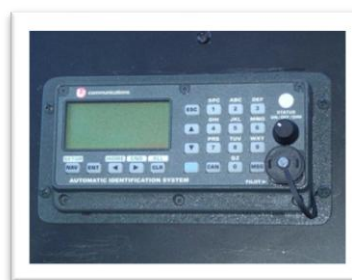
Figure 4.14.4 Transponder

This 38 foot Metal Shark was equipped with an available single mounting point suitable for the VHF antenna mount. The mast area was deemed suitable for GPS antenna mounting. The ceiling panels required removal to gain access to the overhead and the cable chases. The console was surveyed, and a location for mounting the transponder was identified (see Figure 4.14.1 NRP 148, *Tangier Sound*).

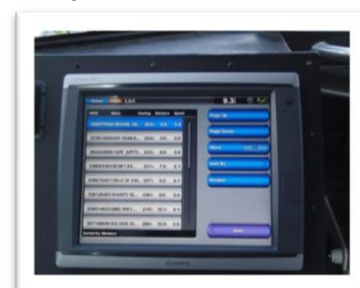
Figure 4.14.5 Plotter

The Data cable was routed to a suitable area in the Port electrical bay. A terminal block was installed to make the connections, and the chart plotter (see Figure 4.14.5 Plotter) was connected on NMEA channel 2.

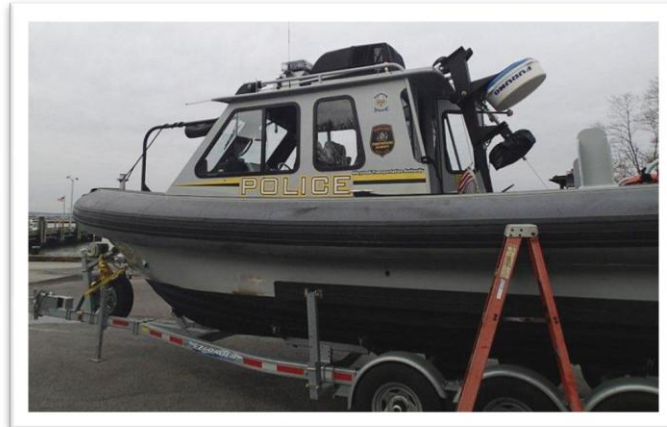
Figure 4.15.1 MD Transportation Authority Police, *Marine One*

This 25 foot Sea Ark had sufficient space for the antenna mounts and antennas to be mounted while still leaving clearance for the infrared camera (see Figure 4.15.1 MD Transportation Authority Police, *Marine One*). A power source/switch (Spare) for the transponder was identified on the power panel.

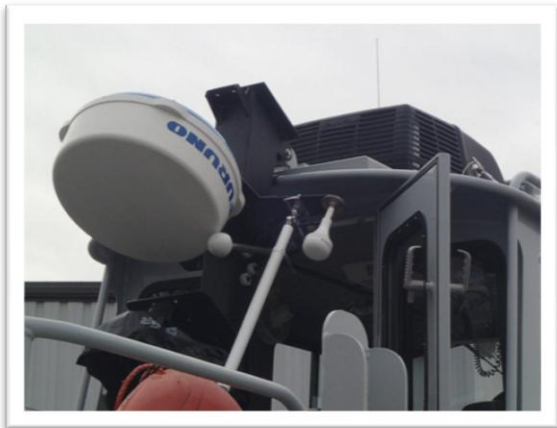
Figure 4.15.2 Mast & Antenna

GPS and VHF Antennas were located on the mast and cable clams were installed in the mast to accommodate the cables (see Figure 4.15.2 Mast & Antenna). The transponder was wired to the power panel. The transponder location was discussed with the vessel operator and located to the port side below the console on a built-in tray (see Figure 4.15.3 Transponder). The integration of the transponder and Garmin chart plotter was completed and verified.

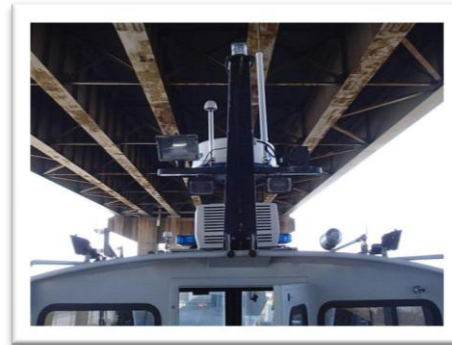
Figure 4.16.2 Antenna

The mast was lowered, and antenna mounts were installed. Access holes were cut into the mast to accommodate cables. Cable glands were installed and cable ends were terminated. Antennas were installed and the cables were routed into the cabin (see Figure 4.16.2 Antenna). The center ceiling panels and an access plate were removed to allow for cable routing. Cables were routed down the window cable chase, and an access hole was made to route the cables to the transponder and the power panel. The transponder was mounted and the GPS and VHF cables terminated (see Figure 4.16.3 Transponder). The power and ground cables were routed through the cable chase to the power panel in the console.

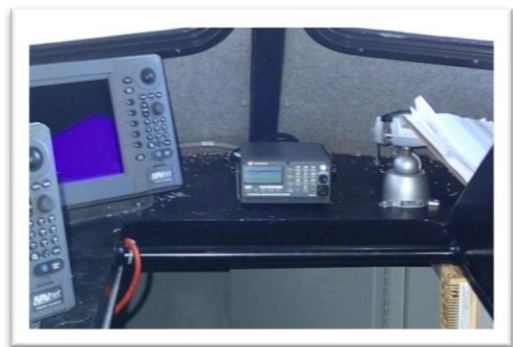
Figure 4.16.3 Transponder

The power panel was temporarily removed for cable installation. A 6-pin Furuno data cable was installed to facilitate future upgrade of the chart plotter to a model that supports AIS (e.g. Furuno RDP149). The data cable was connected to the transponder and Data 2 of the RDP139 chart plotter. This data cable is interchangeable between the two units.

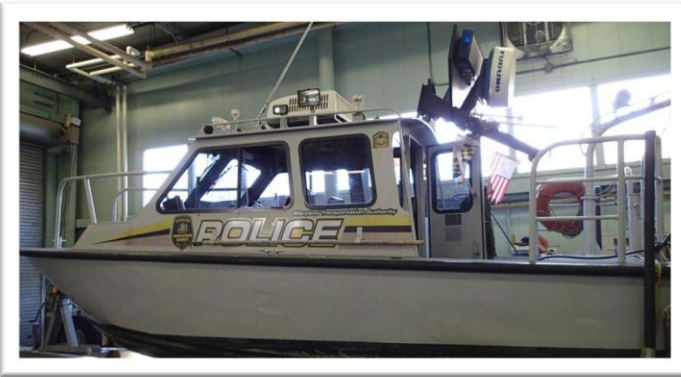
Figure 4.18.1 MD Transportation Authority Police, *Marine Four*

This was the oldest Sea Ark vessel in this group of ETS integrations. The vessel contained a V-berth forward, making cable installation problematic (see Figure 4.18.1 MD Transportation Authority Police, *Marine Four*). Radios were installed onto a tray covering the ceiling panel in the main cabin, inhibiting panel removal (see Figure 4.18.2 Cabin).

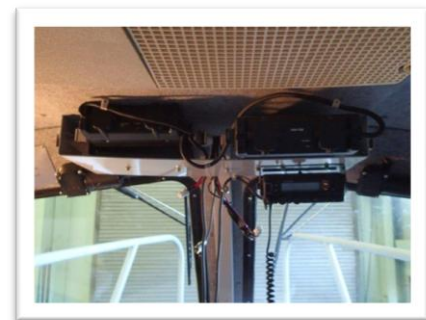
Figure 4.18.3 Cables

Several ceiling panels in the berth were removed to allow access. Cables were routed above the ceiling panel (see Figure 4.18.3 Cables) and down the wind screen beside the cable channel and fastened with cable clams. The transponder was located on the top port console between the Furuno 1833C radar display and the GD 1700C chart plotter (see Figure 4.18.4 Transponder). The transponder power was collocated with the chart plotter power switch.

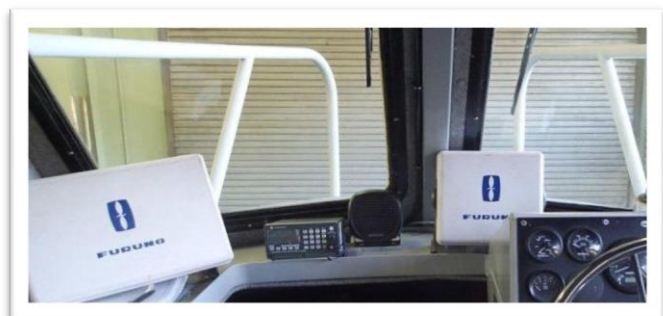
Figure 4.18.4 Transponder

The data cable was installed; however, the Furuno units are incompatible with AIS. The firmware for these units must to be updated for the integration of the Protec-M to function.

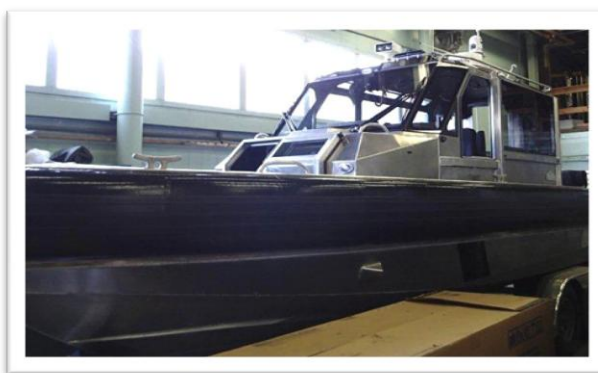
Figure 4.19.1 Annapolis City Police, *Annapolis*

The ETS integration was the first installation of this type on the 25 foot Metal Shark vessel and all ceiling panels required removal to determine the approach (see Figure 4.19.1 Annapolis City Police, *Annapolis*). Existing cables were traced one at a time (due to small size of the cable chase) to determine the access point to the cable chase (see Figure 4.19.2 Cable Access).

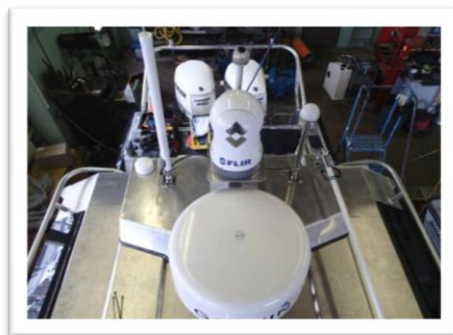
Figure 4.19.3 Antenna

The GPS and VHF cables were pulled through the cable chase from the antennas (see Figure 4.19.3 Antenna) with some difficulty due to 90 degree bends. Two access cuts were made in the chase to allow for a fish tape. With consultation of the vessel operator, the transponder was flush-mounted in the console (see Figure 4.19.4 Transponder). The template was installed and all cables and air conditioning vents were removed from the inside of the console. Pilot holes were drilled and an opening was cut in the console for the transponder. The VHF and GPS antenna cables were terminated and the power and communication cables were routed to the power panel access point (see Figure 4.19.5 Power Panel). The power cable was terminated in the first available spare circuit breaker. The grounds were terminated to the grounding bus. All cables were secured in place. The communications cable for the Garmin 5212 chart plotter was integrated with the transponder.

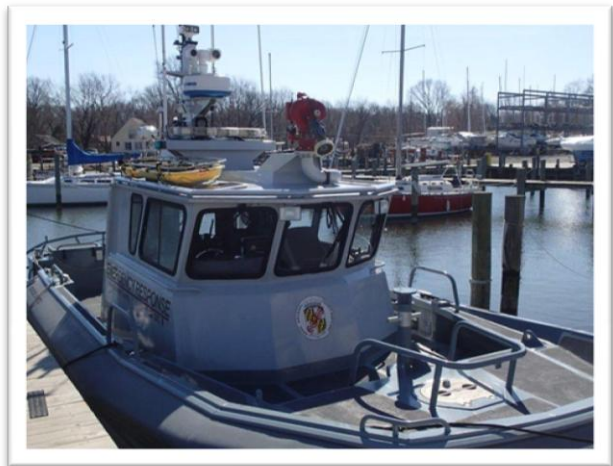
Figure 4.20.1 Anne Arundel County Police, *Patriot*

Integration on this 35 foot Moose boat required an in-depth survey to determine equipment locations (see Figure 4.20.1 Anne Arundel County Police, *Patriot*). The mast is twice the size of the Sea Ark vessels; three people and a come-along are needed to raise and lower it for the integration. The VHF and GPS antenna mounts were located on the forward portion of the mast beside the light bar. There was no obvious access to the cable tray that runs the length of the vessel. There was no area on or under the console to accommodate the transponder. No access to the cable tray was found above the main ceiling panel or above a smaller ceiling panel in the head.

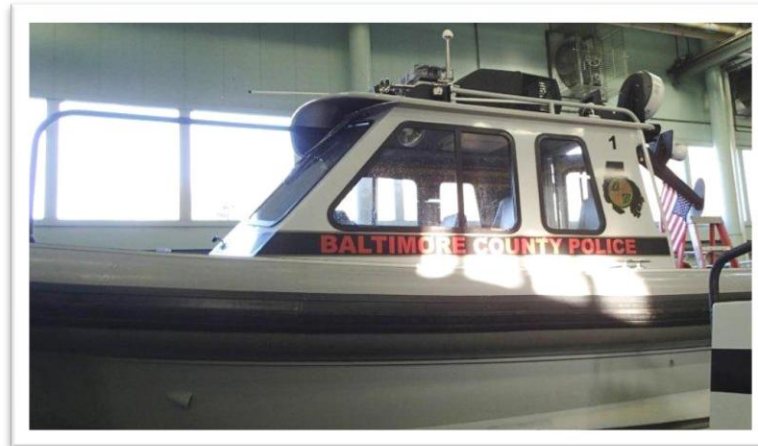
Figure 4.21.1 Baltimore County Police, *MARINE 1*

This 25 foot Sea Ark did not have sufficient space to install the antenna mounts and antennas, and allow enough clearance for the camera system (see Figure 4.21.1 Baltimore County Police, *MARINE 1*). A power source/switch for the transponder was identified on the power panel.

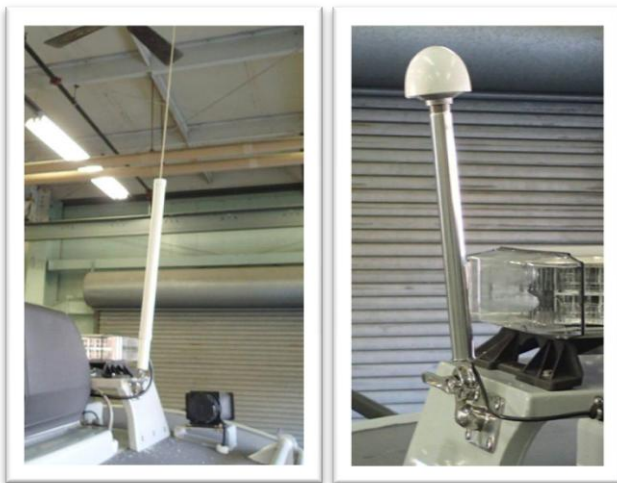
Figure 4.21.2 Antennas

The antenna mounts and antennas were located on the sides of the light bar bracket (see Figure 4.21.2 Antennas). Cable clams were installed in the roof to accommodate the cables. The transponder was installed on the side of the shelf below the console on the port side (see Figure 4.21.3 Transponder). The integration of the transponder and Garmin 4212 chart plotter was completed and verified.

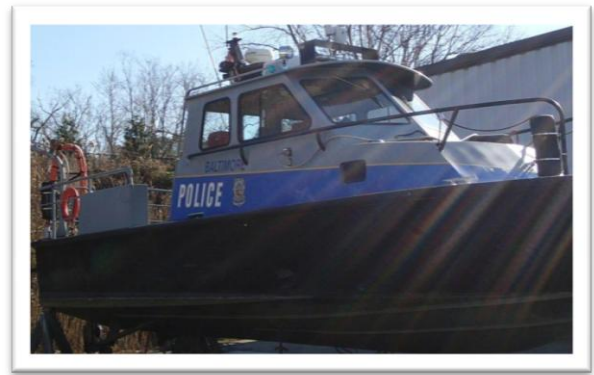
Figure 4.22.1 Baltimore Police Department, *Dauntless*

This older, 36 foot Sea Ark did not have an area on the mast suitable for antenna installation (see Figure 4.22.1 Baltimore Police Department, *Dauntless*).

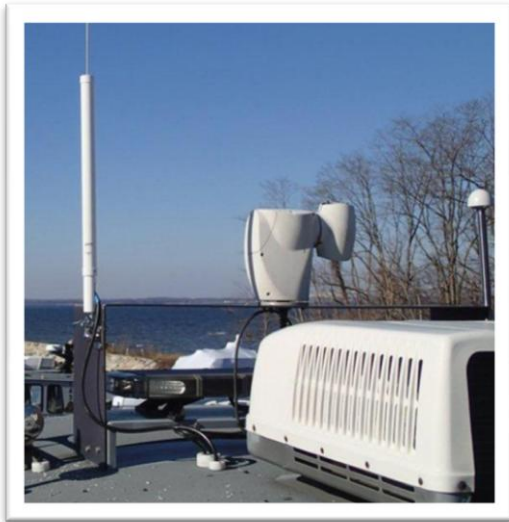
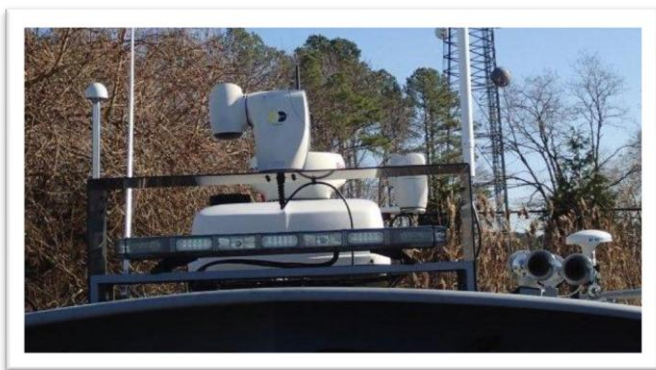
A bracket that covers the forward light bar and serves as a mount for one of the camera systems was used as a mounting location for the antenna mounts (see Figure 4.22.2 Side View of Antennas and Figure 4.22.3 Antennas). Access holes were drilled, and cable clams were installed. The cables were routed through the roof panel and down through the electrical cabinet. The transponder was mounted to the starboard side console and positioned to give the boat operator a clear view of the unit (see Figure 4.22.4 Transponder). The chart plotter and radar system on this vessel are not compatible with AIS. The data cable was provided to the operator for future integration to an upgraded radar/plotter.

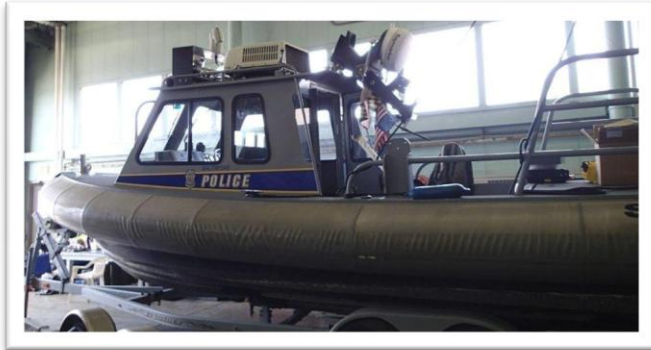
Figure 4.23.1 Baltimore Police Department, *Ram 9828*

This 25 foot Sea Ark had GPS and VHF antennas on the mast (see Figure 4.23.1 Baltimore Police Department, *Ram 9828*). A power source/switch for the transponder was identified on the power panel.

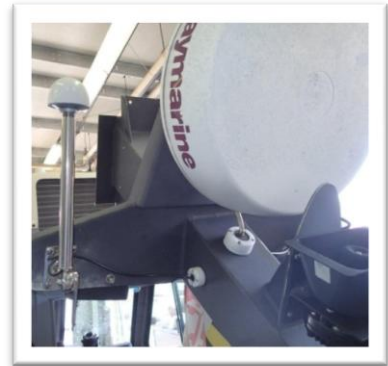
Cable clamps were installed in the mast to accommodate the cables (see antenna and mast at Figure 4.23.2 Mast and Figure 4.23.3 Antenna). The transponder was wired to the power panel. The transponder was mounted on the lower edge of the console and positioned to allow for sufficient space between the port passenger seat and the unit (see Figure 4.23.4 Console and Figure 4.23.5 Transponder). Chart plotter integration was not accomplished because the Furuno 1850WDF chart plotter is not AIS capable.

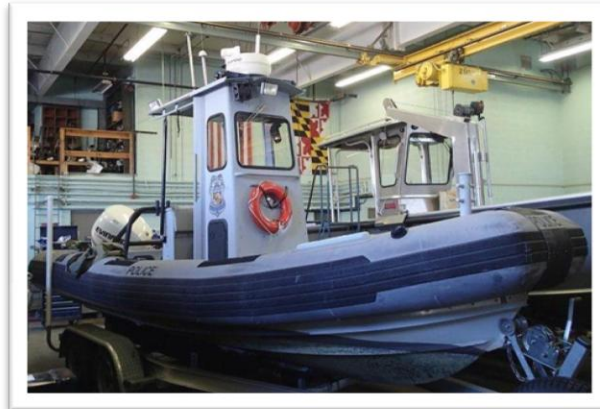
Figure 4.24.1 Baltimore Police Department, *Hurricane 1*

This 18 foot Zodiac had an open cockpit with an aluminum cover over the cockpit and part of the passenger area (see Figure 4.24.1 Baltimore Police Department, *Hurricane 1*). The electronics enclosure located above the console did not have sufficient space to mount the transponder. There was sufficient space available on the console for mounting the transponder.

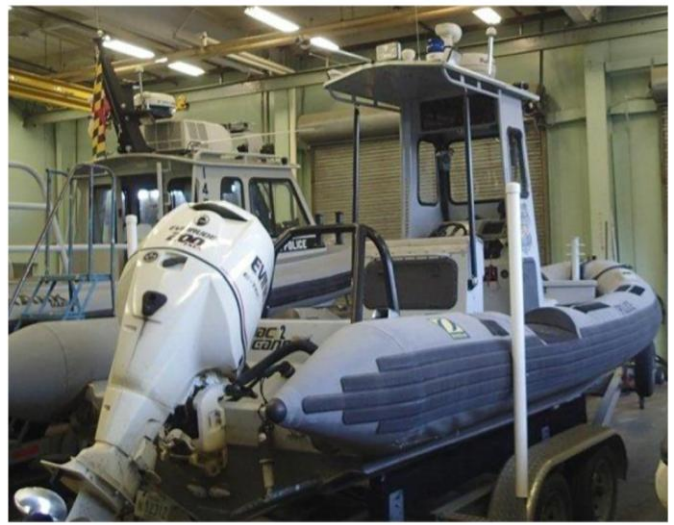
Figure 4.25.1 Baltimore Police Department, *Hurricane 2*

This 18 foot Zodiac had an open cockpit with an aluminum cover over the cockpit and part of the passenger area (see Figure 4.25.1 Baltimore Police Department, *Hurricane 2*). The electronics enclosure located above the console did not have sufficient space to mount the transponder, nor was there was sufficient space available on the console for mounting the transponder.

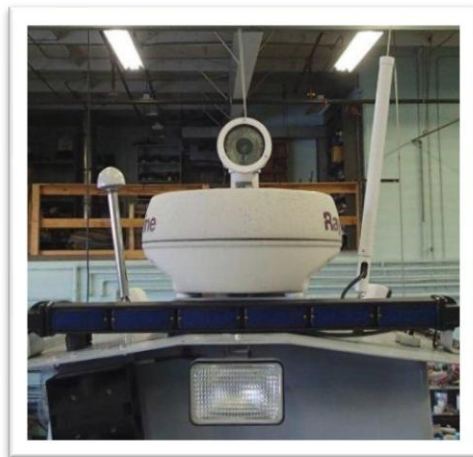
Figure 4.25.2 Antenna

The antenna mounts were installed directly onto the roof (see Figure 4.25.2 Antenna).

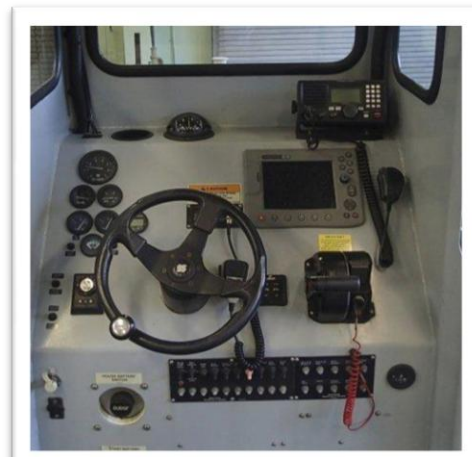
Figure 4.25.3 Console and Transponder

The Radar/Chart Plotter on this vessel is a Raymarine C80 with only one NMEA connection. This connection is used by the ICom VHF-DSC radio. After consulting with the vessel operator, the NMEA cable was installed on the plotter with the other end being used by the ICom VHF radio, and the DSC input was disconnected to allow for the connection of the AIS transponder.

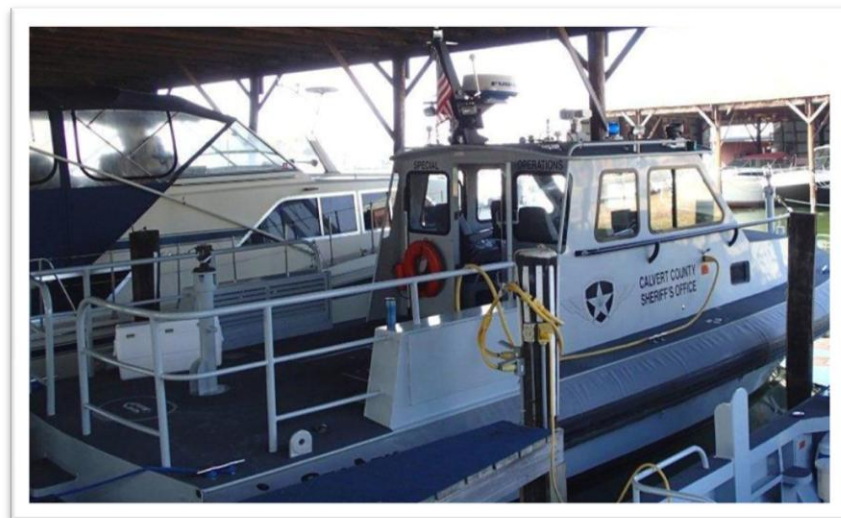
Figure 4.26.1 Calvert County Sheriff, *SPECOPS 2*

This 36 foot Sea Ark did not have a power source/switch available for use (see Figure 4.26.1 Calvert County Sheriff, *SPECOPS 2*).

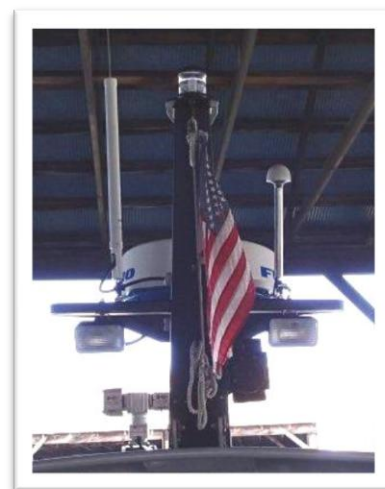
Figure 4.26.2 Antennas

GPS and VHF antennas were located on the mast, and cable clams were installed in the mast to accommodate the cables (see Figure 4.26.2 Antennas). The power for the unit was provided directly from the DC main switch and can be switched at the pilot's power console. The transponder was installed on the console shelf behind the radar display unit (see Figure 4.26.3 Console and Figure 4.26.4 Transponder).

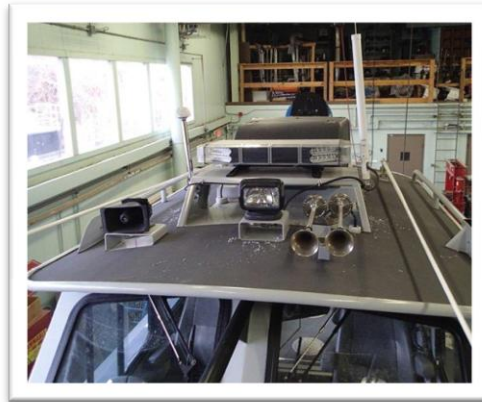
Figure 4.27.1 Calvert County Sheriff, *SPECOPS 3*

This 25 foot Sea Ark did not have sufficient space to install the antenna mounts and antennas while allowing enough clearance for the camera system (see Figure 4.27.1 Calvert County Sheriff, *SPECOPS 3*). A power source/switch for the transponder was identified on the power panel.

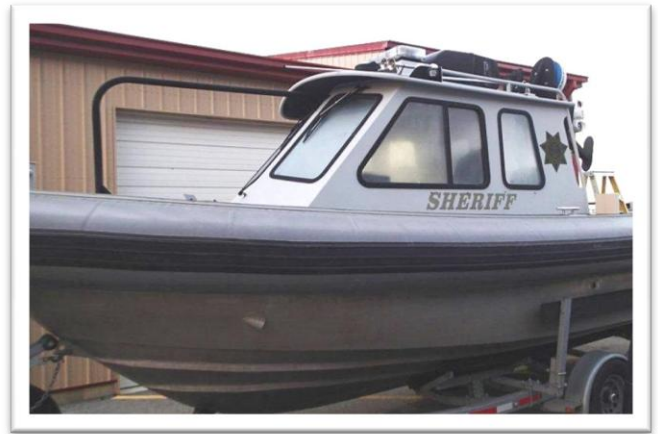
Figure 4.28.1 Charles County Sheriff, *Boat 1*

This 25 foot Sea Ark did not have sufficient space to install the antenna mounts and antennas, and still have enough clearance for the camera system (see Figure 4.28.1 Charles County Sheriff, *Boat 1*). A power source/switch (GPS) for the transponder was identified on the power panel.

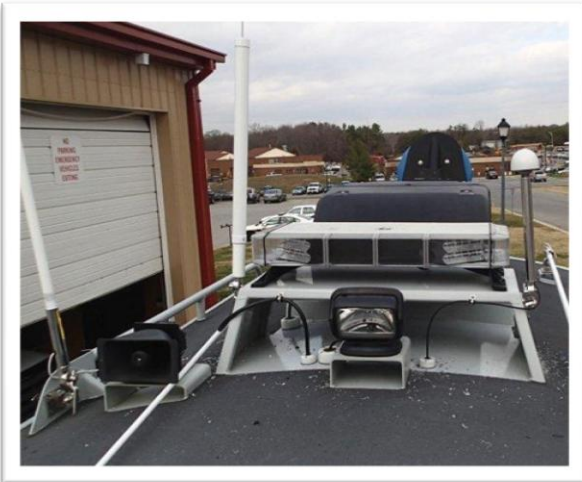
Figure 4.28.2 Antennas

The GPS and VHF antenna mounts and antennas were located on the sides of the light bar bracket (see Figure 4.28.2 Antennas). Cable clams were installed in the roof to accommodate the cables. A power source/switch (GPS) for the transponder was integrated. The transponder was installed on the side of the shelf below the console on the port side (see Figure 4.28.3 Console and Figure 4.28.4 Transponder). The integration of the transponder and Garmin chart plotter was completed and verified.

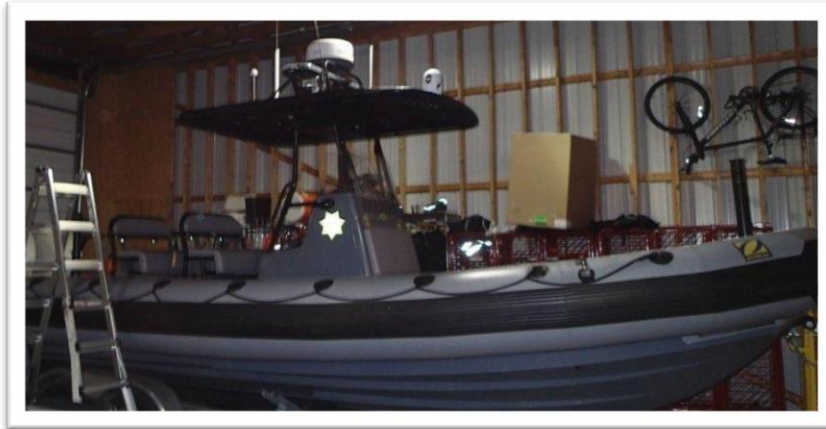
Figure 4.29.1 Charles County Sheriff, *Boat 2*

This 24 foot Zodiac had an open cockpit with a canvas cover over the cockpit and part of the passenger area (see Figure 4.29.1 Charles County Sheriff, *Boat 2*). There were no readily available points for the antenna mounts nor was there sufficient space on the console to mount the transponder.

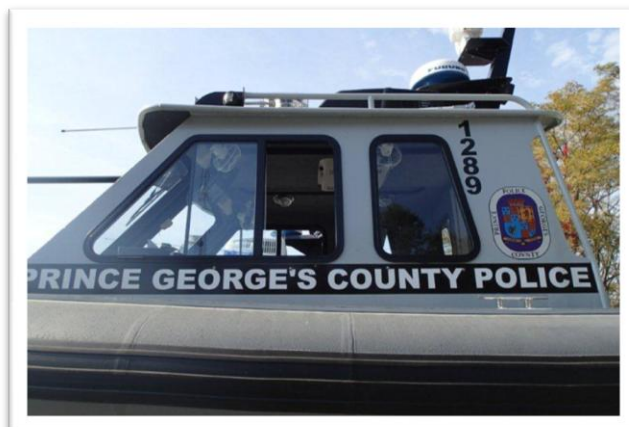
Figure 4.30.1 Prince Georges County Patrol Vessel, PG1289

The vessel is equipped with a Garmin 541S chart plotter that has an integrated data and power cable. Several hours were spent attempting to identify a communications error between the AIS and the chart plotter. A second visit on 7 November 2012 was required to continue troubleshooting, and an additional visit was needed to repair a severed cable. During the troubleshooting, it was noted that the vessel had been stored with the mast open during several days of inclement weather. The mast, VHF connector, and VHF antenna were filled with water, which caused an initial Voltage Standing Wave Ratio (VSWR) error during transmission.

Inspection of the GPS cable from the antenna to the transponder revealed that the cable had been severed at the mast opening. An additional site visit was required to repair the cable and complete the integration.
