A Remedy for a Chronic Dredging Problem

By Mr. David C. Gordon

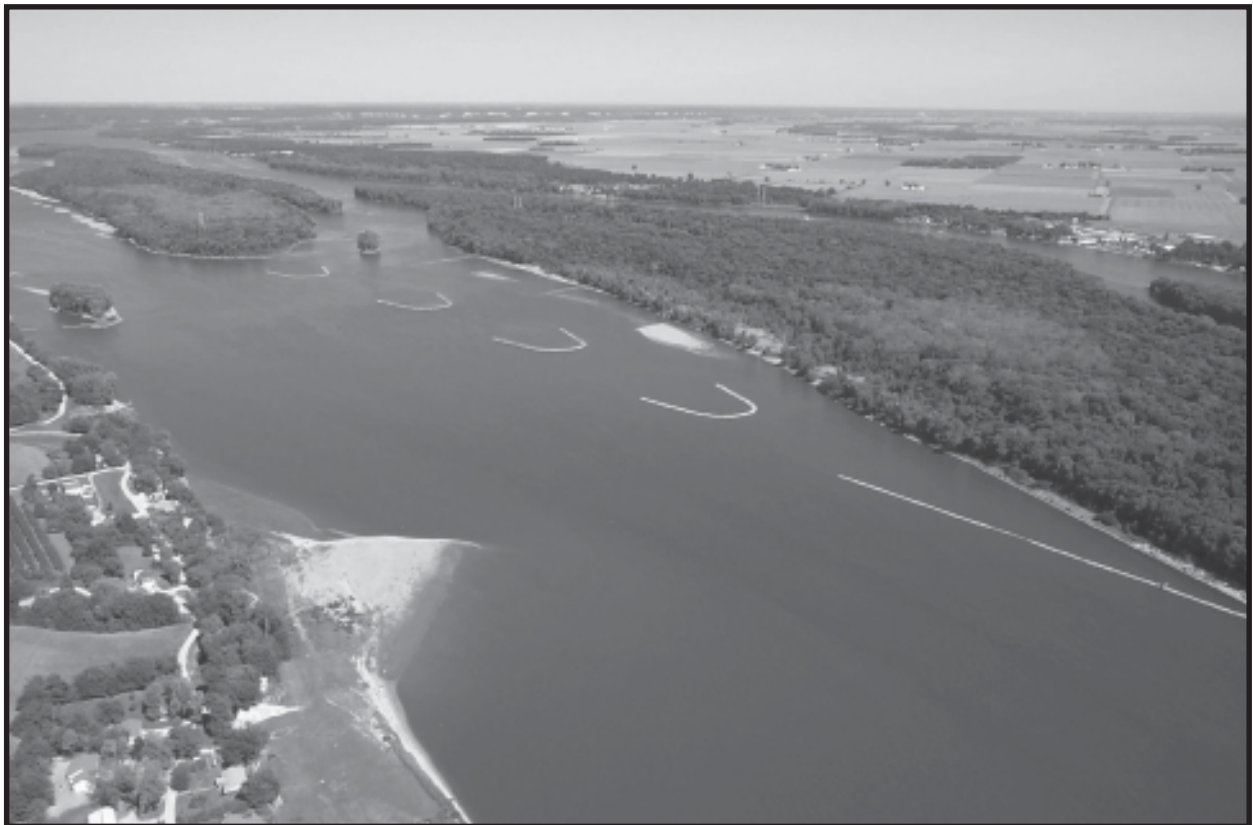
Innovative river training structures remedied a chronic dredging problem and created unique aquatic habitat.

The team agreed on an unconventional design that addressed the needs and concerns of everyone involved. The design consists of a unique longitudinal dike and four chevron structures. The 1,200-foot-long longitudinal dike extends off of Bolter Island and is angled downstream in a nearly parallel alignment to the flow of the river. Downstream of this structure are four chevrons about 850 feet apart and built of graded 5,000-pound, maximum-size stone. The chevrons are

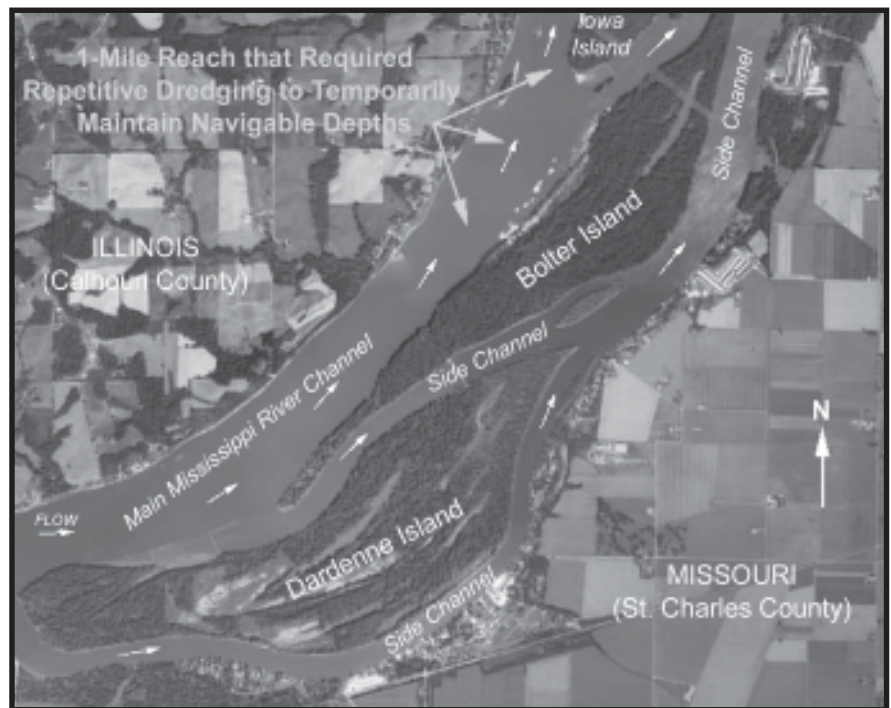
Area requiring repetitive dredging

One cause of repetitive dredging through the reach was the loss of flow in the main channel to the side channels. Measurements of flow distribution show that, at times, the main channel carries less than 50 percent of the total flow in the river while the majority of water flows through the side channels.

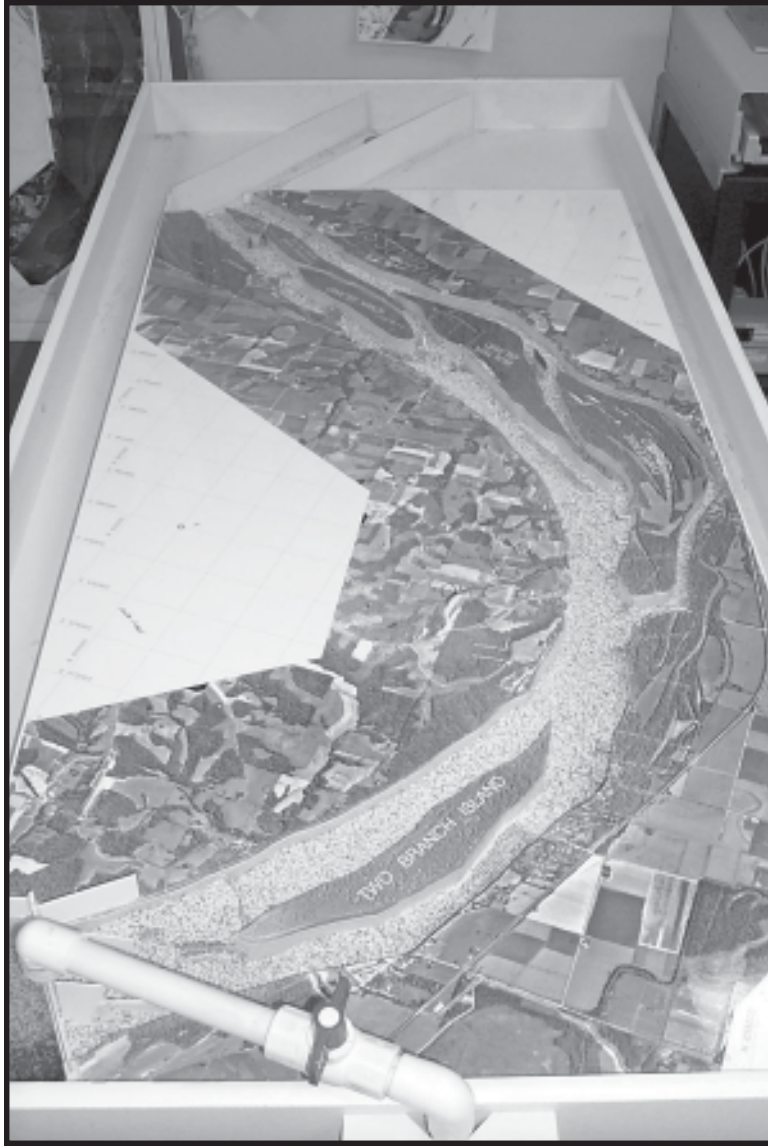
Bolters Bar Micro Model

The model used to study the Bolters Bar reach was developed at the USACE Applied River Engineering Center, St. Louis, Missouri. The model—which incorporated almost 11 miles of the main river channel, as well as each side channel and every river training structure—was only 6 feet long and 3 feet wide. The bed material used to simulate the riverbed of the Mississippi was a granular plastic.

Surveys of the river bottom were used to calibrate this model. The plan formulation team then used the model to idealize numerous design possibilities for consideration by the design team. These concepts were later scientifically tested in the model to determine their probable effect on the riverbed. Results of these tests were then presented to the plan formulation team for evaluation.

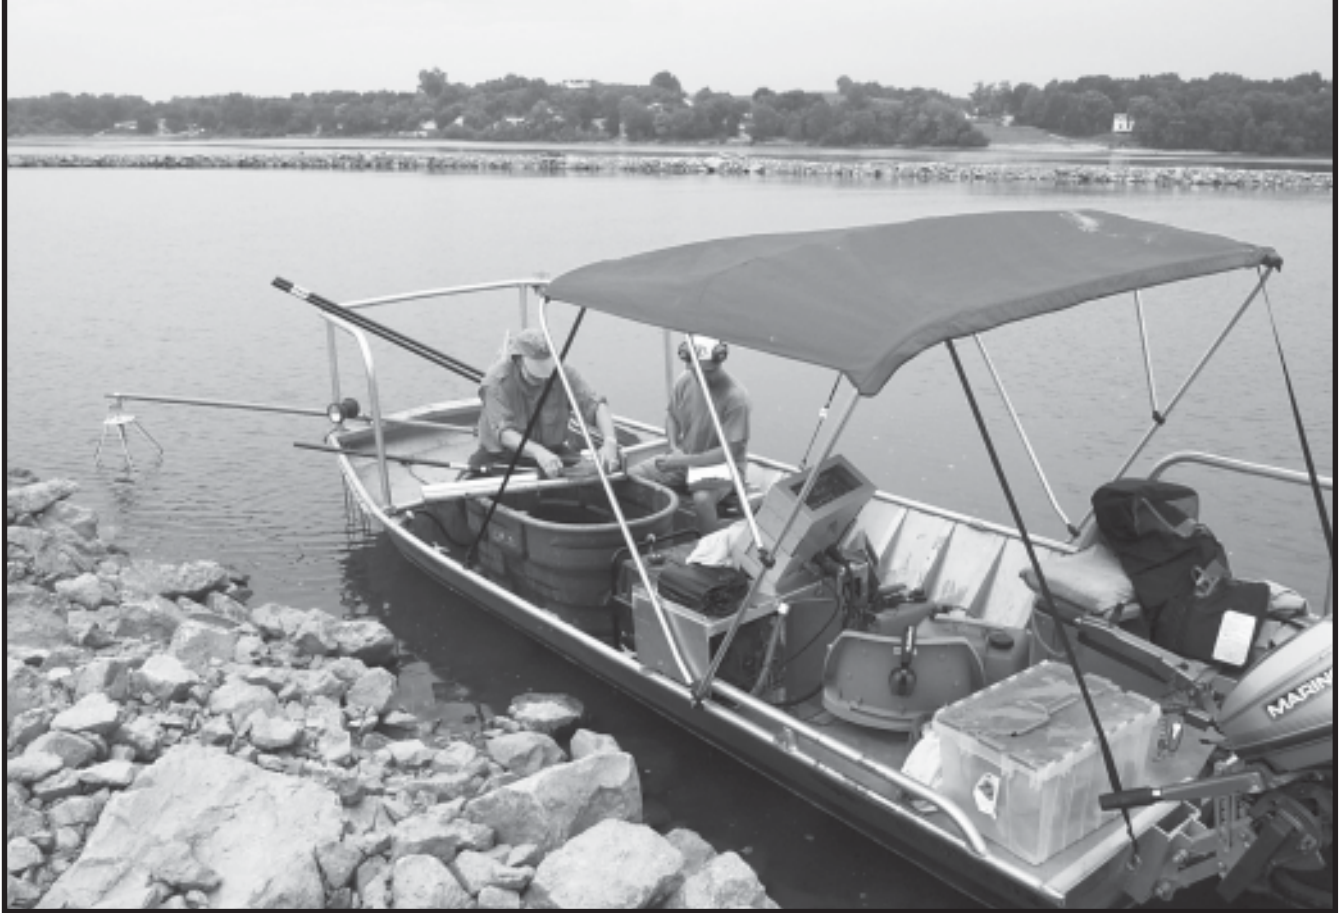
USACE biologists collect fisheries data around a chevron at Bolters Bar

about 250 feet long, 200 feet wide between the downstream ends of the legs, and 600 feet in total length along the perimeter of the structure. The project was completed in 2002 at a cost of nearly \$1.5 million for about 160,000 tons of stone.

Although biological monitoring can take years to assess, the results from similar chevrons give a valid representation of what could be expected to occur in and around these structures. Six other chevrons built in the 1990s have been extensively monitored for their biological effects. More than 50 species of fish and a highly diverse group of macroinvertebrates have been collected in and around the structures. Physical data has shown that these structures have created several different types of river habitat with variable depths, flow velocities, and substrates and multiple wetted edges where plant life can flourish. It has been documented that this environment is very conducive to the needs of overwintering fish and provides ideal conditions for a nursery for juvenile and larval fish. Plant life that establishes itself along the wetted edges provides good cover and habitat for
