**US Army Corps  
of Engineers®**  
Portland District

# **Mount St. Helens Project Cowlitz River Levee Systems 2009 Level of Flood Protection Update Summary**

Cowlitz River at Longview/Kelso, Washington

February 4, 2010

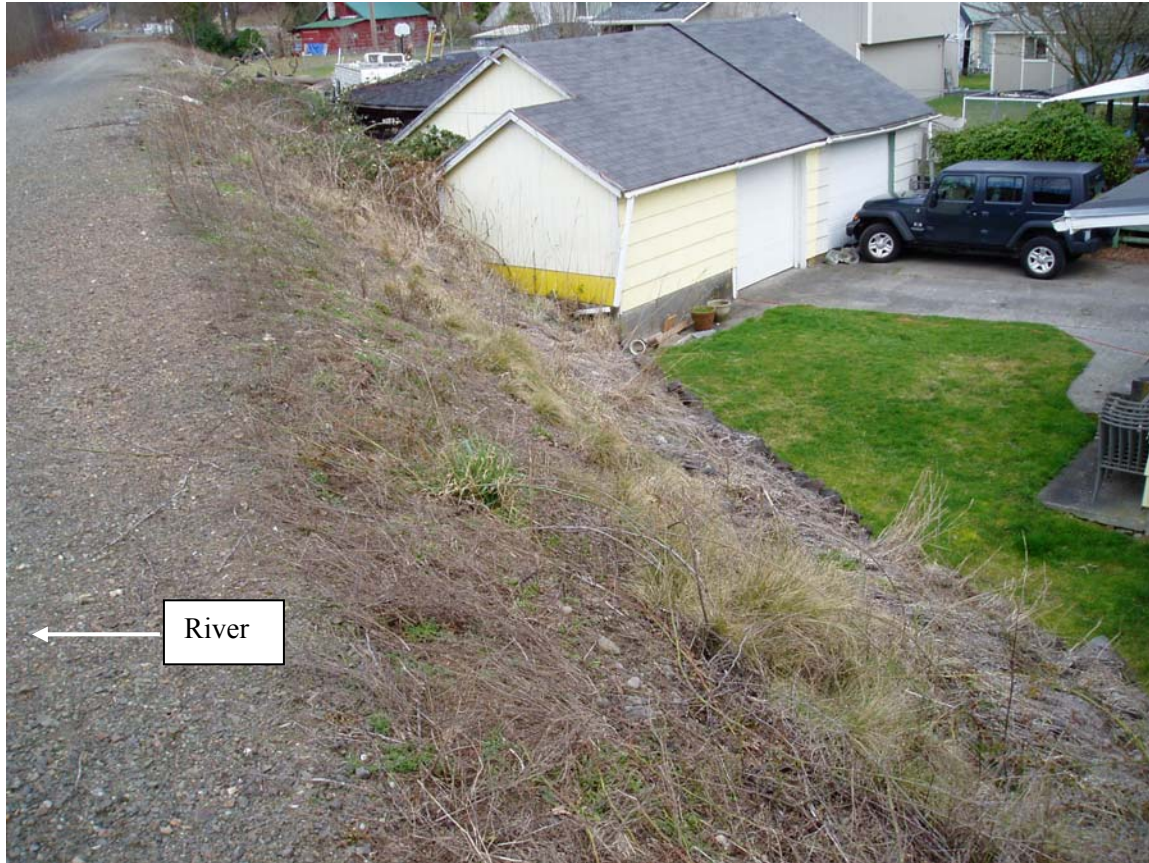
*Photo 2.2. Castle Rock reach CR2*

Reach CR2 extends from approximately station 4+80 to station 16+60. Instead of quarry waste, plywood crib structures were used to temporarily raise this stretch of levee in 1982. Reach CR2 has house structures and large trees very close to, and in, the backslope of the levee.

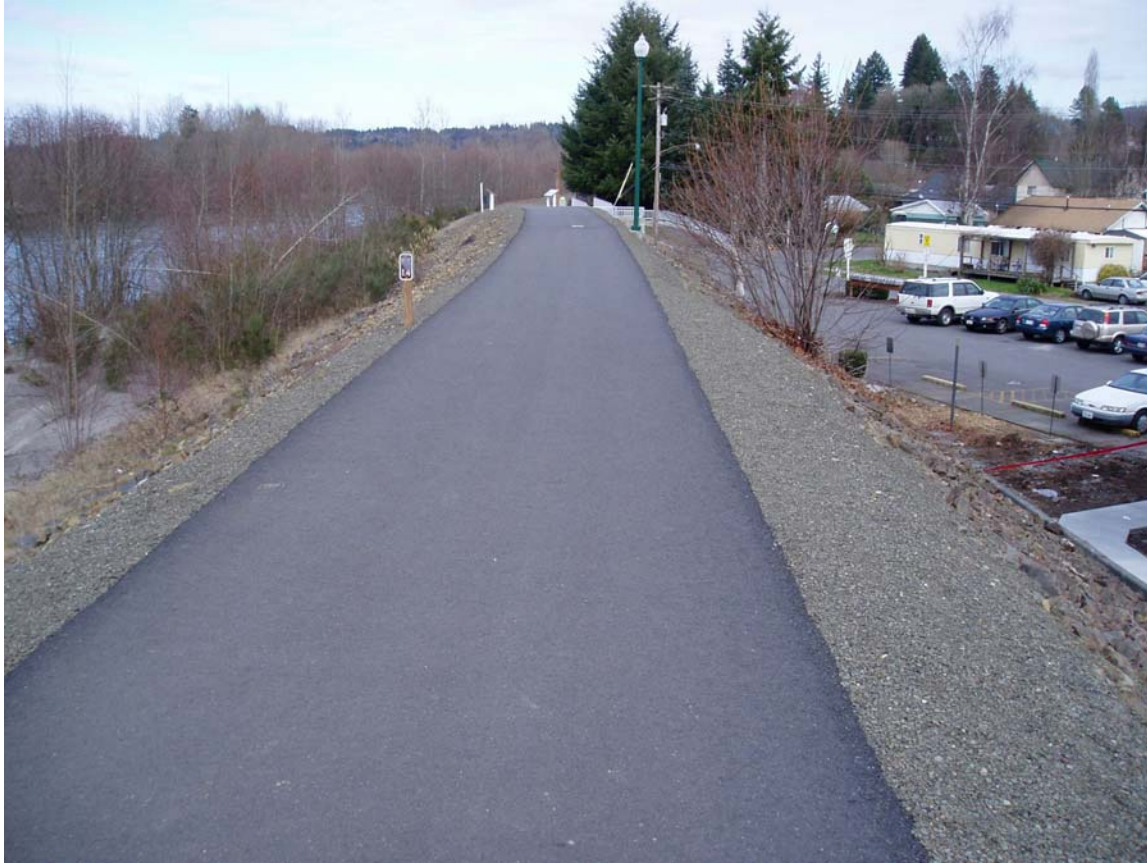
*Photo 2.3. Castle Rock reach CR3*

Reach CR3 extends from approximately station 16+60 to station 22+80. There is approximately 3 – 4 ft of quarry waste material that was placed as a temporary raise in 1982 and has not been removed.

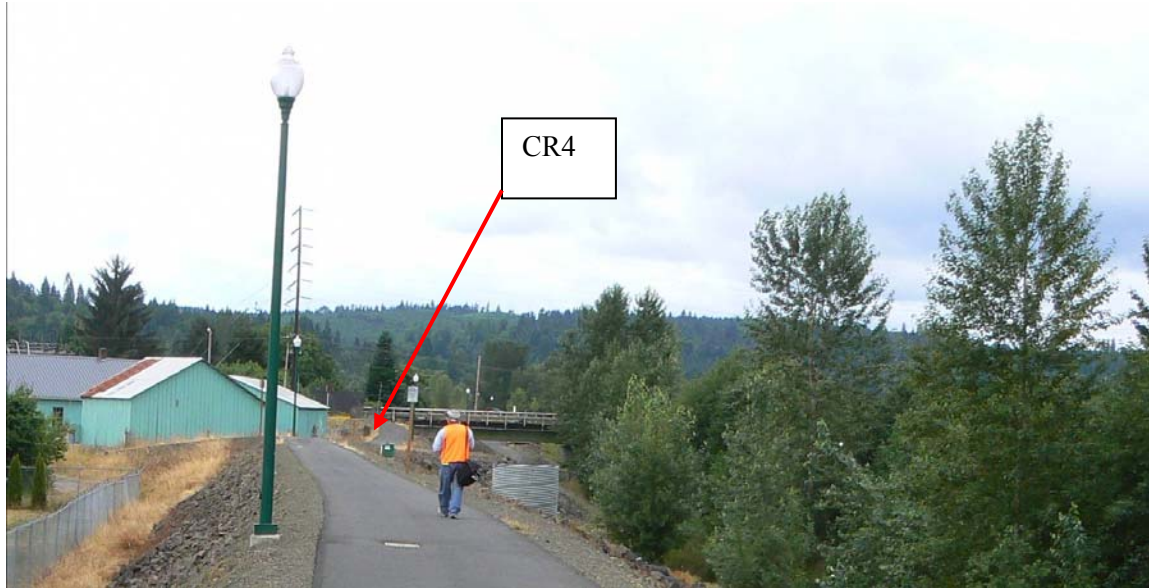
*Photo 2.4. Castle Rock reach CR4*

Reach CR4 extends from approximately station 22+80 to station 25+50. This is another stretch where plywood crib structures were used to temporarily raise the levee in 1982.

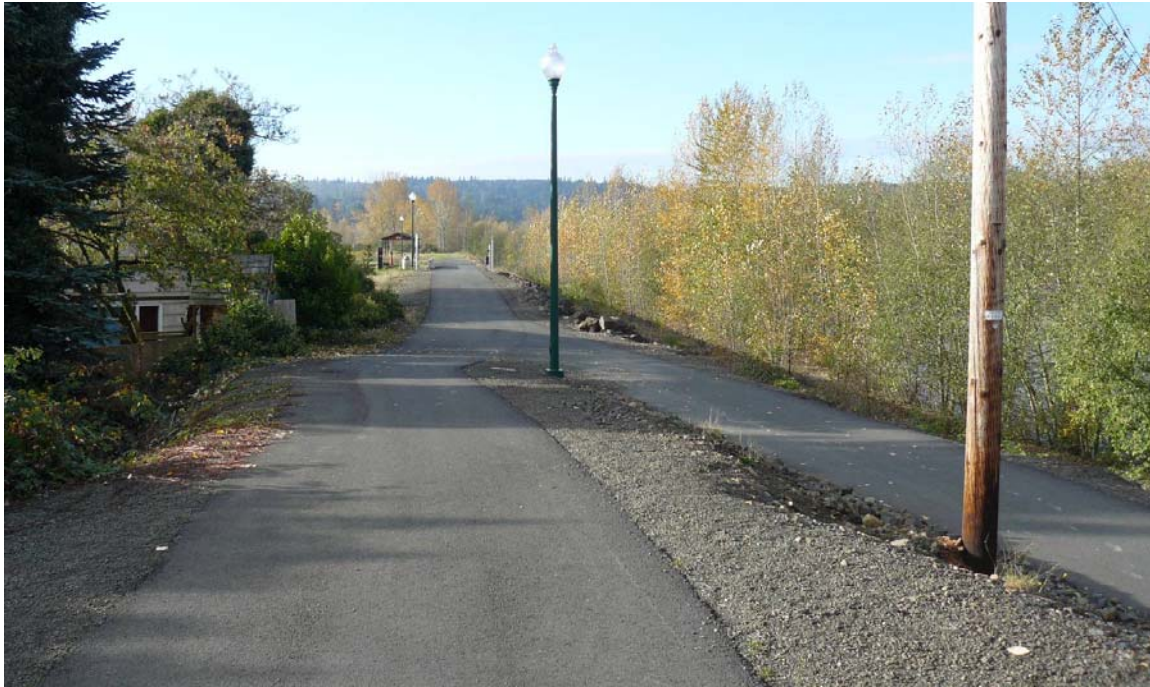
*Photo 2.6. Castle Rock reach CR6*

Reach CR6 extends from approximately station 26+70 to station 34+20. This reach was constructed prior to 1980; it does not sit on the 1980 mudflow (sand) and it has a less steep backslope than the levee north of the bridge.

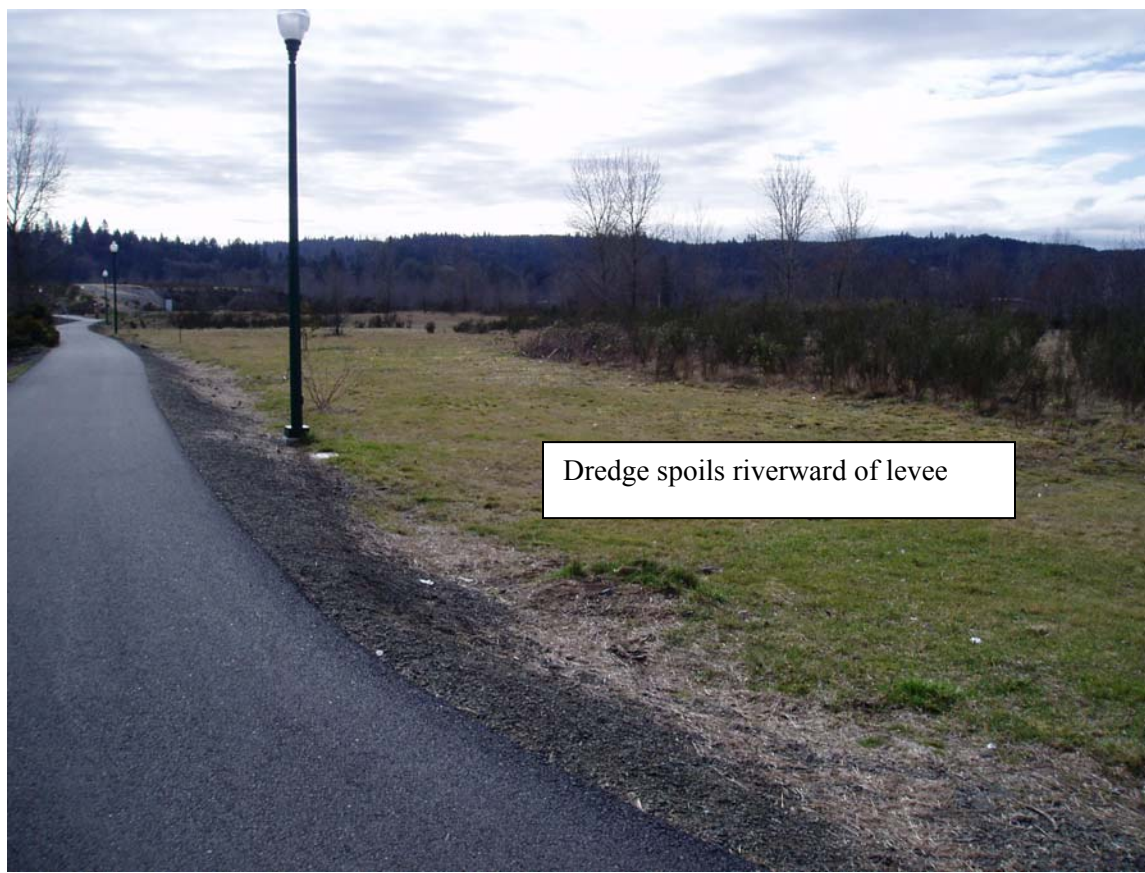
*Photo 2.7. Castle Rock reach CR7*

Reach CR7 extends from approximately station 34+20 to station 59+00. There is a large dredge spoil area riverward of the levee protecting this reach. The elevation of the spoil area is similar to the top elevation of the levee.

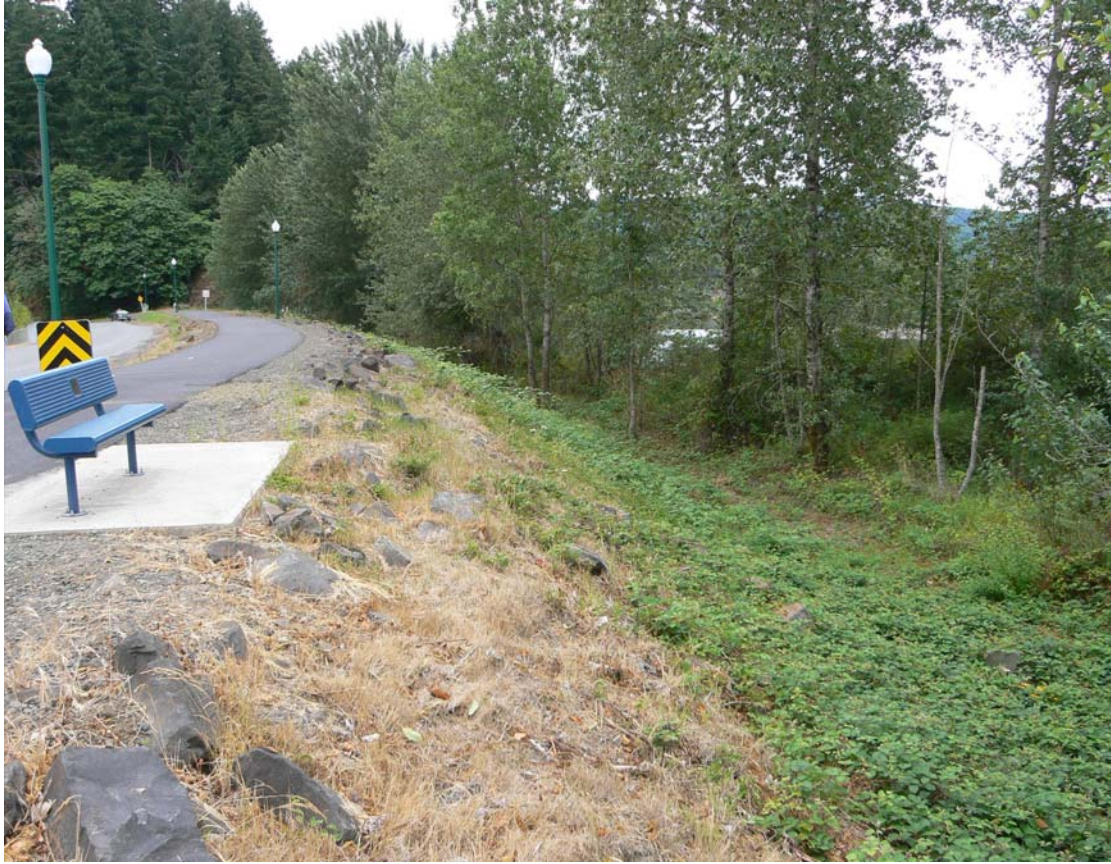
*Photo 2.8 b. Castle Rock reach CR8, riverward slope with riprap to levee crest*

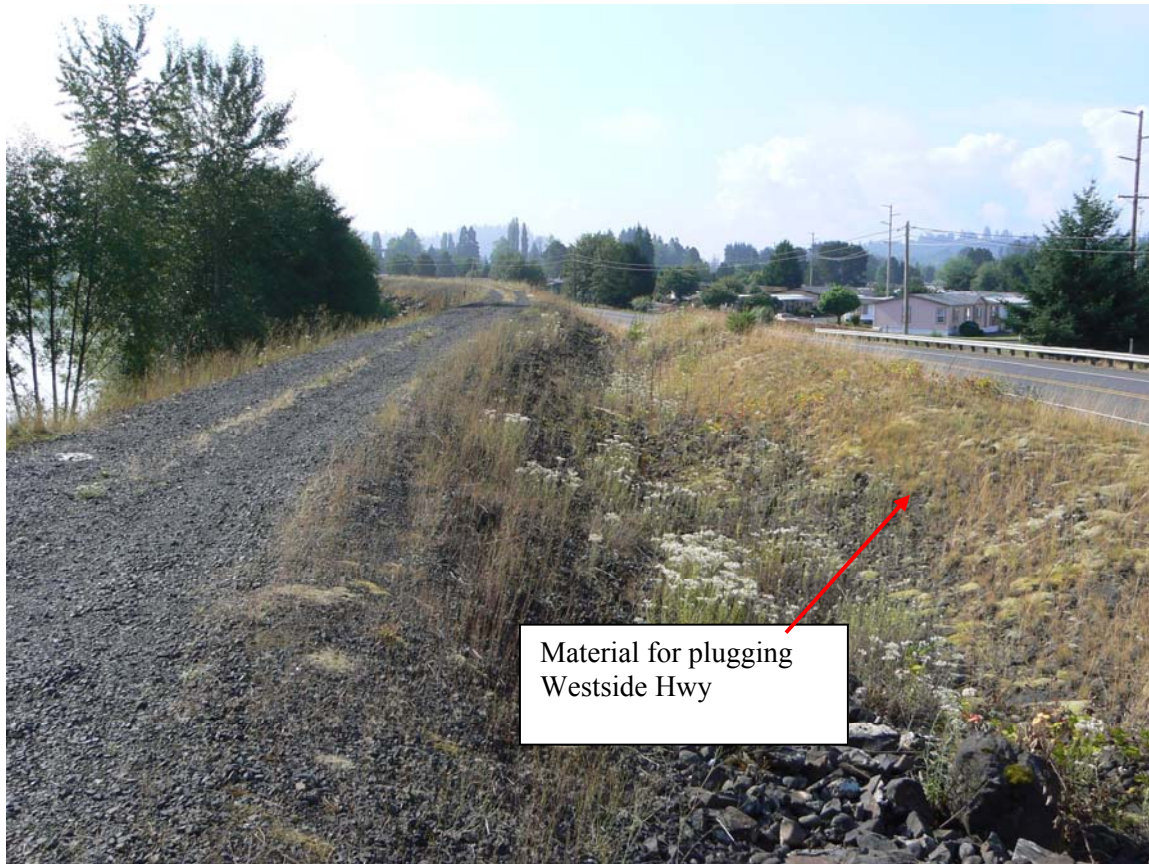
*Photo 3.1. Lexington reach LX1*

Reach LX1 is the upstream end of the system west of Westside Highway. The photo below shows the stockpile of material available for closing the highway.

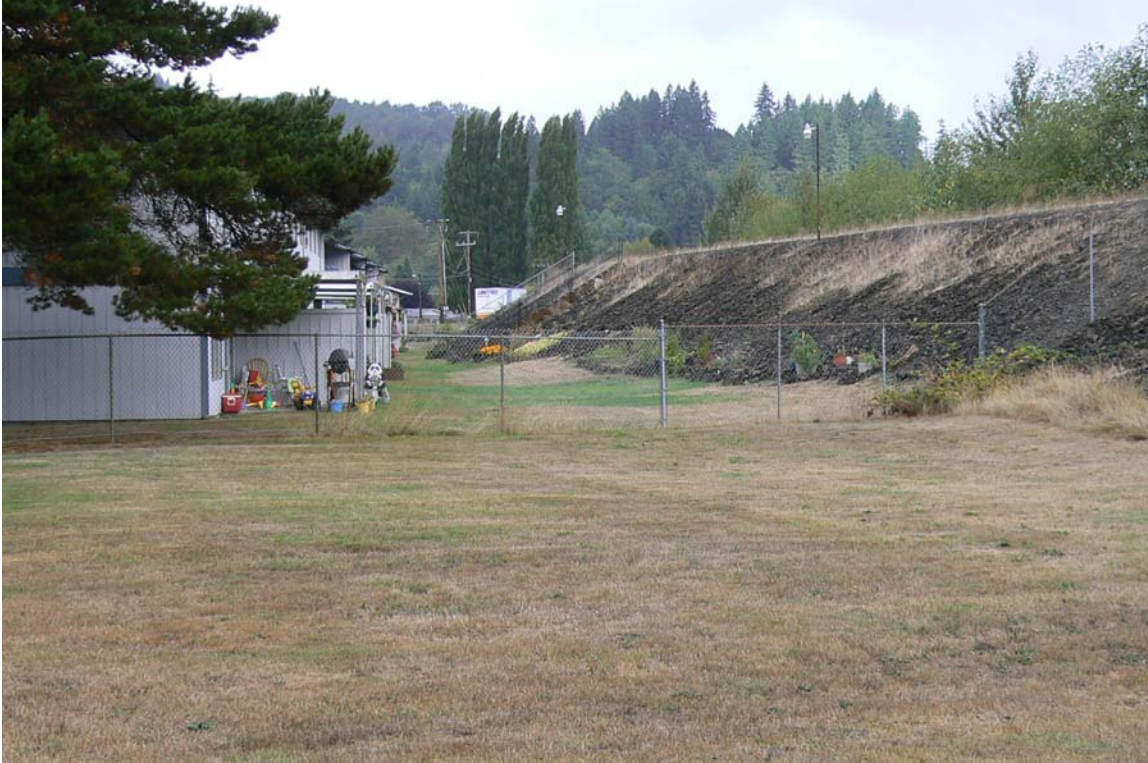
*Photo 3.2. Lexington reach LX2*

Reach LX2 extends from approximately station 20+44 to 88+00. This reach includes McCorkle Creek pump station.

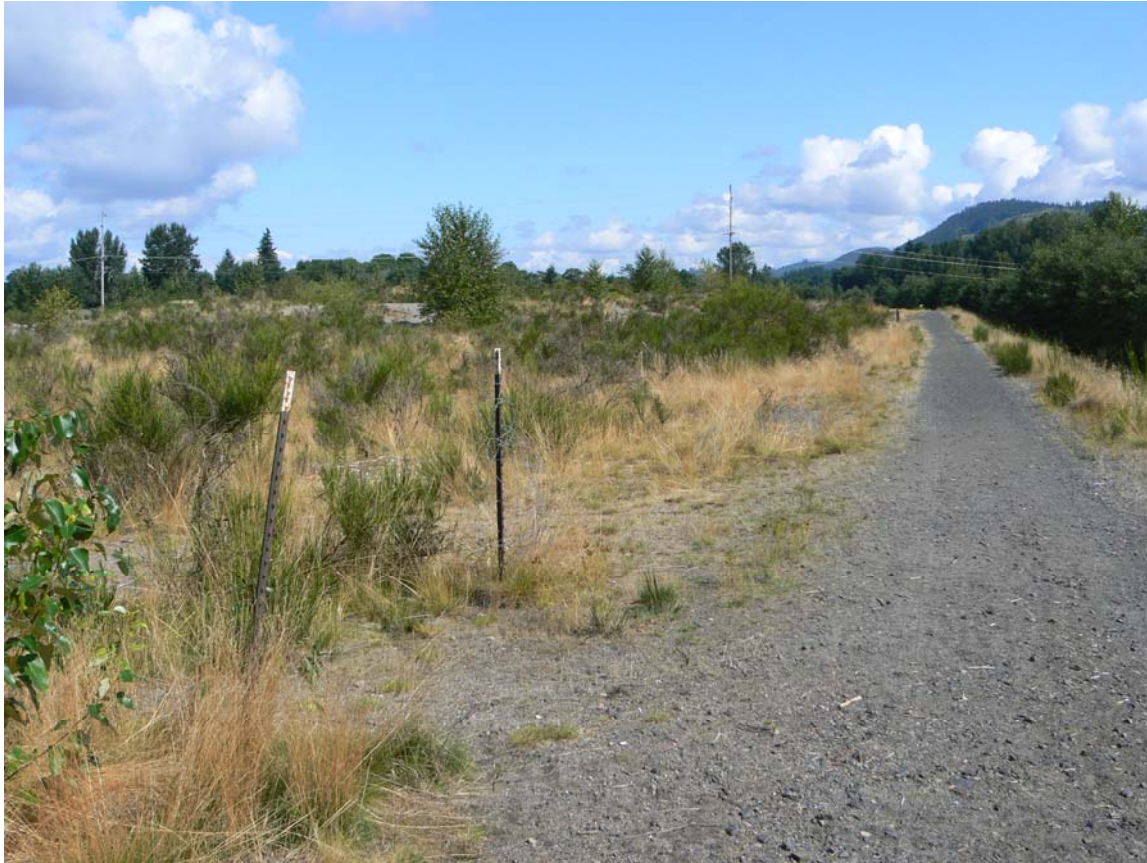
*Photo 3.3. Lexington reach LX3*

Reach LX3 extends from approximately station 88+00 to 93+50. There is dredged material on the landward side of the levee up to the crest elevation. The County reported that some of the dredged sand has been removed. This reach should be re-evaluated if significant volumes of sand are removed in the future, such that the levee has a distinct back-slope again.

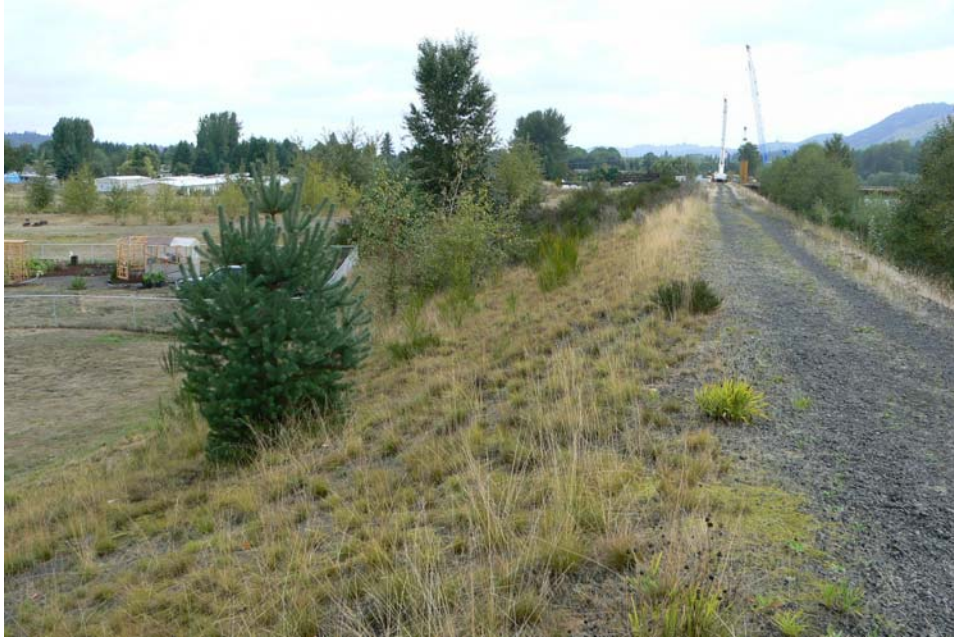
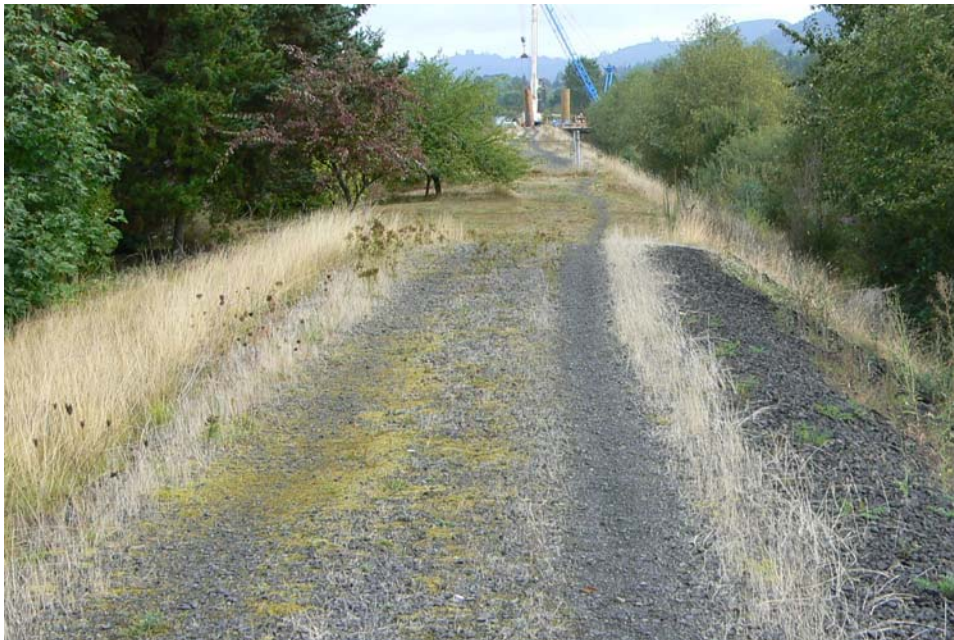
Reach LX4 extends from approximately station 93+50 to 112+00. The low spot in this reach is adjacent to an A-frame house.

*Photo 3.4 b. Lexington reach LX4, low spot in front of A-frame house*

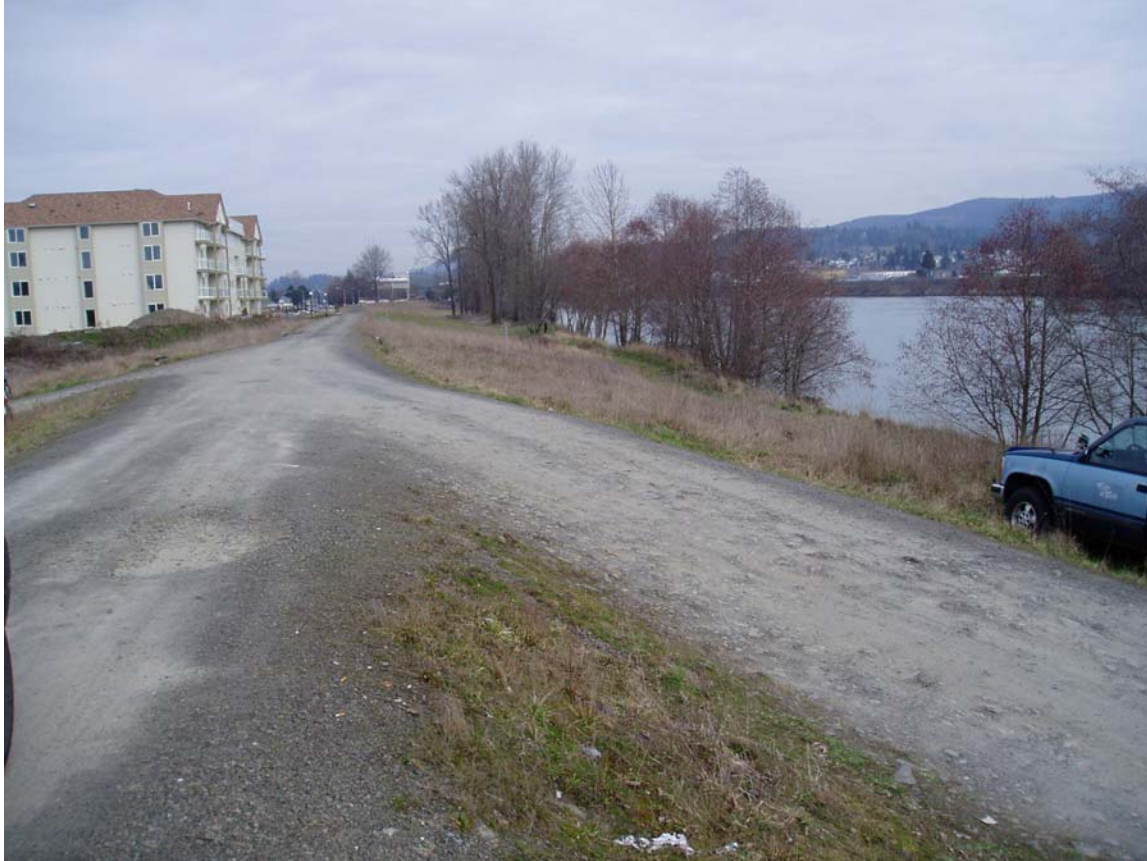
*Photo 4.3. Longview reach LV3*

Reach LV3 extends from approximately station 57+00 to 94+00. Figure 4.2 shows spots where the top of levee is below the 1980 Design Water Surface.

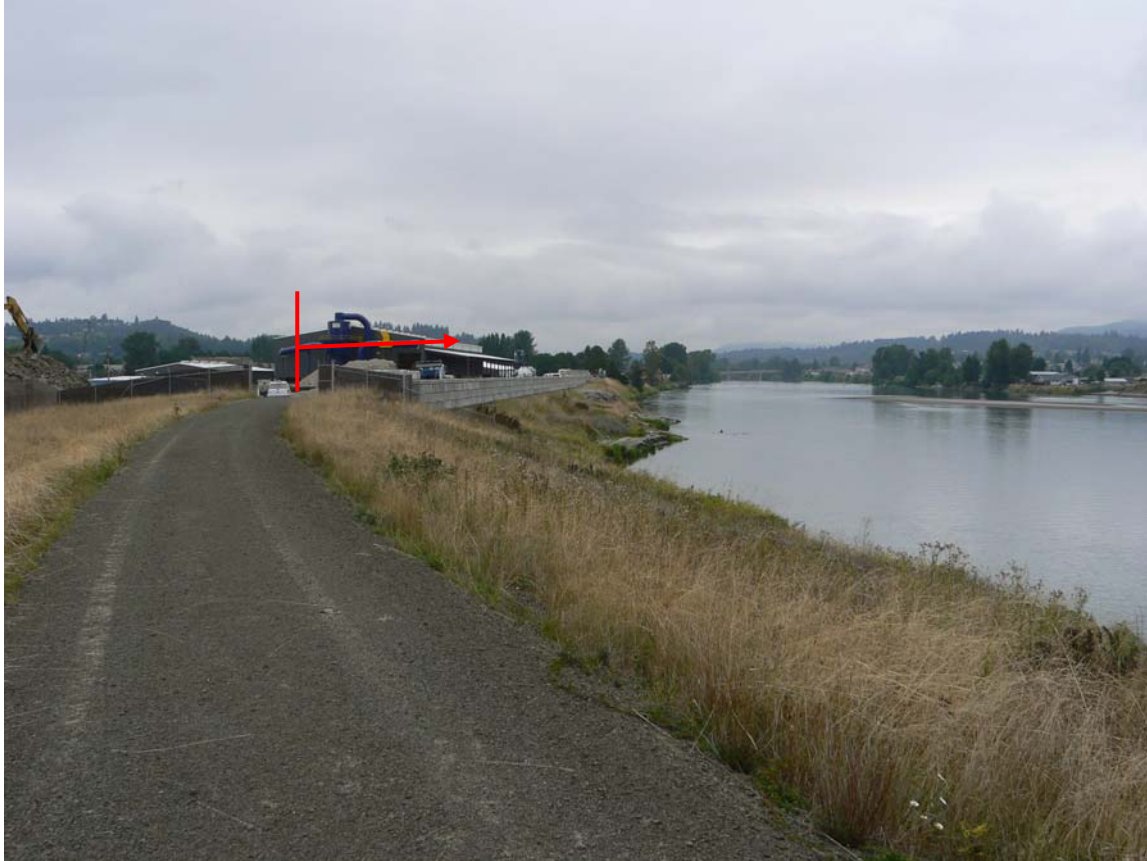
*Photo 4.4. Longview reach LV4*

Reach LV4 extends from approximately station 94+00 to 102+00. A concrete block wall has been built along this stretch on the riverward shoulder of the levee.

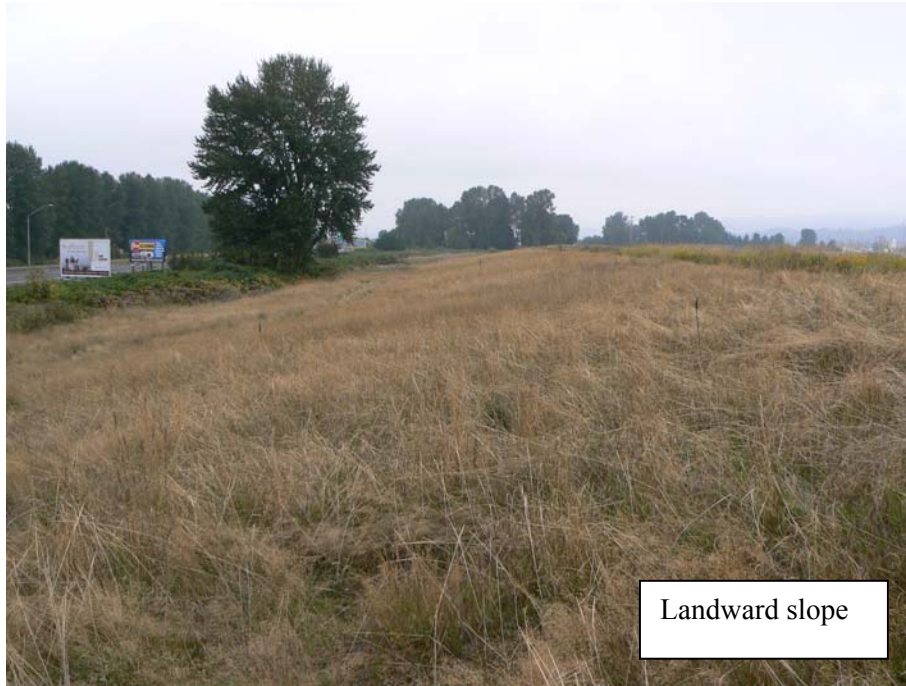
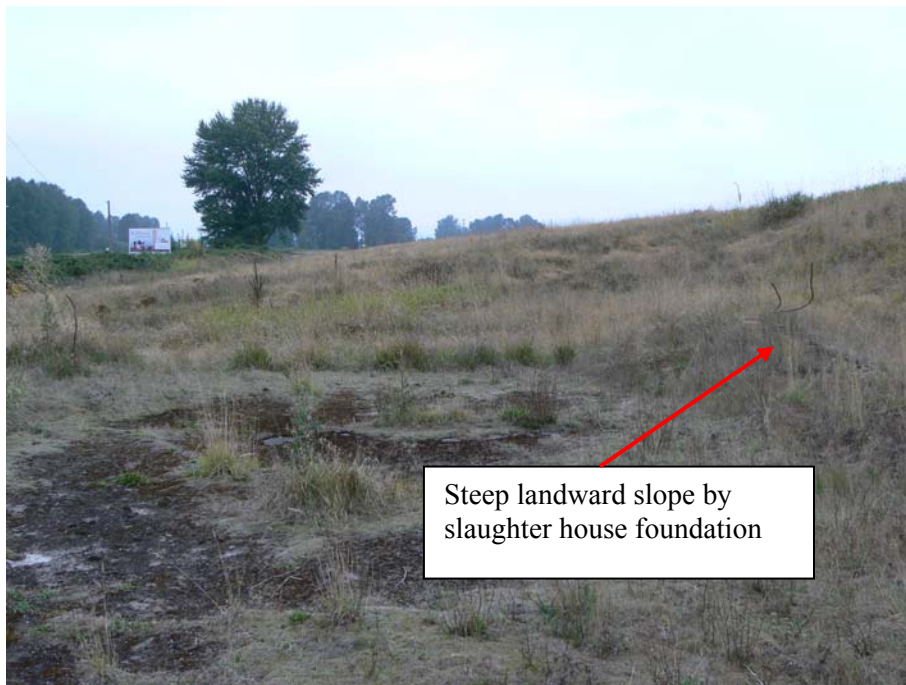
Reach LV5 extends from approximately station 102+00 to 161+00. Survey data indicates one low spot near the north end of Marine View Drive. Photo 4.5 b below shows where a slaughter house was removed and the landward slope is steeper than desirable.

*Photo 4.5 b. Longview reach LV5, removed slaughter house location*

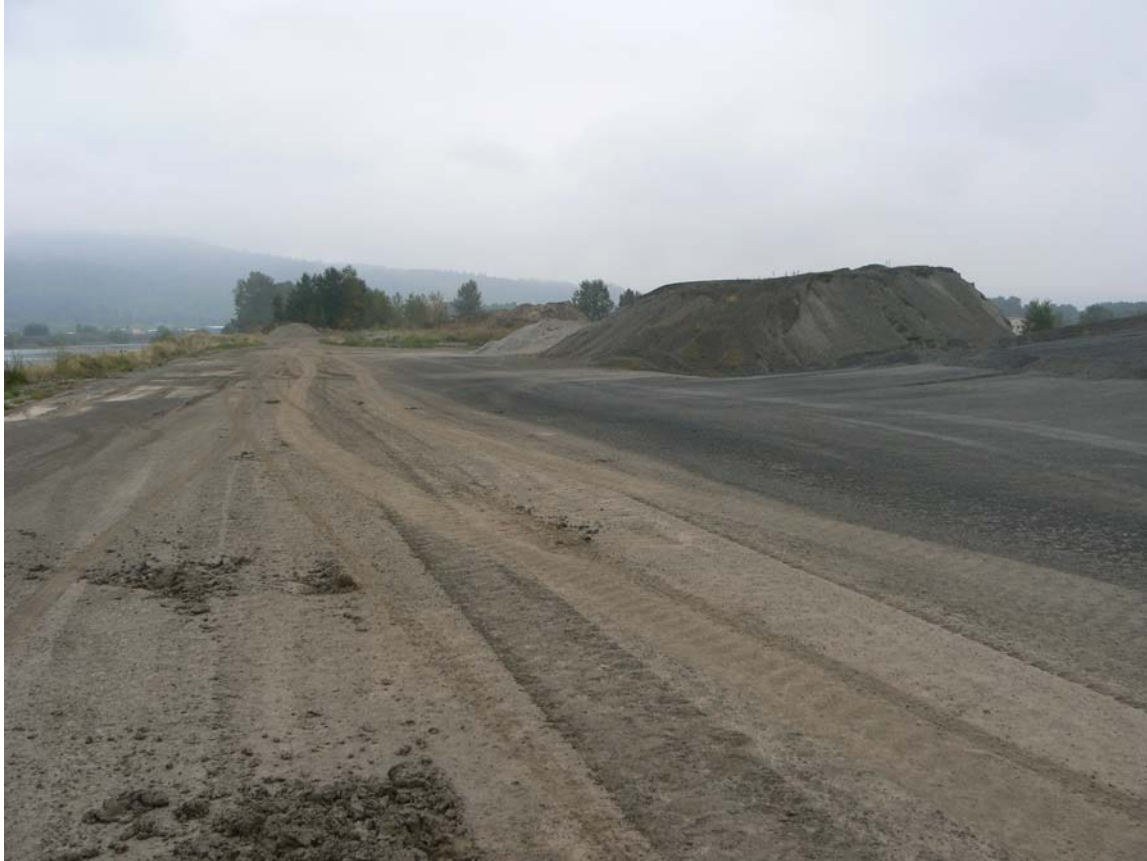
*Photo 4.6. Longview reach LV6*

Reach LV6 extends from approximately station 161+00 to the end of the levee. This reach is essentially high ground as dredged material has been placed on the landward side.

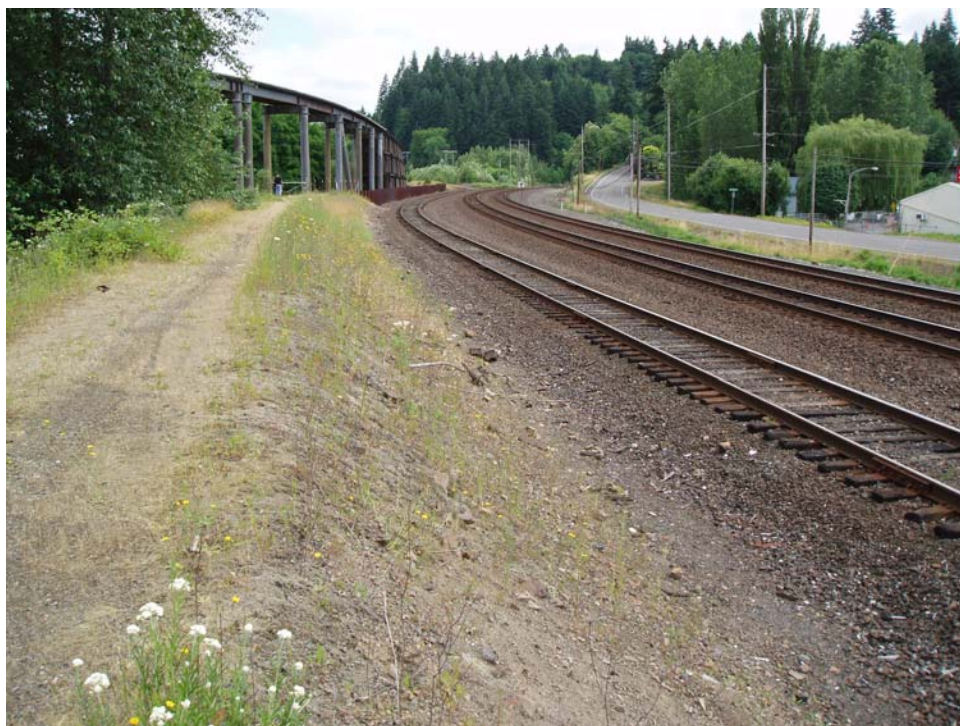
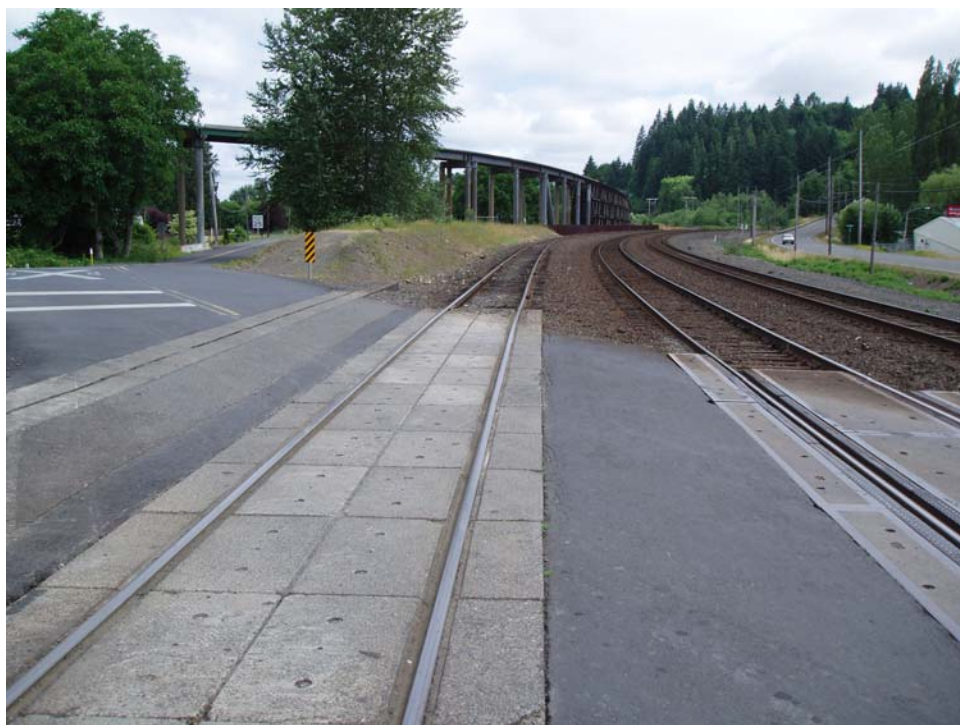
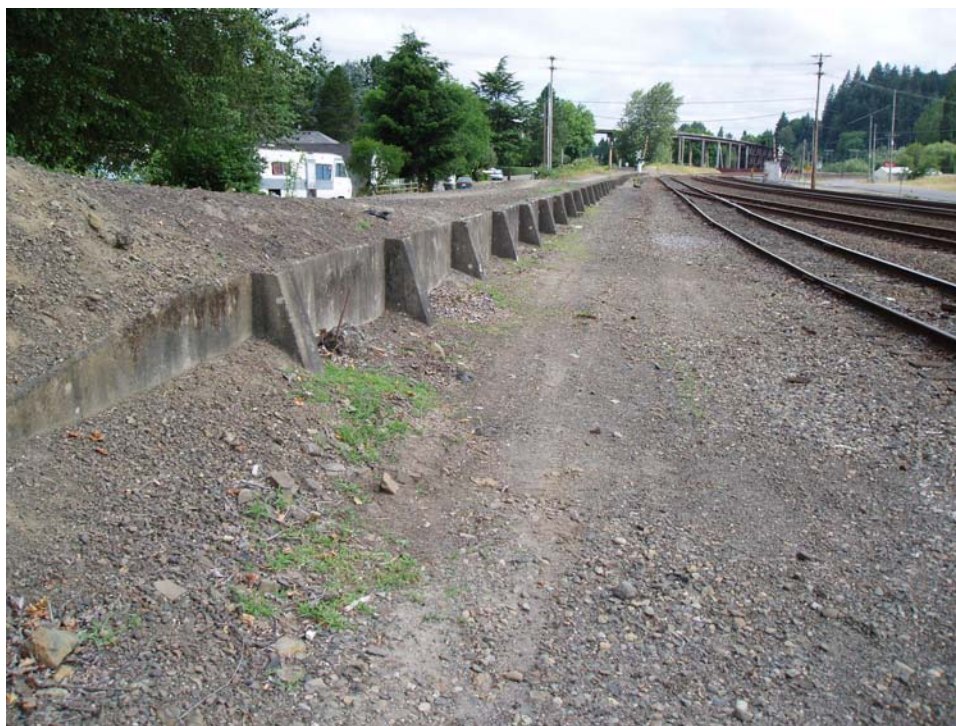
*Photo 5.1 b. Kelso reach KL1, short embankment*

*Photo 5.1 c. Kelso reach KL1, road crossing*

*Photo 5.1 d. Kelso reach KL1, concrete flood wall*

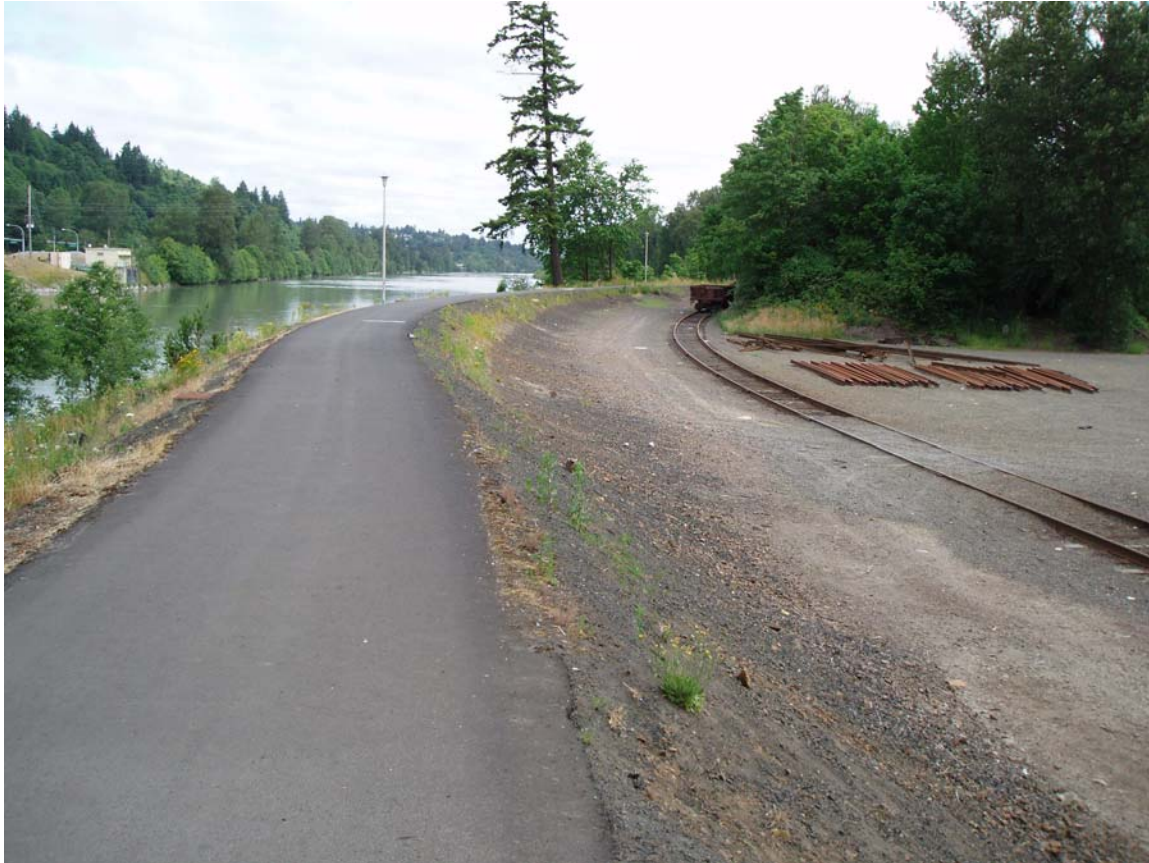
*Photo 5.2. Kelso reach KL2*

Reach KL2 extends from approximately station 31+00 to 112+86. The levee section has railroad tracks close to the landside toe as shown in the photo below.

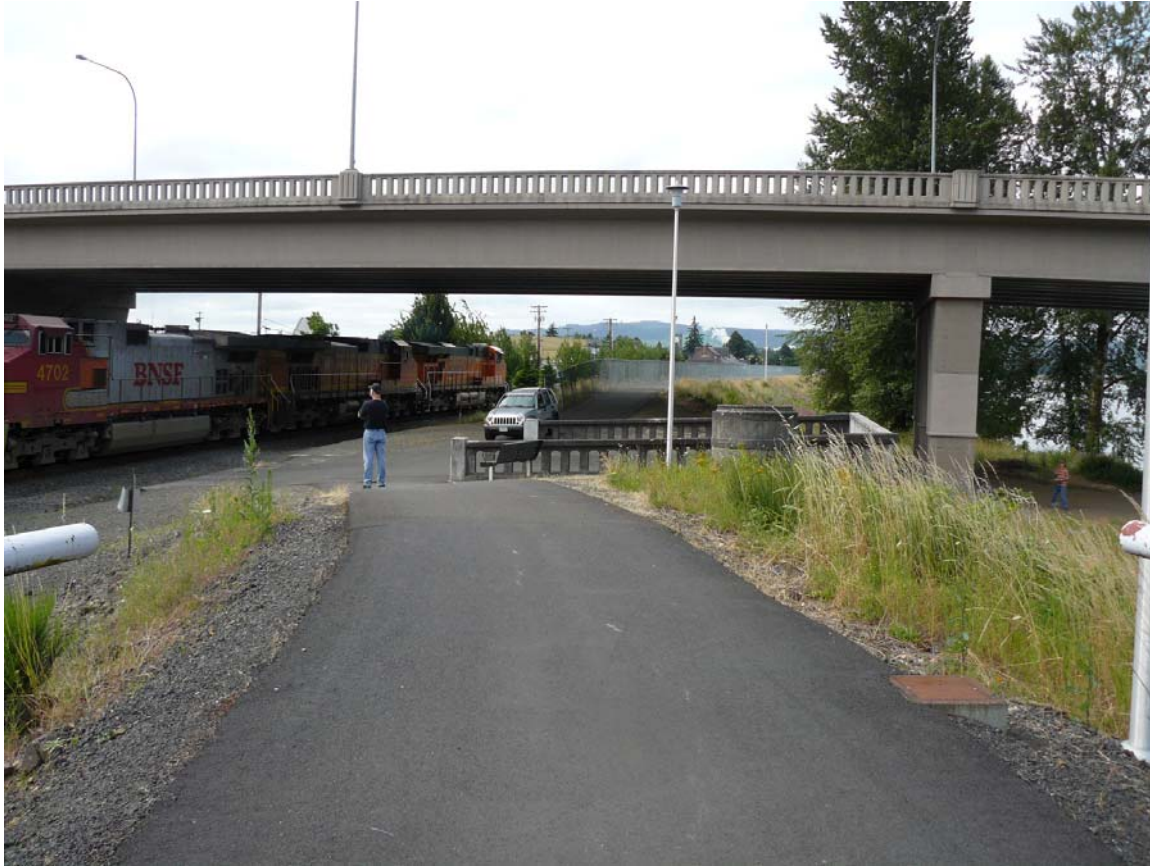
*Photo 5.3. Kelso reach KL3*

Reach KL3 is Rotary Landing beneath the Allen Street bridge. This is an approximately 300-ft-long low spot in the levee.

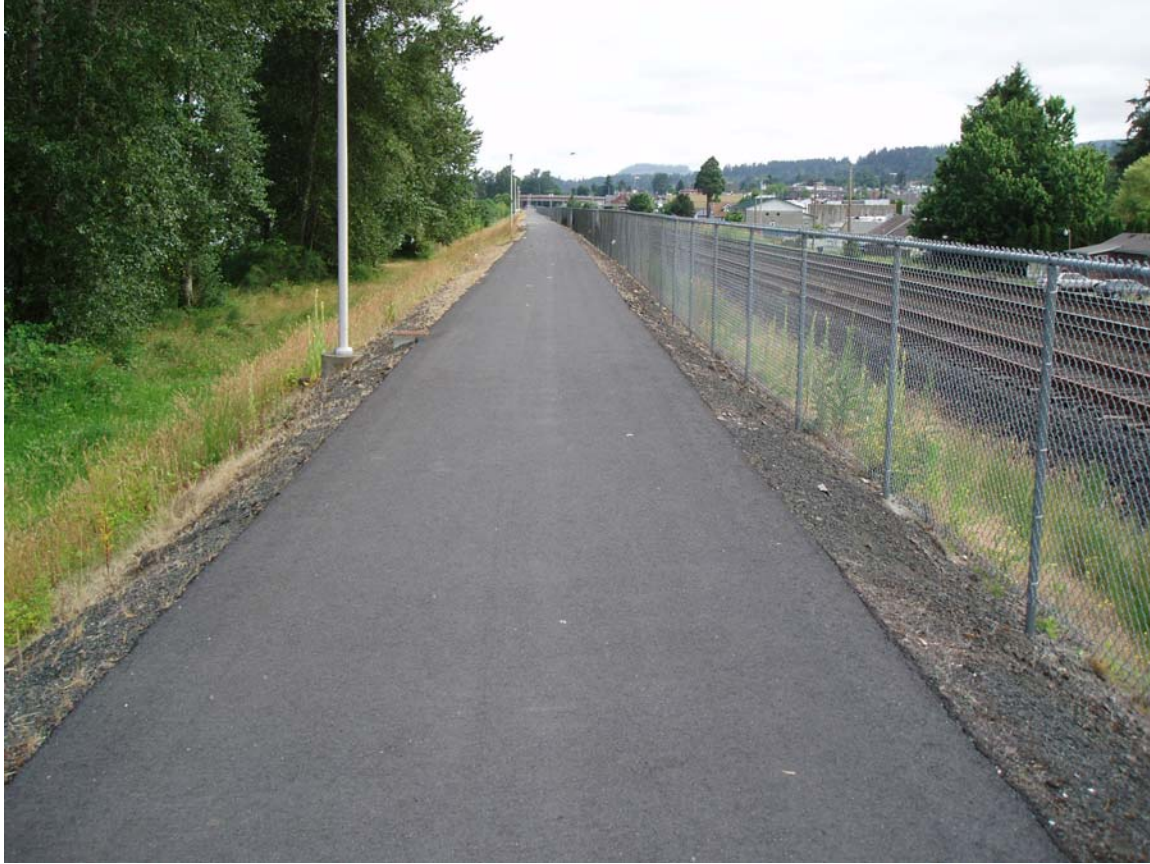
*Photo 5.4. Kelso reach KL4*

Reach KL4 extends from approximately station 115+93 to 141+70. The levee section has railroad tracks close to the landside toe as shown in the photo below.

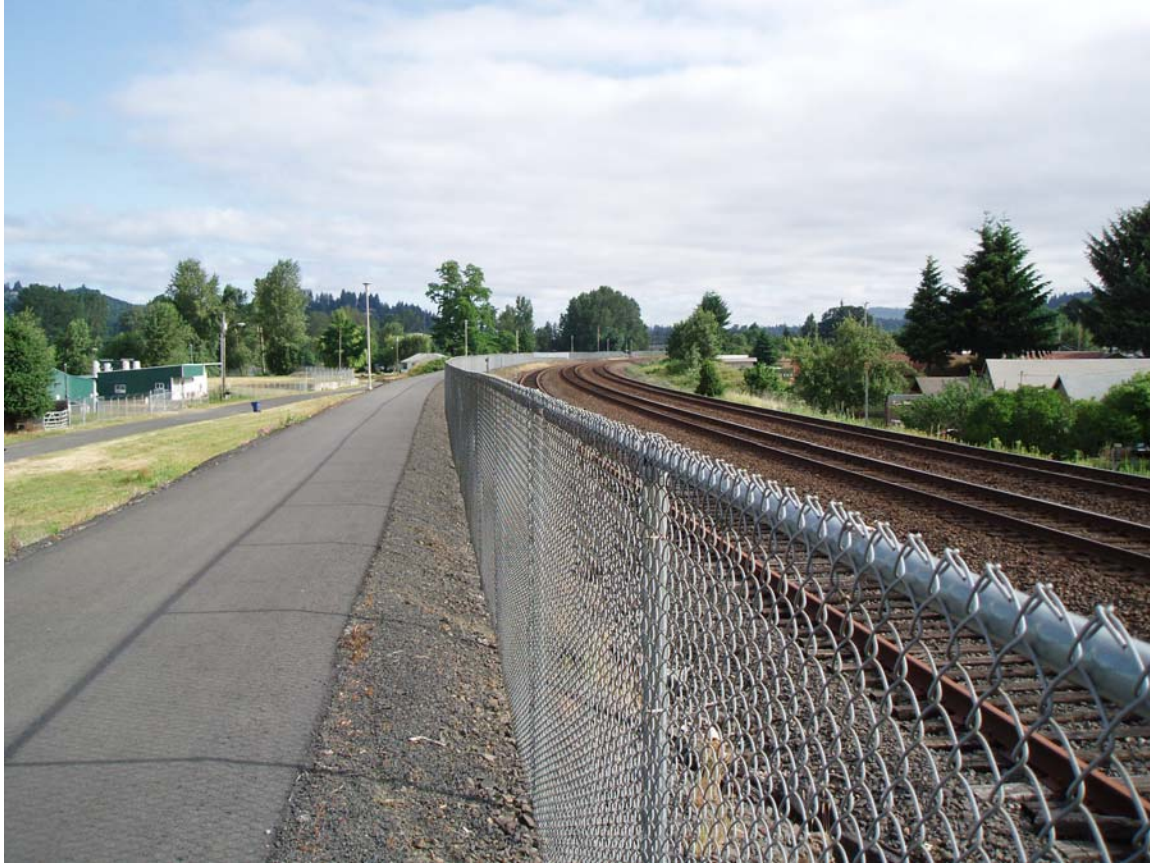
*Photo 5.6. Kelso reach KL6*

Reach KL6 extends from approximately station 143+45 to 158+69. The levee section has railroad tracks close to the landside toe as shown in the photo below.

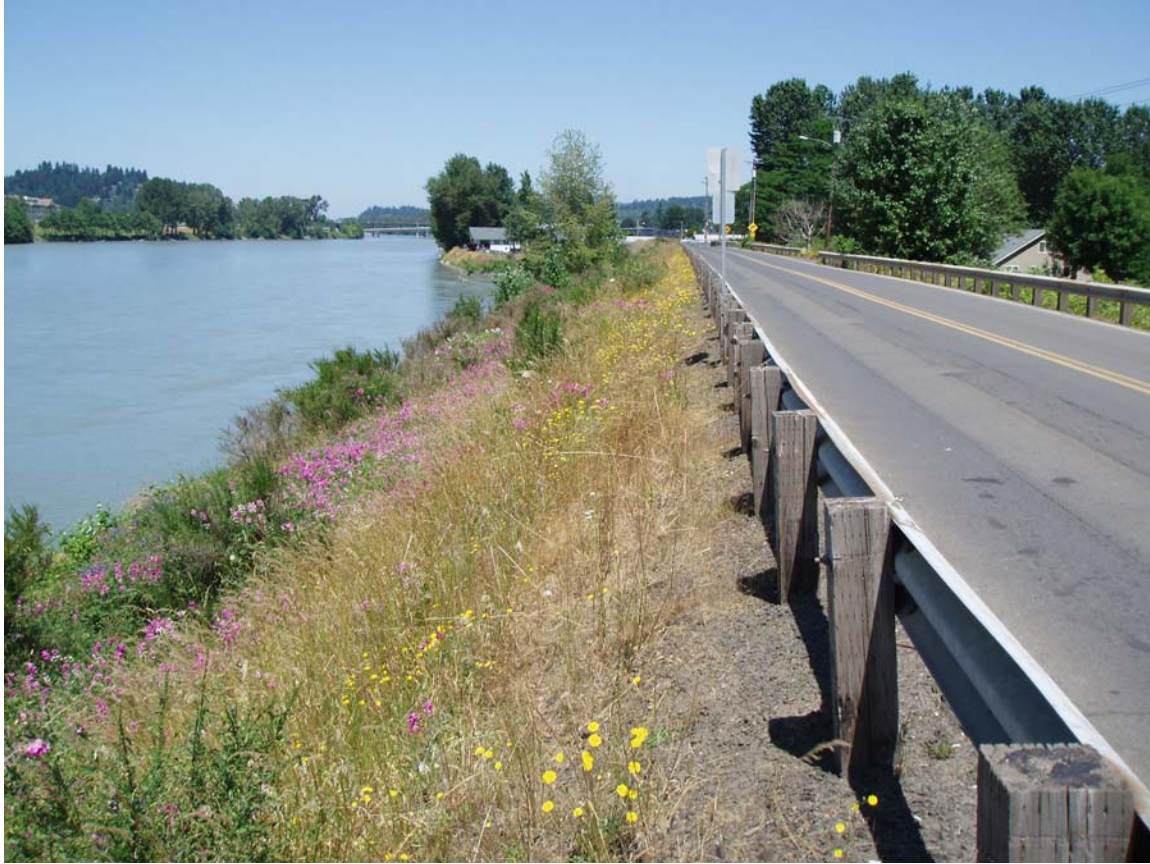
*Photo 5.7. Kelso reach KL7*

Reach KL7 extends from approximately station 158+69 to 178+75: South River Road to Olive Street. The levee section in this reach is wider than in reaches KL2, KL4, and KL6.
