**US Army Corps  
of Engineers®**  
Portland District

# **Mount St. Helens Project Cowlitz River Levee Systems 2009 Level of Flood Protection Update Summary**

Cowlitz River at Longview/Kelso, Washington

February 4, 2010

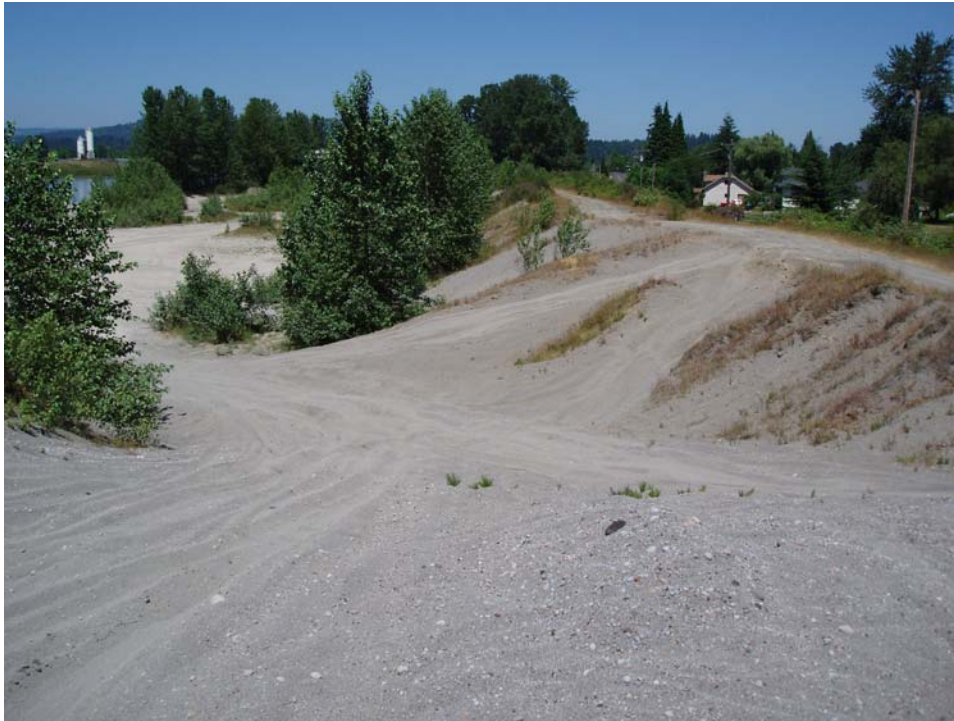
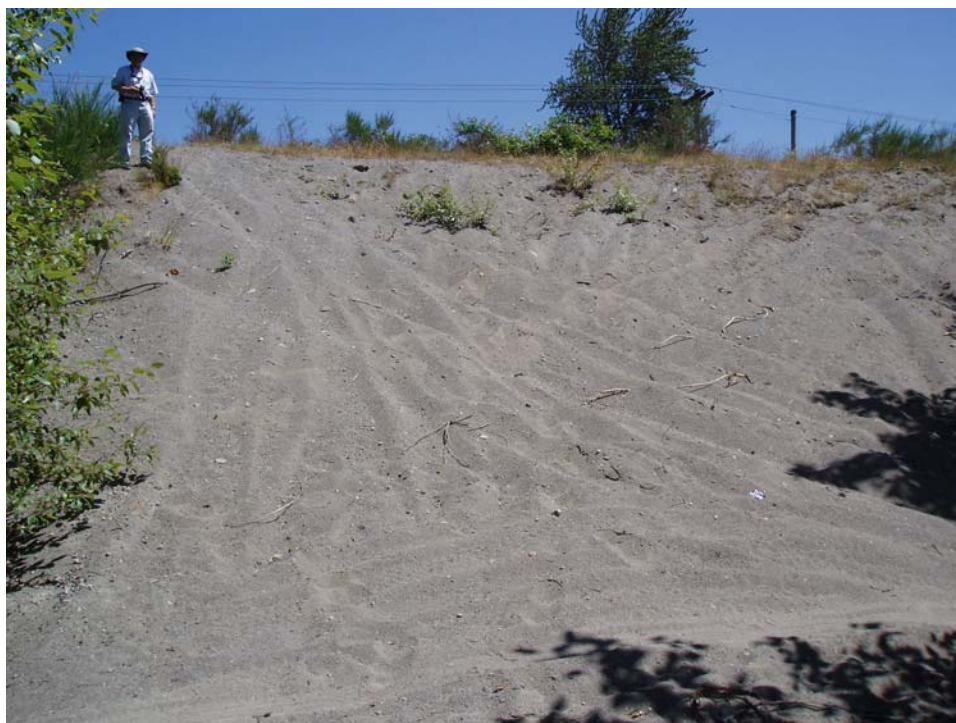
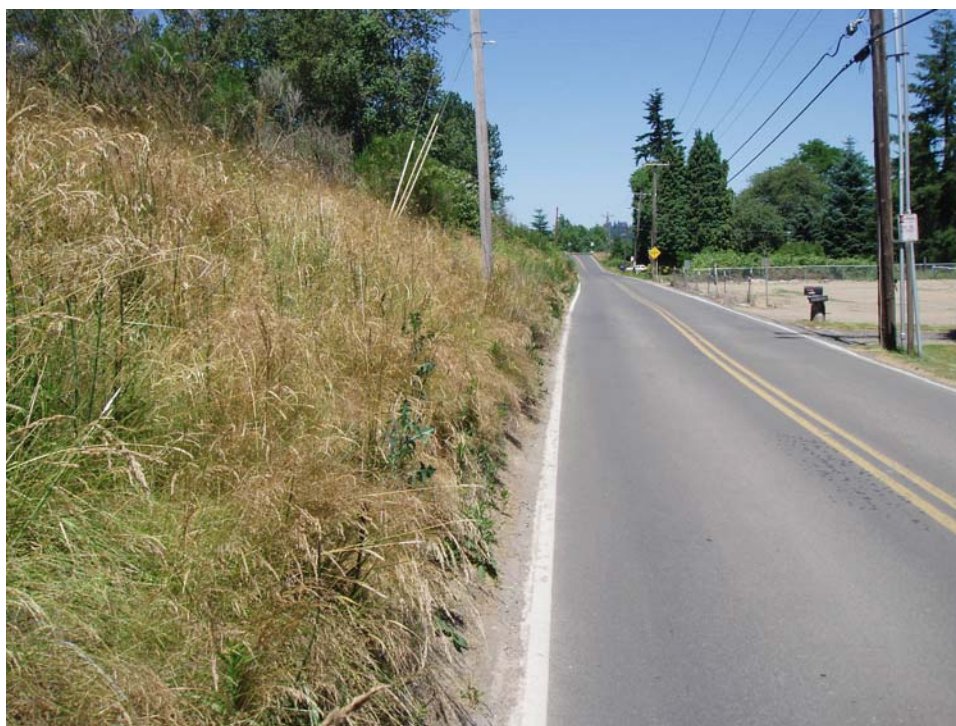
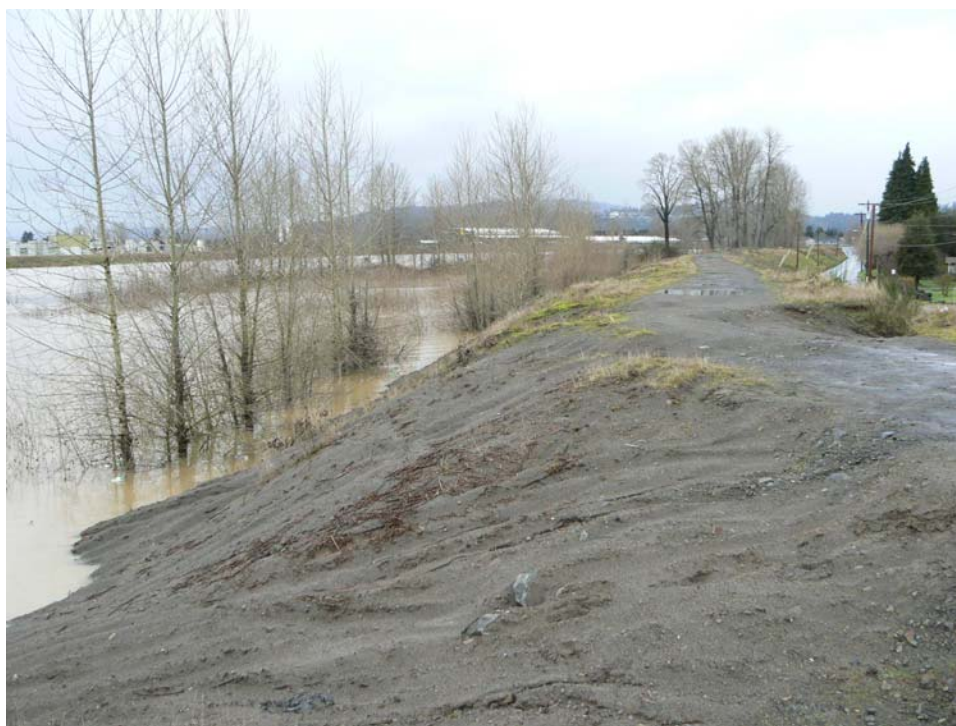
Reach KL8 extends from approximately station 178+75 to 191+70. Dredged sand previously placed riverward of the levee has been removed along this stretch of levee. Though the presence of riprap on the exposed riverward slope is not apparent in the photos below, riprap is on the levee slope below a thin layer of remaining dredged sand. The presence of the riprap, the placement of which is shown on Drawings CZR-7-5/5 and /6, was verified by a field investigation. Photo 5.8 c shows South River Road and the relatively steep landward slope in this reach.

Based on the analyses at station 60+53, the 1980 DWS is considered the SWL for most of the levee. The levee in reach KL8 is the exception. The lower SWL for this reach is shown in Figure 5.2. The reason for the lower SWL here is the emergence of seepage on the steep landward slope. This seepage can cause sloughing of the cohesionless levee sand. Seepage emerging from the bottom 3 ft of the slope is considered manageable because the slope can be buttressed (e.g. with crushed rock or quarry waste) if sloughing occurs, as South River Road runs along the toe of the levee, providing easy access for trucks and equipment.

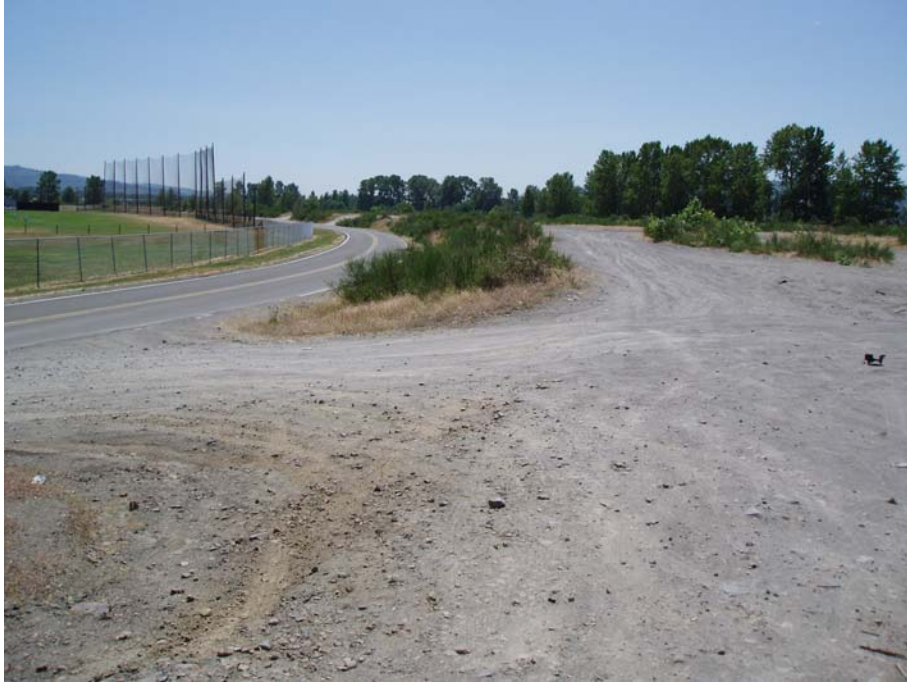
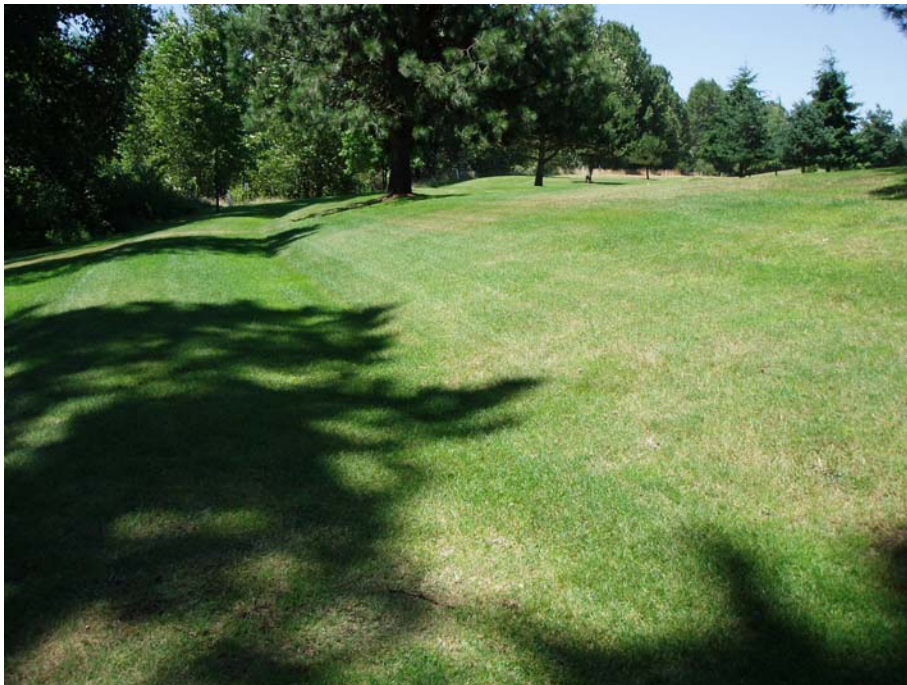
Reach KL9, which extends from approximately station 191+70 to 255+73, is essentially high ground now due to placement of dredged material adjacent to the levee.

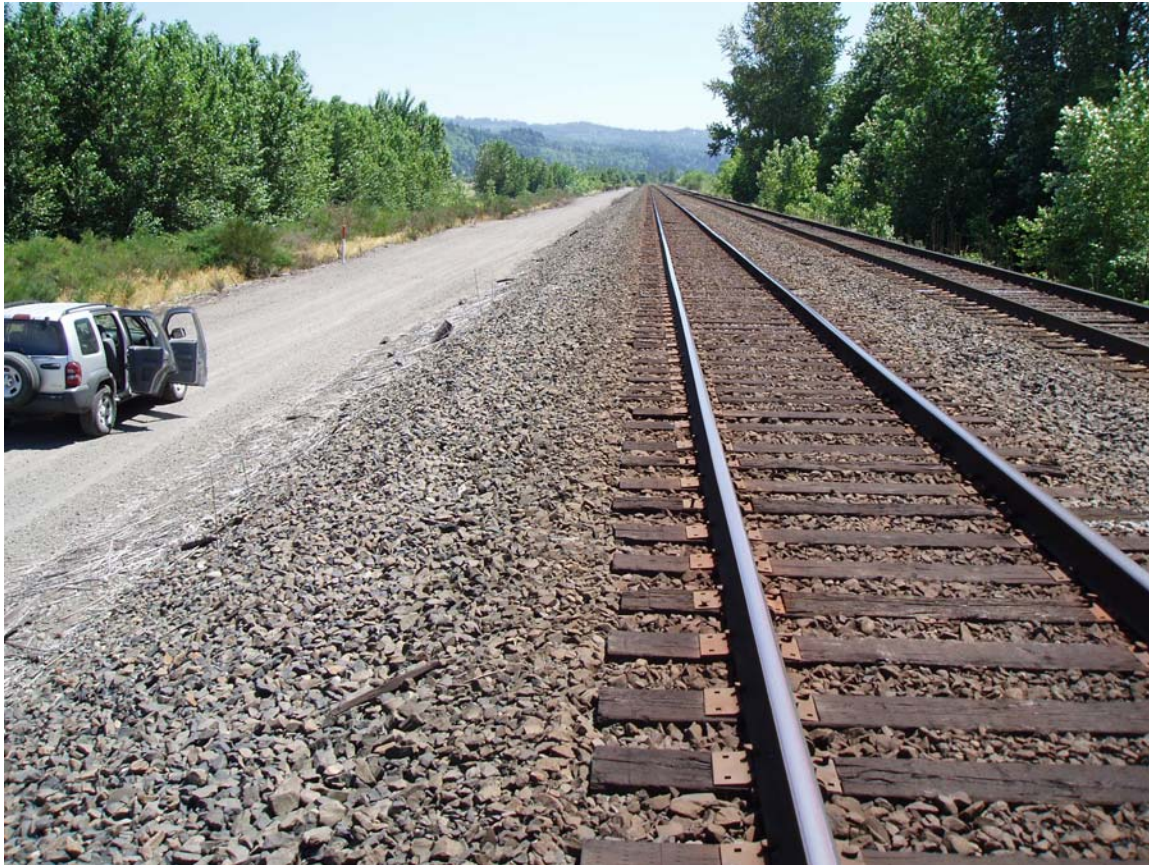
*Photo 5.10. Kelso reach KL10*

Reach KL10 extends from approximately station 255+73 to the downstream end of the levee: the mouth of the Coweeman River. This reach is a broad sand railroad embankment. The railroad embankment is about 27 ft wide at the top. A 24-ft-wide side-road berm is located on the landward side of the railroad embankment, with a top elevation about 6 ft below the top of the railroad embankment.

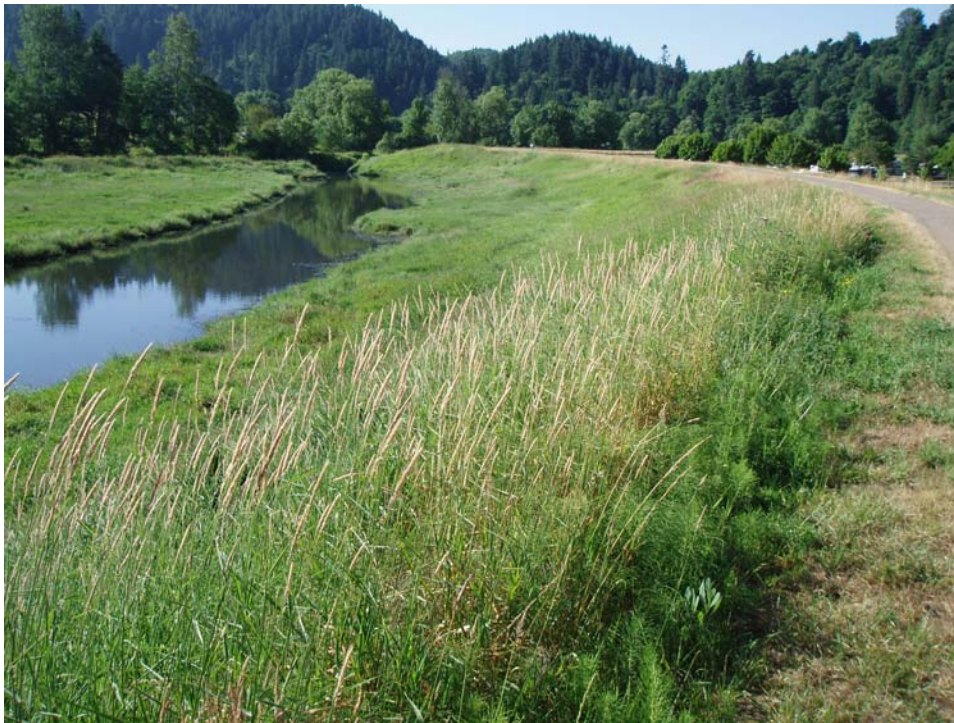
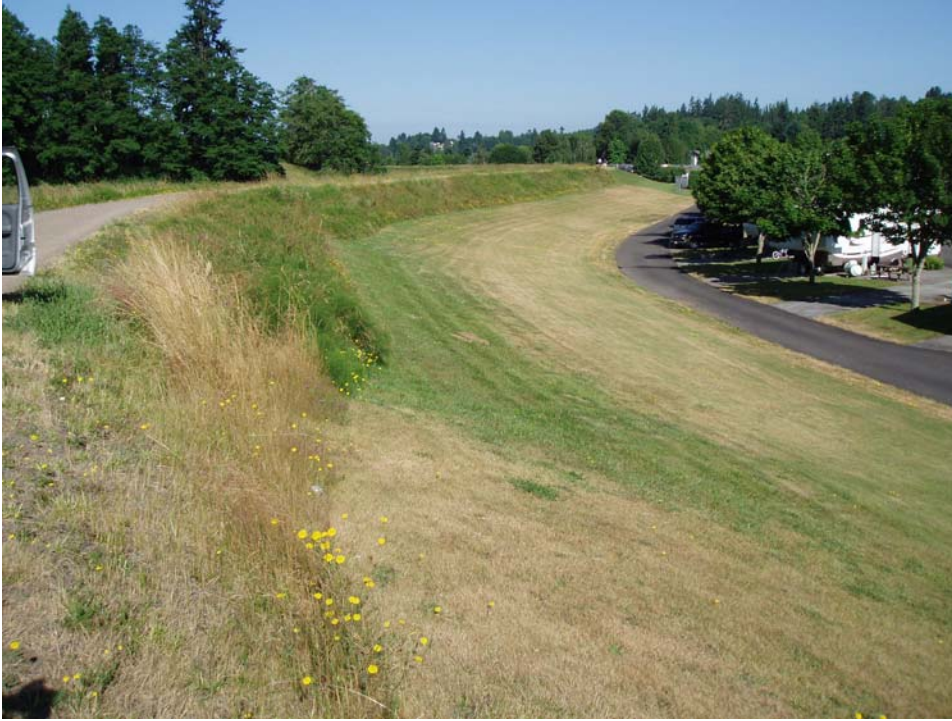
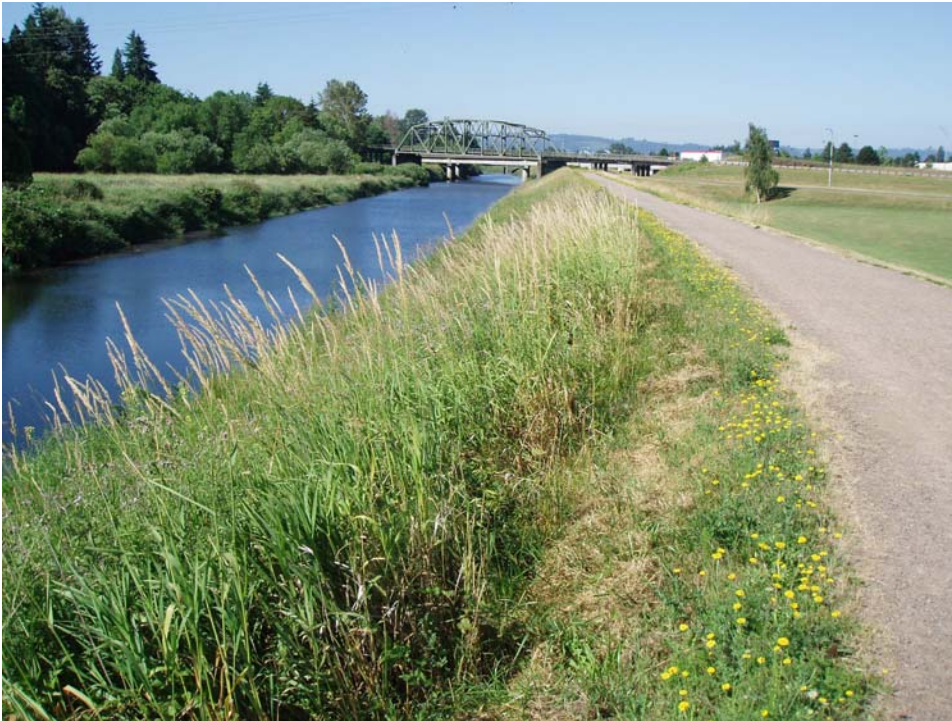
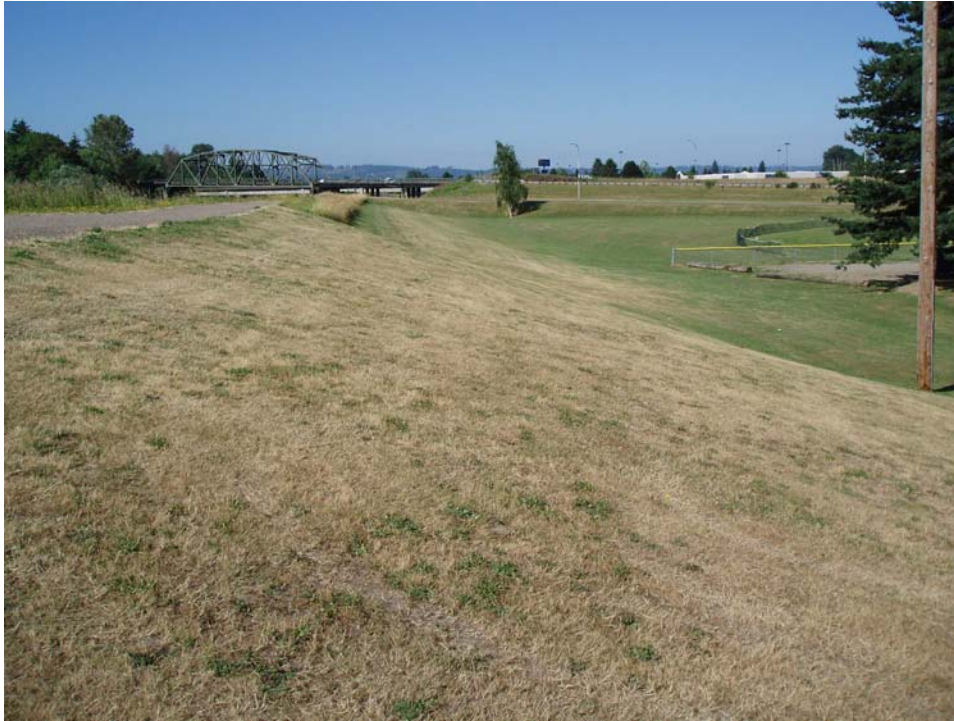
Due to its uniformity, the Coweeman levee was not divided into reaches. There is a dredge disposal site near the mouth of the river that creates high ground adjacent to the levee. This area would be treated differently if a levee improvement were to occur. The high ground area is not a problematic area and is not represented by an index point.

*Photo 6.1. Coweeman, riverward side near upstream end of levee*

*Photo 6.2. Coweeman, landward side near upstream end of levee*

*Photo 6.3. Coweeman, riverward side of levee in vicinity of station 65 – 70*

*Photo 6.4. Coweeman, landward side of levee in vicinity of station 65 – 70*

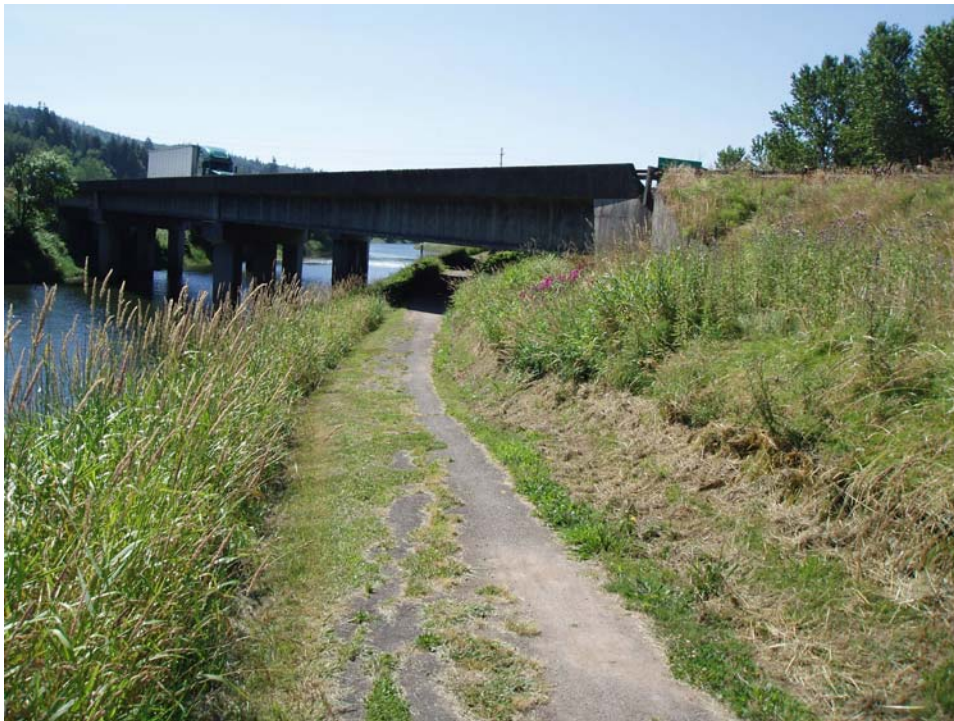
*Photo 6.5. Coweeman, levee at I-5 crossing at station 137*

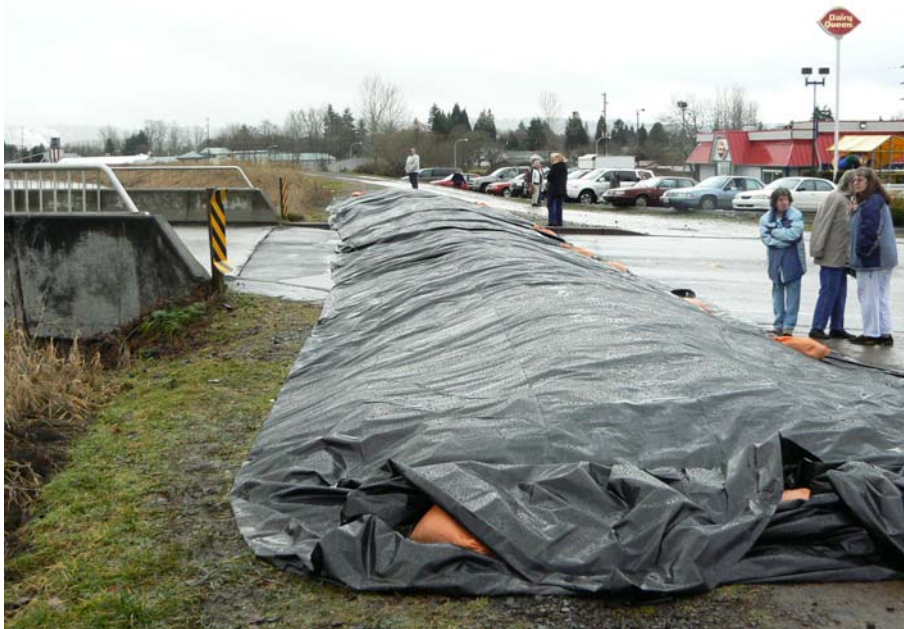
Photo 6.6. Coweeman: quarry waste wrapped in plastic sheeting across Grade Street
