Burrowing by Sailfin Catfish (*Pterygoplichthys* sp.): A Potential Cause of Erosion in Disturbed Environments

by *Oliver van den Ende*

Van den Ende, O. 2014. *Burrowing by sailfin catfish (Pterygoplichthys sp.): A potential cause of erosion in disturbed environments*. ANSRP Technical Notes Collection. ERDC/TN ANSRP-14-1. Vicksburg, MS: U.S. Army Engineer Research and Development Center. <http://el.erd.usace.army.mil/ansrp/ansrp.html>.

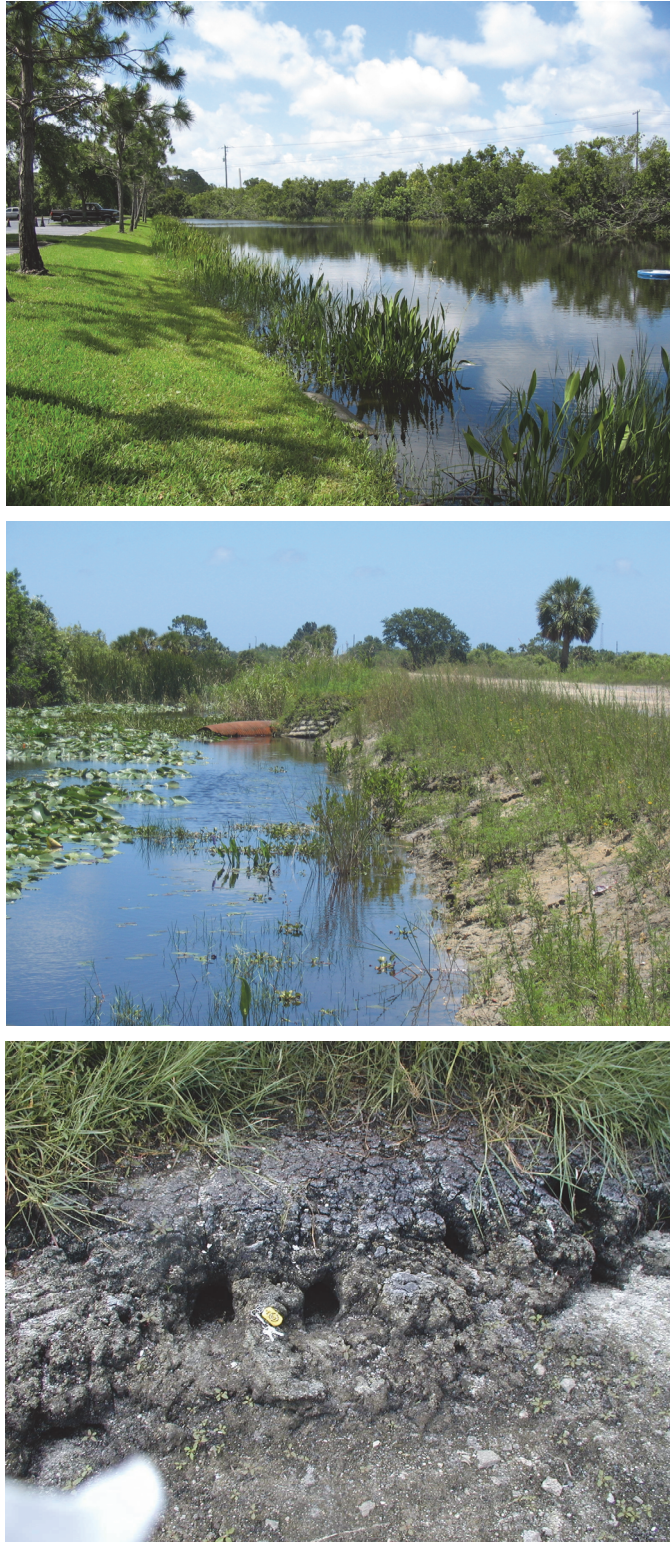
Figure 2. Representative localities: Imperial Hotel retention pond (top); Eau Gallie Ditch (middle); Sotille Canal showing burrow-ridden bank (bottom).

Study area. Fieldwork was conducted during the period June-September 2005 in Brevard County, Florida. Sailfin catfish, believed to be vermiculated sailfin catfish (*Pterygoplichthys disjunctivus*) based on pigmentation (Page 1994)), were present in most freshwater systems connected to the St. Johns River (Figure 1). Sites selected represented small urban water bodies, a flood control canal, and a borrow area (Figure 2).
