**EXPERIMENTAL INVESTIGATION OF MECHANICAL BEHAVIOR OF AN
OXIDE/OXIDE CERAMIC COMPOSITE IN INTERLAMINAR SHEAR AND
UNDER COMBINED TENSION-TORSION LOADING**

THESIS

AFIT-ENY-14-M-26

AIR FORCE INSTITUTE OF TECHNOLOGY

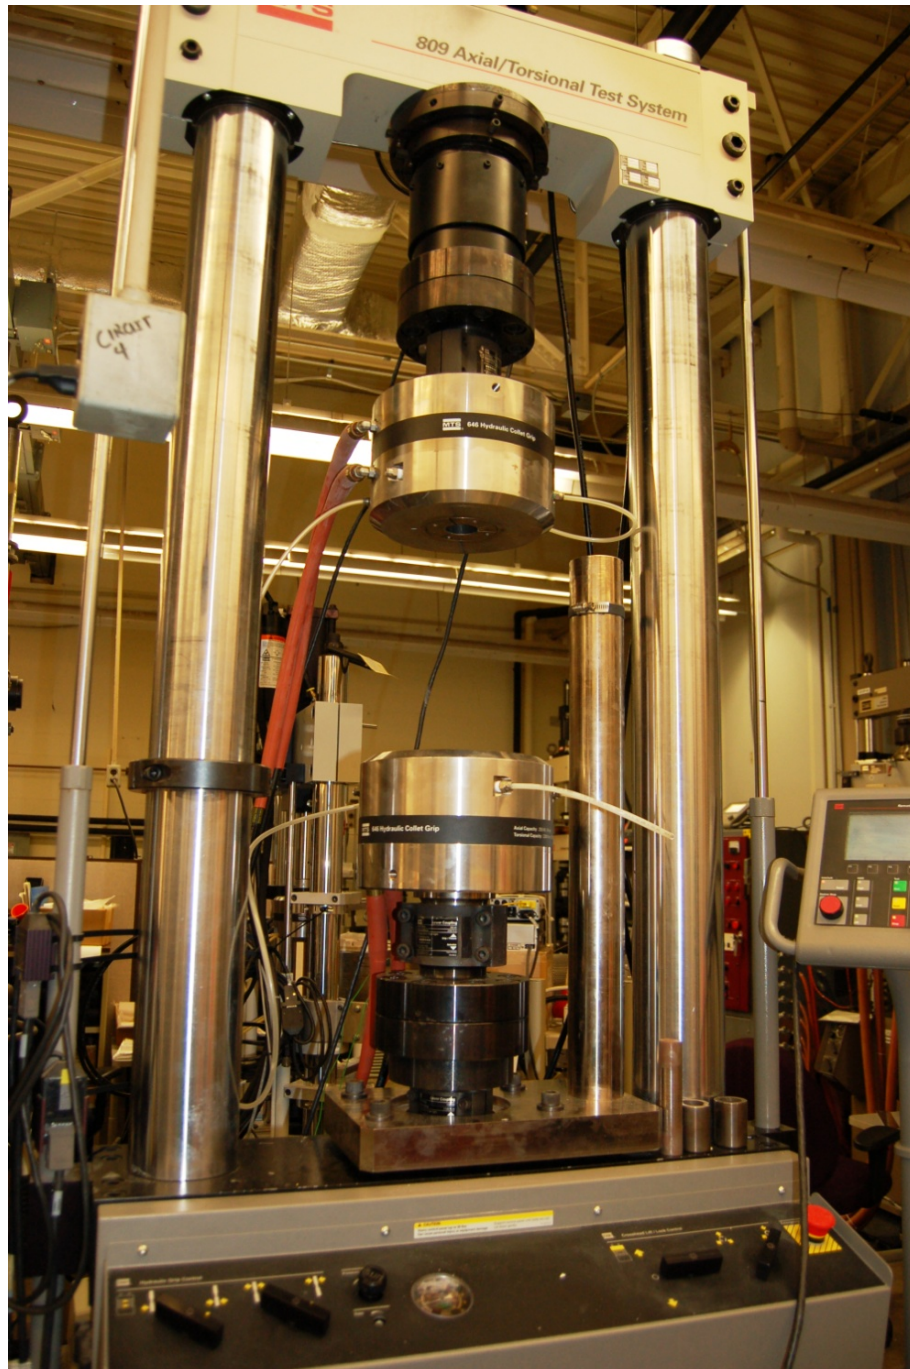
Figure 8. MTS 809 load frame.

Biaxial tension-torsion tests were conducted using an MTS 809 Axial/Torsional test system equipped with MTS 646 hydraulic collet grips. The MTS 809 Axial/Torsional test system has the axial capacity of 98 kN (22,000 lbs) and the torsional capacity of 1130 N·m (10,000 in-lbs). An MTS TestStar IIm digital controller and a PC with TestStar IIm Station Manager Software (version 5.3B 3243) were used for input signal generation and data acquisition. Test setup is shown in Figure 8. The grip pressure in all tests was set to 5 MPa. To accomplish strain measurement, thin-walled tubular specimens were instrumented with strain gauges, which were connected to a rack of 11 Vishay Precision Group 2300 Signal Conditioning Amplifiers (SCAs) seen in Figure 9. The SCAs applied a 0.5 V excitation to the 350 Ω strain gages to condition the signal for proper recording by the MTS system. During the tests, damage development and failure of each specimen were recorded with a Dantec Dynamics Nanosense MkII high speed camera (Figure 10).

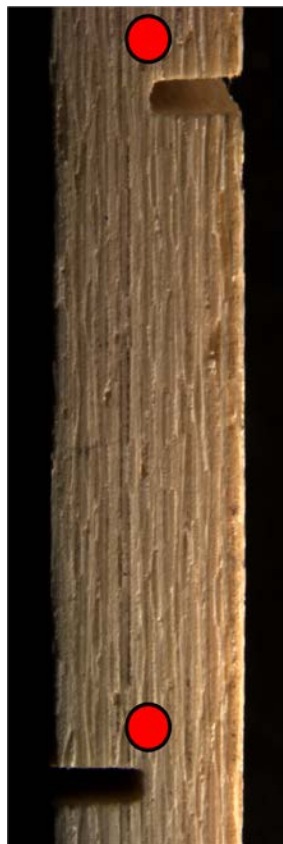
Figure 12. Extensometer positioning on the DNS specimen.

specimen using M-Bond 200 adhesive. Note that in the case of CMCs, the specimen surface does not require extensive preparation, unlike metals where oxidation needs to be removed. Prior to gripping in the MTS testing machine, the test specimen was inserted into the susceptor. Then the testing machine is placed in displacement control and the top portion of the specimen is gripped. The next step is to switch control to force, command zero force and grip the bottom portion of the specimen. Once the test specimen is gripped, the furnace is placed around the specimen and the extensometer is mounted. Note that in the case of the DNS specimens, the extensometer rods were placed as close to the root of the notches as possible (Figure 12).

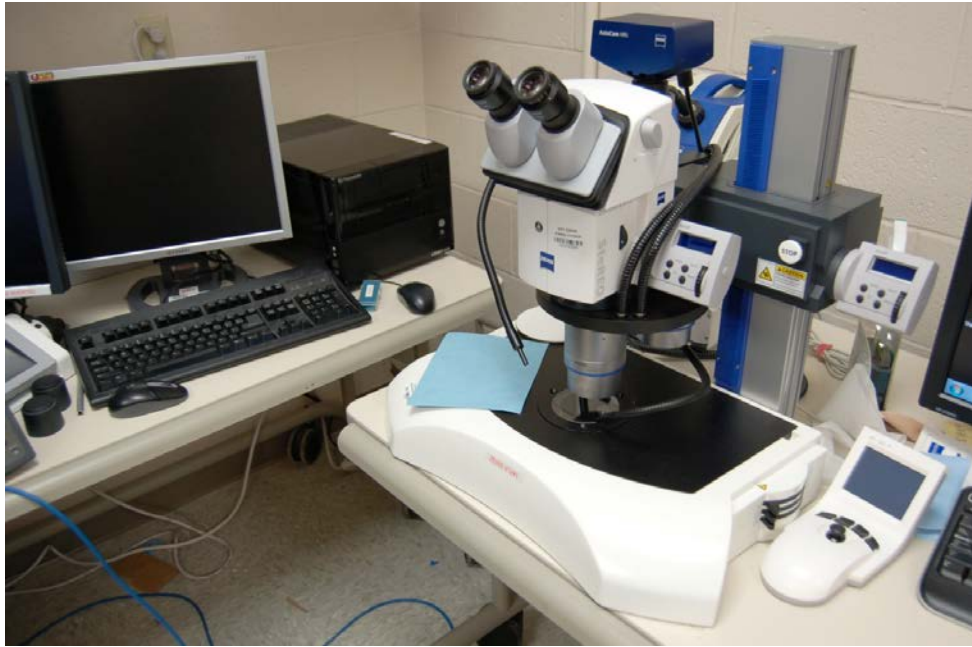
Figure 16. Zeiss Discovery.V12 stereoscopic optical microscope.

Fracture surfaces of the tested specimens were analyzed using a Zeiss Discovery.V12 stereoscopic optical microscope equipped with a Zeiss AxioCam HRc digital camera (Figure 16) and a Quanta 450 Scanning Electron Microscope (SEM) (Figure 17). In preparation for SEM examination, specimens were cut on a Buehler IsoMet 5000 Linear Precision Saw (Figure 18).

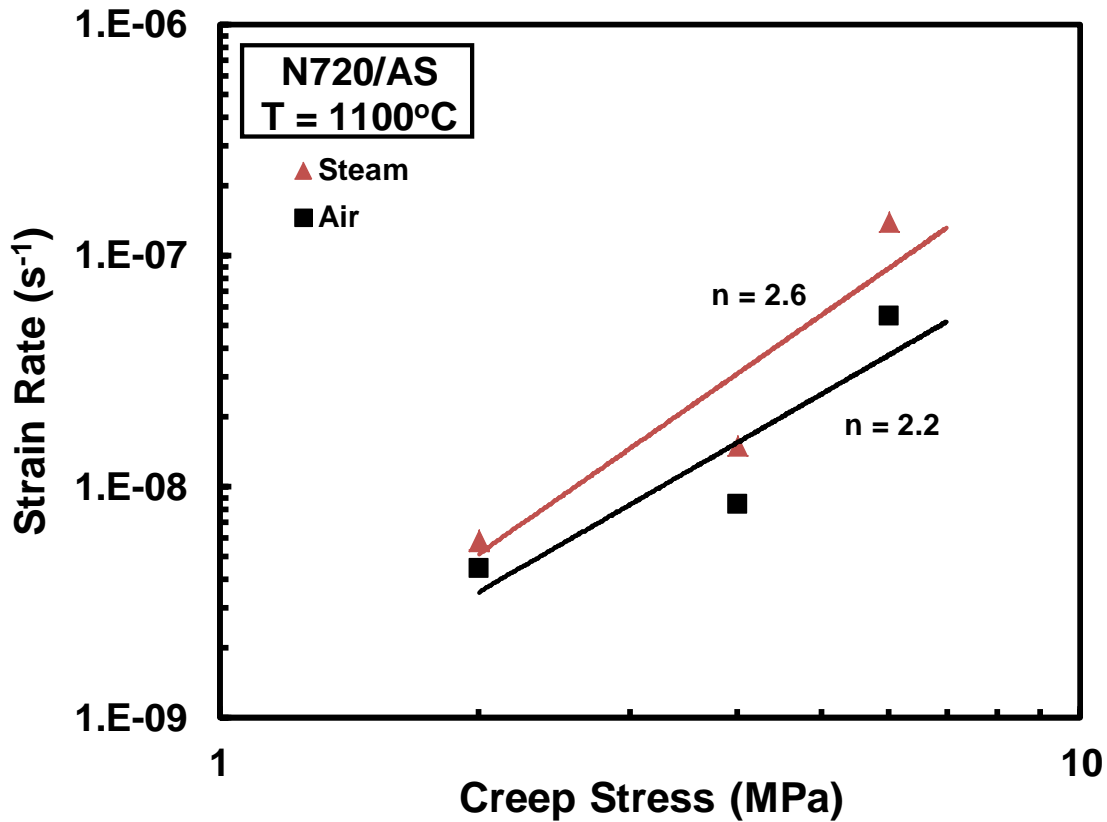
Figure 23. Minimum creep rate as a function of applied interlaminar shear stress for N720/AS CMC at 1100 °C in air and in steam.

Where $\dot{\epsilon}$ is the minimum creep rate, A is a temperature-dependent coefficient that accounts for the activation energy and other variables, and τ is the applied interlaminar shear stress. The stress exponent was $n = 2.2$ in air and $n = 2.6$ in steam. These values of the stress exponent are lower than the stress exponent of $n = 3$ reported by Buchanan et al

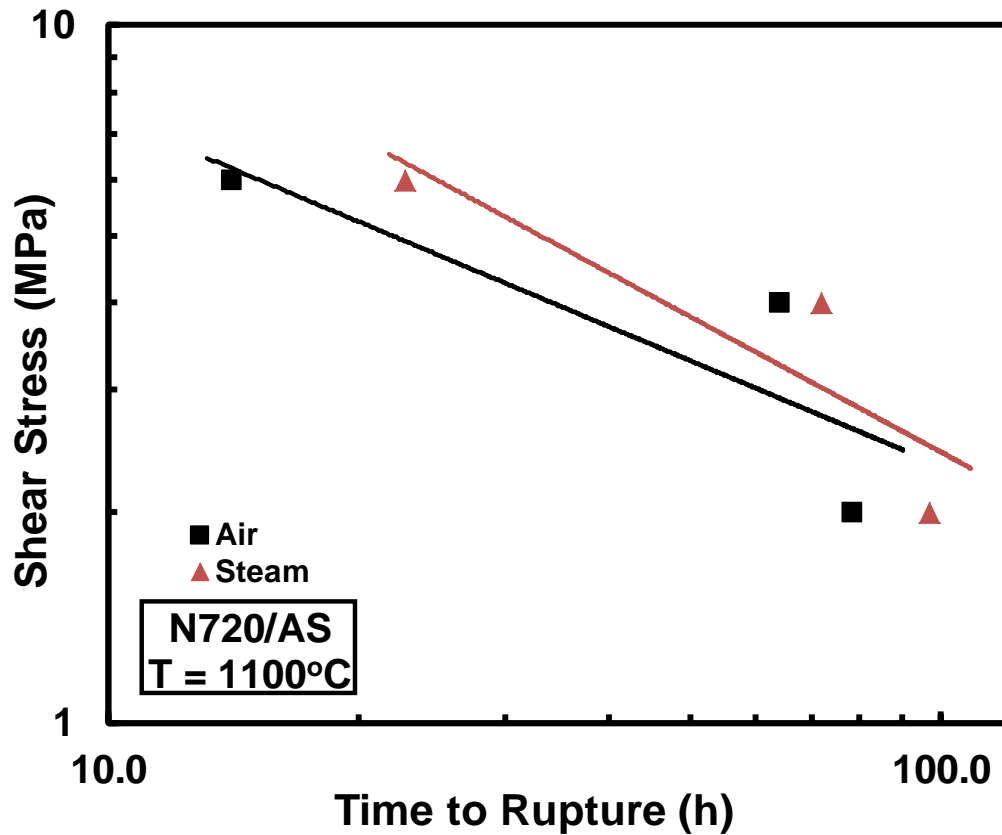
Figure 24. Interlaminar shear stress vs. time to rupture for N720/AS CMC at 1100°C in air and in steam.

Stress-rupture behavior is summarized in Figure 24, where the applied interlaminar shear stress is plotted vs. time to rupture at 1100°C in air and in steam. As expected, creep lifetimes decrease with increasing applied stress. Surprisingly, the presence of steam at 1100 °C appears to be beneficial. Creep lifetimes produced in steam are consistently longer than those obtained in air. Recall that creep behavior in interlaminar shear is dominated by matrix behavior. Matrix strengthening may be occurring at 1100°C in steam under load, which would account for improved lifetimes in steam.

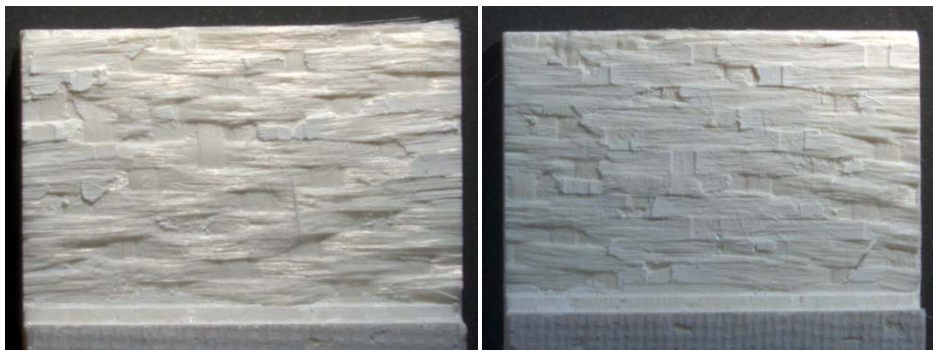
Figure 25. Fracture surface of the DNS specimen tested in compression to failure at 1100 °C in air (test duration < 15 s).

A representative fracture surface of the DNS specimen tested in compression to failure at 1100 °C in air (test duration < 15 s) is presented in Figure 25. It is seen that fracture occurs along the shear plane mainly through delamination of woven 0/90 fiber layers from the matrix-rich regions, with only minimal fiber fracture. The fracture surface in Figure 25 is largely clean and smooth, suggesting that a single fiber layer is involved in delamination. While virtually no rough areas can be seen in Figure 25, higher magnification views in Figure 26 reveal some debris and fiber breakage. The SEM micrographs in Figure 26 also show small amounts of the matrix material that remain bonded to the fibers exposed during delamination.

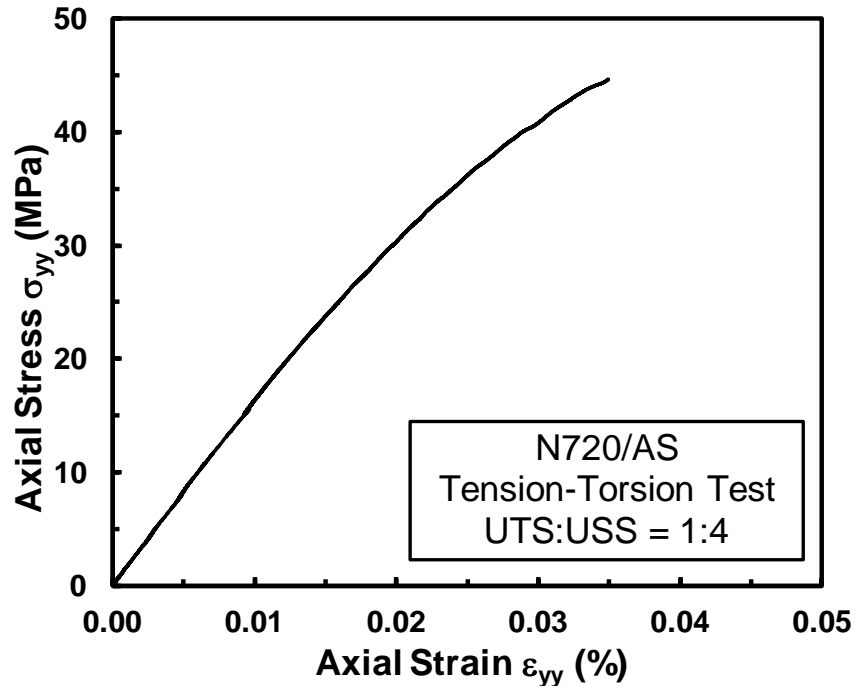
Figure 33. Axial stress σ_{yy} vs. axial strain ϵ_{yy} curve for Specimen A tested in combined tension-torsion with the SR of 1:4.

Specimen A was loaded to failure in combined tension-torsion with a SR of 1:4. The failure stresses were $\sigma_{yy} = 44.7$ MPa and $\tau_{xy} = 27.3$ MPa. The axial stress - axial strain curve and the shear stress – shear strain curve obtained in this test are shown in Figures 33 and 34, respectively. The axial stress – axial strain curve in Figure 33 becomes slightly nonlinear when the axial stress exceeds 20 MPa. Axial strain produced in this test remains very small, below 0.04%. Conversely, the shear stress – shear strain curve in Figure 34 remains linear only up to about 10 MPa. Considerable nonlinear stress-strain behavior is observed at stresses exceeding 10 MPa. Note that shear strain at failure (0.29%) is approximately an order of magnitude higher than the axial strain (0.04%) at failure. The strong nonlinearity of the shear stress-strain response, dominated by the matrix behavior in interlaminar shear is in strong contrast to the nearly linear axial stress-strain response, dominated by the N720 fibers. As seen in Figure 35, the failure surface of specimen A is nearly perpendicular to the loading axis. Notably, the failure mode is similar to that observed in a combined tension-torsion test of N720/AS involute tubular specimen by DeRienzo [90]. Fibrous fracture appears to dominate the fracture surface, indicating crack deflection around the fibers.

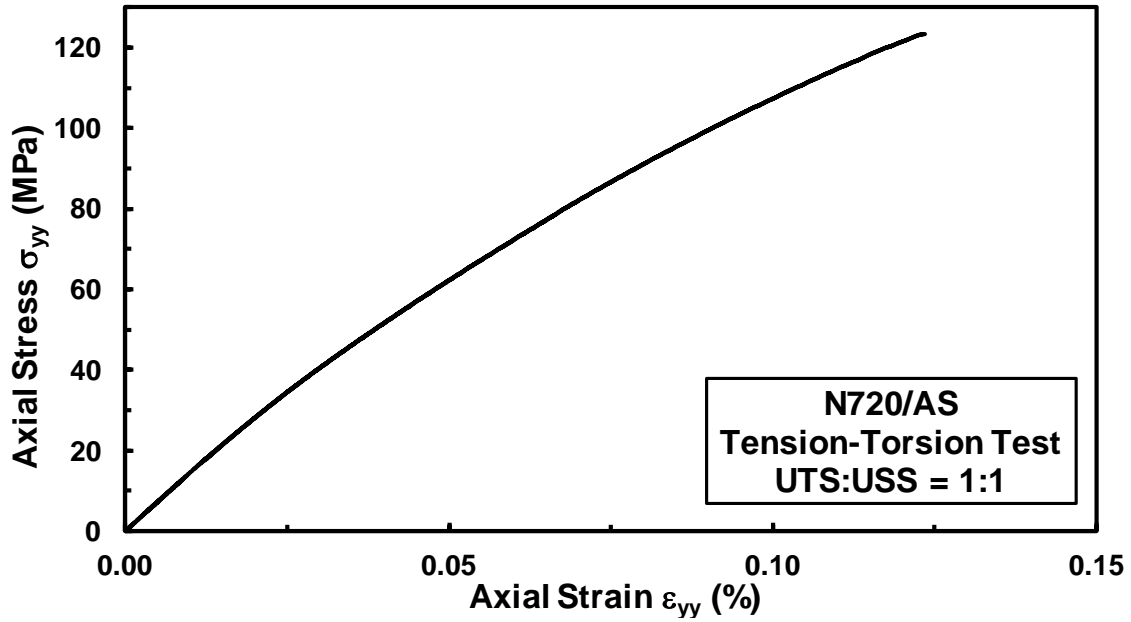
Figure 36. Axial stress σ_{yy} vs. axial strain ϵ_{yy} curves for specimen B tested in combined tension-torsion with the SR of 1:1.

Specimen B was loaded to failure in combined tension-torsion with the SR of 1:1. The failure stresses were $\sigma_{yy} = 123$ MPa and $\tau_{xy} = 18.6$ MPa. The axial stress – axial strain curve and the shear stress – shear strain curve obtained in this test are shown in Figures 36 and 37, respectively. As in the case of specimen A, the axial stress-strain curve is nearly linear to failure, while the shear stress-strain curve exhibits strong nonlinearity. As in the case of specimen A, the slight nonlinearity of the axial stress-strain response of specimen B becomes apparent as the axial stress exceeds 20 MPa. Conversely, the shear stress-strain response of specimen B departs from linearity at a lower stress of approximately 5 MPa. In test B axial stress at failure (123 MPa) is nearly three times that produced in test A. Yet the shear stress at failure in test B is (18.6 MPa) is not drastically lower than that in test A. It is noteworthy that the axial strain at failure (0.12%) is nearly an order of magnitude higher than that obtained for specimen A (0.04%). In contrast, shear strain at failure (0.28%) is not dramatically different from that produced by specimen A (0.22%). The failure surface of specimen B is depicted in Figure 38. It is seen that the failure surface has a portion that is nearly perpendicular to the specimen axis and a portion that is at a well-defined 45° angle to the specimen axis.

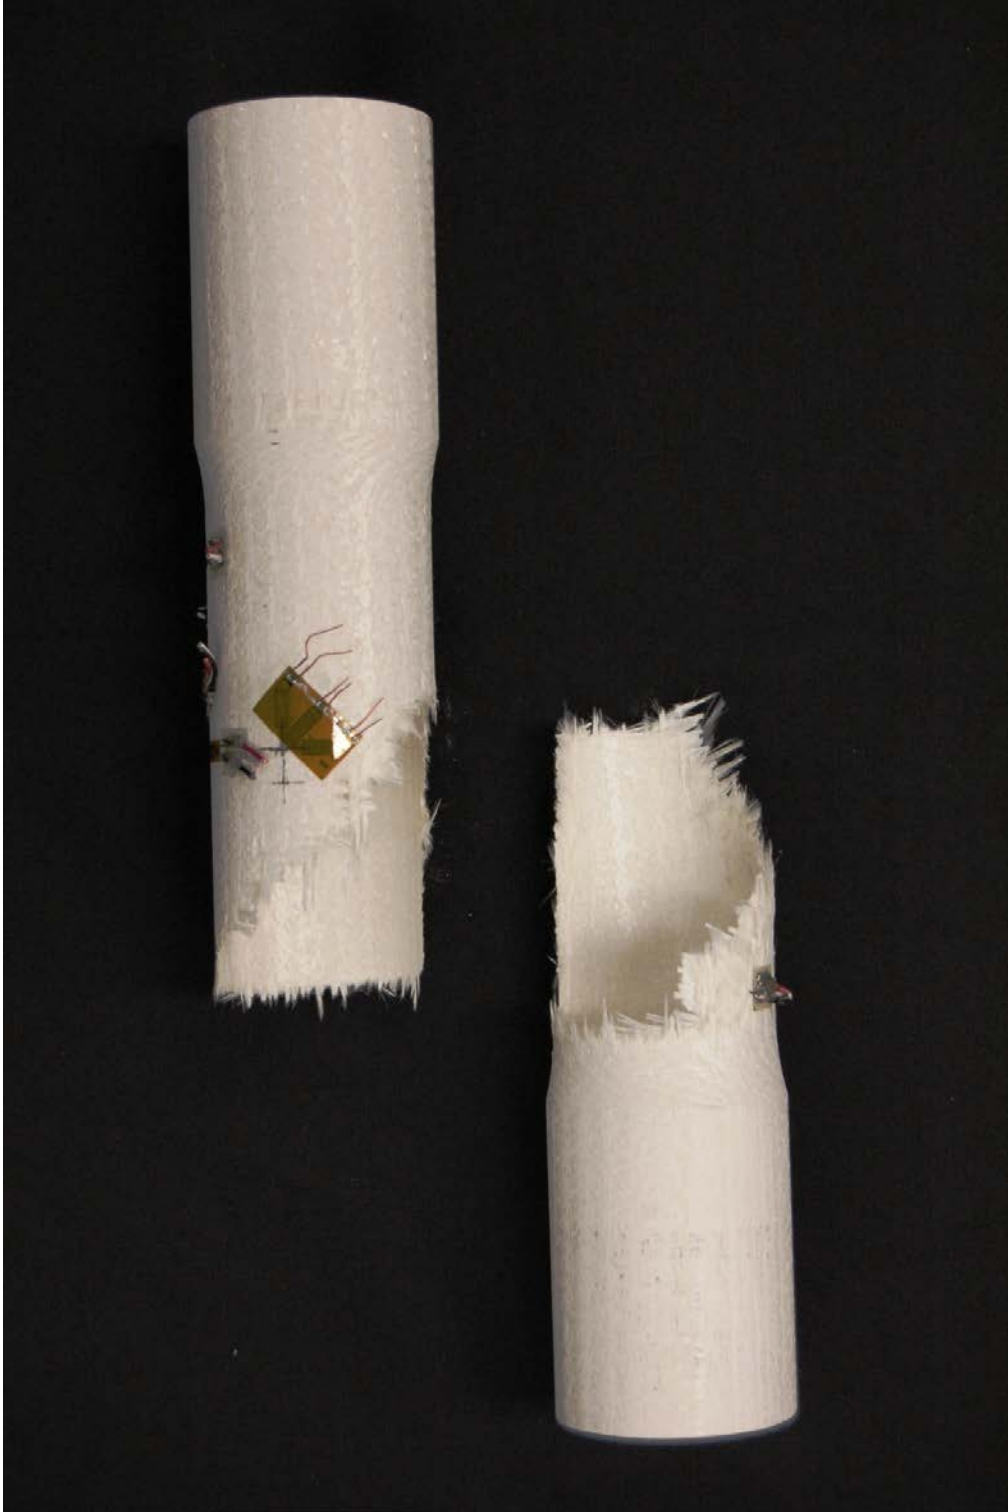
Figure 38. N720/AS specimen B tested in combined tension torsion with the SR of 1:1.

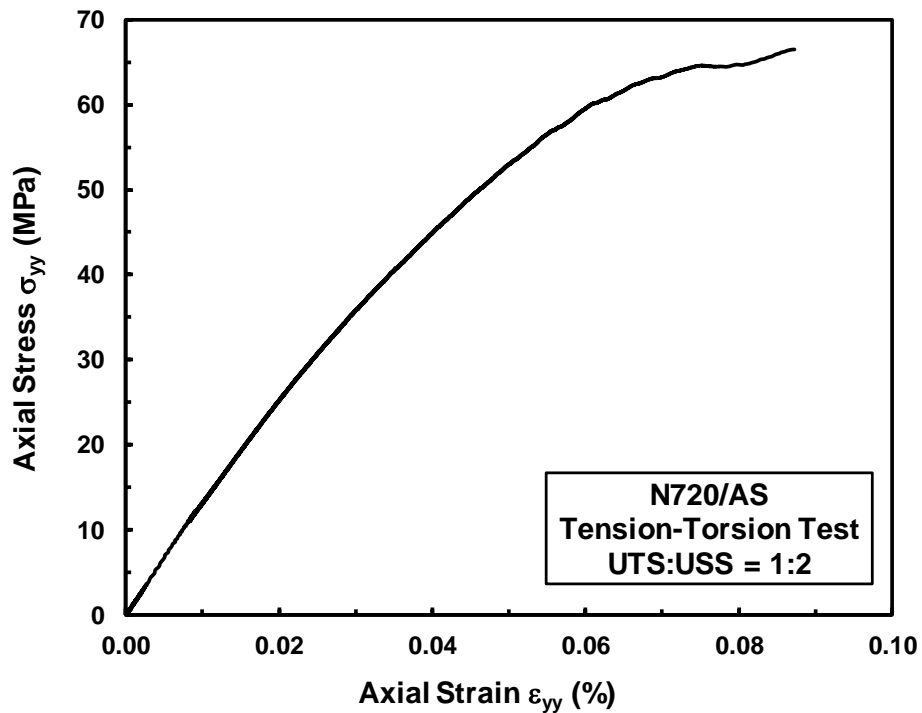
Figure 39. Axial stress σ_{yy} vs. axial strain ϵ_{yy} curves for Specimen C tested in combined tension-torsion with the SR of 1:2.

Specimen C was loaded to failure in combined tension-torsion with the SR of 1:2. The failure stresses were $\sigma_{yy} = 66.5$ MPa and $\tau_{xy} = 19.5$ MPa. The axial stress – axial strain curve and the shear stress – shear strain curve obtained in this test are shown in Figures 39 and 40, respectively. Note that the failure stresses obtained in this test fall between the corresponding failure stresses produced in tests A and B. The same observation can be made regarding axial and shear strains at failure. The shear stress-strain behavior of specimen C remains similar to those exhibited by specimens A and B. However, the axial stress-strain curve obtained for specimen C show considerably stronger nonlinearity than those obtained for specimens A and B. This difference may be due to specimen-to-specimen variability. Additional tension-torsion test must be performed before a definitive conclusion can be attempted.

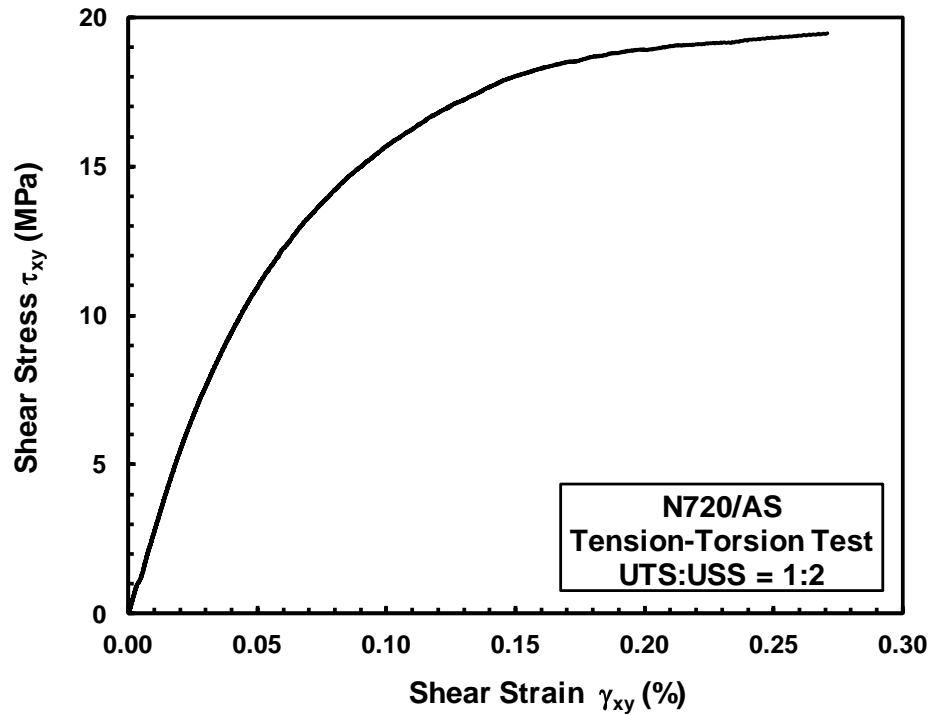
Figure 40. Shear stress τ_{xy} vs. shear strain γ_{xy} curves for specimen C tested in combined tension-torsion with the SR of 1:2.

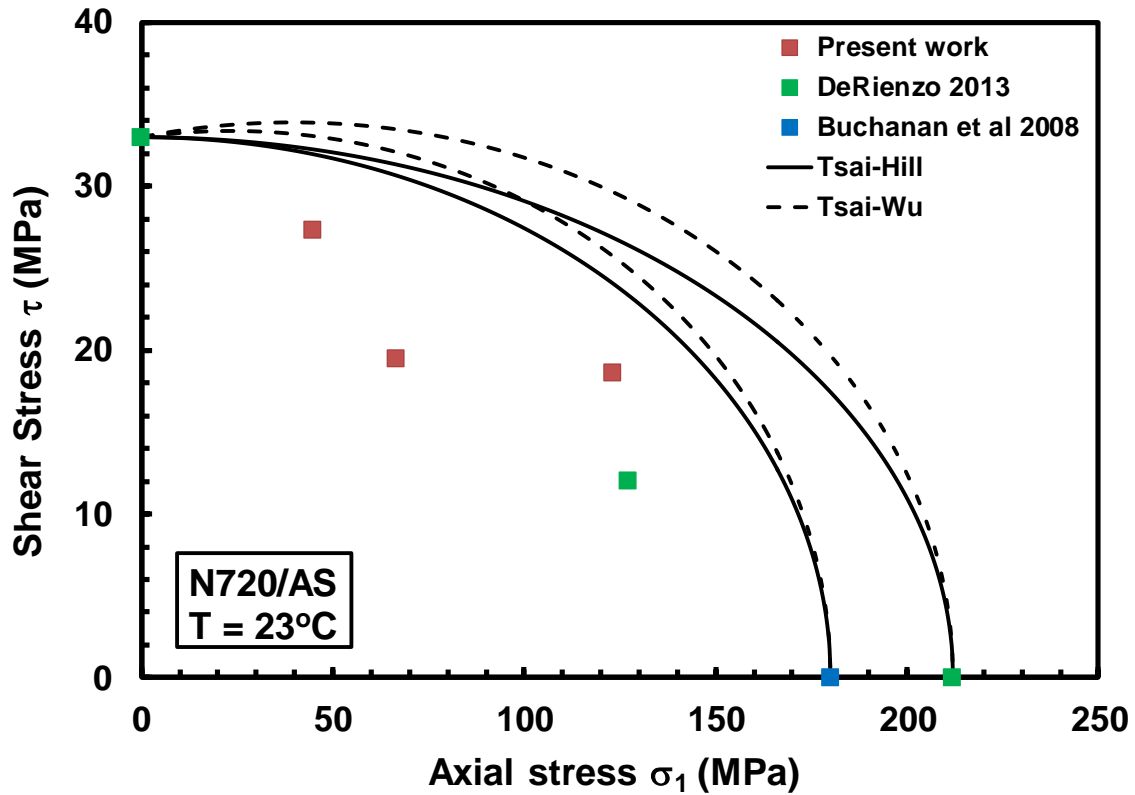
Figure 42. A comparison between experimental and predicted failure envelopes for N720/AS composite under combined tension-torsion. Failure stress values from DeRienzo [90] and Buchanan et al [98] are also included.

As seen in Figure 42, the failure stresses obtained in tension-torsion tests for the N720/AS composite appear to follow a trend similar to those predicted by the Tsai-Hill and Tsai-Wu failure theories. Further comments on the efficacy of these or any other failure theories in representing failure of the N720/AS composite should be reserved until considerably more experimental data are available. It is particularly recommended, that
