## Cadmium Coating Alternatives for High-Strength Steel JTP – Phase II

Westminster, CO  
3 September 2009

# Project Overview

- Assess DoD-selected Cadmium alternatives in accordance with the DoD-approved Joint Test Protocol (JTP) for both traditional plating and brush plating of HSS applications.  
(JTP is available at [www.jgpp.com](http://www.jgpp.com))

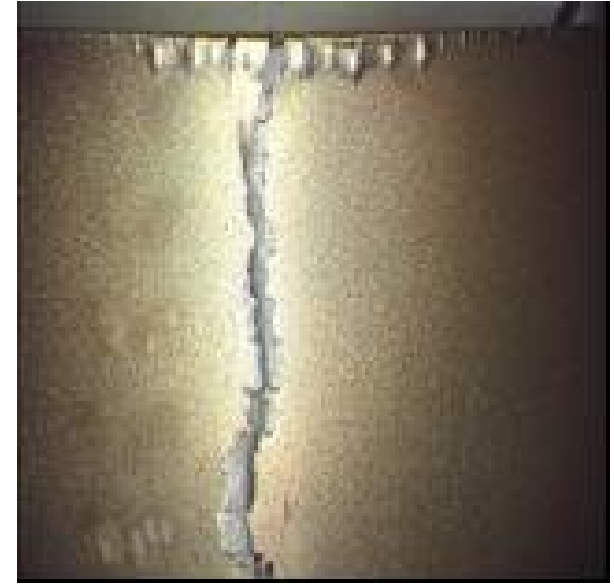
Electroplated  
Aluminum on Ti-6-4

- All primary coatings passed using both 4130 steel & 17-4 stainless
- LHE Zinc-Ni and electroplated Al failed bend adhesion for Ti-6-4 due to spalling and edge buckling respectively

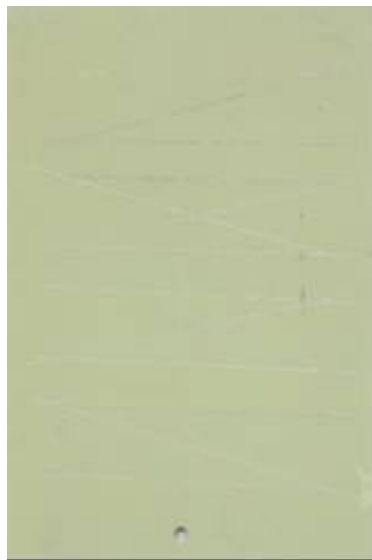
**IVD Al with MIL-PRF-85582 C1,  
after 4 days**

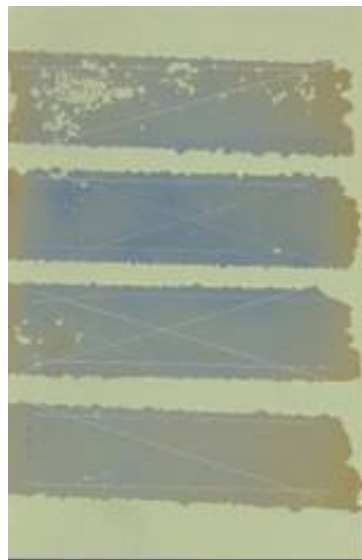
**LHE Zn-Ni with  
MIL-PRF-85582  
C1, after 4 days**

- **Primary coatings passed paint adhesion testing with one exception (LHE Zinc-Ni failed for 85582 Class C1 after 4 and 7 days)**

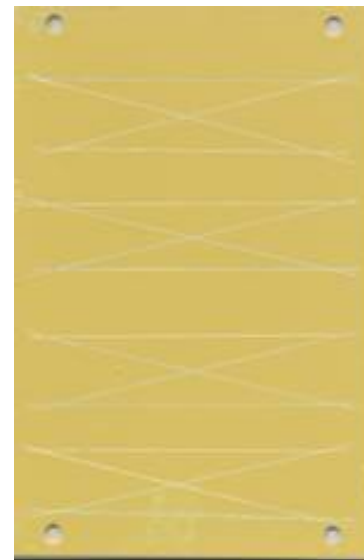
**Electroplated Al  
with MIL-PRF-  
23377, after 7 days**

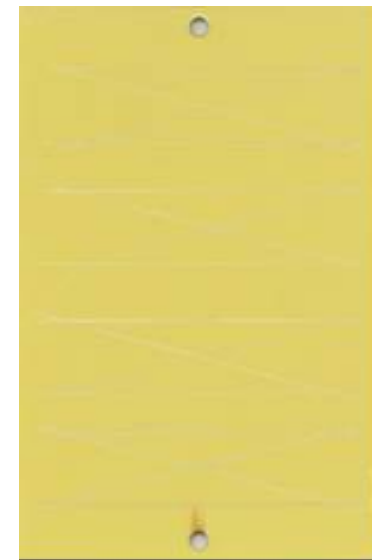
**Sputtered Al with  
MIL-PRF-23377,  
after 4 days**

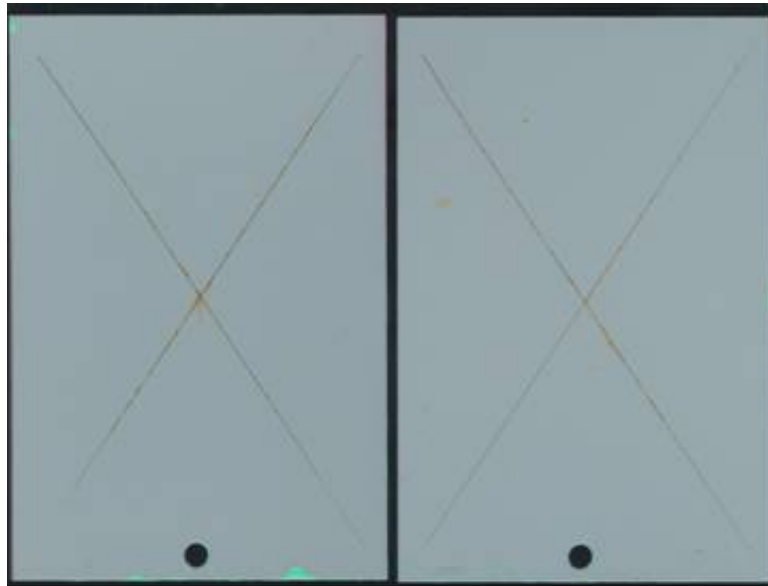
**Cd-plated panels  
(3000 hours)**

- Three primers tested for a maximum exposure of 3000 hours
- Cadmium performed the best with all 9 ratings after 3000 hours
- LHE Zn-Ni performed similarly to cadmium, with three panels achieving 9 ratings, though two others achieved a 4 and 5 for creepage and pinhole rust
- Electroplated Al lasted 3000 hours but received ratings ranging from 0 – 5
- Sputtered Al and IVD Al both failed to achieve 3000 hours of exposure due to excessive rust

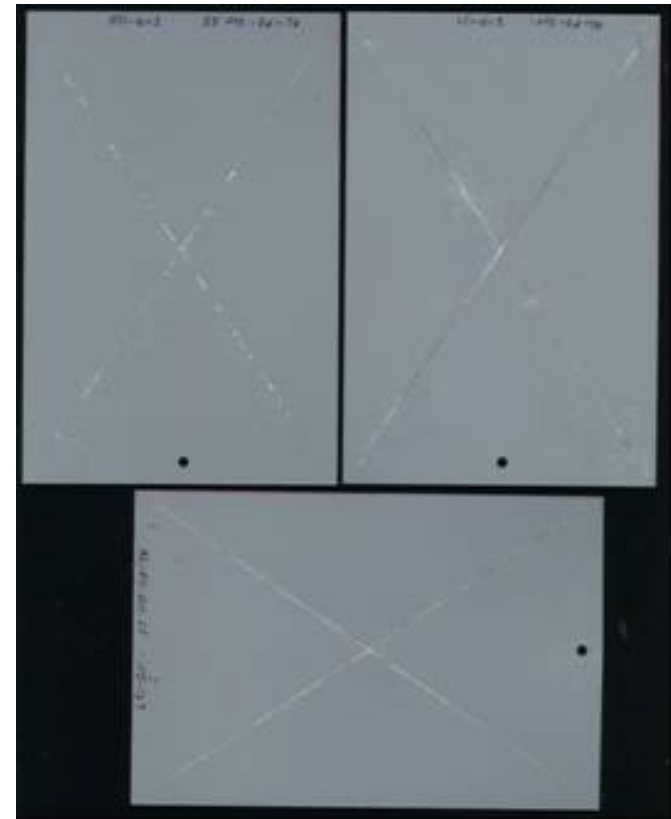
**IVD Al Coated Panels  
(2000 hours)**

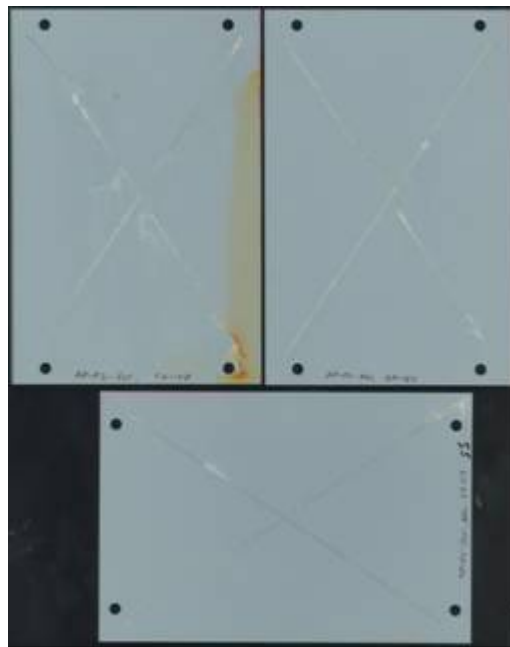
**Electroplated Al  
Panels  
(3000 hours)**

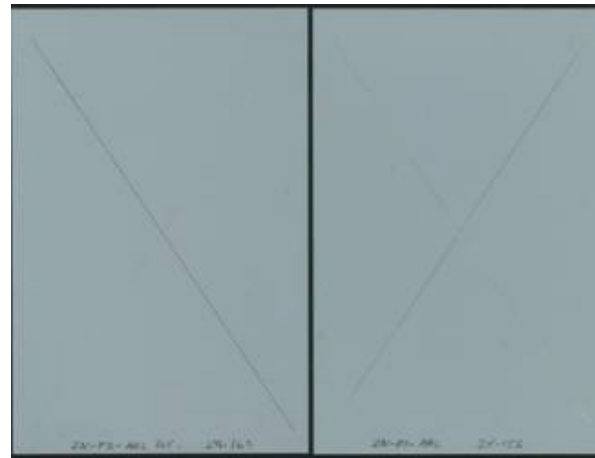
**LHE Zn-Ni Panels  
(2000 hours)**

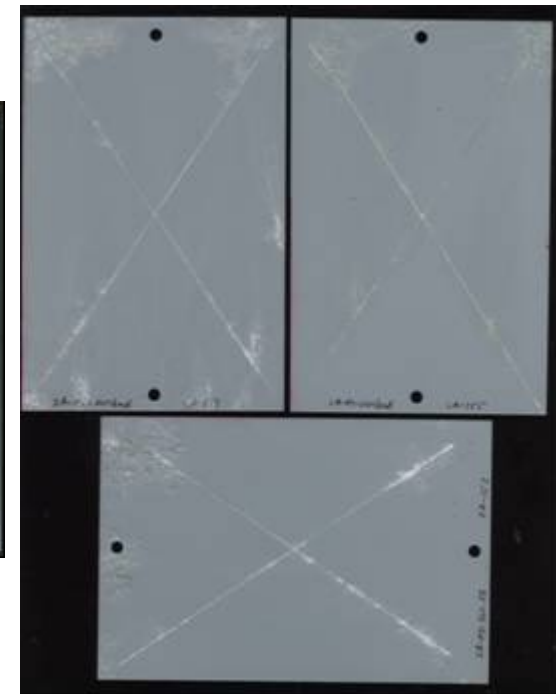
**Sputtered Al  
Panels  
(1500 hours)**

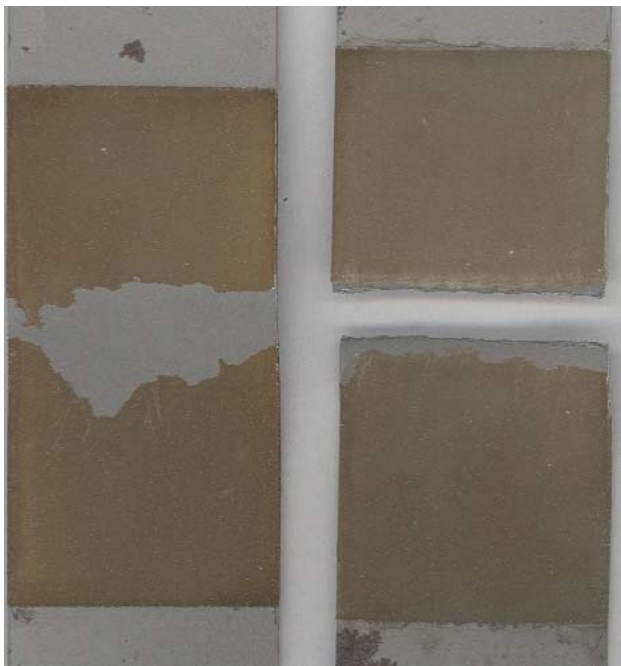
**Brush Plated Cd (baseline)**

- Brush plated Cd and sprayed Aluminum-ceramic exhibit significant adhesion losses during bend testing
- Brush plated Sn-Zn and Zn-Ni passed adhesion testing
- Results consistent with those observed during Phase I testing

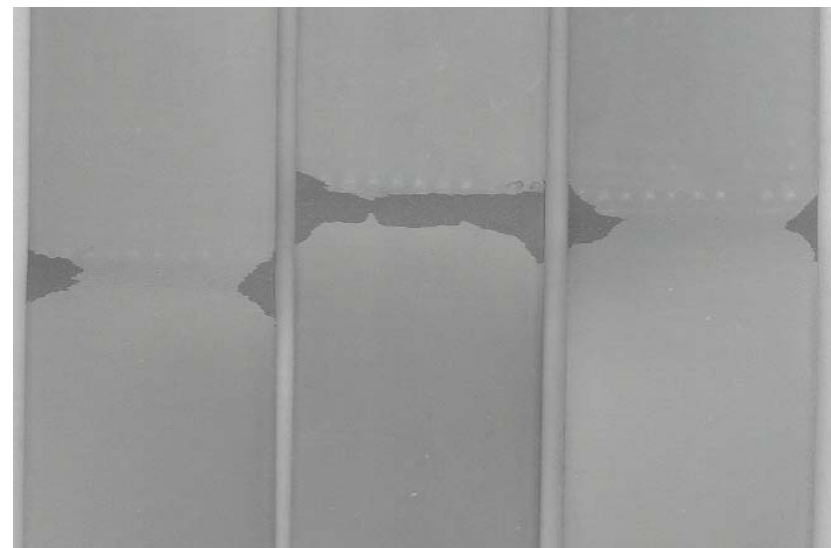
**Sprayed Aluminum - ceramic**

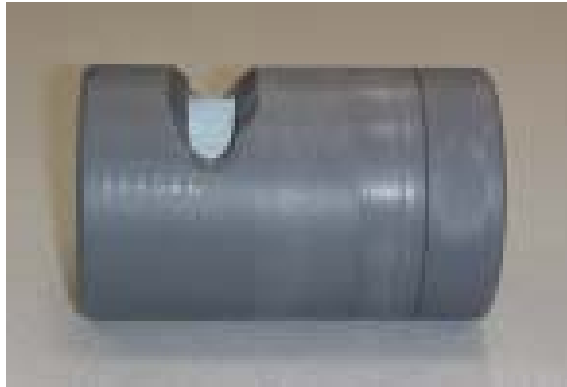
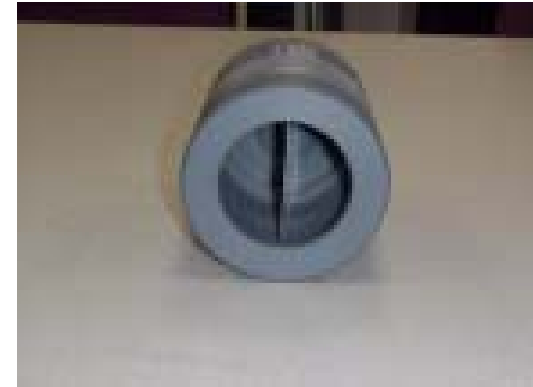
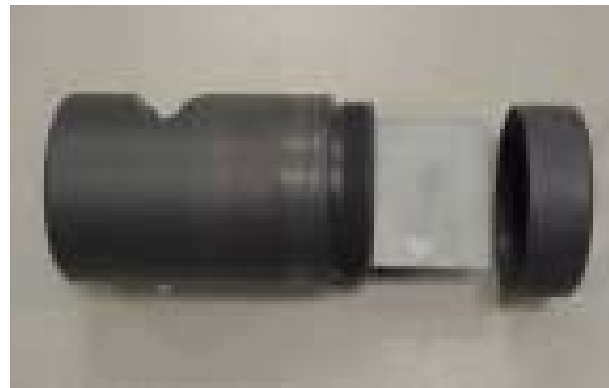
# Throwing Power Fixture

- Test coupon is inserted in fixture and entire assembly is submerged in plating solution
- Fixture alignment can be varied to simulate multiple complex geometries
- Composition readings taken every 0.5" down the length of the coupon

- **General properties (primary coatings)**
  - Appearance – visual exam
  - Throwing power
    - Test fixture surrounds panel, with one access slot
    - Fixture + panel is placed in solution at 3 different orientations
    - Uniformity of coating is measured at 3 locations on each panel
  - Strippability
    - Specimens are stripped by vendor-recommended method
    - Half of specimens are tested
    - Remaining specimens are recoated and tested
      - Hydrogen Embrittlement
      - Adhesion
  - Galvanic Potential
    - Three types of measurements are performed over 5 days: open circuit potential measurement, electrochemical impedance spectroscopy, and tafel analysis

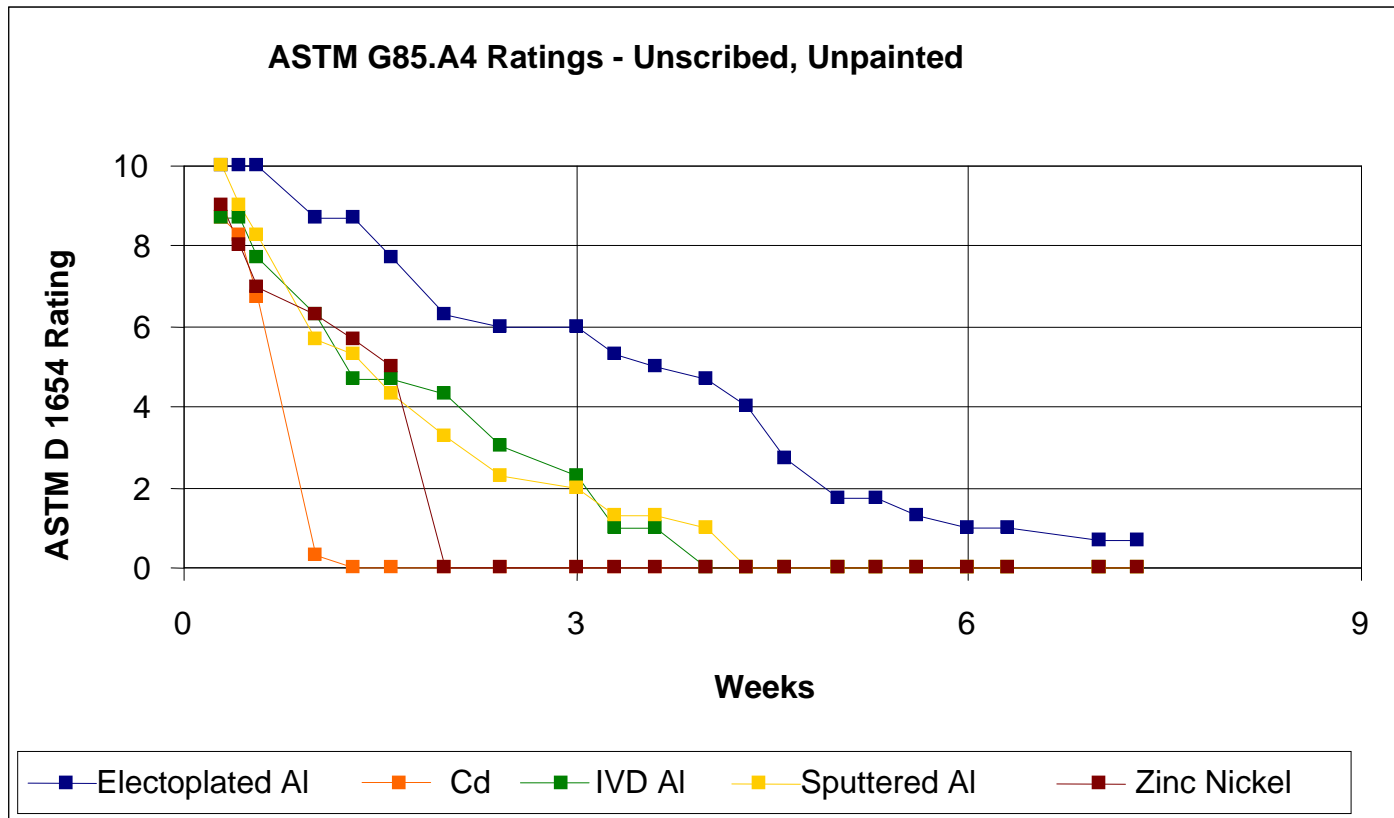
### Unscribed, Unpainted Specimens

- All primary coatings outperformed baseline Cd
- Aluminum coatings yielded the best results, with electroplated aluminum showing the highest level of corrosion resistance

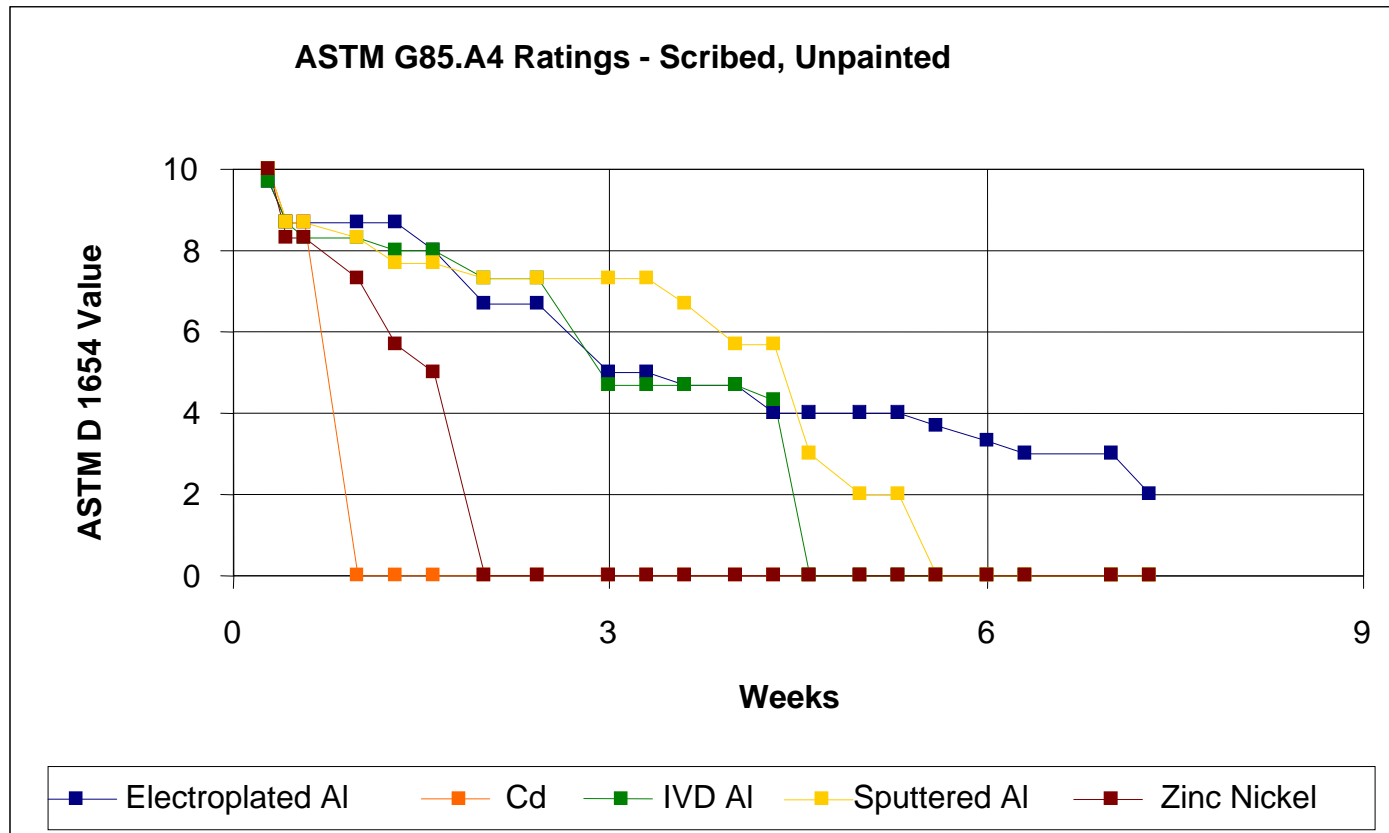
# Primary Coating SO<sub>2</sub> Salt Fog Corrosion Resistance Scribed, Unpainted Specimens

- All primary coatings outperformed Cd in scribed testing
- Zinc-Nickel coating was significantly less effective than the aluminum coatings

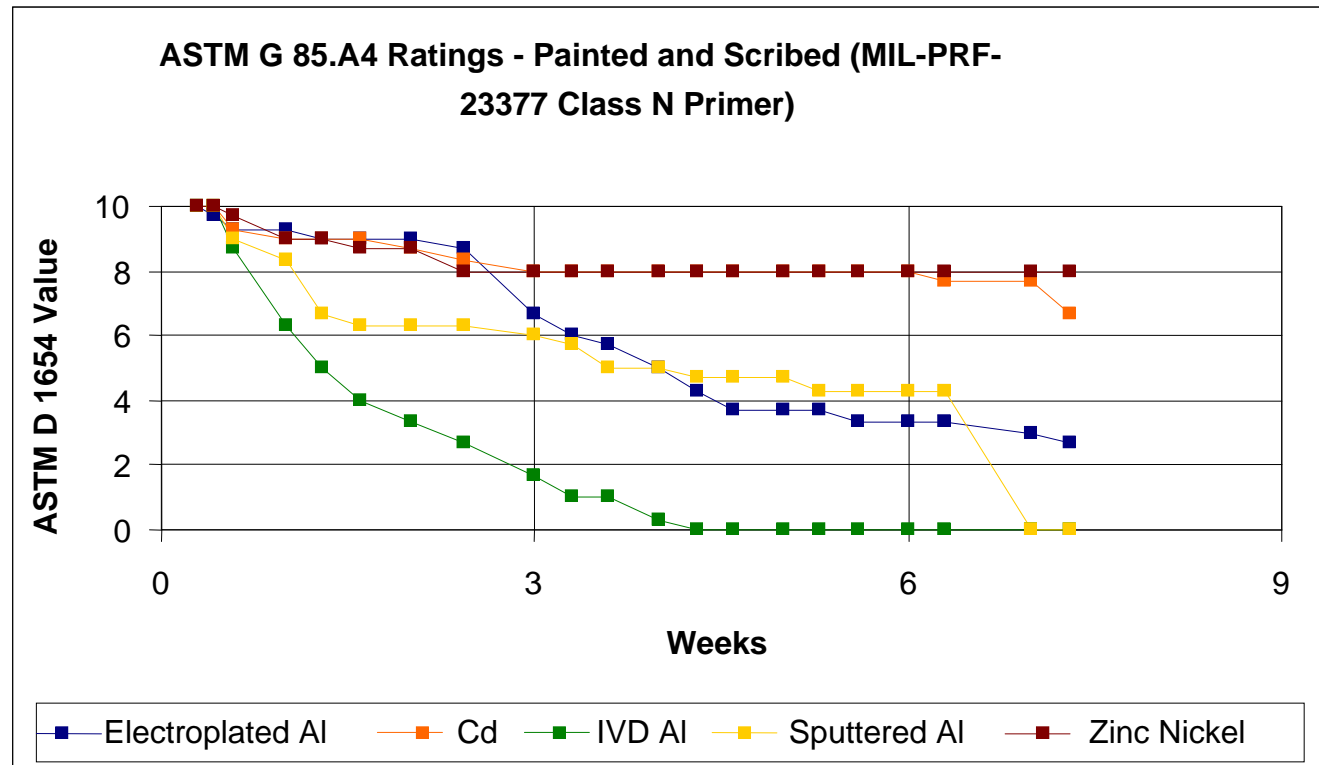
### Scribed, Painted Specimens

- Zinc-Nickel coating performed as well as Cd baseline when painted with MIL-PRF-23377 Class N non-chromated primer
- Aluminum based coatings were less effective, with IVD Al baseline displaying the poorest results
- Results were similar for MIL-PRF-23377 Class C2 chromated primer and MIL-PRF-85582 Class N non-chromated primer
