## **FINAL REPORT**

### **Full-Scale Measurement and Prediction of the Dynamics of High-Speed Helicopter Tow Cables**

Award Number: N00014-07-10135

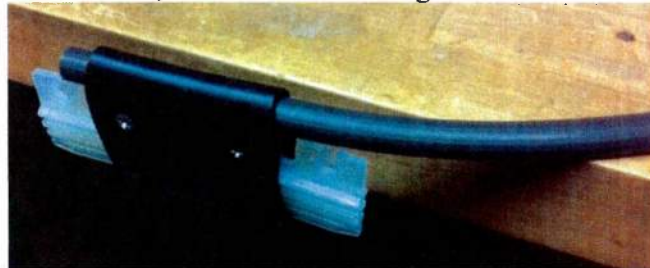
**Figure 3: Single fairing on curved rod. Fairing is on straight section of rod and easily aligns in the direction of gravity.**

Figs. 3 and 4 show an individual fairing on a piece of curved rod. In Fig. 3, the fairing is located on a straight section of the rod. In this case, the fairing can easily rotate completely around the rod. In the picture, the fairing aligns with gravity. In Fig. 4, the fairing is moved slightly to a position on the rod where there is slight curvature. The fairing will easily slide onto the rod if the fairing is aligned with the direction of curvature, however, the fairing can no longer rotate completely around the rod. Fig. 4 shows that with the rod in the same orientation as Fig. 3, yet the fairing is unable to align with gravity. This happens because the fairing has no flexibility. The region of the fairing that attaches around the cable is therefore a straight tube, barely larger than the cable itself. When the fairing tries to rotate, if there is enough curvature in the cable, the individual fairing will become stuck.

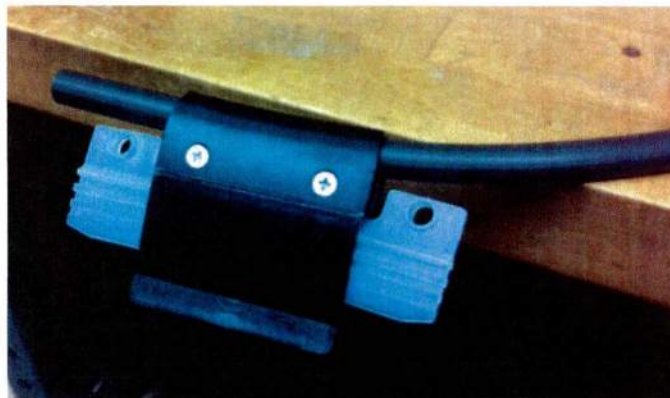
**Figure 4: Single fairing on curved rod. Same fairing as in Fig. 2 is on the same rod, but is moved into a region of slight curvature. Fairing is unable to align with gravity.**

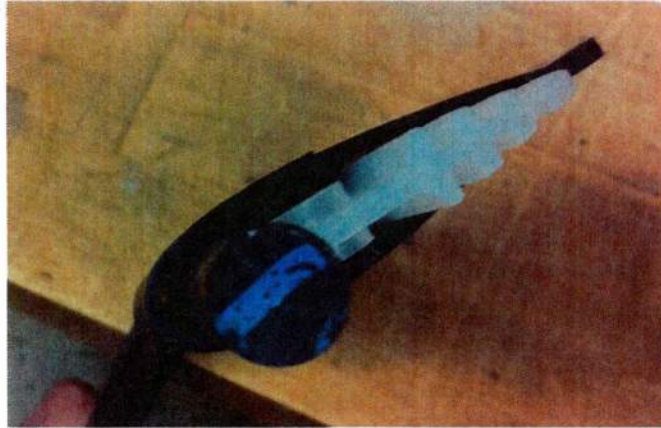
**Figure 5: Bottom view of single fairing on curved rod. The fairing is unable to rotate on the curved rod because the width of the cable hole in the fairing cannot accommodate the additional width from local curvature of the rod.**

Fig. 5 shows a bottom view of a single fairing on the curved rod in a stuck position. One can see in this image that the hole in the fairing, through which the cable passes, is not large enough to accommodate curvature in the rod. The problematic dimension is the width of the hole. The hole is slightly larger in length, which explains why the cable can easily slide onto the curved rod, or easily conform to curvature in a straight plane on a cable. Since the hole is large in the chord length direction, the fairing can accommodate curvature of a cable, where the curvature is in the same direction as the flow velocity. The problem is that if the curvature of the cable remains in a straight plane, but the fairing needs to align to flow that is not in the direction of the curvature, the fairing will be unable to rotate since the width of the hole in the fairing is not large enough to accommodate for out-of-plane curvature. Therefore, the fairing becomes stuck in a particular orientation.

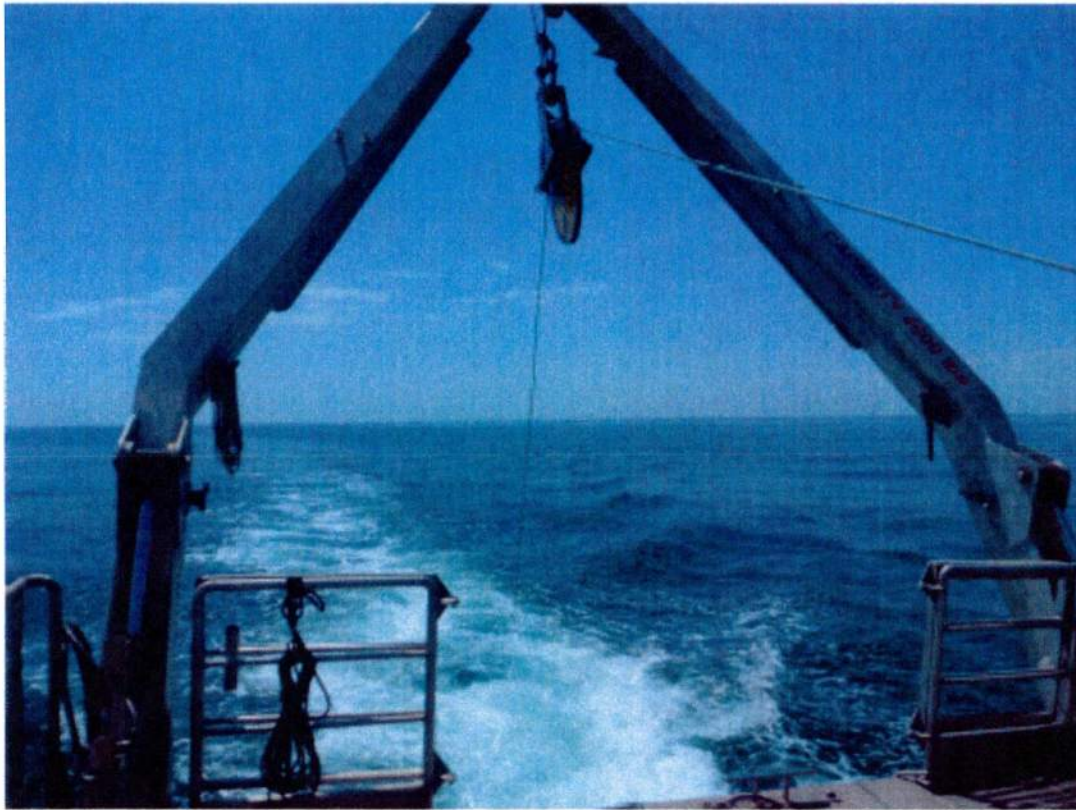
**Figure 6: Towing of the cable with fairings at a speed of just under 8 knots. Straight towing is possible without instabilities. WHOI ship R/V Tioga.**

Figure 6 shows the view from the stern of the ship at a towing speed of 4 knots when no kiting or other instabilities are noticeable.

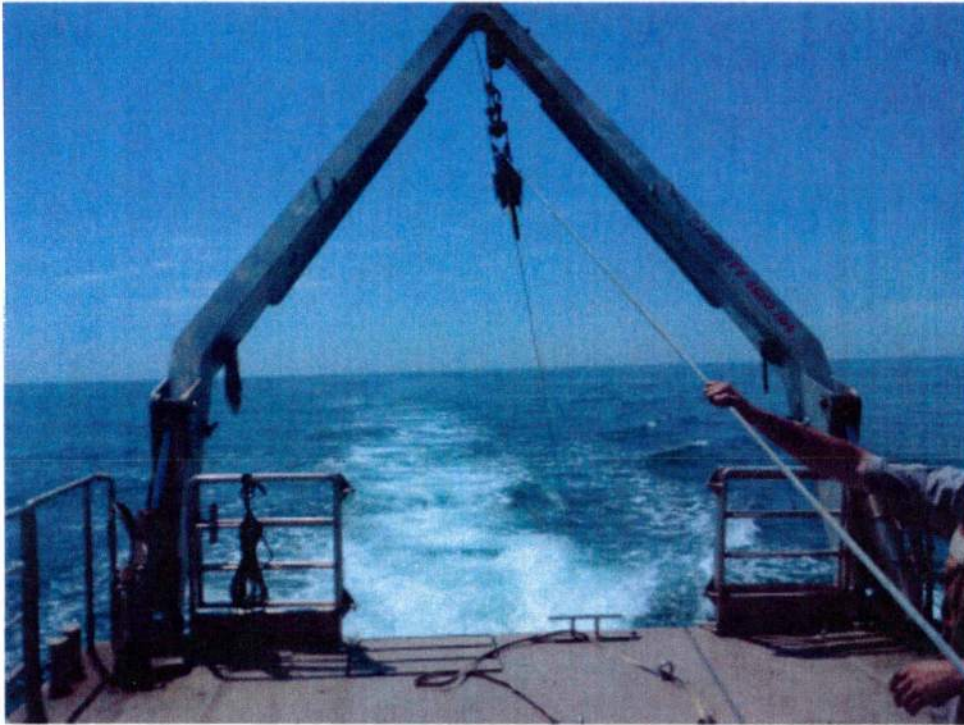
**Figure 7: Towing of the cable with fairings at a speed of 8 knots, which resulted in significant kiting to the right of the viewer. Straight towing was impossible.**

Once the towing speed exceeds 8 knots, the curvature of the cable due to quasi-static hydrodynamic loading exceeds the threshold value that will cause adjacent fairings to have significant inter-frictional forces. As a result, some of the fairings are “stuck” in a non stream-aligned position, or even undergo plastic deformations. As shown in Figure 7, this causes the development of a side lift force, and hence “kiting”, an unstable behavior of the towed cable, developing large lateral motions, either to one side or the other. This phenomenon is predicted by the software when the hydrodynamic data from the Towing Tank tests are employed; and was clearly shown in the field tests.

As Figure 7 shows, once a speed of 8 knots was reached, the cable was kiting to one side, a clearly undesirable effect of the fairings being unable to straighten with the flow. Towing in a straight line was impossible, even with corrective action taken from the boat.

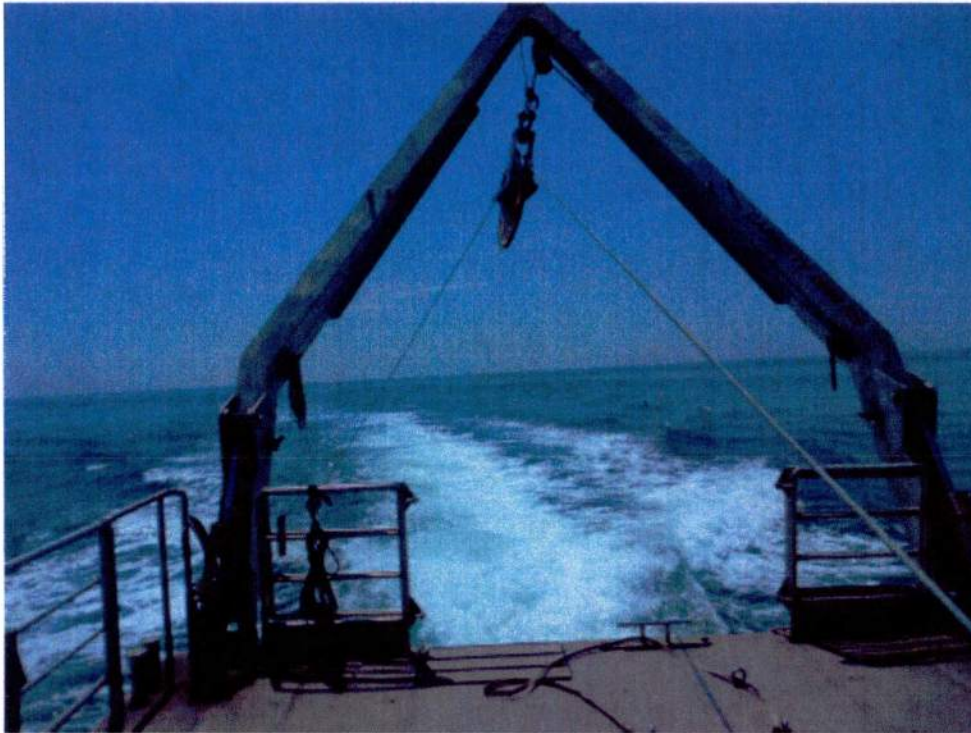
**Figure 8: Towing of the cable with fairings at a speed of 12 knots, resulting in severe kiting to the left of the viewer. Straight towing was also impossible, while unstable kiting was also observed.**

At an even higher speed of 12 knots, severe kiting developed, as shown in Figure 8. Kiting could develop either to the left or to the right, demonstrating that it was caused by the inter-fairing friction and the buckled-like form of the fairings. Kiting was significantly more severe than at lower speeds and the cable could move from one side to the other.

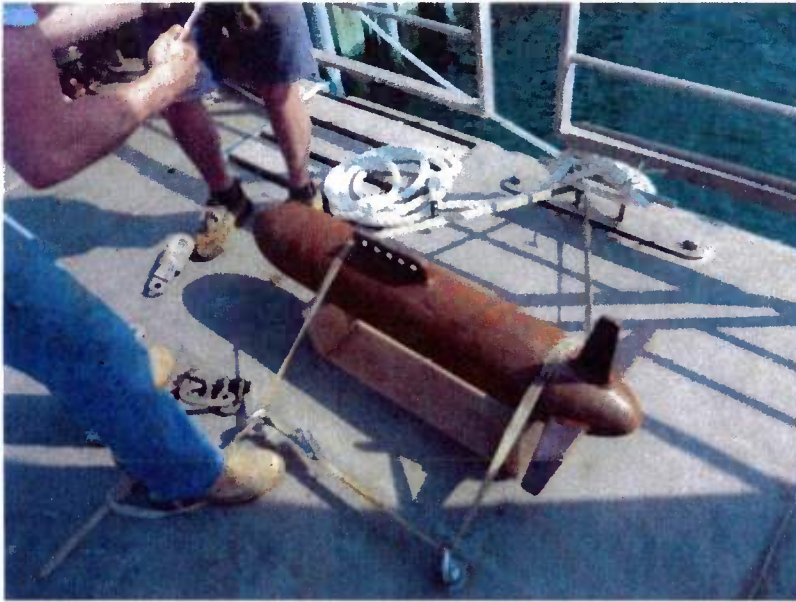
**Figure 10: 250 kg towed vehicle to stabilize the end of the towed tether with fairings. Stabilization was impossible beyond a speed of 8 knots, due to kiting.**

Figure 10 shows the towed vehicle that was used to stabilize the end of the faired tether. Stabilization was impossible beyond a speed of 8 knots, demonstrating the importance of developing curvature-tolerant fairings or alternative means of VIV cancellation, to avoid directionality effects and kiting.
