# FINAL REPORT

## Direct Push Chemical Sensors for DNAPL

ESTCP Project: ER-0109

Stephen H. Lieberman  
**Space and Naval Warfare Systems  
Command**

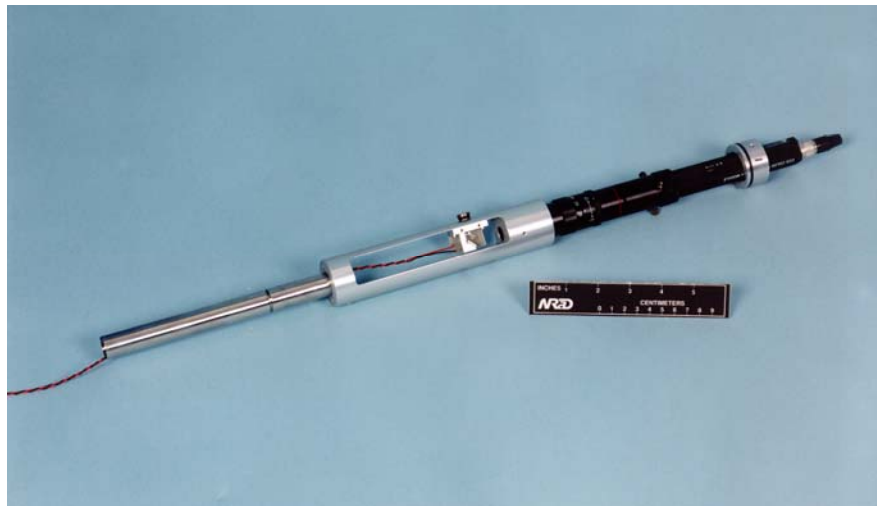
**Figure 18. .** Photograph of downhole video imaging system probe. Soil in contact with the sapphire window is illuminated with scattered light from white LEDs. The soil is imaged through a lens system coupled to a color CCD camera. The video signal is returned to the surface where it can be viewed in real-time and recorded using a video recorder or stored digitally.
