*Final Report*

**Addendum**

**Natural Pressure-Driven Passive Bioventing**

**Naval Facilities Engineering Service Center**

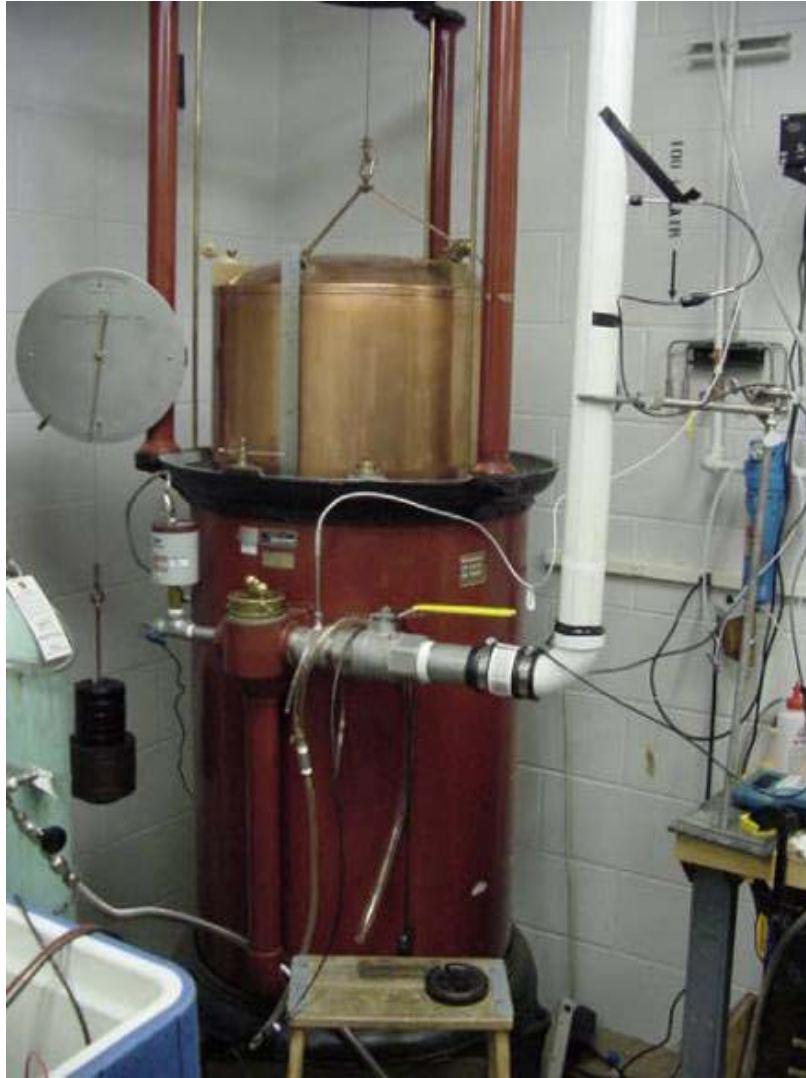
**Figure C-5. Bell Prover with TSI Air Velocity Transducer**

Results of the measurements indicate that placement of the probe tip in the pipe does slightly affect the measurement by approximately  $\pm 0.2$  cfm. More significantly, however, the results indicate that the lower limit of the velocity transducer is approximately 0.25 to 0.30 cfm, depending on the placement of the probe tip. This corresponds to a flow velocity of approximately 10 ft/min and agrees with the manufactures stated range of 10 ft/min to X, where X is the selected maximum range of the transducer. Therefore, the lowest output of the velocity transducer is approximately 10 ft/min (0.23 cfm in a 2-inch-diameter PVC pipe) and corresponds to an output current of 4 mA. As observed in the wind tunnel tests, a zero flow condition produces a very slightly negative value on the data logger due to processing of the signal between the TSI air velocity transducer and the logger.
