# Human-Induced Changes in Back-Barrier Environments as Factors in Tidal Inlet Instability with Emphasis on Florida

*by Richard A. Davis, Jr. and Gary A. Zarillo*

**PURPOSE:** This Coastal and Hydraulics Engineering Technical Note (CHETN) provides general information about the consequences of human alterations of back-barrier environments on tidal inlet stability, including several examples from the gulf coast of peninsular Florida.

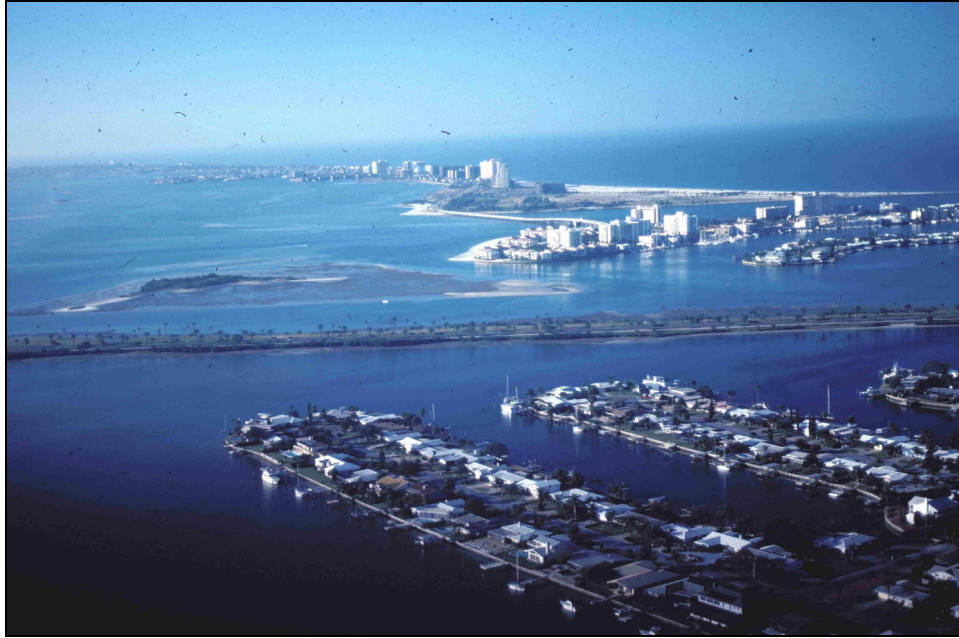
Figure 3. Clearwater Causeway connecting the mainland with the nearby barrier island

**Causeway Construction.** The easiest and most economical way to construct roads from the mainland to barrier islands is by dredging material from the estuaries and bays landward of the barrier and placing the borrow material as fill for the roadbed (Figure 3). Boat traffic was provided for by including small openings with lift bridges. Some causeways also have additional small bridges to increase circulation and thereby address the problem of water quality. No attention was paid to tidal circulation behind the barrier or between the open coast and the back-barrier bays. Such barriers present artificial tidal divides between inlets. Construction of these causeways began in the early 1920s, and within one or two decades nearly all barrier islands had at least one such thoroughfare connecting it with the mainland.

These causeways were, in effect, dams across the back-barrier areas that partitioned the open water and severely limited the tidal flux that could pass through them. As a consequence, the tidal prism of various inlets was changed significantly. Because of the large number of causeways, the typical effect was partitioning of the tidal prism, leading to a reduction in inlet stability and subsequent migration of the inlet along the open coast. This condition reduces inlet cross section and/or closure of the inlet by littoral sediment. The littoral sediment cannot be adequately flushed from the inlet mouth due to slower currents generated by the flux of the reduced tidal prism. This situation caused the need for many of the inlets to be stabilized by structures to maintain navigation and keep some of the inlets from closing.

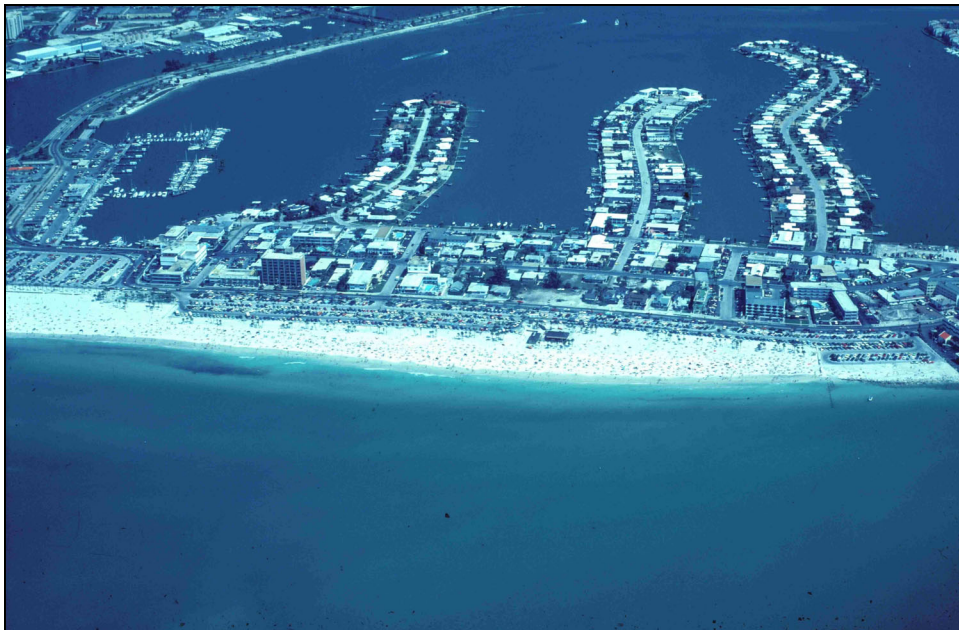
Figure 4. Typical back-barrier area in Florida showing dredge-and-fill development

**Dredge and Fill.** As the barrier islands became completely developed, there was pressure for more space on which to place homes and commercial properties. The solution of the time (1950s) was to dredge from one area and fill in another, thereby creating buildable upland property in areas that were originally intertidal or subtidal environments. The typical result was a series of elongate upland areas separated by finger canals (Figure 4) that were produced from dredging of what was previously mangrove communities and/or sea grass beds.

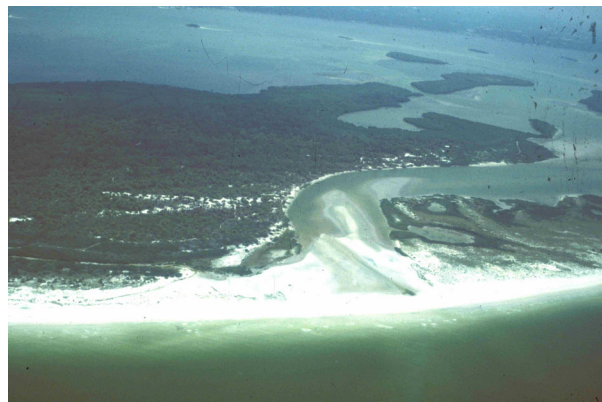
Figure 8. Dunedin Pass

a. In 1979 as a mixed-energy inlet with a prominent ebb delta

b. In 1990, 2 years after closure

The final event that led to the closure of Dunedin Pass was the passage of Hurricane Elena in 1985. Although this storm did not make landfall near the inlet in question, it did generate enough wave energy to remove the ebb-tidal delta that existed at the mouth of the inlet (see Figure 8a). By this time the inlet channel was only about 50 m wide and 1.5 m deep with a small tidal prism. After removal of the ebb delta, the northward moving littoral drift along Clearwater Beach Island to the south caused the channel to fill within 3 years (Figure 8b). The absence of severe storms and their associated surge in between removal of the ebb delta and final closure, contributed to the trend for closure. The inlet has remained closed for the past decade with sediment being added regularly through washover during the passage of winter cold fronts.

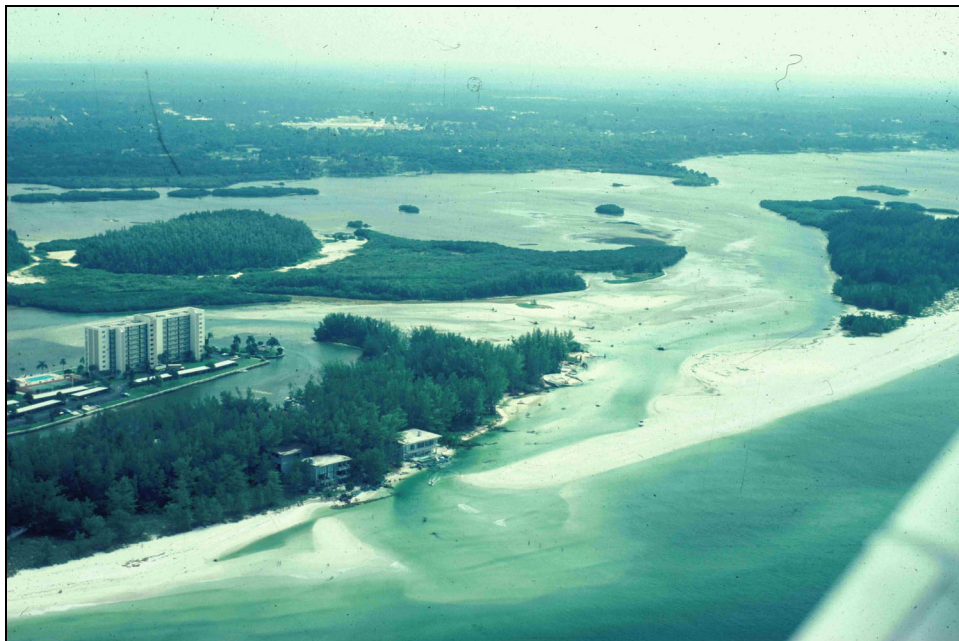
Figure 11. Midnight Pass in 1983 just before closure

This narrow and shallow bay had several elongate oyster reef complexes along its length whose orientation and configuration perpendicular to the shoreline (Figure 11) indicated that at least some tidal currents moved along the length of the bay, and not simply in and out of Midnight Pass. Oysters receive their nourishment from suspension feeding, which means the most efficient organization is to stretch across the currents that are carrying the suspended nutrient material.
