# ESTCP Cost and Performance Report

(SI-0309)

## Reclamation of Wood Materials Coated with Lead-Based Paint

May 2008

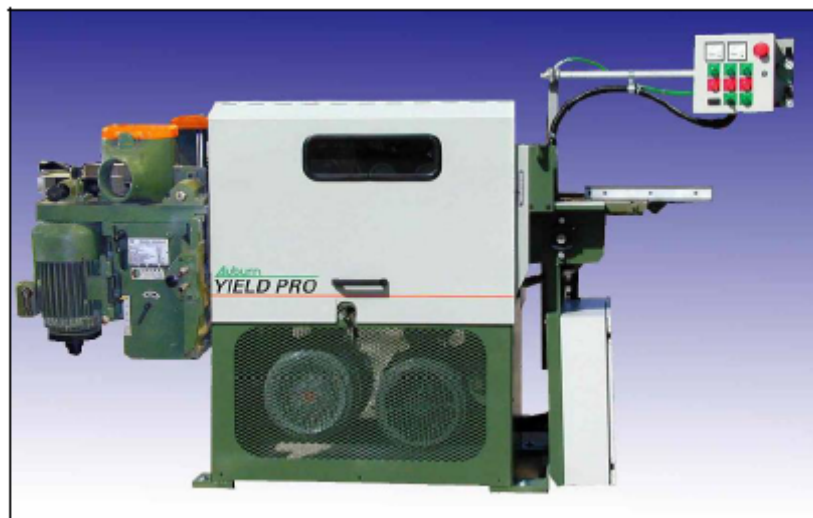
The central feature of the MU is the YieldPro wood planing and sawing machine made by Auburn Machinery, Inc.<sup>3</sup> (AMI) (Figure 1), which can process up to three surfaces of wooden stock using any of several different configurations. The configuration evaluated in this demonstration consisted of three planing heads (top, bottom, and one side head) and a side-ripping blade. (Hogging blades can also be used for greater material removal.) The MU is capable of machining three surfaces simultaneously in a variety of configurations.

**Figure 1. Auburn YieldPro wood milling machine.**

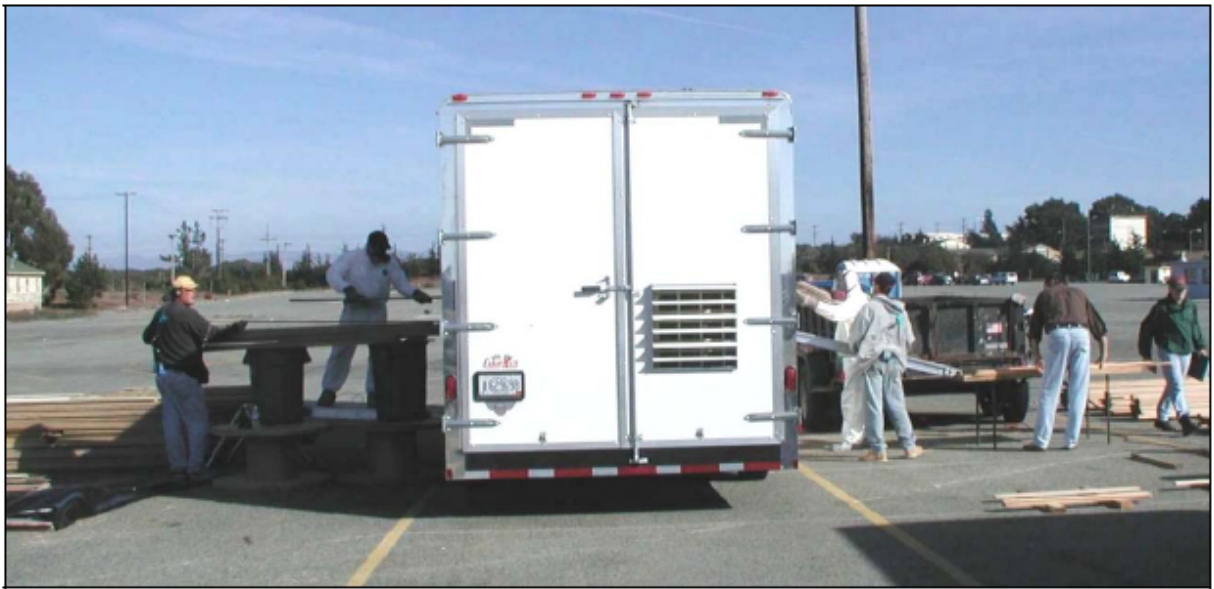
The YieldPro was housed in a self-contained mobile trailer that includes standard commercial electrical generation, air compression, dust collection, residue storage, and fire-suppression systems. The dust collection system is equipped with a high efficiency particulate air (HEPA) filter to contain shavings, sawdust, and debris. The residue storage chamber is equipped with an auger conveyer for transferring the collected debris into transport containers. Figure 2 illustrates painted boards being inserted into the mobile planing unit and the clean boards being extracted from the other side.

**Figure 2. Self-contained MU for planing LBP from wood.**

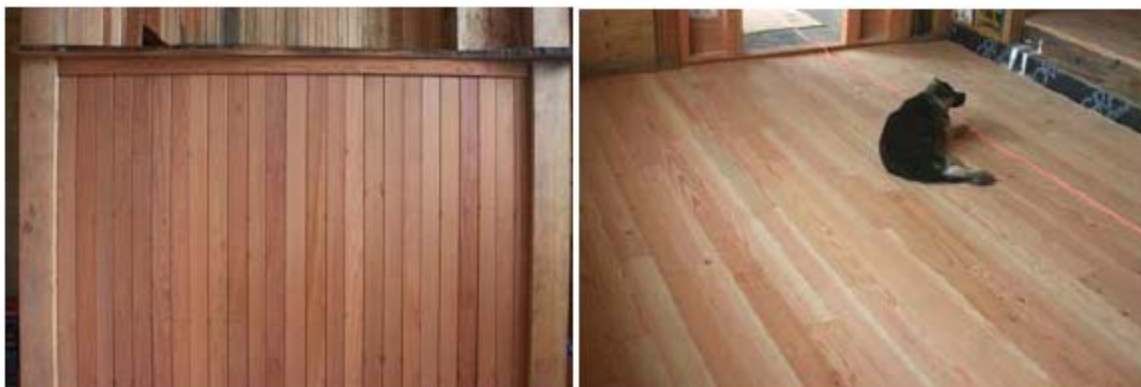
**Figure 4. Redwood paneling (left) and Douglas fir tongue and groove (T&G) flooring (right) milled from a portion of salvaged siding from the Camp Roberts.**

The amount of heartwood and sapwood is an important quality characteristic in the redwood species, with a higher content of heartwood more desirable. “All heart”—100% heartwood content—is the highest grade. Most of the redwood pieces were heartwood. There were

relatively few knots observed; more than 94% of the redwood was clear, and more than 58% of the Douglas fir was clear. Material losses due to end splits or other conditions requiring end-trimming accounted for only 4.7% of the total linear footage. Little decay from in-service use was found in the blanks, but drilled utility holes were occasionally found. Some observed wood discoloration was probably caused by nail corrosion.
