# ESTCP Cost and Performance Report

(CP-9506)

## Photocatalytic Destruction of Nitrate Esters in Air

July 2000

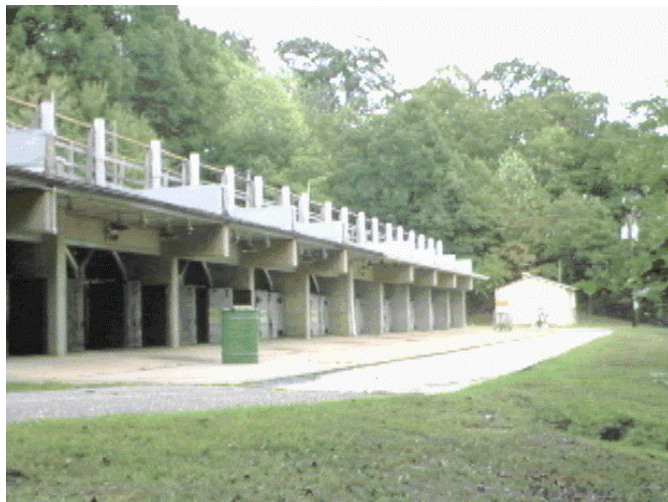
**Figure 1. Annealing Oven Facility at Building 871.**

The solventless extrusion production plant is the only Navy facility of this type and is classified as mission critical. Many of the items produced in this facility support triservice DoD requirements and foreign military sales. There are currently two annealing oven facilities at IHD, Buildings 579 and 871, which will both be replaced once the new MILCON annealing oven project is complete. Buildings 579 and 871 are located approximately 800 feet and 50 feet, respectively, from the fence line. Their proximity to the fence line is a significant factor in IHD's inability to comply with the state regulations. Building 871, pictured in Figure 1, consists of 20 ovens.

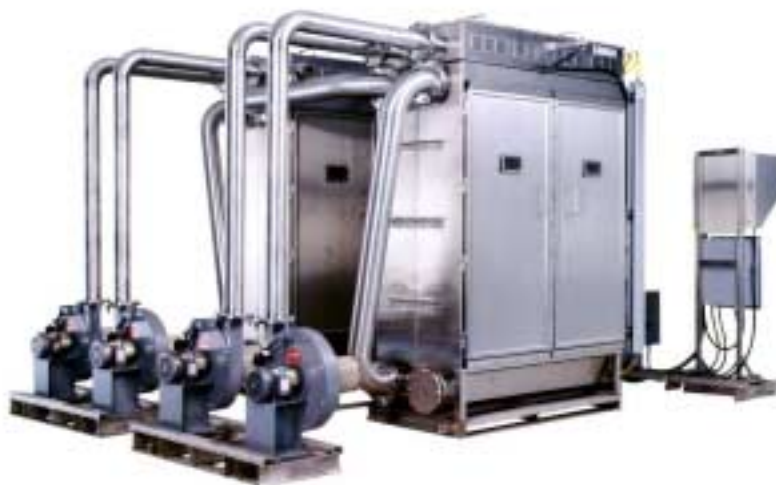
**Figure 3. 650-scfm PPCU (Inlet Manifold Removed).**

FSEC designed the 650 scfm PPCU to remove 99.5% of the NG released from an annealing oven having a flow rate of 650 scfm and containing a maximum concentration of 10 ppmv NG. The PPCU was designed to be easy to install, operate, control, and maintain. Adding the PPCU had no effect on the annealing process. The PPCU, pictured in Figure 3, was composed of two stand-alone modules, an integrated thermal management system, a power distribution center (PDC), a system control center (SCC) and four external cooling fans. The PPCU modules were made of 316 stainless steel welded construction. The modules were connected in parallel via external 6-inch-diameter piping located on the ends of the unit. The control system for the PPCU was based on the Trojan Technologies UV 3000 water treatment system. All the electrical components were standard off-the-shelf items. The PPCU operated off a single 208-volt, three-phase power input that was fed to the PDC. The total electrical power requirement was 19 kVA. The PDC also housed the communication board that controlled and monitored the lamps. All communications to and from the PDC originated from the SCC via an RS 422 serial link. The operator controlled the system by interfacing the SCC via local or remote terminals. Local operator interface was accomplished via a menu-driven workstation that included a LCD display and two keyboards. The system was password protected and was fitted with a meter to record the cumulative hours of operation.

Each module of the PPCU was made up of two banks of low-pressure mercury lamps (LPMLs), and each bank contained 16 LPMLs. The total number of LPMLs in the unit was 64. The LPMLs emit essentially monochromatic light having a wavelength of 253.7 nm. Lamps were accessed via the top of each module through a non-contact air-cooling compartment. The electrical connections for each lamp were housed in this compartment. The lamp ballasts were located opposite the entrance and were housed in aluminum ballast boxes. The cooling compartment was separated from the contaminated fluid by an outer quartz sleeve, which resembled a large test tube and enclosed the lamps. The sleeves were made of type 214 clear fused quartz circular tubing and were rated for 89% UV transmission.

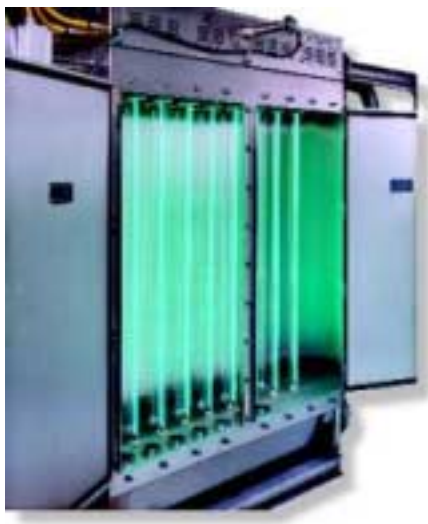
**Figure 4. Interior of 650-scfm PPCU Module (Lights “On” and No “Socks”).**

The catalyst socks were secured to the unit with plastic cable ties. Plastic ties were selected over metal clamps to eliminate metal pinch points. The top of the catalyst cartridge attached to a bulkhead, through the center of which passed the LPMLs and quartz sleeves. The bulkhead forced the gas to pass through the illuminated catalyst cartridge. Contaminated gas was prevented from entering the cooling compartment by two O-ring seals on the outside of the quartz tubes. The bottom of each sock was attached to a nipple at the bottom of the bank. The contaminated air was distributed to each sock via a plenum located beneath the banks. The plenum was fitted with Teflon drain plugs to allow for cleaning. Access to the catalyst cartridges was provided by side access doors

as shown in Figure 4. Each door housed a neoprene gasket, which sealed the unit, and contained a view port to enable visual inspection of the unit during operation.

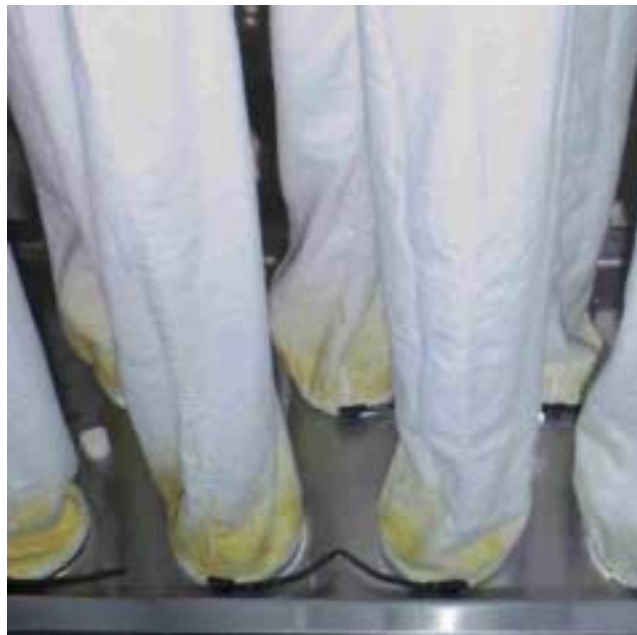
The non-uniform deposition of contaminants is clearly illustrated in the photographs in Figures 7 and 8 of the used socks from Test Three. The stains located on the outside of the socks indicated the area on which contaminants were concentrated. Since the stains were not uniformly distributed along the length of the socks, it seems reasonable to conclude that the NG was not uniformly distributed along the length of the socks. Figure 8 also clearly shows that the first 4 inches of the socks are a different color than the remainder of the sock. This area corresponded to the portion of the sock in which no lamp extended and indicated an area of less photocatalytic activity.

**Figure 7. Used Catalyst Socks in Bank A after Test Three.**

**Figure 8. Used Catalytic Socks in Bank B after Test Three.**

Inspection of the catalyst socks at the completion of the Test Three resulted in several important observations. There were stains on the outside of the socks, which had never been seen before. Although the outsides of the socks were stained, the interiors of the socks were uniform in color. Perhaps more importantly, the socks in Bank B of each module were not as discolored as in the previous two tests. In fact, the socks in Bank B looked reusable as shown in Figure 6. Two socks were sampled from each module for residual NG measurements. The socks were taken from opposite ends of the same bank. The residual NG measurements for Bank A showed a per sock concentration of 52 and 9 mg. The high concentration occurred at the end of the unit farthest from the inlet. Bank B showed no difference between the positions, and each sock contained 26 mg of NG.

There was a distinct color difference between the Bank A socks of Tests One and Two, which were exposed to UV light for a short time, and those of Test Three, which were exposed to the UV light for 168 hours. In the first two tests, the color was yellow, whereas in the last test the color was dark brown. In the first two tests, the dark discoloration corresponded to reduced performance but, in Test Three, the performance did not seem to decrease. It is thought that the dark coloration was due to degradation of the socks. The socks, although still intact, had suffered mechanical degradation. Upon removal, the socks were very dusty and could be easily torn by hand. The combination of mechanical degradation and discoloration indicated that the socks could not be used continuously for one year. Furthermore, to be sure that the contaminants are destroyed, it is recommended that the socks be replaced after each run.
