ERDC TN-EWN-14-2  
August 2014

## Epifaunal Community Development on Great Lakes Breakwaters: An Engineering With Nature Demonstration Project

By Thomas J. Fredette, Burton Suedel, Cynthia J. Banks,  
Richard J. Ruby, Paul Bijhouwer, and Anthony M. Friona

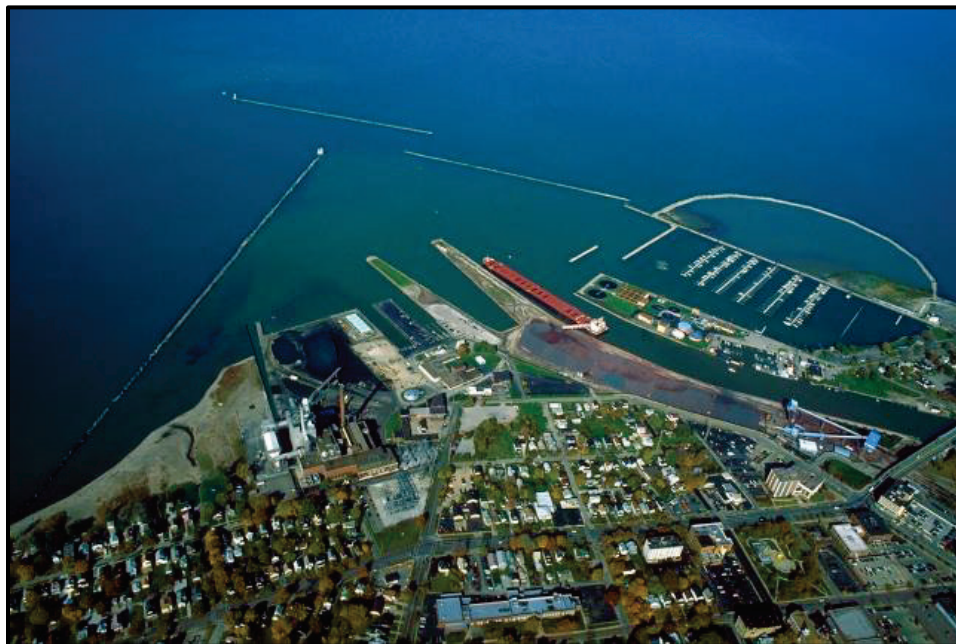
Figure 2. Example of harbor breakwaters and other coastal infrastructure development at Lorain, Ohio (photo: USACE Digital Library).

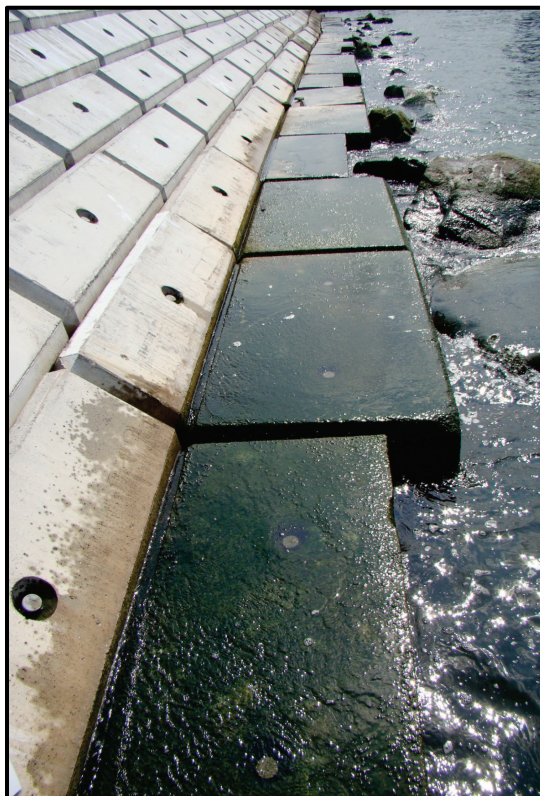
Figure 4. Cleveland Harbor breakwater constructed of concrete toe blocks (partially submerged and algae covered) and slope blocks (photo: T.J. Fredette).

**Approach.** The EWN demonstration project in Cleveland, OH was constructed as part of scheduled breakwater repairs being conducted by LRB. Since Cleveland Harbor has over 28,000 feet (8,530 m) of breakwaters, LRB typically repairs harbor breakwaters in sections a few hundred feet long as available budget allows. The harbor breakwater is being repaired on a segment-by-segment basis over several years using large precast concrete blocks on the harbor side of the breakwater and quarry stone on the outside of the breakwater. The harbor side concrete block repairs involve placing a line of rectangular toe blocks (about 8' x 5' x 4' [2.4 x 1.5 x 1.2 m]) to

form the base of the structure and several courses of sloped blocks leading to the crest of the structure (Figure 4). The first phase of the EWN toe block installation took place in April 2012.

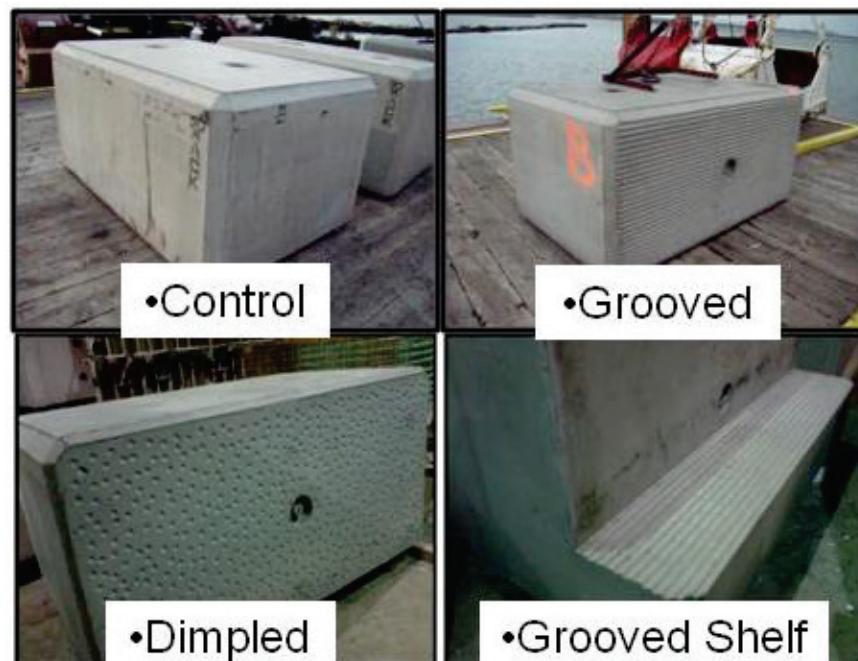
Figure 5. Control and modified toe blocks used in the Cleveland breakwater repair (photos: T.J. Fredette).

Three separate surface texture/roughness treatments, in addition to unmodified control blocks, were applied to the block surfaces that face out from the structure: grooved, dimpled, and grooved shelf (Figure 5). The grooved surfaces were created using a commercially available form liner (Spec Formliners, Inc. Pattern 1705, 305 Standard Spec Flute) and the dimpled surface used a custom built form liner using plywood and round headed carriage bolts (Figure 6). The width and depth of the textures (Figure 7) were selected with the intent of providing habitat diversity; they were also selected to be open enough to discourage invasive goby species from using them as refuges. Dimples were about 250 mm wide and 7 mm deep. Grooves were 1.5 inches apart on center and 0.5 inches deep (38 mm on center and 13 mm deep). The grooved shelves were 18 inches (0.46 m) deep and began 18 inches (0.46 m) above the bottom of the block.

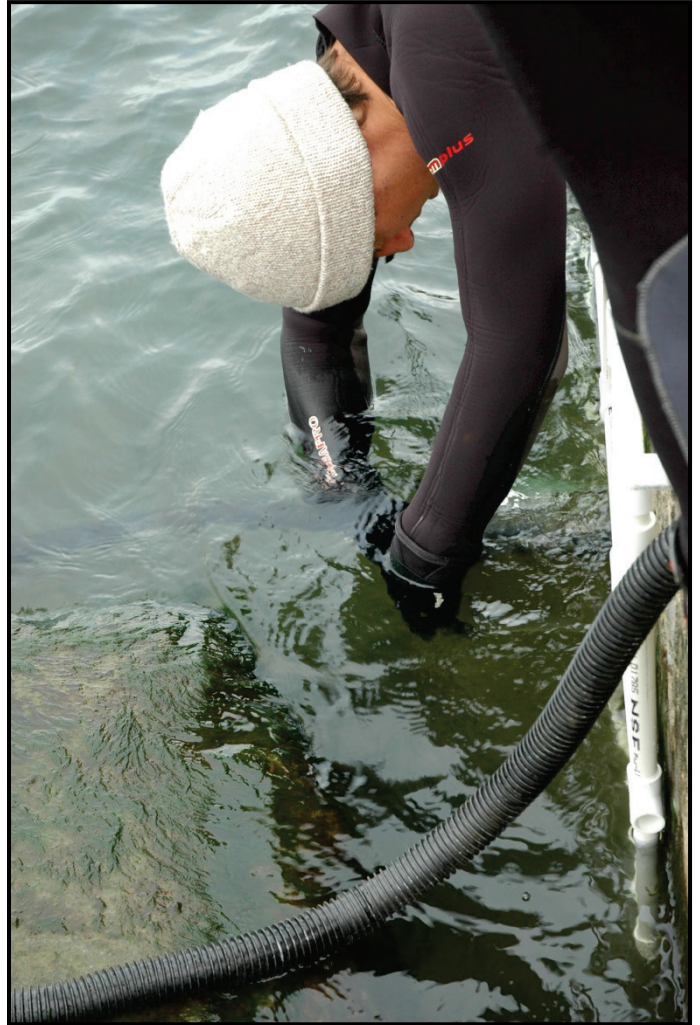
Figure 10. Sampling a toe block using the Plexiglas sampler, scraper, vacuum, and the PVC pipe sampling grid (photo T.J. Fredette).

Sampling was conducted at the Cleveland site in October 2012, June 2013, and October 2013. A fourth event in late 2014 will complete the scheduled sampling. Sampling of the toe blocks was performed using a specially designed Plexiglas block sampler (Figures 9 and 10). The sampler was about 20 cm in diameter and had a top gasket with a slit to allow access for scraping the block surface using a Plexiglas scraper. Blocks were randomly sampled within treatment (block) type using a quadrat grid to guide the sample's location (Figure 11). Once the block surface was scraped, a suction hose attached to a wet/dry vacuum cleaner powered by a portable generator was inserted through the slit and the contents of the sampler were collected. The vacuum cleaner canister contents were then poured through a 500  $\mu$ m sieve and the contents washed into sample jars for preservation with a 70% denatured ethanol solution. In the laboratory, the invertebrates present in each sample were sorted by major taxonomic group and counted. The algae from each sample was captured on a preweighed paper filter and dried in an oven at 60-65° C for 24-48 hours to determine dry weight.
