# FINAL REPORT

## Field Validation of Visual Cleaning Performance Indicator (VCPI) Technology

ESTCP Project WP-0410

AUGUST 2007

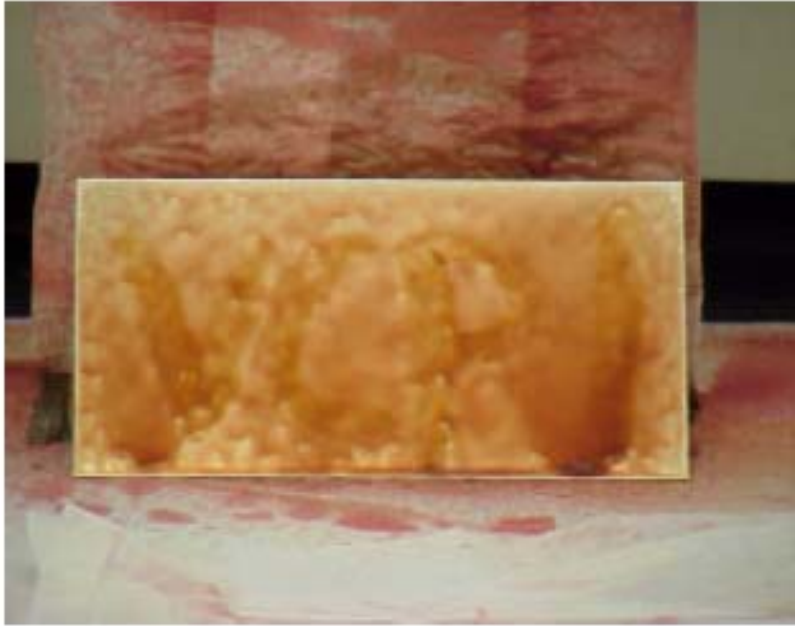
**Figure 2. VCPI Application to Soiled Test Panel during SERDP Evaluation**

VCPI is a dye-containing solution that was developed to indicate where a specific contaminant is on the surface(s) of a piece of equipment. Commercial-Off-The-Shelf (COTS) food grade dyes and coupling agents were selected that preferentially adhere to the contaminants of interest (i.e., for this study - soluble sea salt and hydrophobic soils) (see Figure 1).<sup>4,5,6,7,8</sup> For this ESTCP investigation, two different contaminants required two different dyes for labeling in a real-time production environment. Once the VCPI solution comes into contact with the contaminant of interest, it begins to selectively adhere to the contaminant. In principle, a simple rinse operation reveals the clean areas from the contaminated areas. Contaminated areas on the surfaces of the panels or parts are selectively labeled with the respective VCPI dye that is then removed during the normal cleaning operations. This labeling process allows the operator to focus their cleaning efforts and materials on only those areas that are truly contaminated and provides them with a visual indication of when the substrate is clean (see Figures 2 and 3).

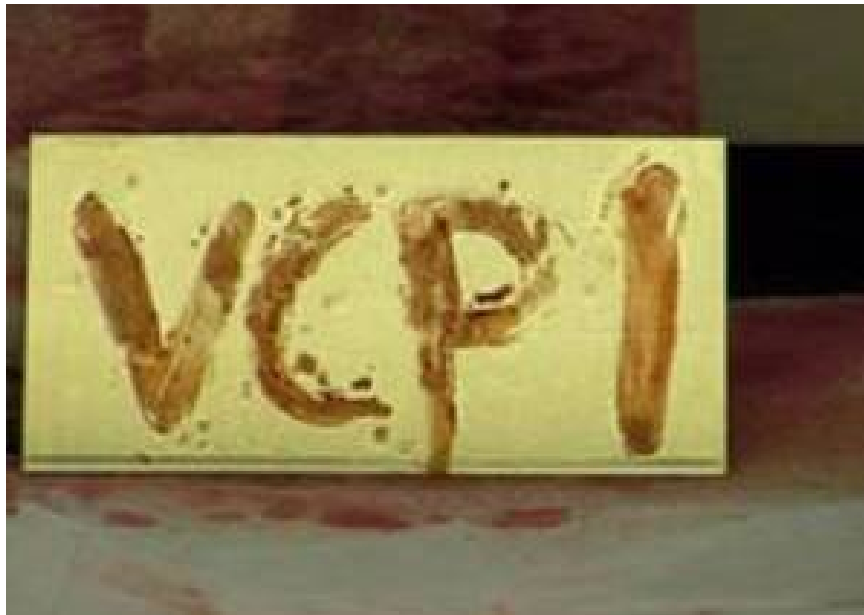
**Figure 3. Visually-indicated Contamination after Solvent Rinsing**

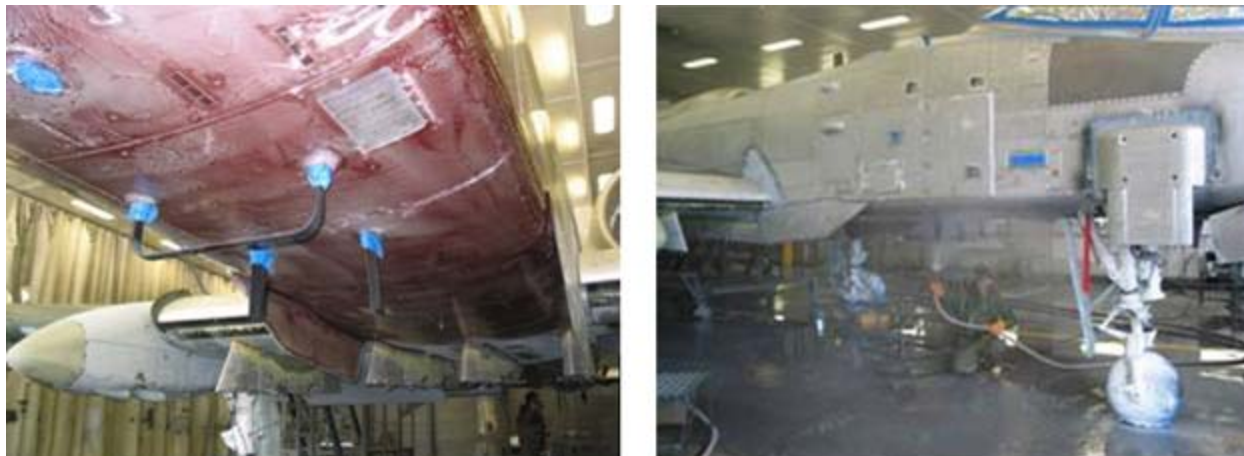
**Figure 6. Application and Removal of VCPI Test Solution to Lower Fuselage of A-10 Aircraft at Hill AFB, UT.**

additional changes were required by the end-user. In accordance with the pre-paint cleaning procedures used on the A-10 aircraft structures, all test surfaces were pre-rinsed with low pressure (i.e., 100 psi) water to simulate the surface rinsing that they would see in Building 270 at HAFB, UT. As expected, this rinsing operation did not remove or dilute the concentration of the representative hydrophobic contaminants on the underwing and fuselage surfaces of the aircraft (~225 ft<sup>2</sup>). As shown in Figure 6, the surfaces of the aircraft structures were sprayed until uniformly wetted with the VCPI dye solution, allowed to dwell (~ 1 minute) on the surfaces of the structures being investigated, and then rinsed by a fire hose with deionized water.

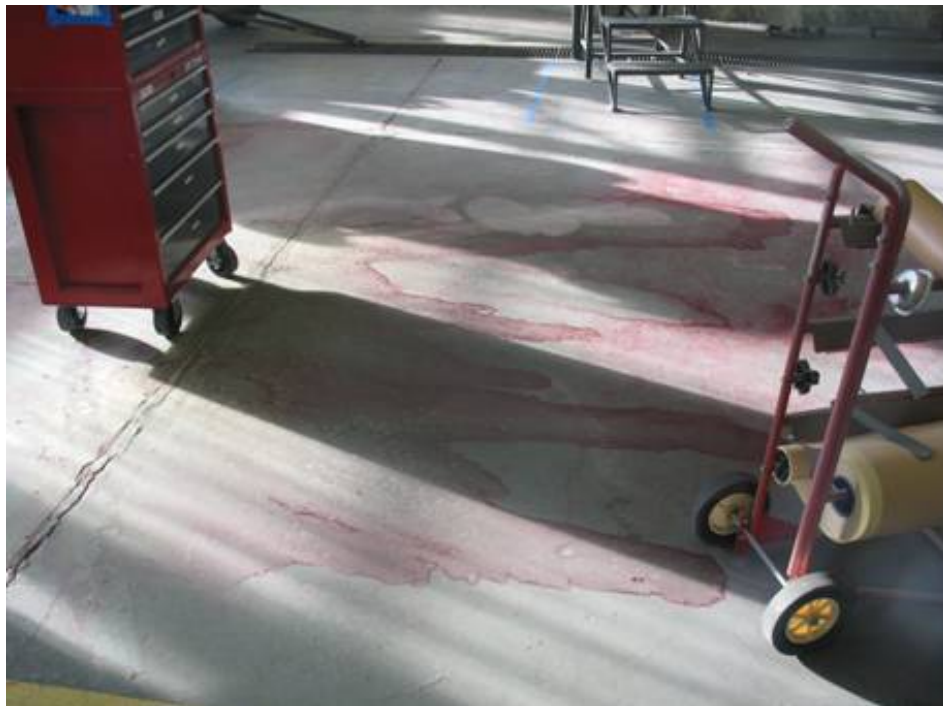
**Figure 8. Post-demonstration VCPI Staining of Maintenance Hanger Floor**

Numerous areas on the parts were stained. In addition to the localized staining of these component parts, there was a significant staining of the hanger floor (see Figure 8) immediately below and adjacent to the aircraft. Production personnel also complained about the heavy staining of their coveralls and boots. The staining issue represented a major drawback for the technology demonstration, especially with the difficulty in removing the stains from the white colored topcoat on the landing gear components. The A-10 management team and production supervisor overseeing the demonstration did not want to incur the cost and downtime associated with stripping, cleaning, masking, and repainting the stained gear components. Fortunately, a COTS chemical solvent was identified and used on clean white cotton clothes to safely remove the red stains. No loss of coating gloss or damage to the white topcoat was evident throughout the cleaning operation.

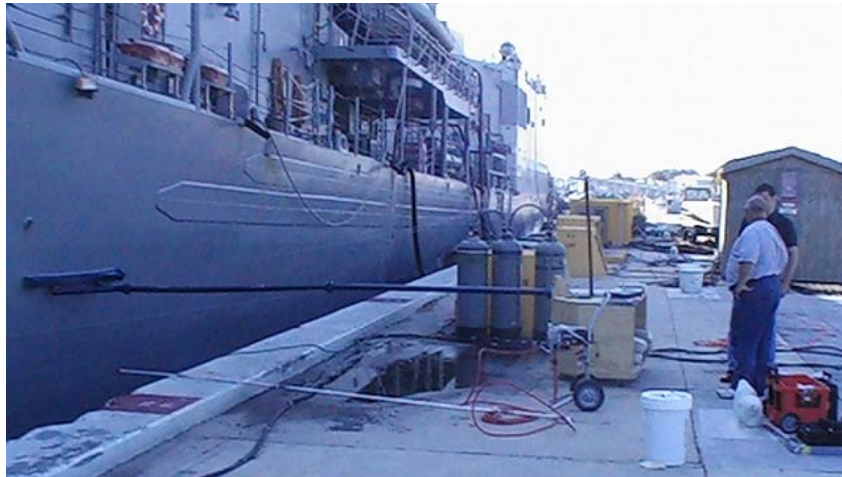
**Figure 10. VCPI and Rinse Water Containment Equipment on Hull Surface**

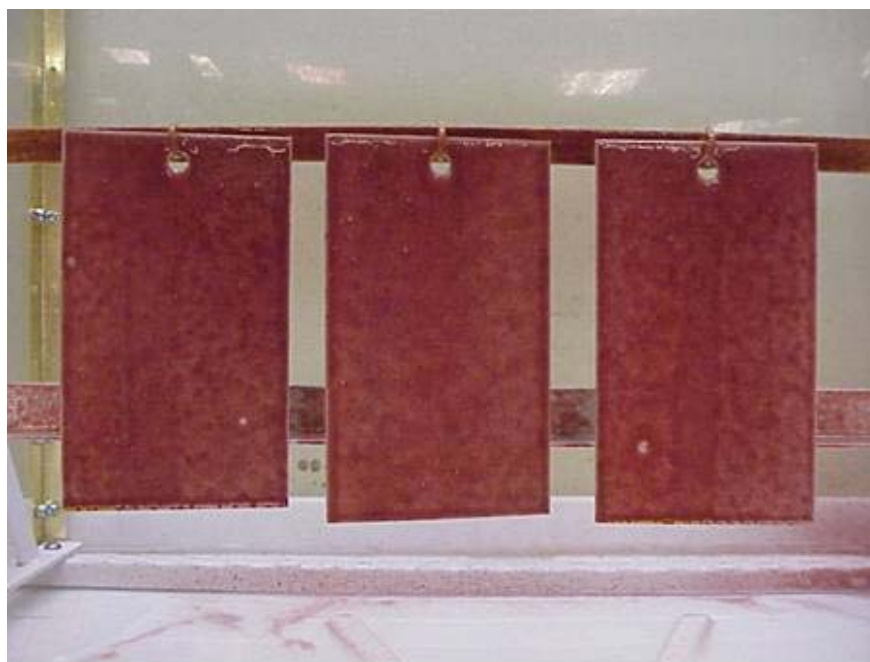
**Figure A3. Laboratory Test Panels after Oil RedO Labeling**

Application of the VCPI dye solution was accomplished by spray application using the DeVilbiss EXL-520S HVLP suction feed spray gun, with a gun inlet pressure of 30 psi. Once the gun was set no changes were made. The panels were pre-rinsed with water to simulate the surface rinsing that they would see at the prep facility. The surfaces of the panels were then sprayed until wet, with the timer started for Contact Dwell Time. Figure A3 documents an example of the surface of three panels after a spray coating of the 0.5% Xanthan gum with 12,000 ppm ORO mixture selected for the Air Force VCPI Dem/Val test.

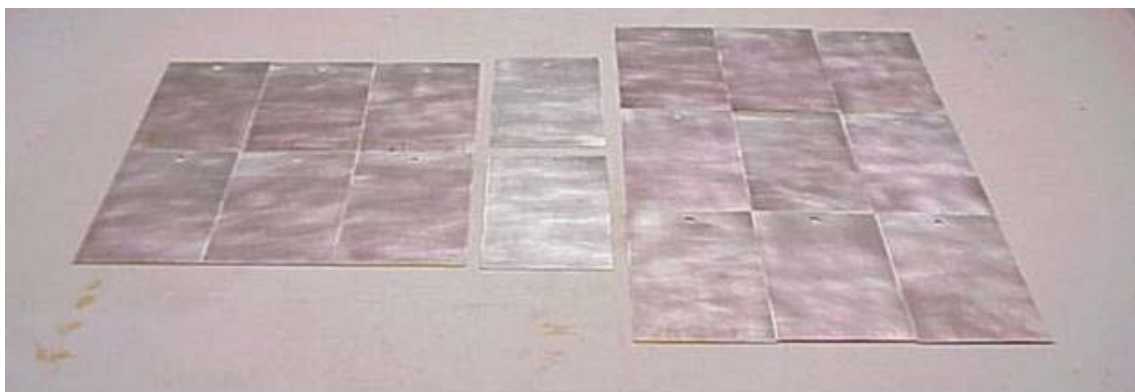
**Figure A6. Light Box Photograph Documenting VCPI Dye Solution with Cool White Fluorescent Lamps**

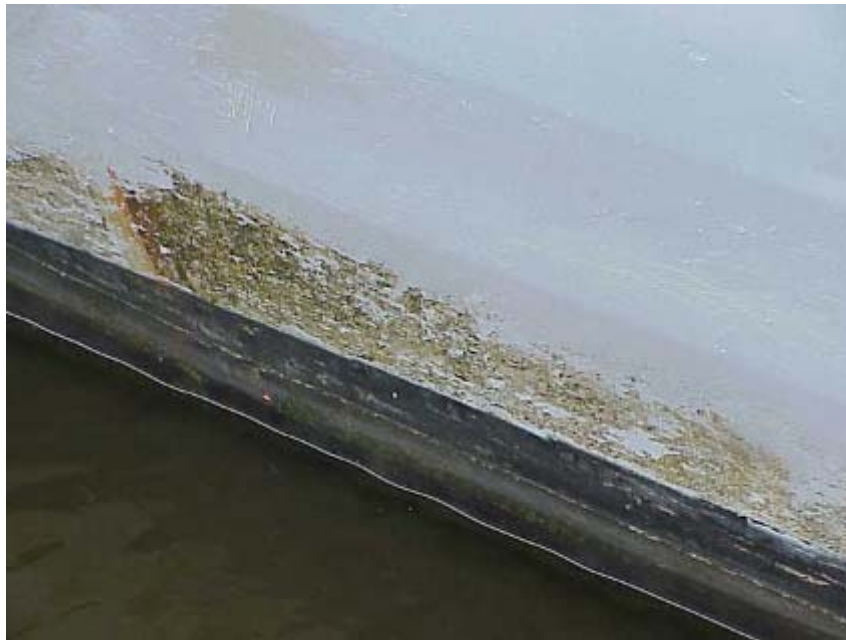
**Figure A13. Salt and Biofilm Contamination on Lower Ship Hull**

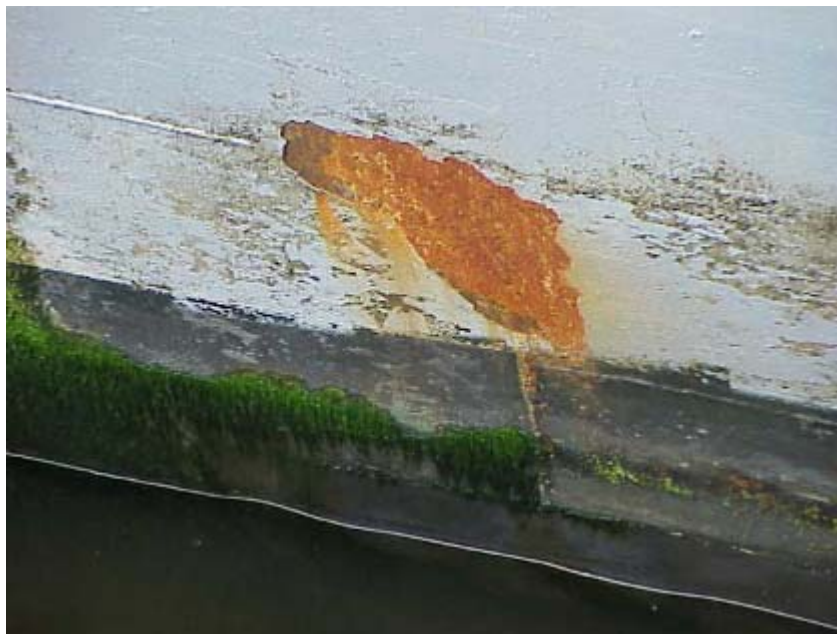
**Figure A14. Rust on Lower Ship Hull**

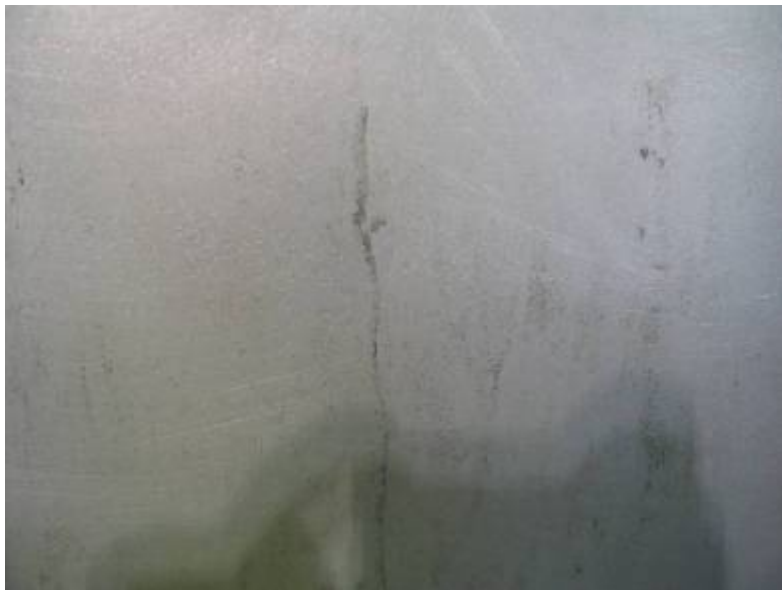
**Figure D7. Cleaned Panel Showing Paint and Glue Residues**

6. The surfaces were inspected. The front (near side) panel, designated the “A” panel, still had residual glue and primer; see Figure D7. This was removed using MEK, see Figure D8.

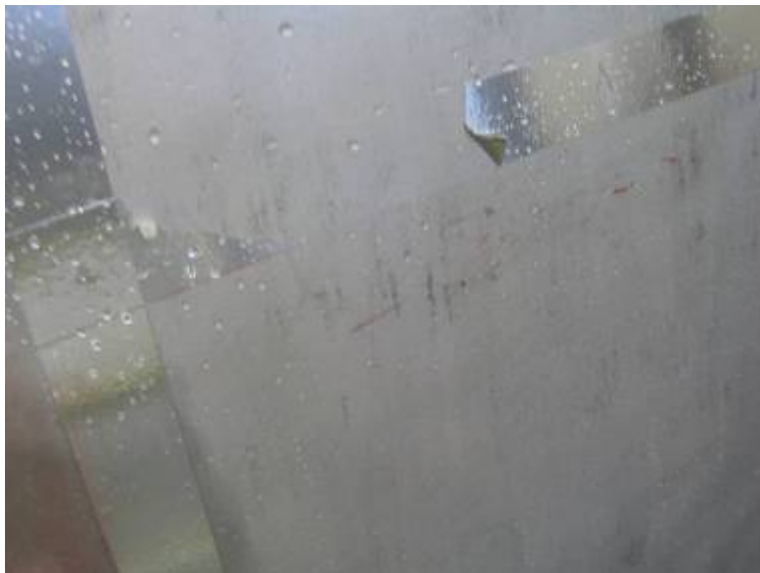
**Figure D19A. Close up of VCPI-Labeled Hydraulic Fluid on Segment A-3**

6. The panel and each segment were then inspected; see Figure D18. The control areas, and the PreKote<sup>®</sup>-labeled area, A-5, showed no labeling. The lube oil-labeled area in segment A-2 was strongly colored. The grease-labeled area in segment A-4 was also readily detected. The hydraulic fluid-labeled area in segment A-3 was only slightly colored. A portion of the silver tape used to separate the segments was removed. A very pale pink coloration of VCPI-labeled hydraulic fluid contaminated area can be seen below the area where the tape was placed. See Figure D19A.

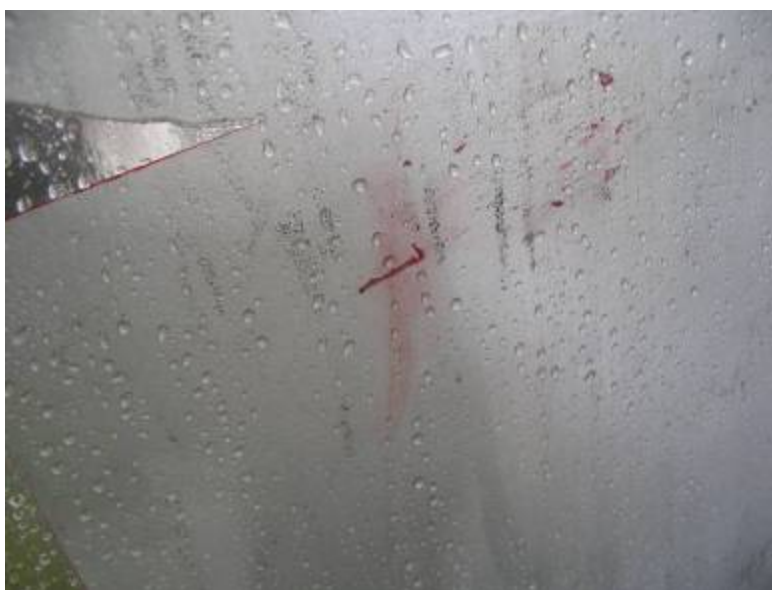
**Figure D19B. Glue Colored by VCPI Solution**

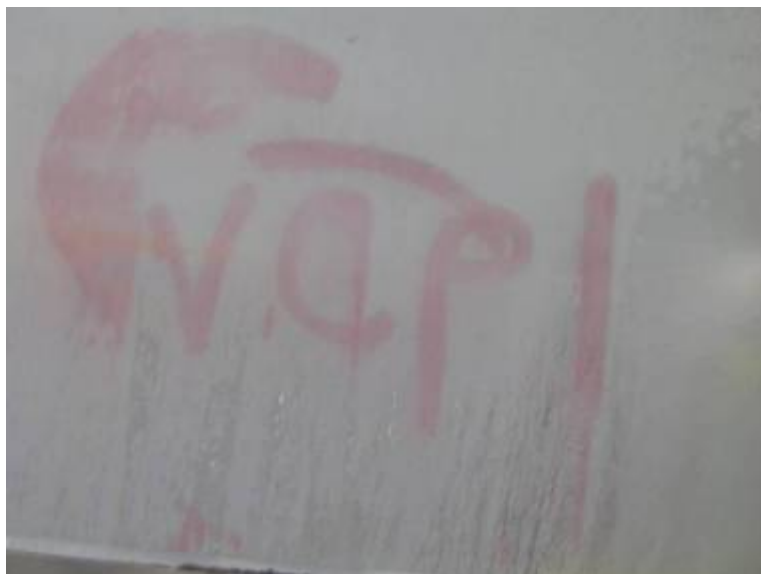
**Figure D30. Hydraulic Fluid-Contaminated on Painted Surface After Gentle Spray**

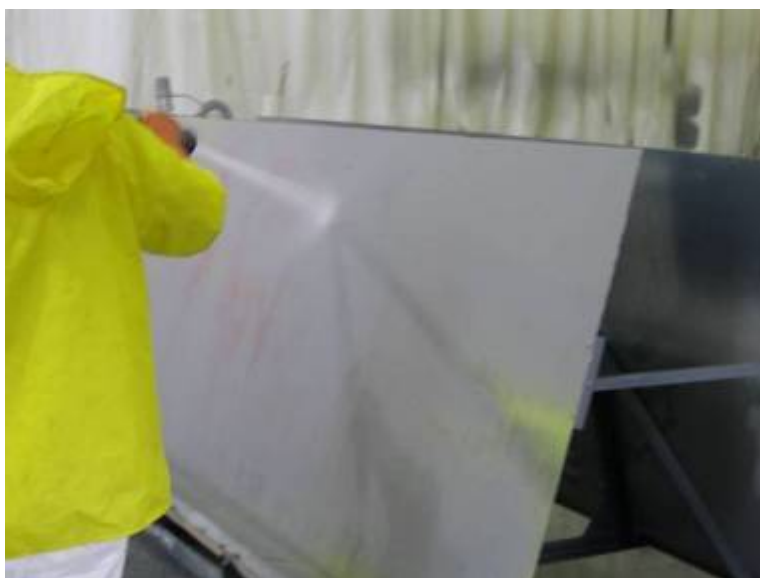
**Figure D31. Hydraulic Fluid-Contaminated Painted Surface After Extended Water Rinse**
