# **Cleaning Verification Monitor Technique Based on Infrared Optical Methods**

**PP-1138**

## **Final Report**

Shane Sickafoose, David Ottesen, Douglas Scott  
Sandia National Laboratories  
Livermore, CA 94550

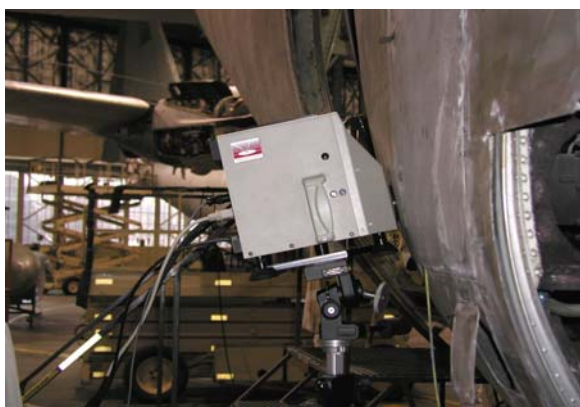
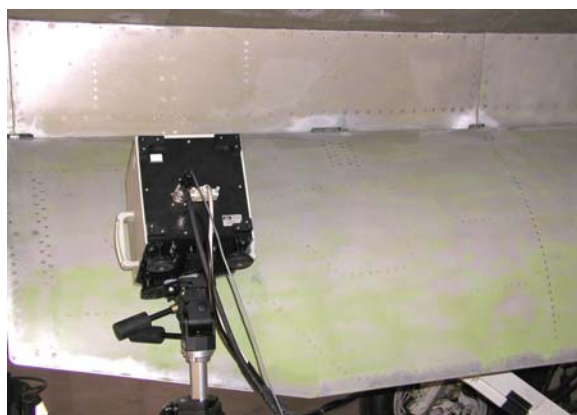
Figure 21. Portable FTIR analyzing (A) C130 bare aluminum belly and (B) an area containing yellow epoxy primer on an F-16.

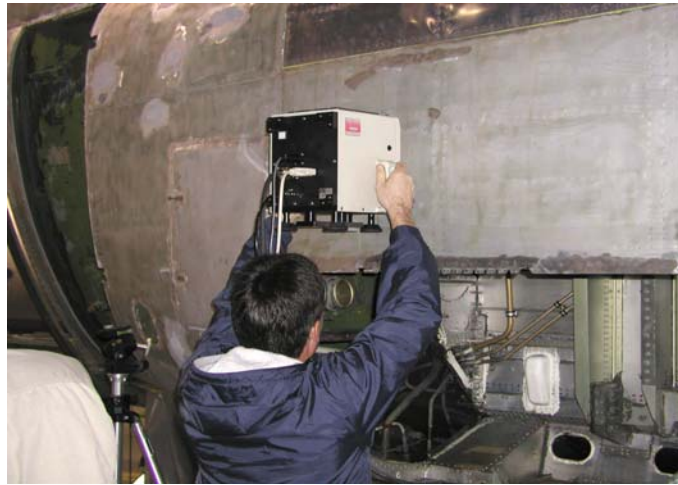
Figure 22. FTIR operator at the C130 demonstrating handheld FTIR operation.
