Report No. CG-D-06-15

# Cost Benefit Analysis of Boat Lifts

September 2014

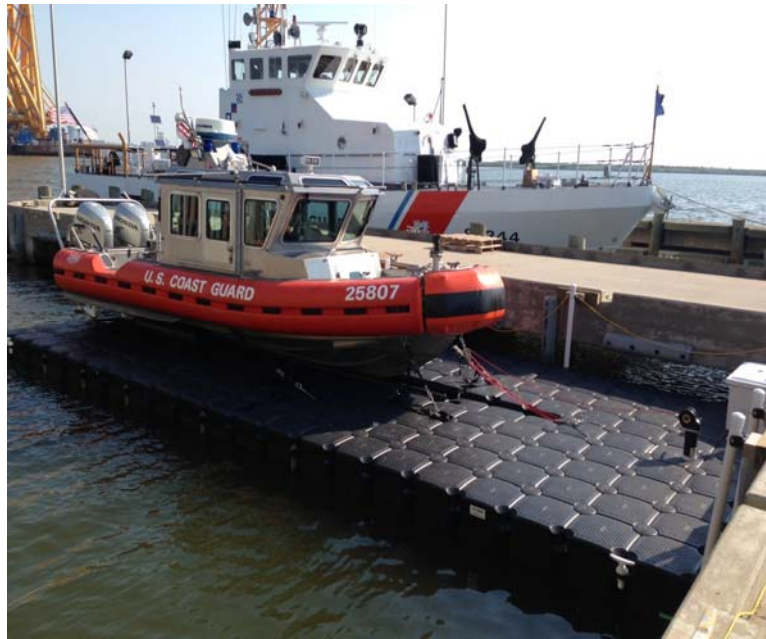
Figure 3. Jet dock.

The Jet Dock salient characteristics assessed included launching and recovery time. The Station launched the 25-foot RB-S in under two minutes. The Station took longer to recover the boat at an average time of three minutes and 25 seconds. These times fell within the stakeholder desired range for launch and recovery time. The lift also was fixed to the pier via tide manager poles that allowed the lift to rise and fall with the tide and vessel traffic wakes. To maintain stability in the lift, the RB-S was anchored at three locations to the Jet Dock: one point at the eye hook on the boat's bow and two ratchet straps located about four-feet aft on the port and starboard side of the bow.

The team monitored the performance over a 12-month period for any breakdowns or issues. The Station reported only one incident over the year, which was quickly resolved. The crew initiated a call to the technical representative to report a slow response time lifting the vessel out of the water. The technical representative quickly diagnosed the problem as the forward tide manager poles being tied too tight. The Station slacked the lines two-inches and alleviated the problem. Other than this one issue, the Station continually praised the performance and ease of maintenance of the Jet Dock boat lift.

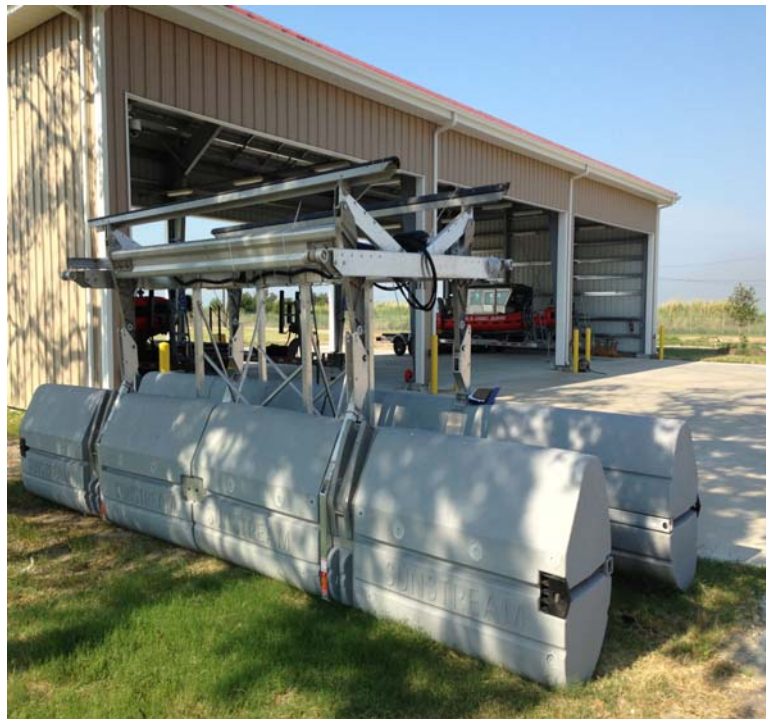
Figure 4. SunStream lift.

The team also monitored this lift for a 12-month period. A common issue that the team encountered included the lift catching under the pier, which posed a risk to stability of the lift itself as one pontoon rose while the other remained trapped under the pier. The Station tried to alleviate this issue by tying the lift across to the other side of the pier, but their attempts were unsuccessful. Additionally, while conducting boat checks, a crewmember slipped between the pier and boat lift and fell into the water while transitioning from the lift to the pier. The crewmember suffered bruised ribs and lost three days works as a result of the mishap.

The Station attempted to continue to use the lift for another month with it being caught under the pier more frequently and ultimately decided the lift was added more maintenance to their schedules than value to their operations. The Station relocated the lift to an adjacent unutilized pier and discontinued its use after five months. Had the infrastructure been a floating dock side-tied to the SunStream lift this problem could have been alleviated. The project team transferred the lift to another unit at the end of the 12-month study with the appropriate pier available for the lift.

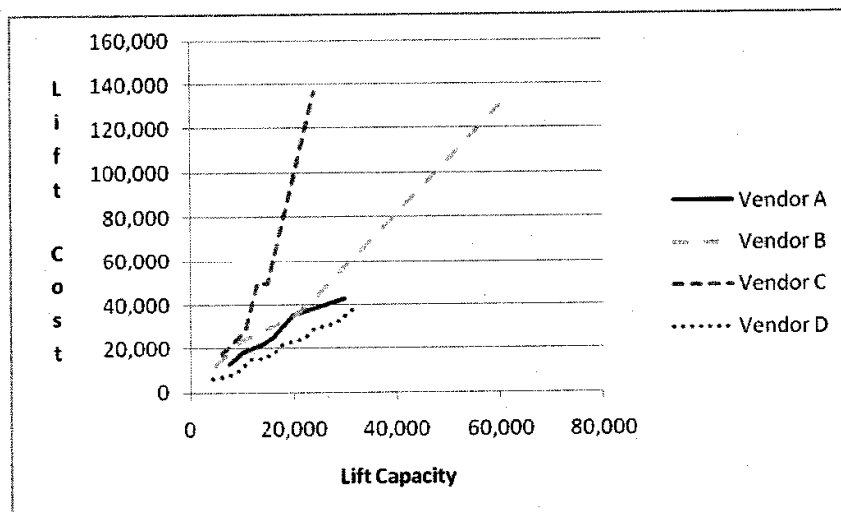
Typically the vendors provide a range of products that increase in cost as the lifting capacity increases. This information is summarized in Figure 1. Survey responses were used to estimate a range of likely installation costs and maintenance costs associated with a typical boat lift and a range for expected service life.

Figure 1 Purchase Price vs. Lift Capacity

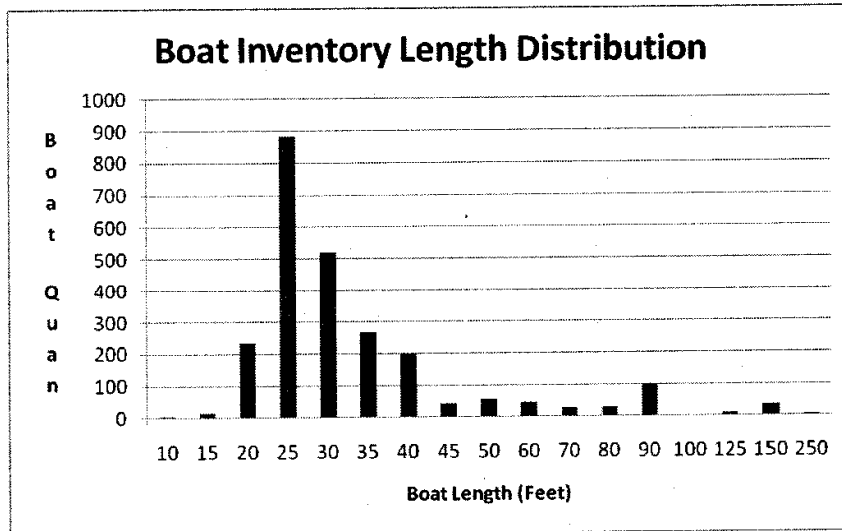
The first boat category filter used was the physical size and shape of the boats. Boats in the current inventory vary in length from 5m to over 200 feet and in weight from a few thousand pounds to several hundred tons. However, the majority of the boats are less than 50 ft. as seen in Figure 2.

Figure 2. Boat Inventory Length Distribution

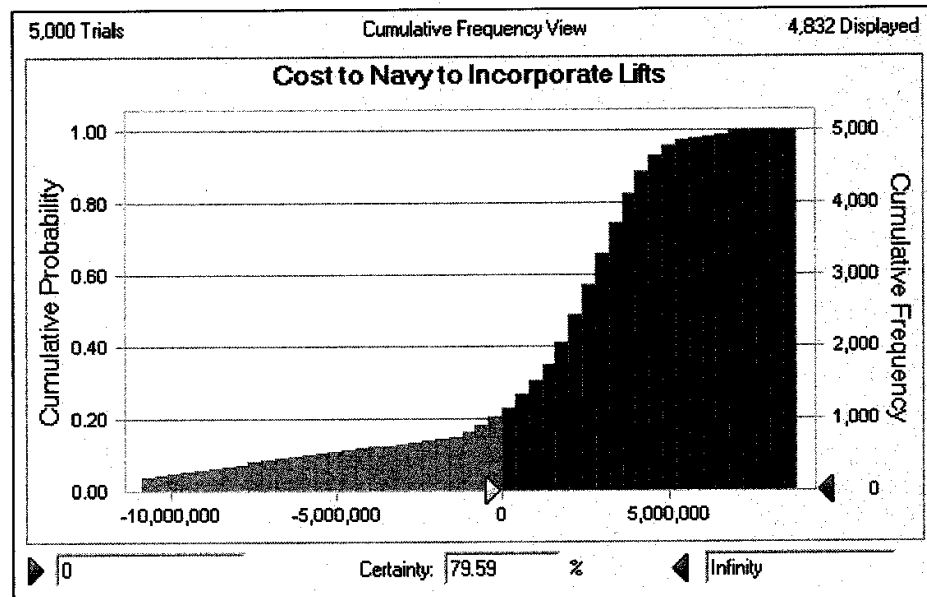
**Figure 3. Lift Implementation Cost (\$) Over Life of 170 Candidate Boats**

The result in Figure 3 shows the cost weighted average over the life of all 170 boats considered as having the most potential benefit by the study. The red bars show the probability of getting a return on the investment, with a 20.41 percent probability of breaking even. The blue bars show the probability that the Navy will incur additional costs by implementing the boat lifts as opposed to current maintenance and boat storage and harboring methods (79.59 percent). Based on this analysis, Navy concludes it is unlikely that implementing boat lifts will provide a return on investment.

The peculiar operational profile of the FP boats warrants an explanation as to service life assumptions for boats and small craft. The service life of any boat is dependent on a number of factors, such as age, usage, operational demands, etc. For planning and inventory management purposes the service life of Navy Standard 7-meter RIBs and Navy Standard 11-meter RIBs is deemed to be 12 years, other boats have an expected service life of ten years when routinely operated at less than 1,000 hours per year, and boats such as Force Protection boats that have 24/7 operational requirements have an expected service life of seven years. A few, generally larger, steel and aluminum boats have service life expectancies of up to 25 years (NSTM 583, P 1-20). For purposes of this study a 12 year service life was used for RIBs, seven years for the 24/7 boats, and ten years for everything else. The risk model created in *Crystal Ball* considered every boat in the group of 24 identified with the greatest cost savings potential, the 146 Force Protection boats in the high tempo operations scenario, and combined information for all lifts. *Crystal Ball* ran the model and estimated this total impact using Monte-Carlo simulation techniques and ran 5,000 simulations. *Crystal Ball* estimates risk by putting risk ranges on low level inputs of an estimate. *Crystal Ball* then runs the estimate numerous times and generates a cost to probability curve. These distributions were then incorporated with the cost model using *Crystal Ball*. A point estimate was developed to create a singular point of reference for cost to implement boat lifts. Risk ranges were then created around the point estimate inputs to populate the *Crystal Ball* model. The software then calculates the cumulative probability of the Navy seeing a return on the boat lift investment. The results of this analysis are shown on Figure 3.

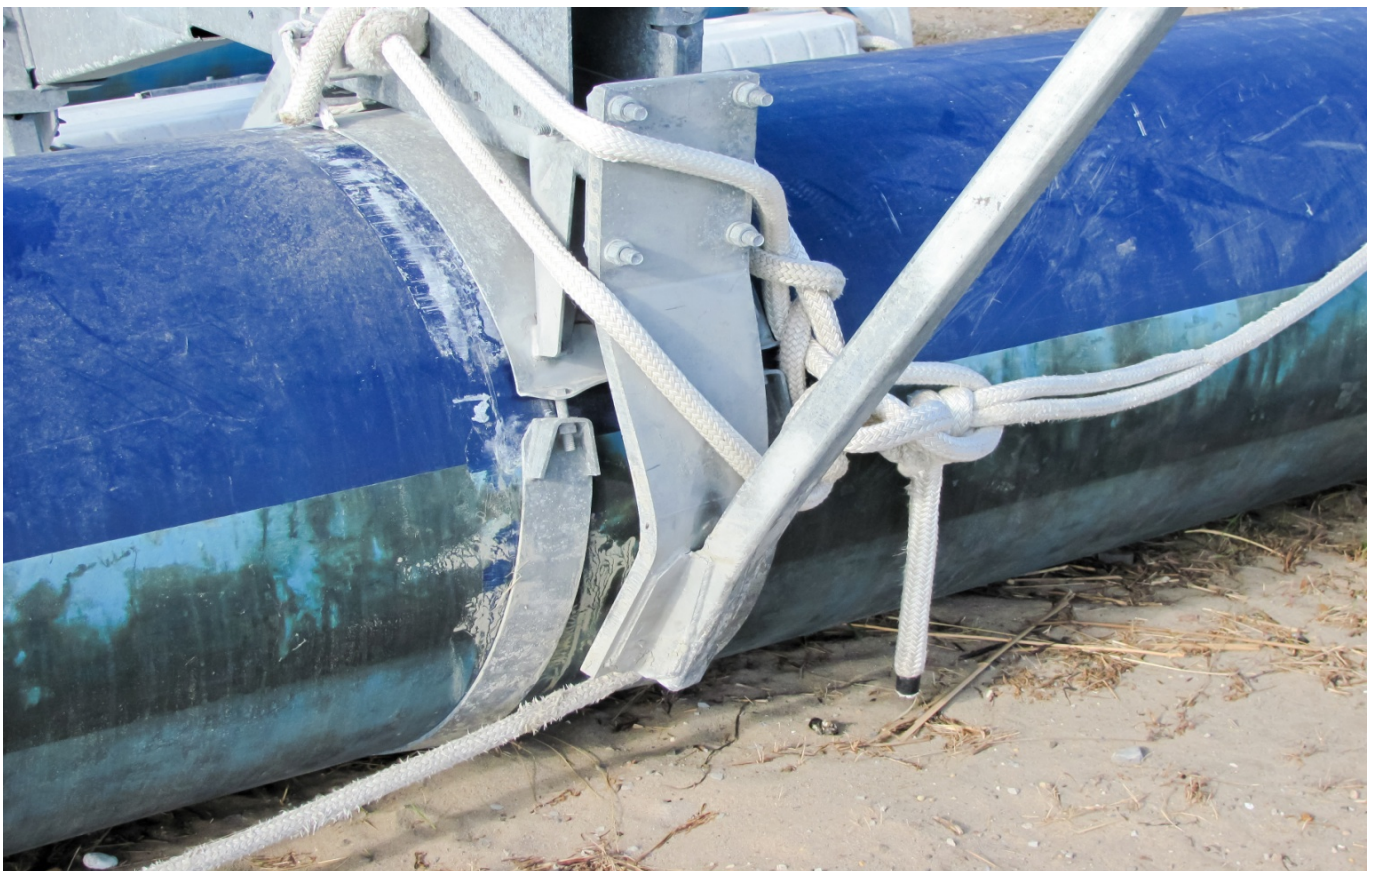
Within one month of installation Hurricane Sandy destroyed all three lifts (Figures B-1, B-2) leaving the project with less than one month of data to compare results. Damaged equipment repair cost exceeded the cost of replacement. Boat lift pontoons on all the lifts were holed and brackets and lifting hinges were sheared. Watertight integrity was compromised in many areas on all three lifts. Due to the cost exceeding replacement all three lifts were disposed of in accordance with Commandant Instruction M4500.5.

Figure B-1. Damaged guide and belly band.

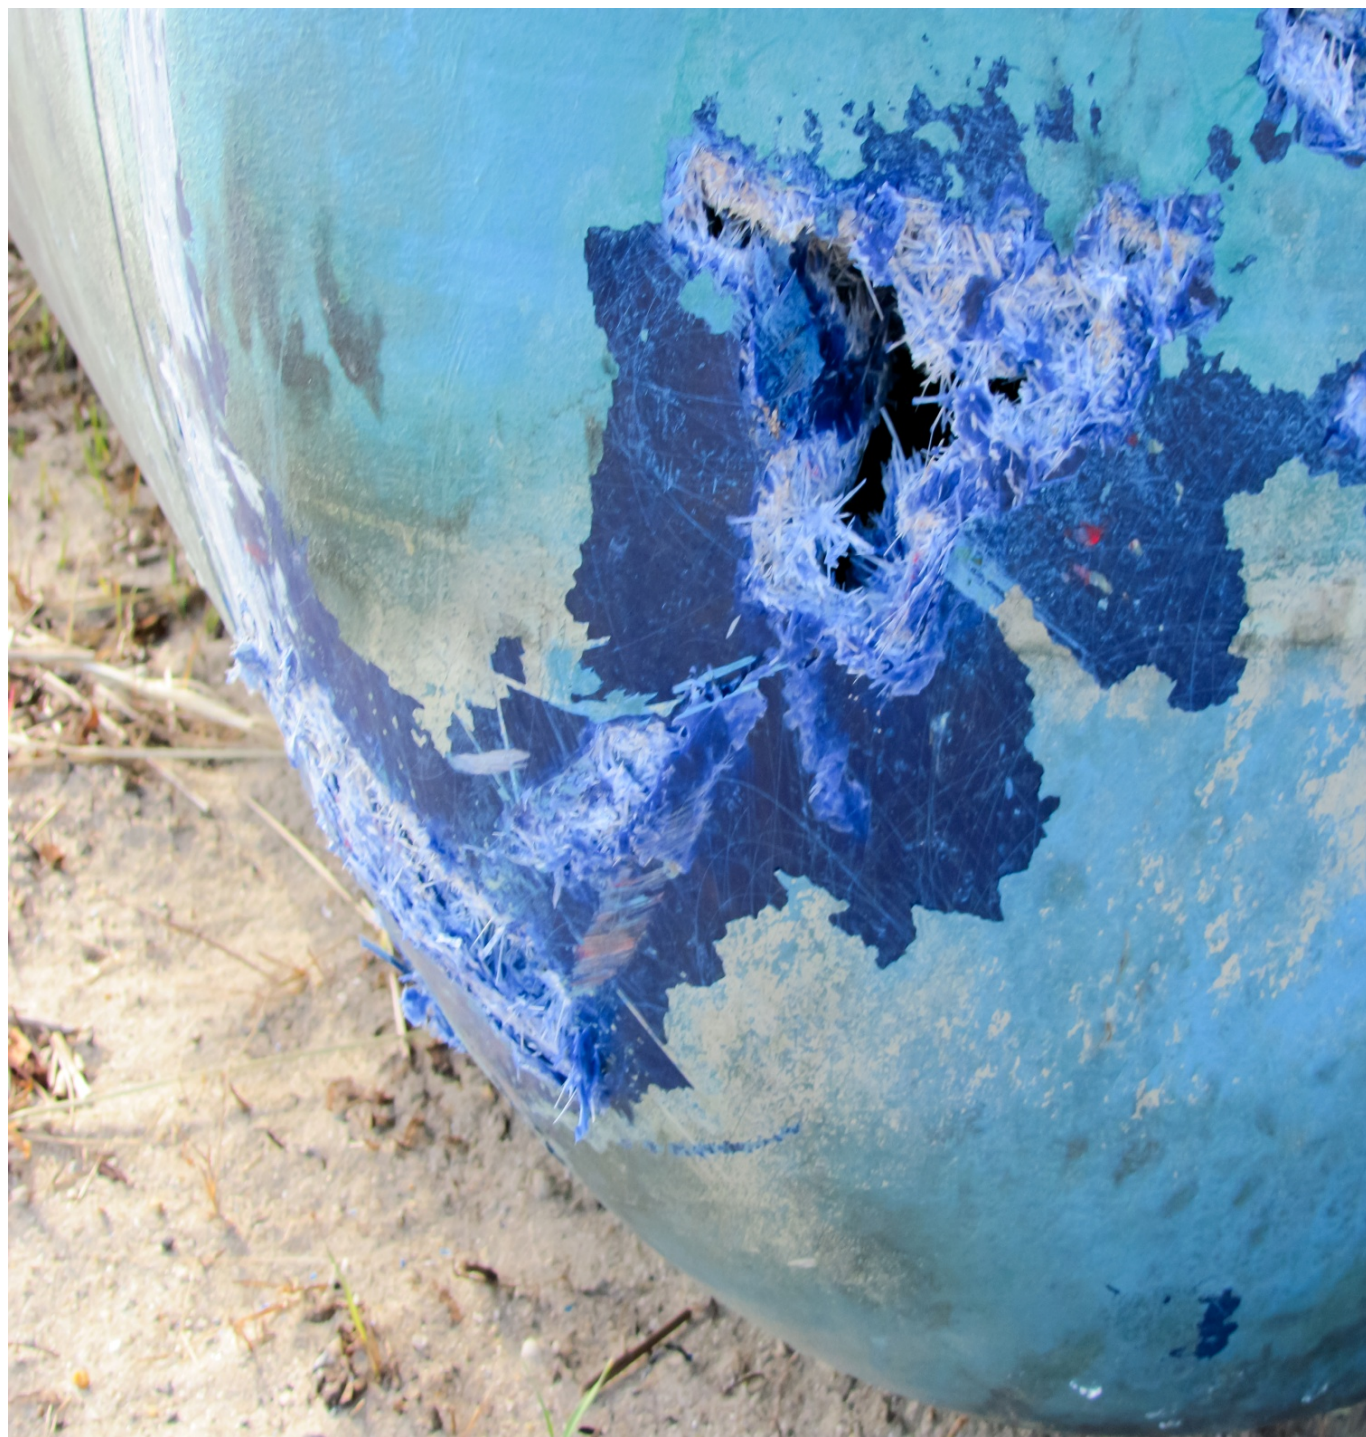
Figure B-2. Damaged area of pontoon.
