TITLE: Orthopaedic Implant Design and Manufacturing for Traumatic Injuries

PRINCIPAL INVESTIGATOR: Diane Wagner, Ph.D.

REPORT DATE: March 2012

TYPE OF REPORT: Final

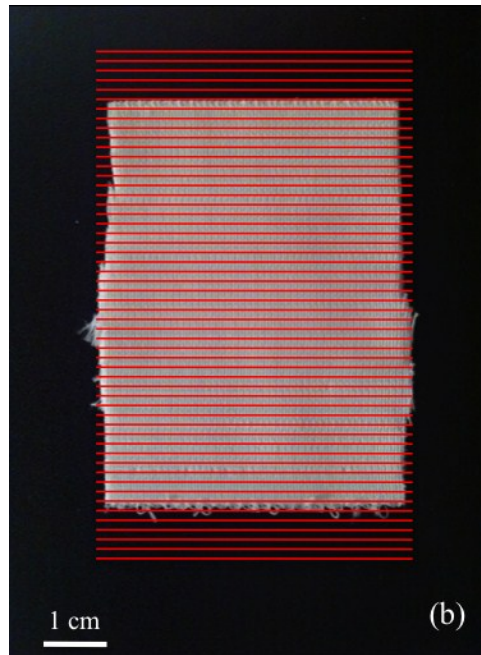
Figure 37: Schematic of laser path overlaid with the 4.5 cm  $\times$  7 cm fabric coupon.

As before, the coupons were centered on the laser stage compressed by a quartz disc, and then welded. All fabrics were exposed to an unfocused beam at 140% of the 100 mm focal length, which yields a 2 mm beam diameter at the fabric surface. A laser profile was created with an overlapping, 1.5 mm beam spacing (Fig. 37). The selected laser parameters were programmed as part of the profile (Table 5).

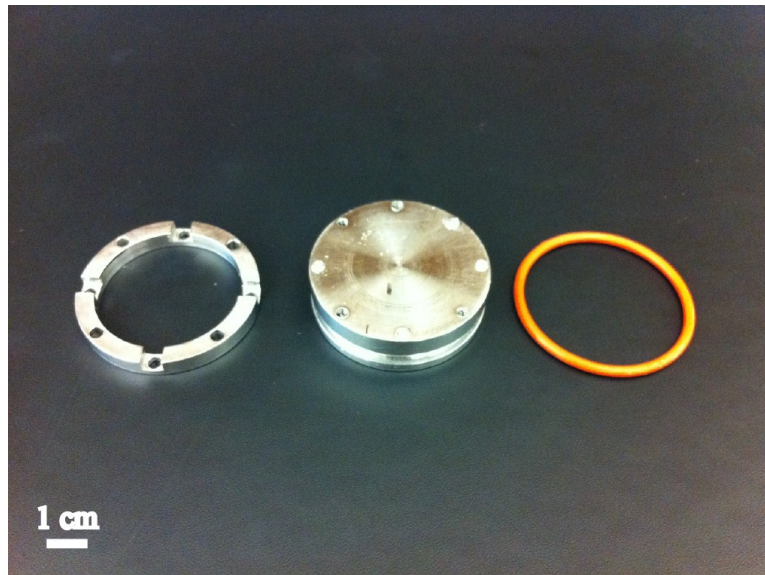
Figure 41: Fixtures used in pin-on-disc wear tests.
