Field Jet Erosion Tests on the Mississippi River Collocated Demonstration Section, Plaquemines Parish, Louisiana

Johannes L. Wibowo, Perry A. Taylor, Bryant A. Robbins,
and Eric W. Smith

June 2015

Final report

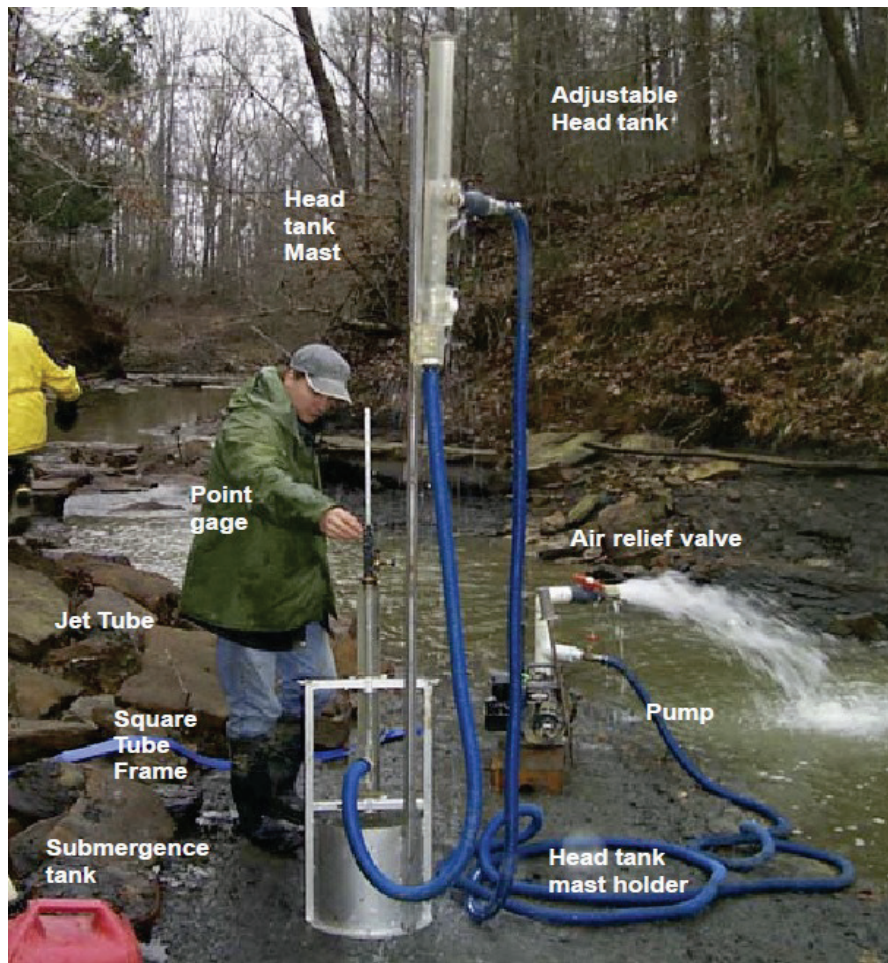
Figure 1. Original JET apparatus using constant water head system (Hanson and Cook 2004, reprinted with permission).

Figure 1 shows the testing apparatus designed by the USDA, Agricultural Research Service, to operate with a constant water pressure from an attached head tank. This apparatus maintains a nonfluctuating pressure head and was designed for testing natural geologic materials of relatively lower density.

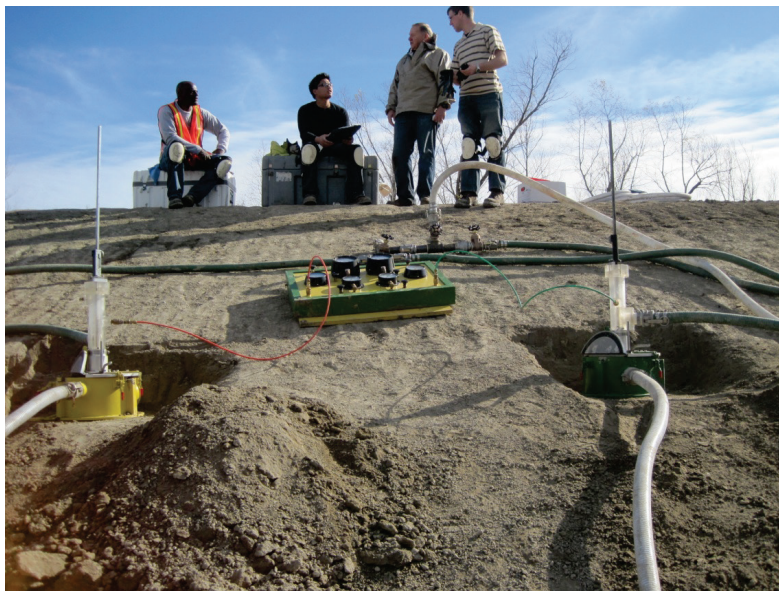
Figure 2. NSL-modified JET apparatus using an alternate water pressure source.

The NSL modified the apparatus to include a water pump that provides an alternative water pressure source and eliminates the head tank. The pressure may fluctuate, but this modified apparatus accommodates erosion testing on more dense geologic material. Figure 2 shows the modified JET apparatus used for this project.

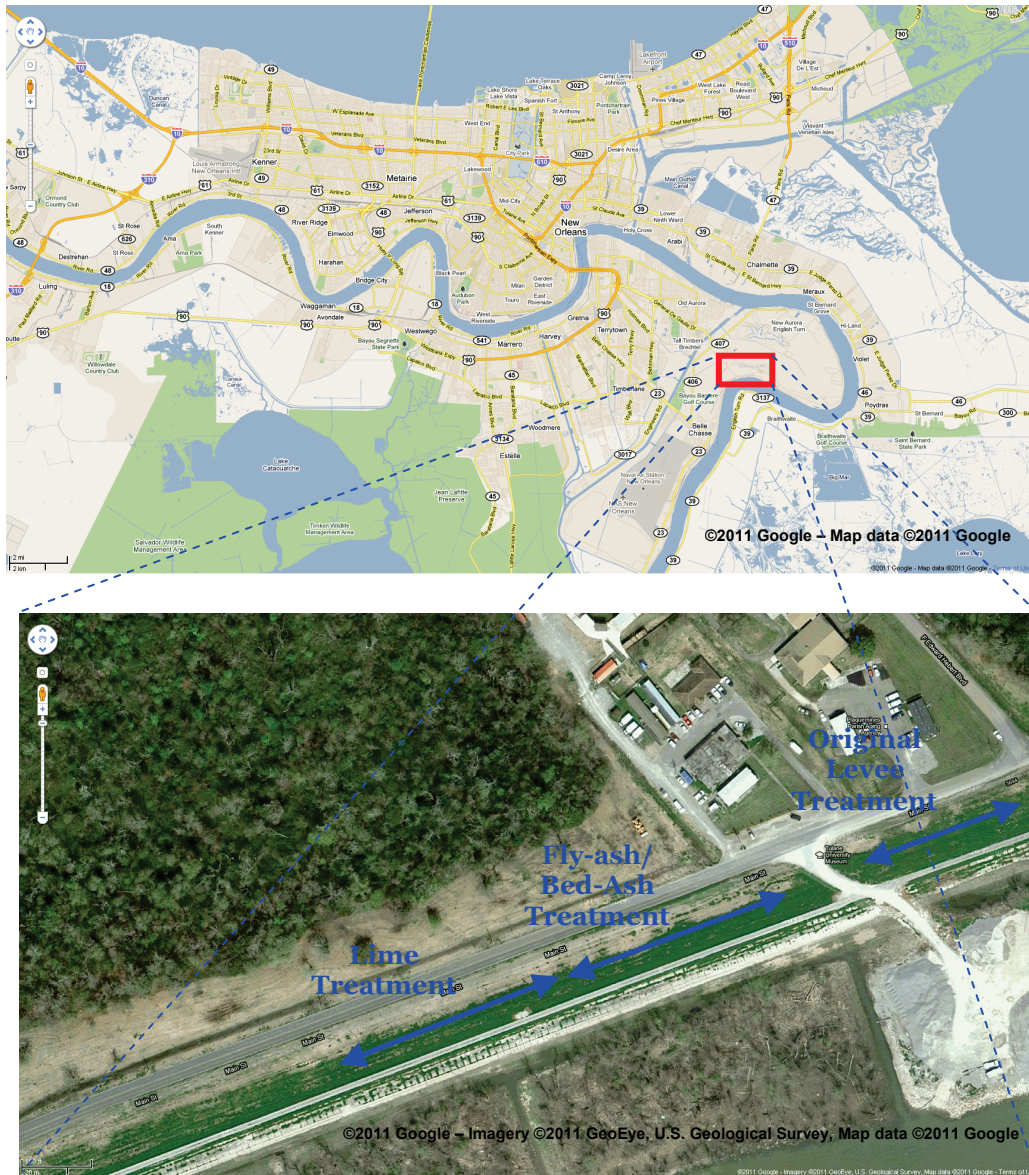
Figure 4. Location of JETs on the Collocated Demonstration Section, Plaquemines Parish, LA.

The demonstration levee is located in Plaquemines Parish, LA, at Belle Chasse, south of New Orleans, parallel to Main Street at the intersection with F. Edward Hebert Boulevard as shown in Figure 4. The test section consisted of two segments: clay levee with fly-ash treatment and clay levee with lime treatment (Figure 4). An untreated section of the original clay levee was also tested. Tests 1, 2, 3, and 4 were performed on the untreated clay levee. Test 5, 6, 7, 8, 13, 14, 15, and 16 were done on the clay levee treated with fly ash. Tests 9, 10, 11, and 12 were performed on the clay levee treated with lime. The coordinates of each test were obtained using a handheld GPS (Table 1).

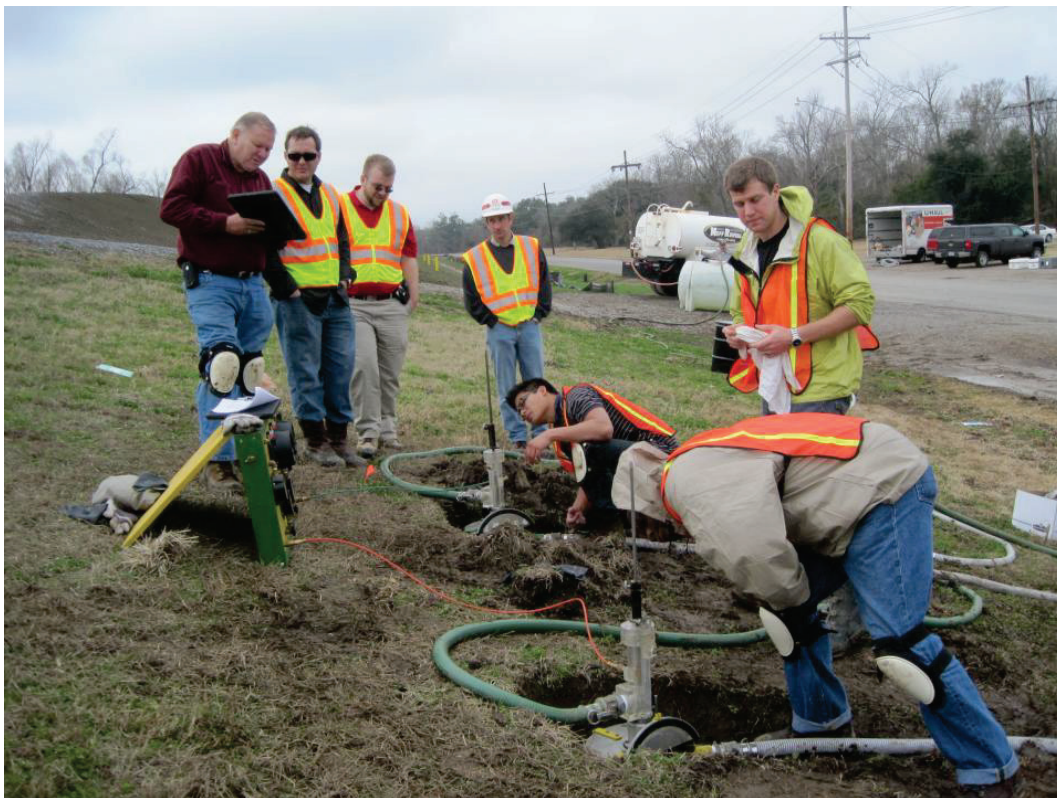
Figure 7. The ERDC team performing an erosion field JET on the untreated clay segment.

The untreated clay segment, constructed of dark brown, high plasticity clay, was well compacted with a wet density ranging between 110 and 116 pcf. The water content during the test ranged from 26 percent to 41 percent. The levee was well covered with grass. Figure 7 shows a photograph of the ERDC team performing a JET on the untreated clay section. Figure 8 shows the photographs of Test 1 before and after a JET was performed. Figure 9 depicts the progress of erosion depth of Test 1 as a function of time.

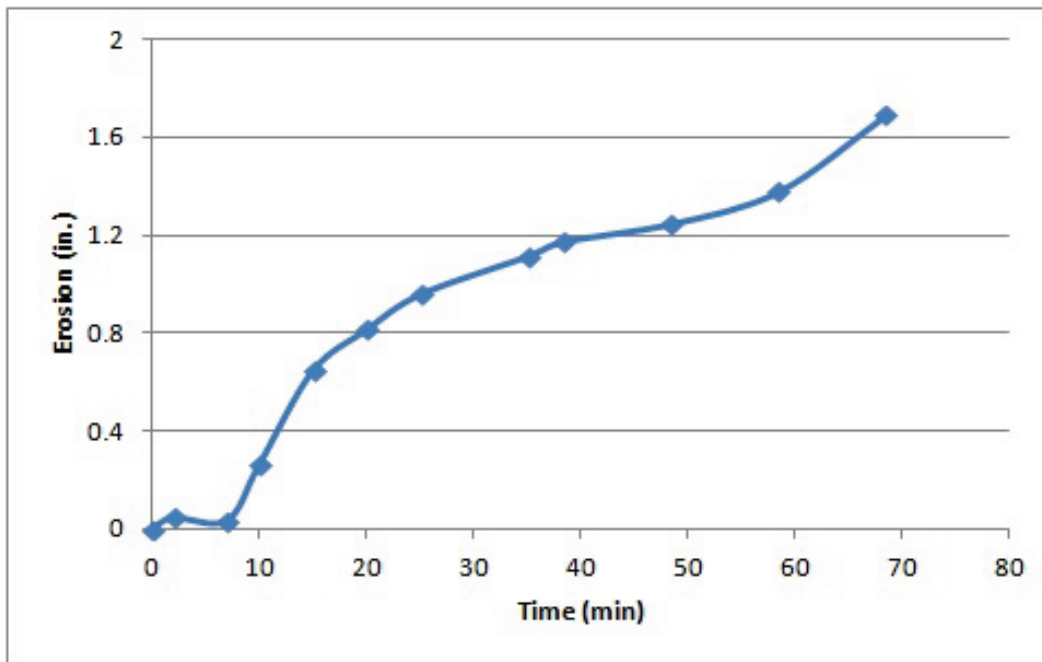
Figure 9. Cumulative erosion depth (in.) versus time (min) of Test 1, on the untreated clay segment.

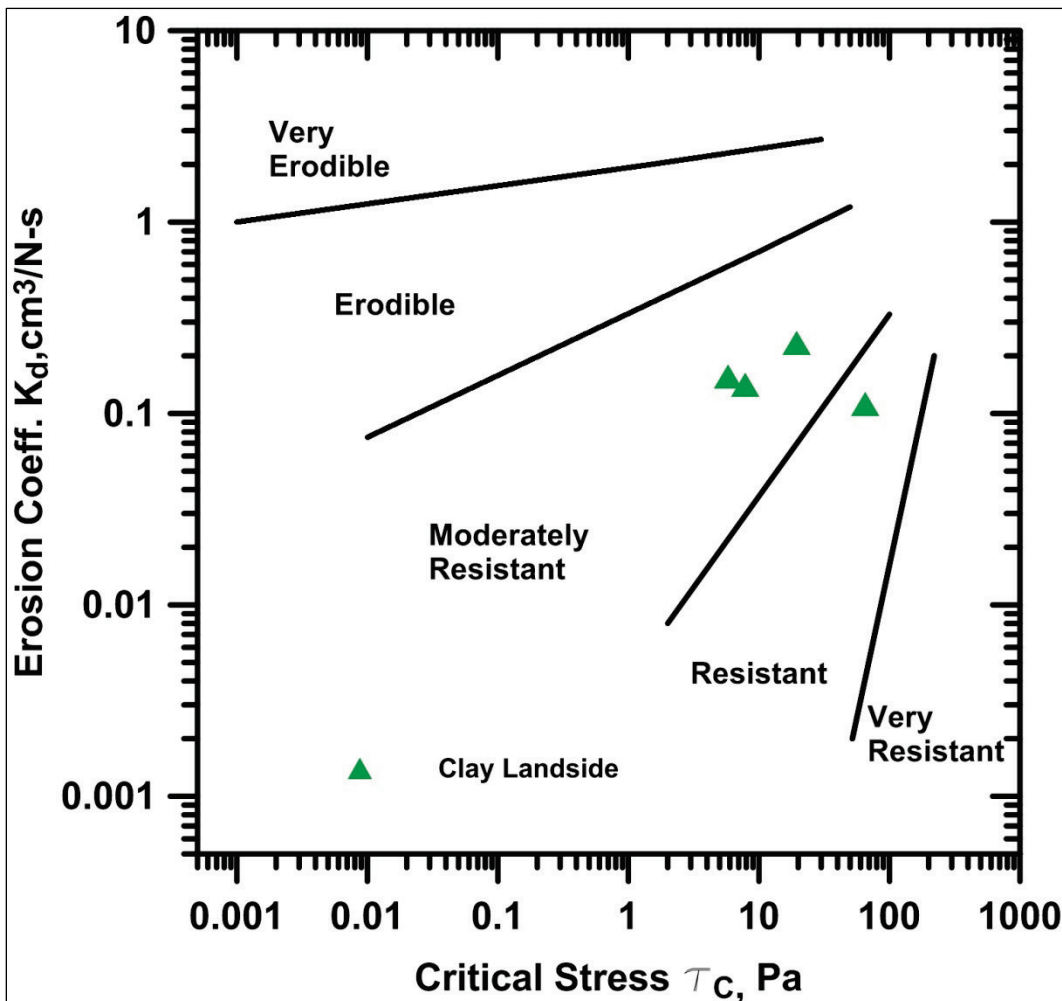
Figure 10. Plot of erodibility coefficient and critical shear stress of the untreated clay segment using erodibility categories proposed by Hanson and Simon (2001).

The erodibility coefficient, k_d , and critical shear stress, τ_c , were calculated using a Microsoft Excel spreadsheet and the Solver utility (Figure 10). The solution procedure begins by fitting the recorded scour depths and time of measurement to an asymptotic function that predicts the equilibrium scour depth at $t = \infty$. The corresponding stress that produces the depth of equilibrium scour is defined as the critical shear stress. A summary of k_d and corresponding τ_c for the original clay levee material is shown in Table 2. Additional photographs and the graphs of test results for the untreated clay section are in Appendix A.

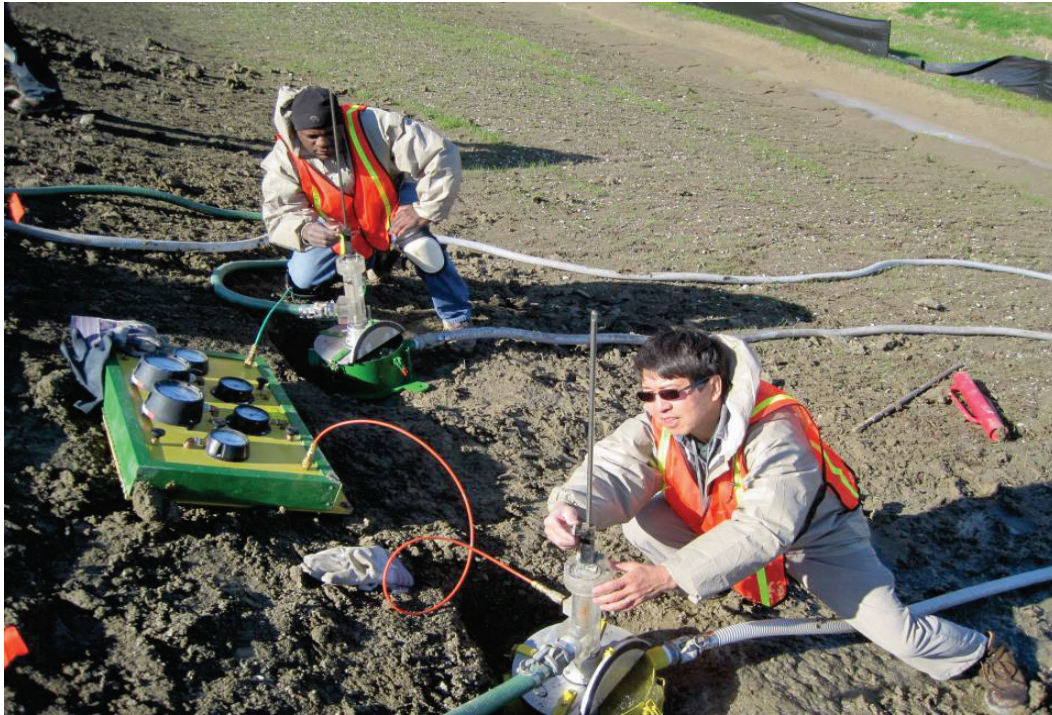
Figure 12. Engineers from ERDC performing field JET on fly-ash/bed-ash-treated segment.

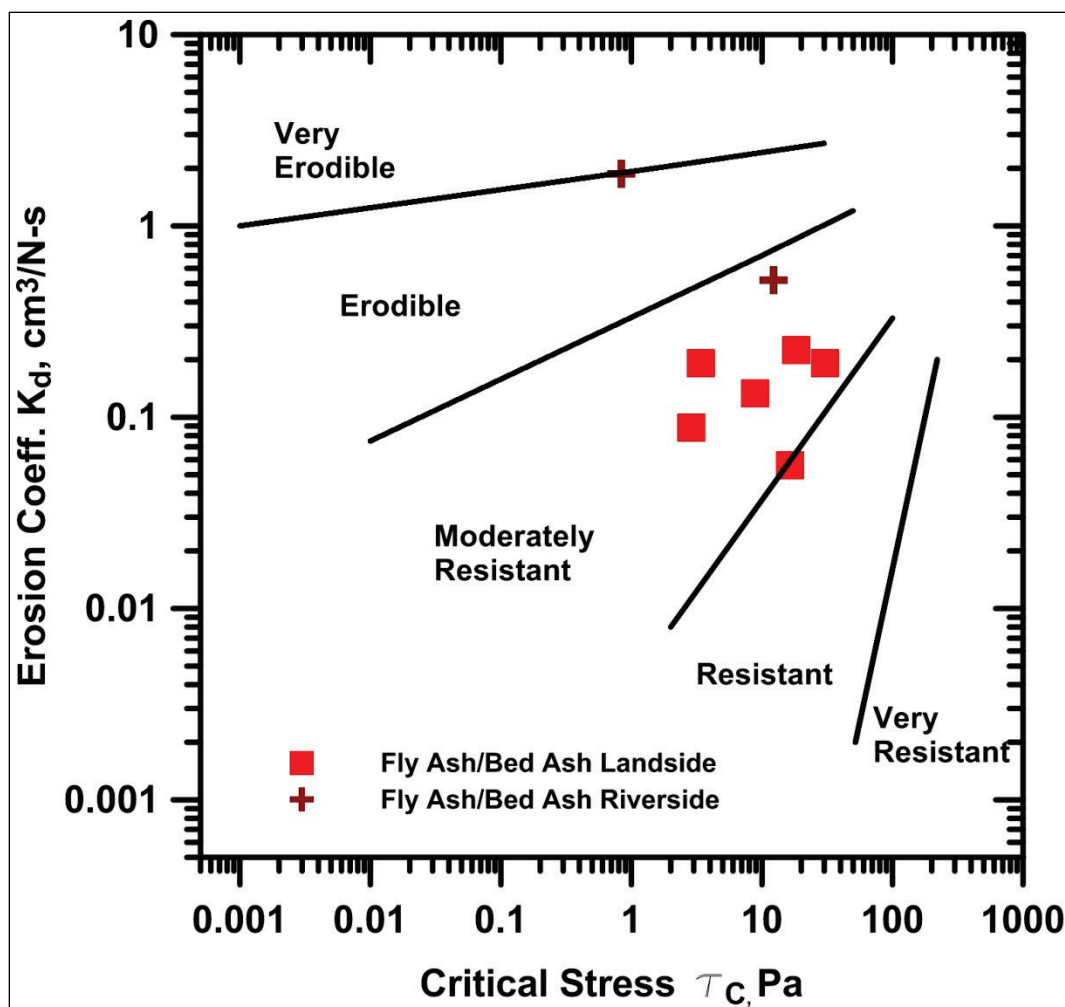
Figure 15. Plot of erodibility coefficient and critical shear stress of fly-ash/bed-ash-treated clay using the erodibility category proposed by Hanson and Simon (2001).

tabulated in Table 3, and the data are plotted on the erosion category chart proposed by Hanson and Simon (2001) as shown in Figure 15. Additional photographs and graphs of test results for the clay levee with fly-ash/bed-ash treatment can be found in Appendix B.

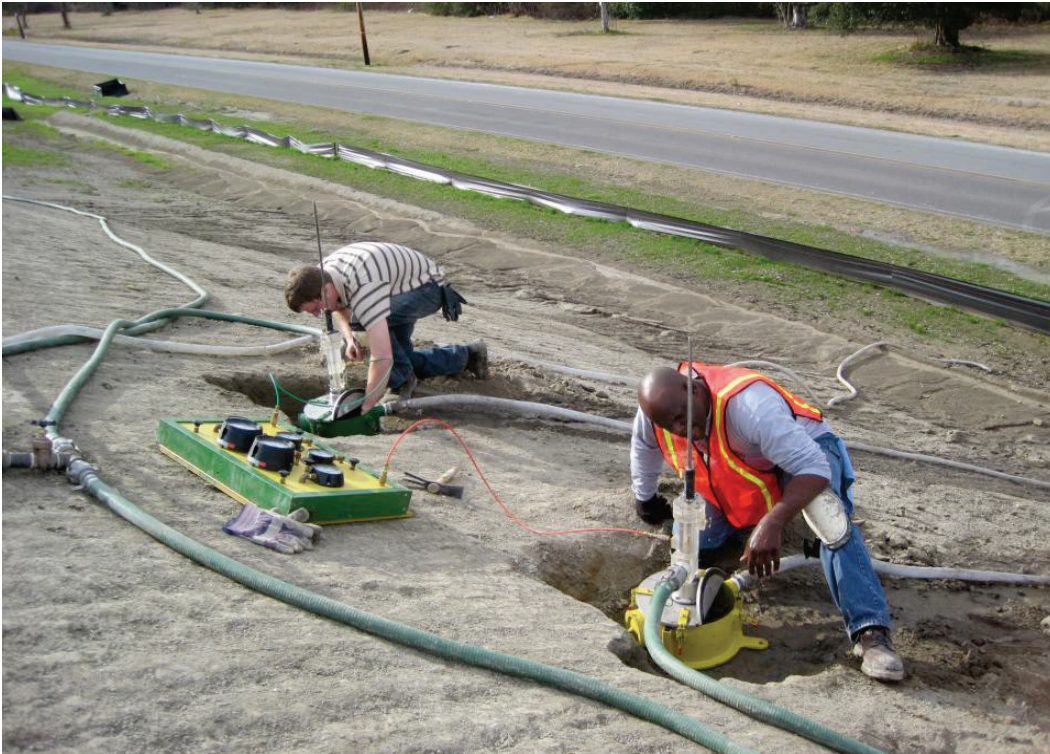
Figure 16. The ERDC team performing a field JET test on the lime-treated segment of the levee.

Figure 16 is a photograph of the ERDC team performing a JET on the lime-treated levee. Figure 17 shows photographs of the lime-treated clay levee before and after JETs were performed. Figure 18 depicts the progress of erosion depth as a function of time. The values for k_d and τ_c are tabulated in Table 4, and the data are plotted on the erosion category chart proposed by Hanson and Simon (2001) as shown in Figure 19. Additional photographs and graphs of test results for the clay section with lime treatment are in Appendix C.

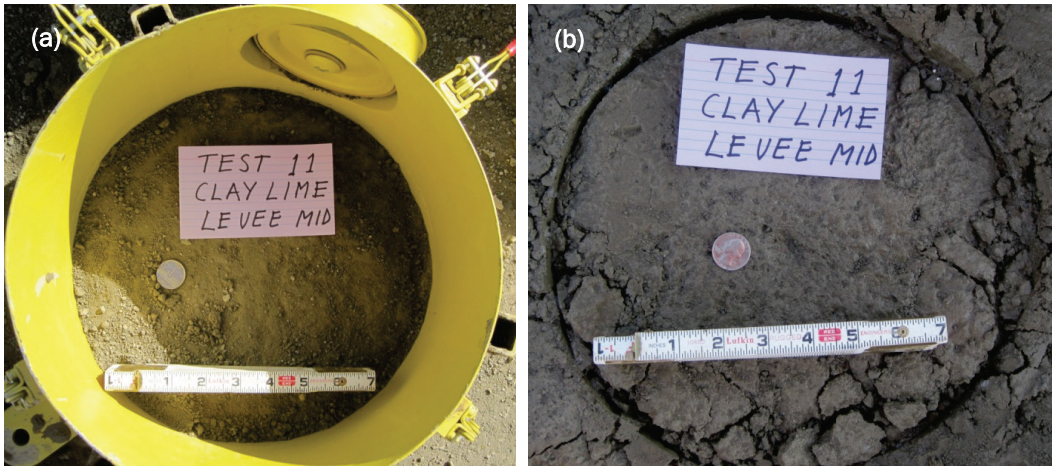
Figure 17. Test 11, clay segment of the levee with lime treatment, (a) before and (b) after a field JET was performed.

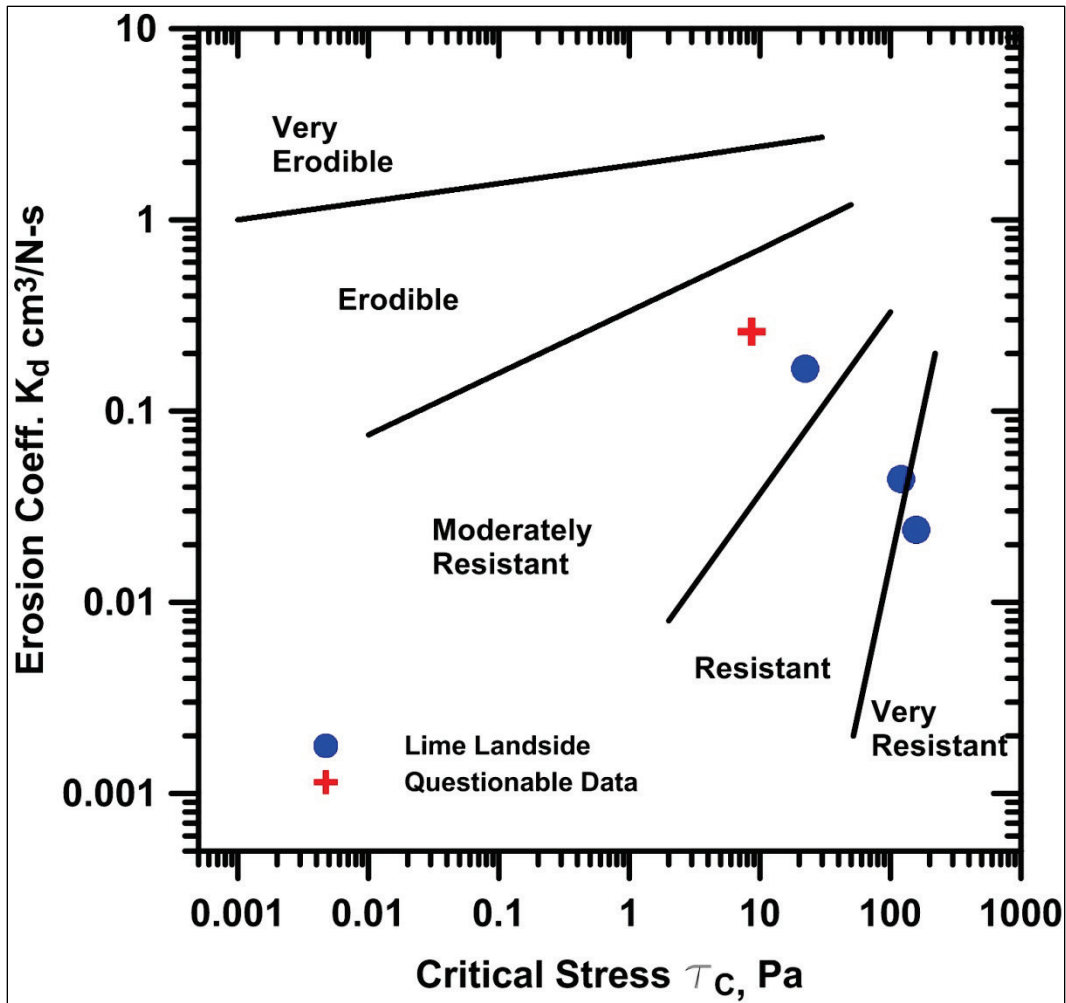
Figure 19. Plot of erodibility coefficient and critical shear stress of lime treatment using the erodibility categories proposed by Hanson and Simon (2001).

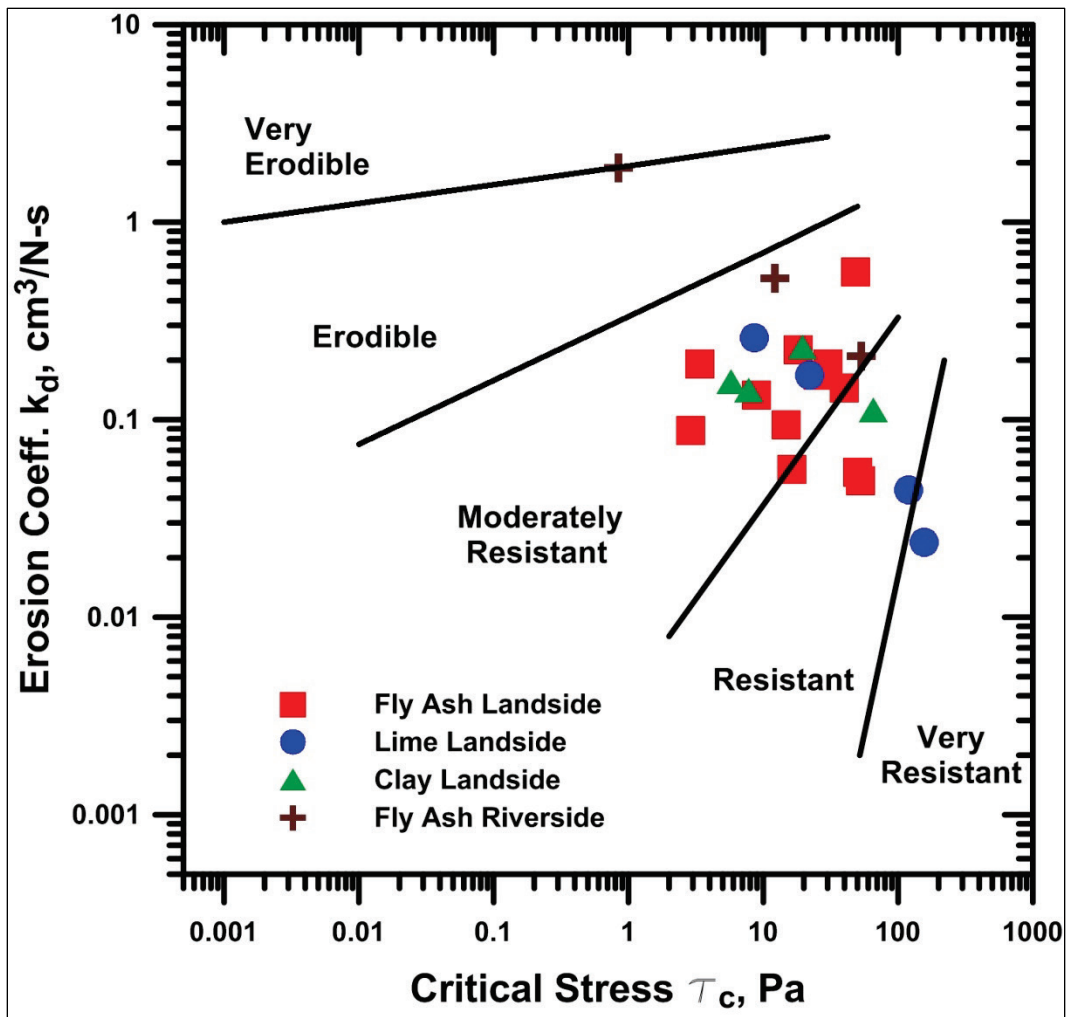
Figure 22. Summary of erodibility coefficient and the corresponding critical stress of all primary and secondary test data.

Figure 21 shows the summary of primary test data using the erosion categories proposed by Hanson and Simon (2001). When the primary data and secondary data were combined as shown in Figure 22, the erodibility category of fly-ash/bed-ash-treated clay improved.

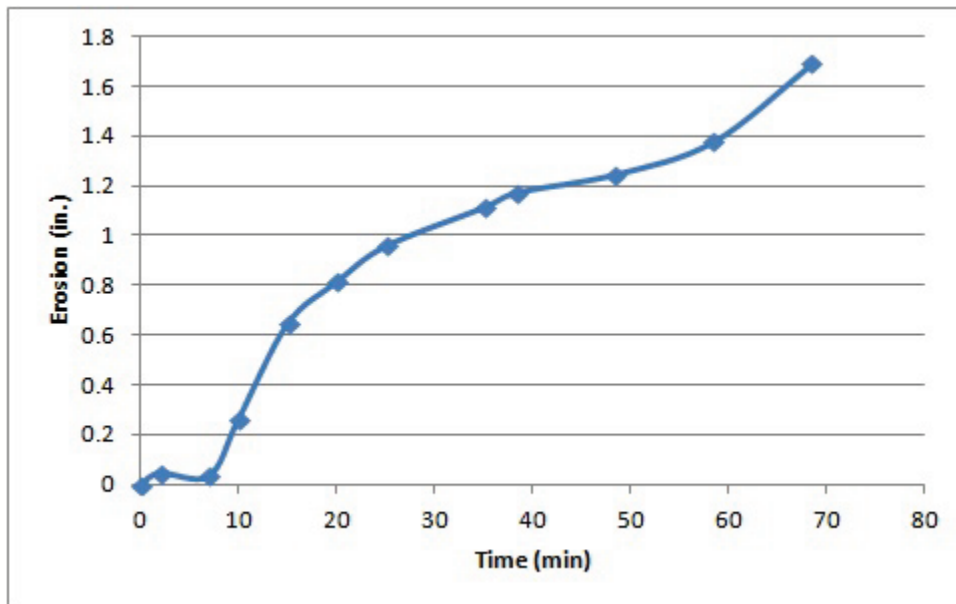
Figure A2. Test 1, cumulative erosion depth (in.) versus time (min).

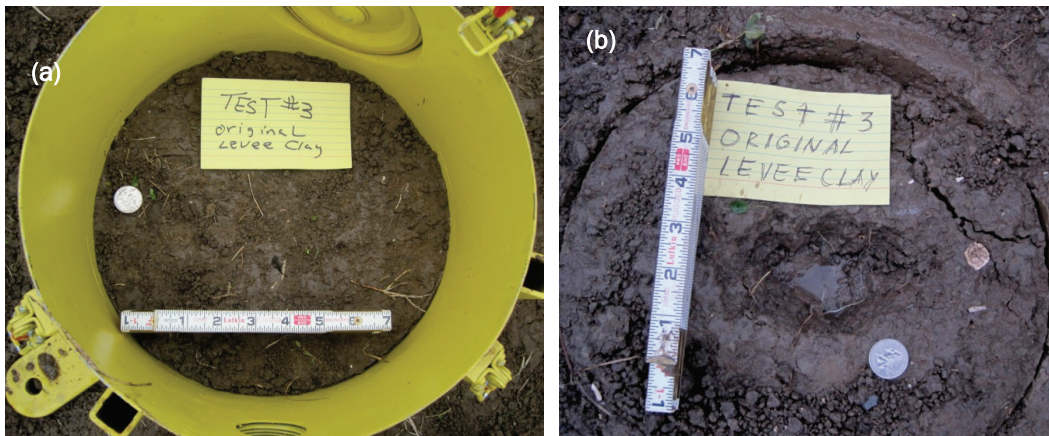
Figure A5. Test 3, (a) before and (b) after a field JET was performed.

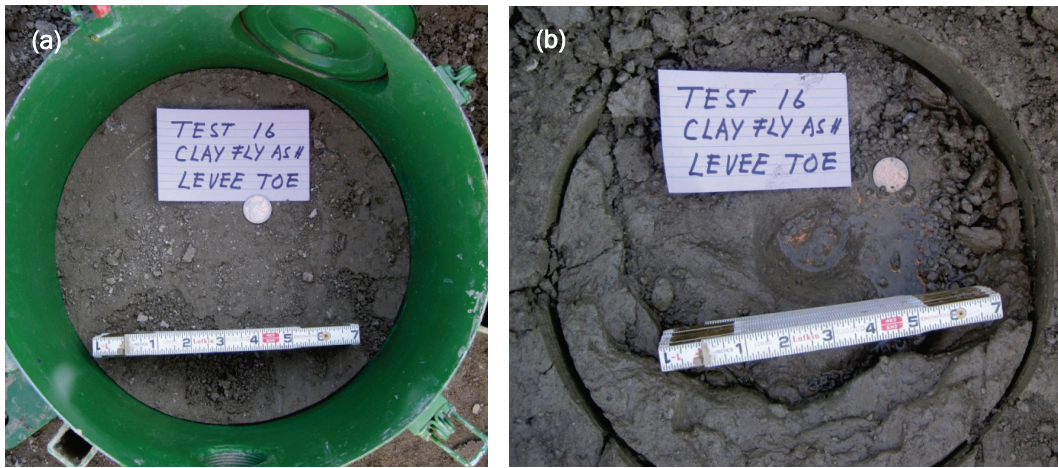
Figure B15. Test 16 (a) before and (b) after a field JET was performed.

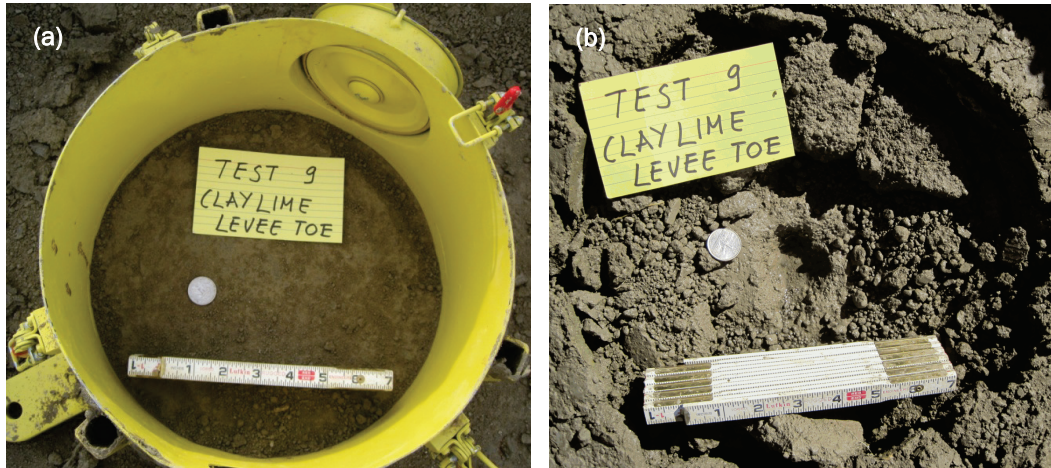
Figure C1. Test 9 (a) before and (b) after a field JET was performed.
