*Dredging Operations Technical Support Program*

# **Characterization of Suspended Sediment Plumes Resulting from Barge Decanting in San Francisco Bay**

Kevin J. Reine and Paul R. Schroeder

June 2015

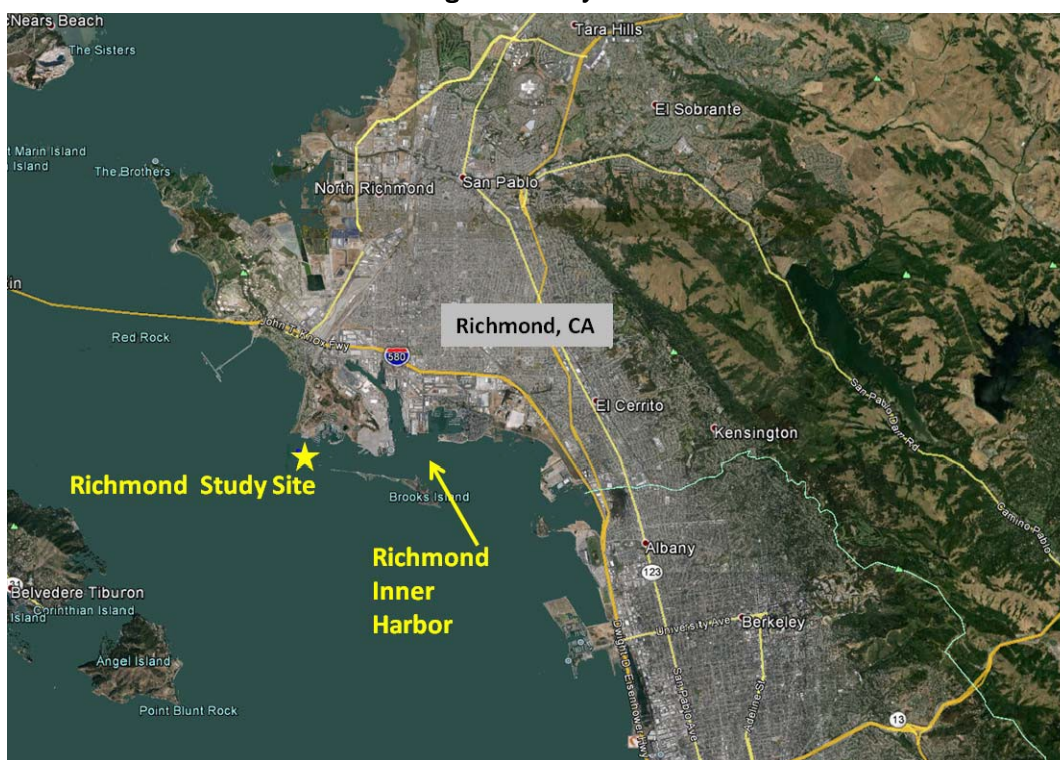
Figure 1. Study Site.

The City of Richmond, California is located in western Contra Costa County. The Port of Richmond is located southwest of the city of Richmond and to the east of the Southampton Shoal Channel and can be found on NOAA Chart 18653 at approximately 37° 54' N and 122° 23' W. The study site was located at the western terminus of the Point Potreno Reach, northeast of Brook's Island, covering an area from 100 m east of Channel Marker "G-7" to approximately 200 m east of Channel Marker "R-6" (Figure 1).

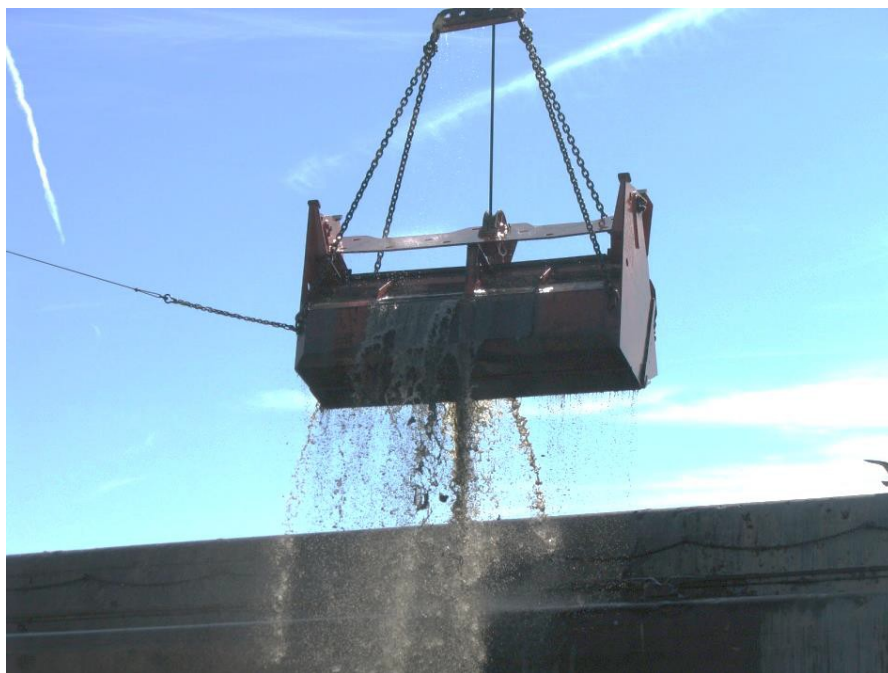
Figure 2. Fourteen cyd closed environmental bucket used by the Dredge *DB Palomor* in the Port of Richmond.

Dredging was conducted by the *DB Palomor* using a 14-cubic yard closed environmental Cable Arm® bucket (Figure 2) operated by RES Engineering, Inc. The dredge has a 75-ton capacity crane with barge dimensions of 150' x 54' x 13'. For position maneuvering, it has the capability of using two 80' spuds or four anchors and buoys. The latter anchoring technique was used during the present study.

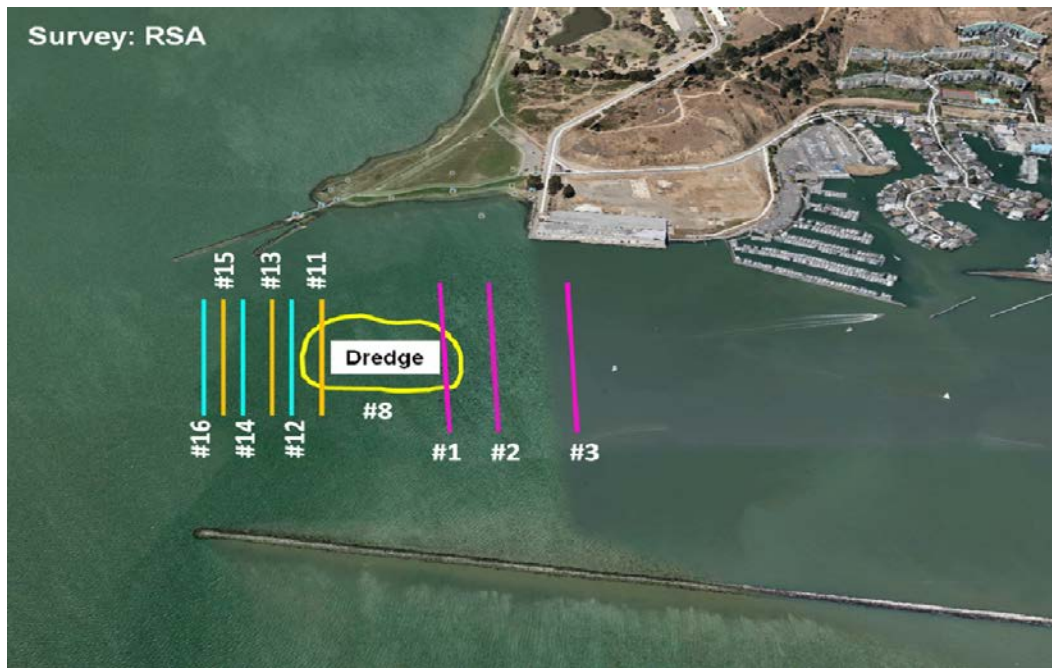
Figure 4. Layout of transects for Survey RSA.

Data collection during an ebbing tide occurred on 8 November 2012. Two surveys were completed. Survey RSA consisted of 10 transects. Transect RSA-8 encircled the dredging operation. Six transects covered a downstream portion of the study site progressing westward from the dredge towards Channel Marker R-6. Downstream extent of the survey was based on the observed decay of the plume in comparison with ambient conditions (Figure 4, RSA-11 through RSA-16). The first of these downstream transects (RSA-11) passed within 30 m of the point of bucket entry and exit from the water. The final transect in the series was occupied 298 m down-current of the dredging operation. Note that transects RSA-1 through RSA-3 were discussed in the above paragraph under the heading “Ambient Survey.” A plan-view layout of transects is depicted in Figure 4. Transect length ranged from 51 to 119 m (mean = 70 m).

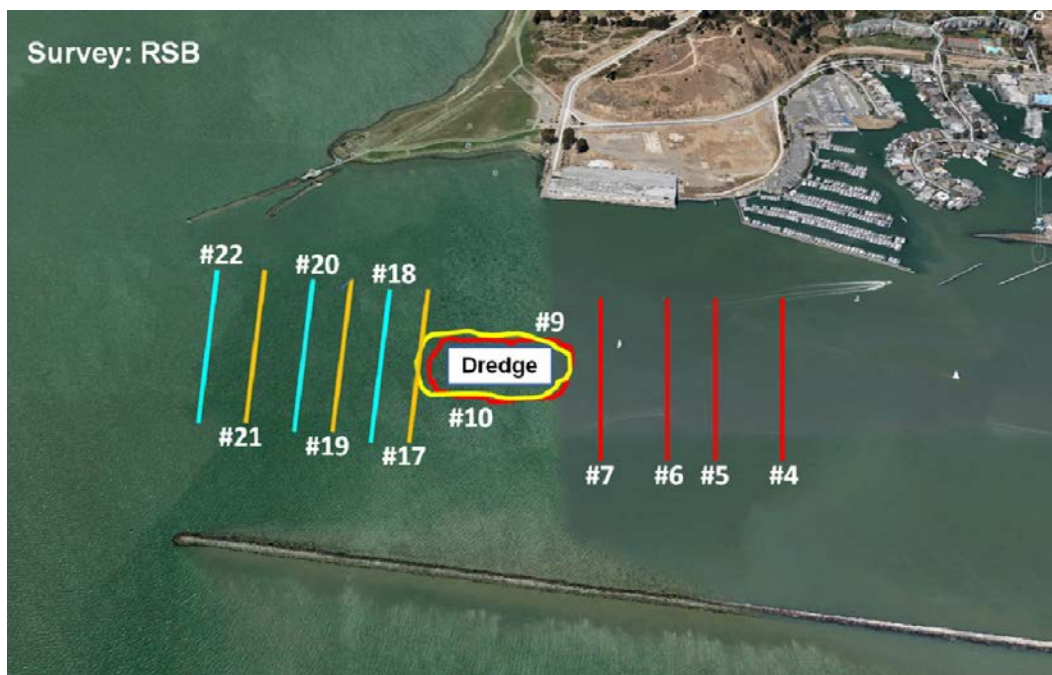
Figure 5. Layout of transects for Survey RSB.

RSB-7 (Figure 5) are representative files depicting ambient conditions. Transects extended laterally across the navigation channel in a north-south direction. Transect length ranged from 49 to 70 m (mean = 58 m).

A second during-dredging ebb tide survey (RSB) produced similar results. A plan-view layout of the survey transects is presented in Figure 5. Figures 10 through 13 (RSB 4 through RSB-7) consisted of a series of four parallel transects (Figure 5, red transect lines) occupied east of the dredge's location, opposite to the direction of current flow, to map ambient TSS concentrations (discussed in a previous section). Background TSS concentrations averaged less than 20 mg/L.
