# **NAVAL POSTGRADUATE SCHOOL**

## **THESIS**

**SYSTEMATIC REVIEW OF ULTRASONIC IMPACT  
TREATMENT PARAMETERS ON RESIDUAL  
STRESSES OF WELDED NON-SENSITIZED VERSUS  
SENSITIZED ALUMINUM-MAGNESIUM**

March 2015

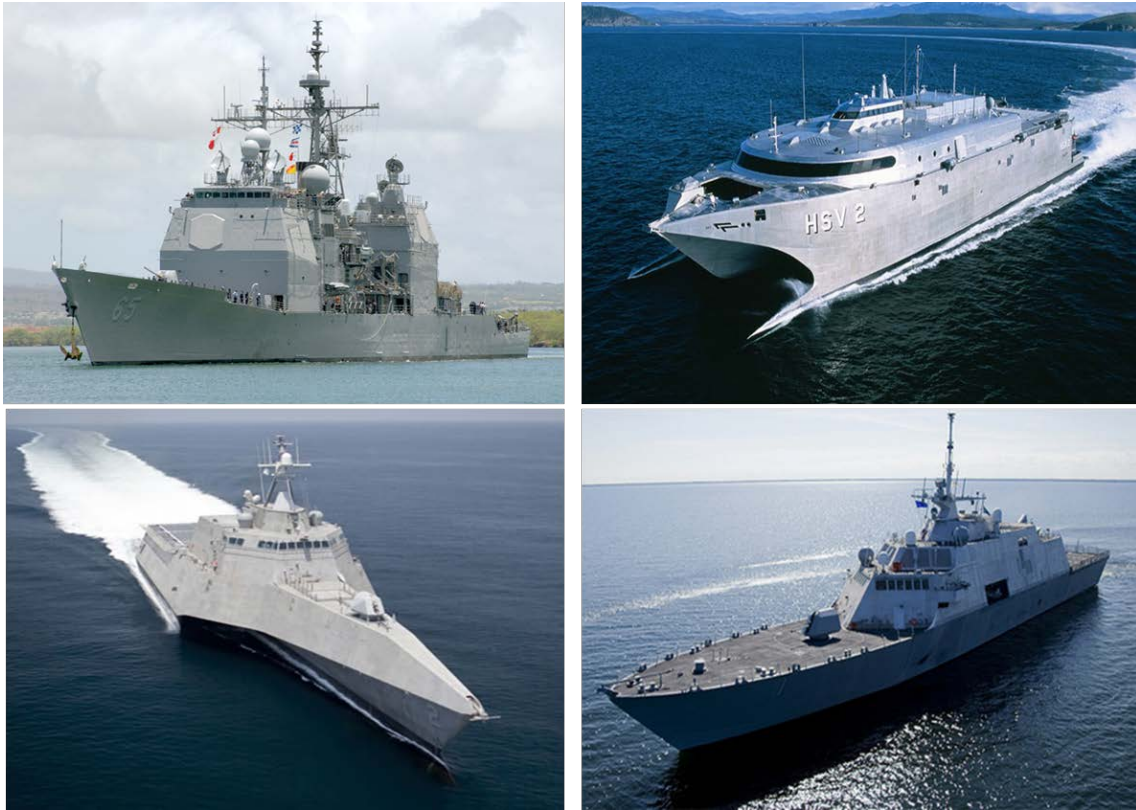
Figure 2. U.S. naval vessels built using marine-grade aluminum-alloy in their superstructures and/or hulls. Clockwise from top left: guided missile cruiser (CG 65), from [5]; high-speed vessel (HSV 2), from [6]; littoral combat ship (LCS 1), from [7]; and littoral combat ship (LCS 2), from [8].

and high-speed vessel (see Figure 2). The superstructure of the Ticonderoga class, which was built using AA5456 and has experienced extensive SCC, is the primary focus of this research.

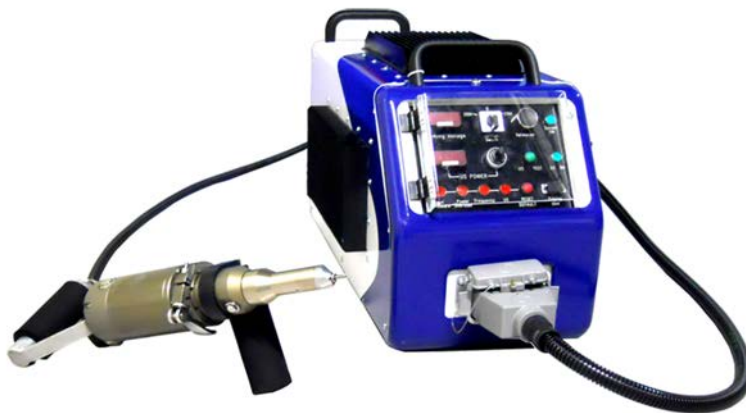
Figure 9. Portable SONATS UIT device with a single-pin applicator attached, from [32].

The SONATS hand held UIT devices, pictured in Figure 8 and Figure 9; create ultrasonic frequencies that are converted to a mechanical displacement of its pin by its piezo-electric emitter. The signal is amplified through various signal promoters before the mechanical vibration is finally transferred to the peening needles (pins). No additional force is required to be applied by the operator, they only need to guide the hand held applicator over the desired region. The pin diameters used can be varied but in shipboard applications is usually 1, 3, or 4 mm in diameter. The vibration amplitude of this device ranges from 10 to 250  $\mu\text{m}$ , and is occasionally designated by percent of input power [31]. Different combinations of the two UIT parameters of vibration frequency (percent input power) and pin size can be selected to produce a range of surface treatments.

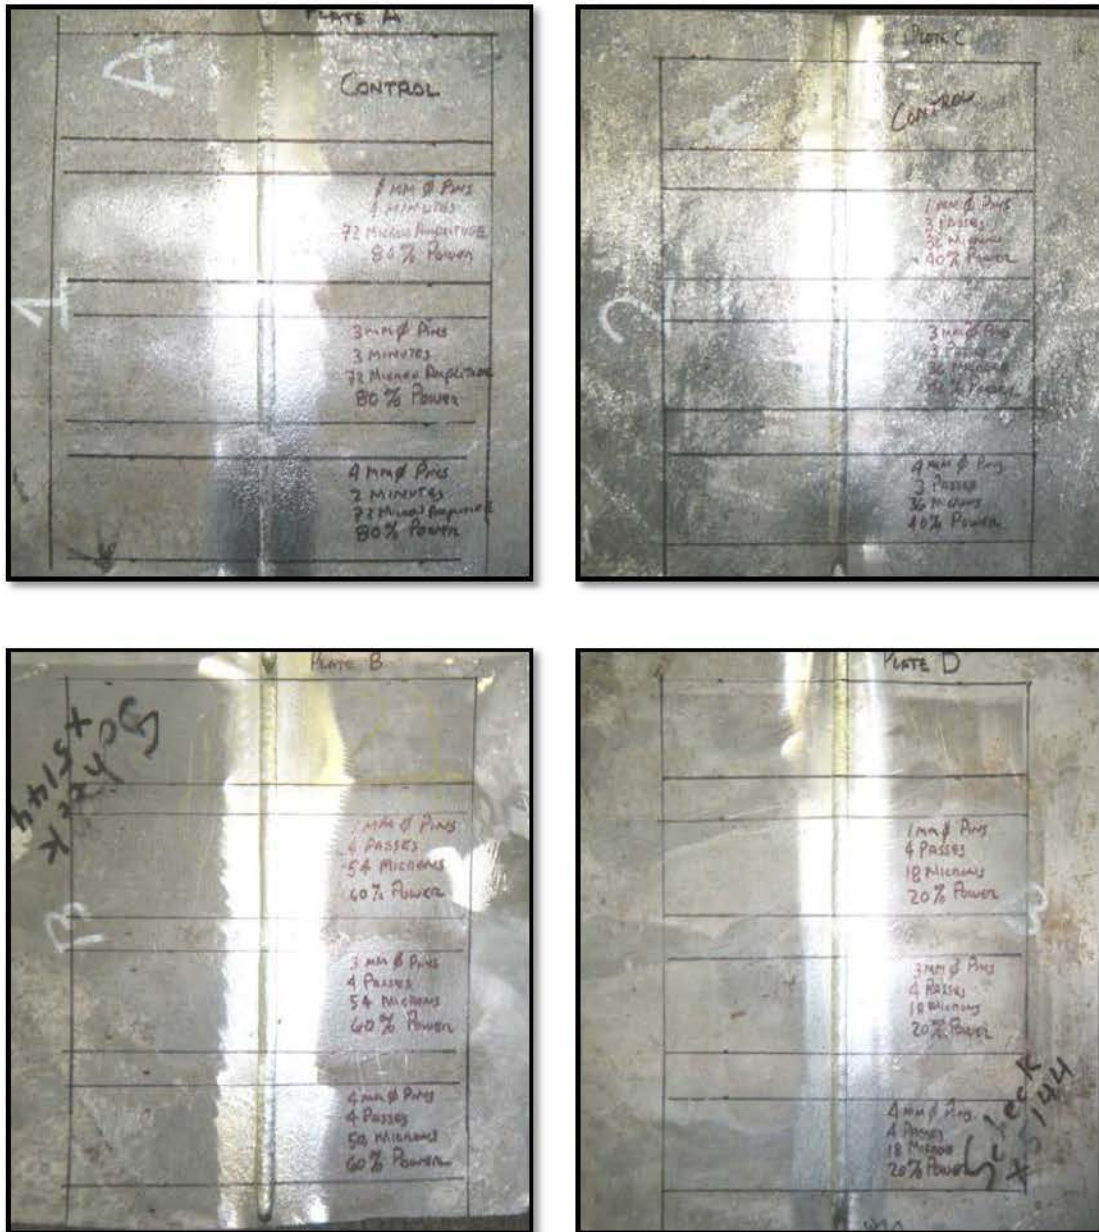
Figure 12. Sensitized, GMAW butt welded AA5456-H116 at various UIT conditions. Clockwise from top left: Surface A, C, D, and B.

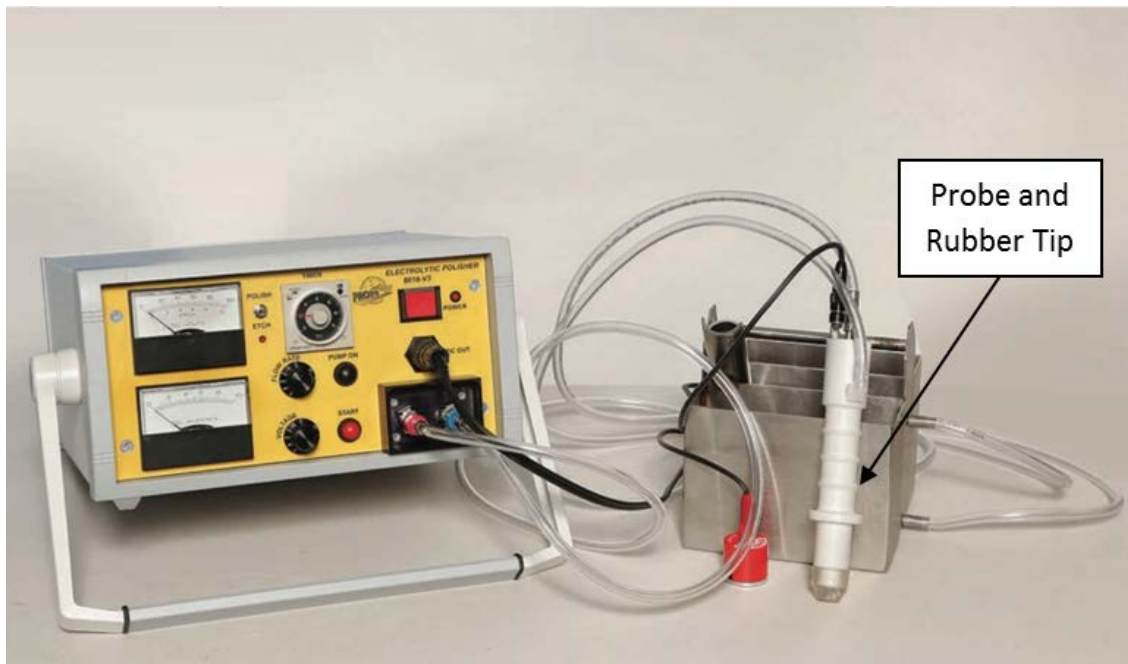
Figure 21. Proto Electrolytic Polisher Model 8818-V3 used to remove surface material for depth-resolved measurements.

The Proto Electrolytic Polisher Model 8818-V3 was used to remove layers of surface material from specified areas of the aluminum samples to allow for depth-resolved residual stress measurements (see Figure 21). A 10 percent perchloric acid-90 percent ethanol solution chilled in a freezer to approximately 0 degrees Celsius (32 degrees Fahrenheit) with an applied voltage of 20 volts was used. The solution was chilled to increase its viscosity and aid in removal of surface material. These parameters resulted in a current between 0.1-0.2 amperes and a material removal rate between 500–1000  $\mu\text{m}$  per 5 minutes of run-time. A 15 mm (0.6 in) diameter rubber applicator tip was used on the probe producing circular polished area with a diameter of approximately 12 mm (0.5 in) (see Figure 21 and Figure 22). To maintain viscosity of the solution was chilled in a freezer between applications. Depth measurements were taken using the Proto XRD automatic positioner.

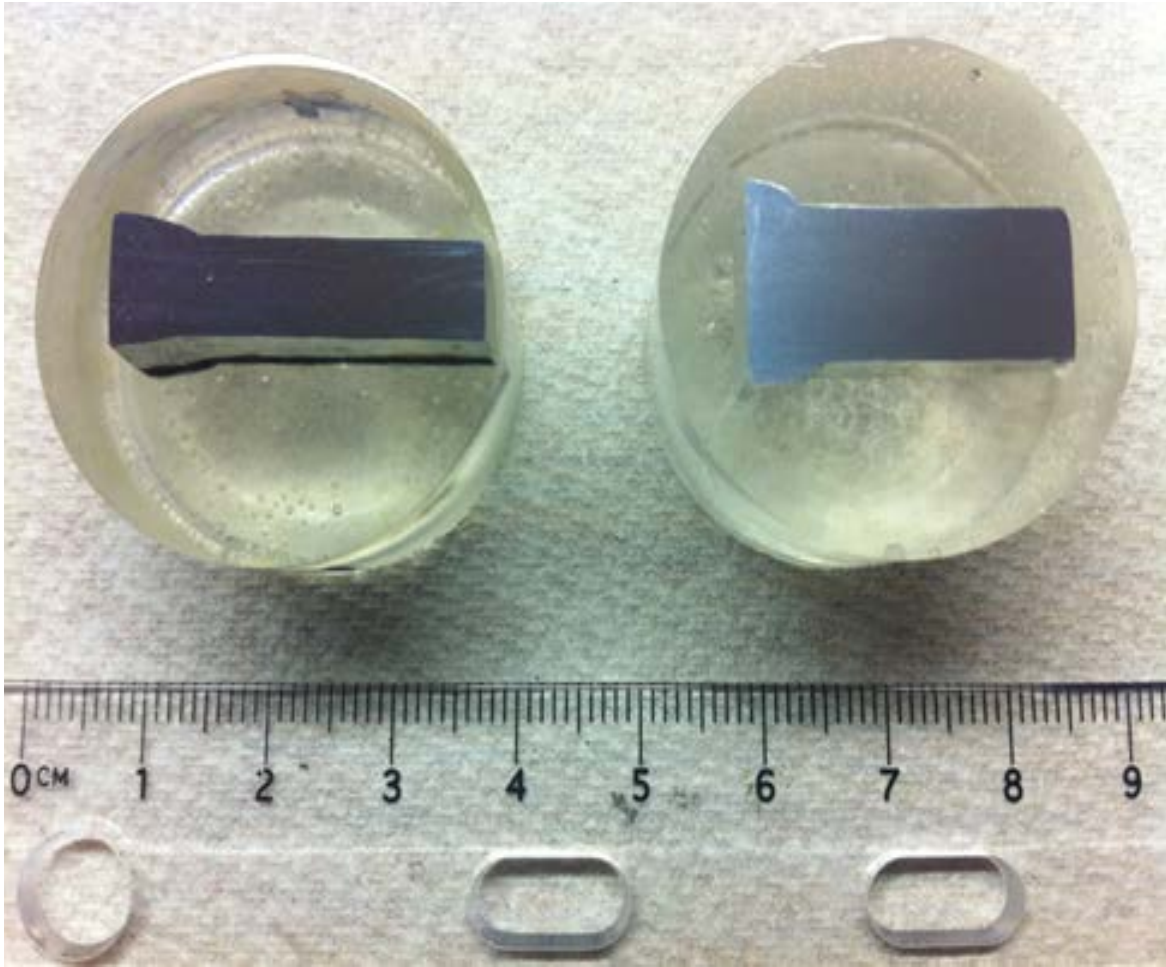
Figure 23. Samples of AA5456 mounted in epoxy molds prior to performing metallographic polishing.

Optical microscopy was used to examine the microstructure of the aluminum after UIT. Cross-sectional samples were cut transverse to the weld from each zone of sample sets one and two; a total of 12 samples, each approximately 6 millimeters (.24 inches) wide and 15 millimeters (.59 inches) long. Each sample was then individually mounted in epoxy molds to allow for metallographic polishing of the cross-section of the weld (see Figure 23). This configuration was used to examine the microstructure as a function of depth from the weld toe through the HAZ and beyond.
